# **FIRE SAFETY INSPECTION REPORT**

**MASIHATA SWEATERS LTD**  
**SOUTH PANISHAIL, BKSP, KASHIMPUR**

**ACCORD**  
on Fire and Building Safety in Bangladesh

April 7, 2014

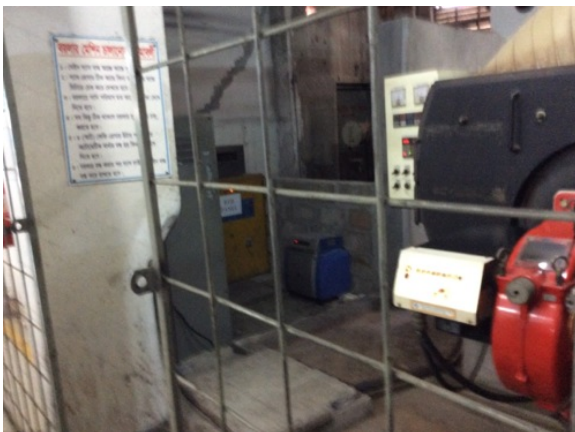
| No. | Category | Finding | Recommendation | Remediation Timeframe |
|---|---|---|---|---|
| F-1 | Fire Rated Construction | The boiler/transformer room on the ground floor is not separated by fire-rated construction due to a non-rated door. | Separate the boiler room by a minimum 2-hr fire-rated construction. Seal and/or protected all openings to maintain the required fire separations | Within 3 months |

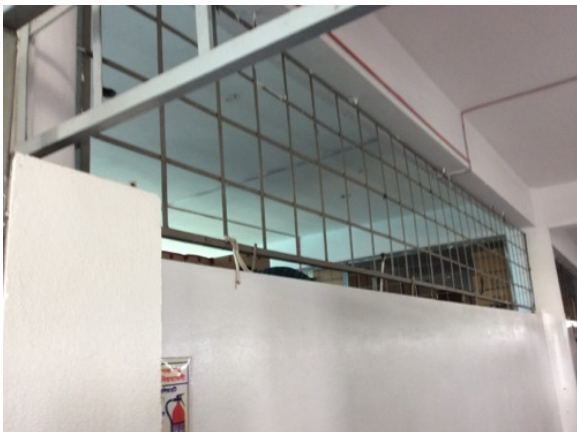
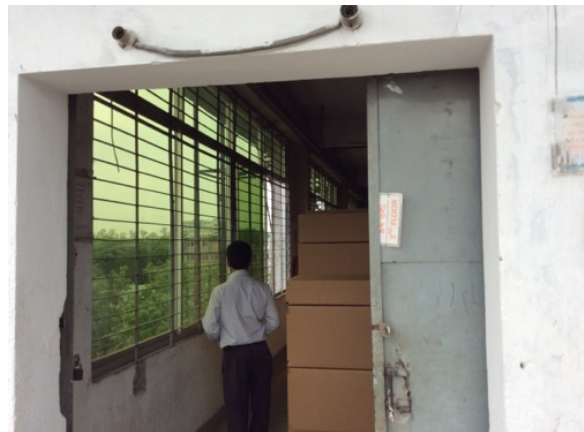
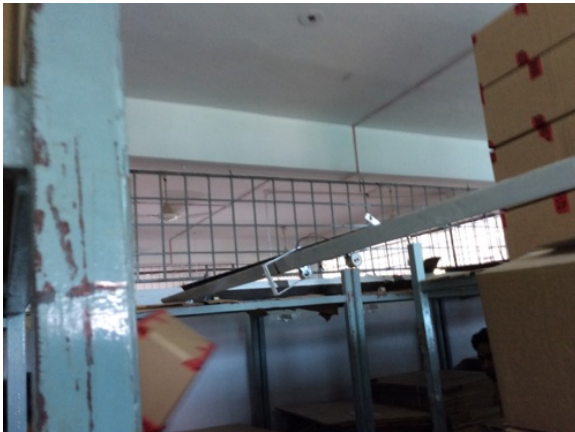
| F-2 | Fire Rated Construction | Storage rooms on multiple floors throughout the building were not separated from adjacent work areas and exit stairs by fire-rated construction. | <p>Provide dedicated storage rooms separated by minimum 1-hr fire-rated construction. Provide vestibules to separate storage rooms from exit stairs and passageways.</p> <p>Where separate storage rooms are not feasible, provide defined storage areas and limit the storage arrangement as follows:</p> <ul style="list-style-type: none"><li>- Maximum height of 2.4m and maximum area of 23m<sup>2</sup></li><li>- If sprinkler protected: maximum height of 3.66m and maximum area of 93m<sup>2</sup></li></ul> <p>Separate areas of unenclosed combustible storage by a minimum clear distance of 3m.</p> | Within 3 months |

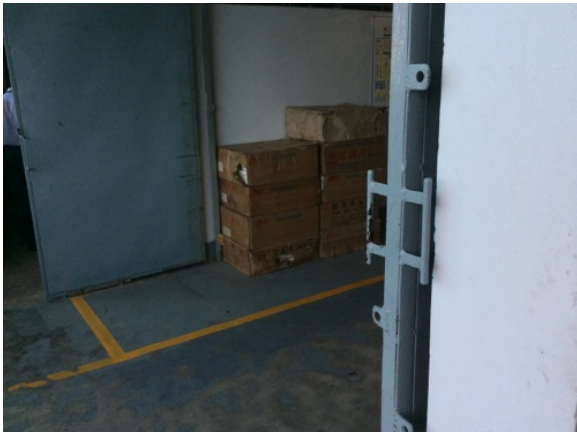
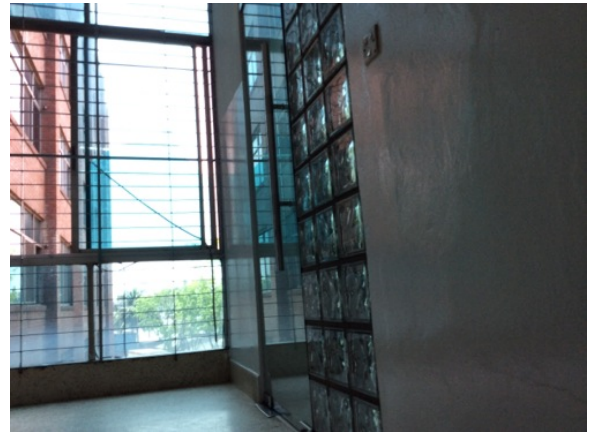
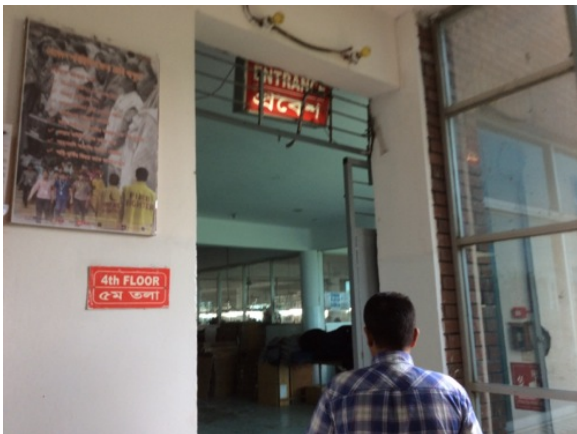
| F-3 | Fire Rated Construction | The Northwest exit stair is not separated from work areas and other spaces on each floor by fire-rated construction. | <p>Provide minimum 1.5-hr fire rated doors and seal all unprotected openings to separate the exit stairs from work areas and other building spaces on all floor levels. Ensure that the fire doors are self-closing and positive latching and that they are provided with fire exit (panic) hardware where serving production floors.</p> <p>If fire doors are required to be held open for functional reasons, provide automatic-closing devices tied to the fire alarm system.</p> | Within 3 months |

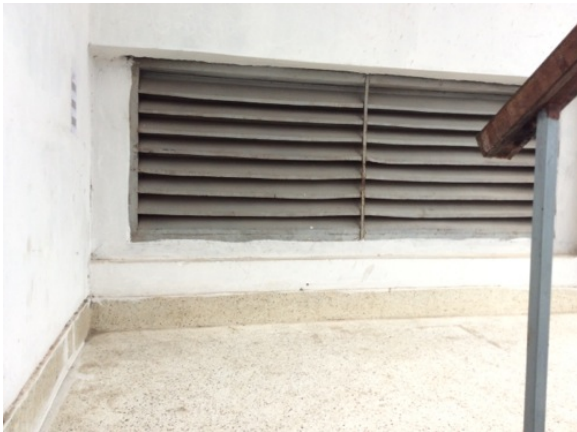
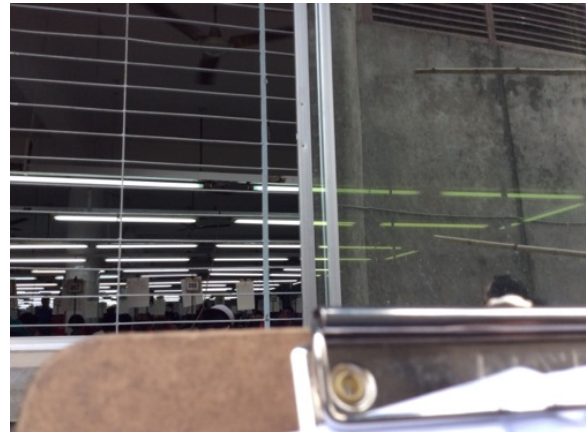
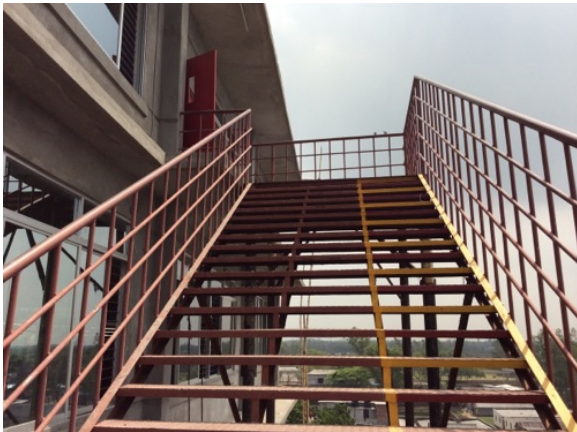
| F-4 | Fire Rated Construction | The exterior exit stairs are not separated from work areas on each floor by fire-rated construction due to unprotected window and ventilation openings. | <p>Provide minimum 1.5-hr fire rated doors and seal all unprotected openings to separate the exit stairs from work areas and other building spaces on all floor levels. Ensure that the fire doors are self-closing and positive latching and that they are provided with fire exit (panic) hardware where serving production floors.</p> <p>If fire doors are required to be held open for functional reasons, provide automatic-closing devices tied to the fire alarm system.</p> | Within 3 months |

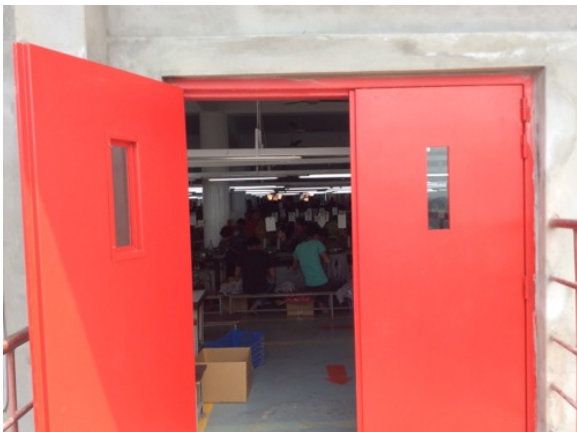
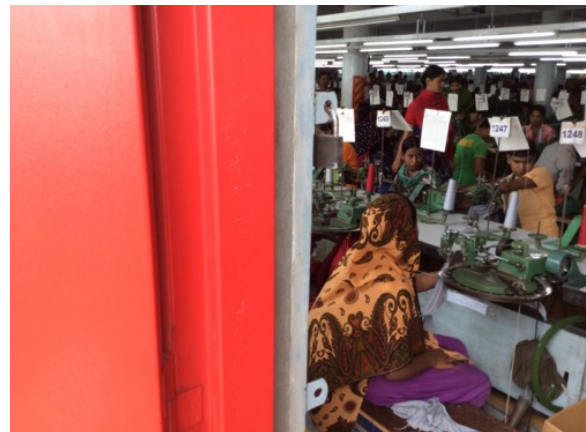
| F-5 | Fire Rated Construction | No documentation of certification or testing was provided for the fire-rated doors provided in multiple locations on exit stairs and various rooms. | Provide documentation that fire doors are tested and certified in accordance with BNBC and NFPA 101. | Within 3 months |

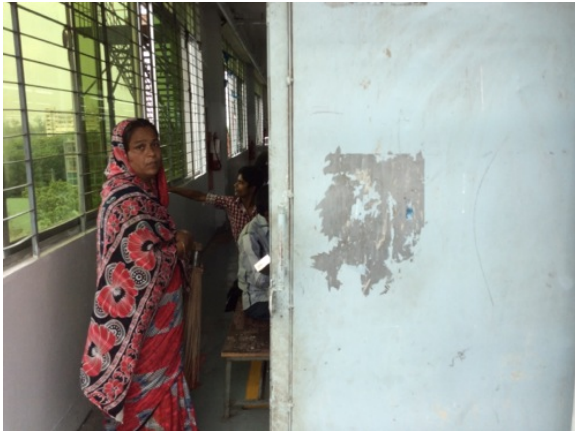
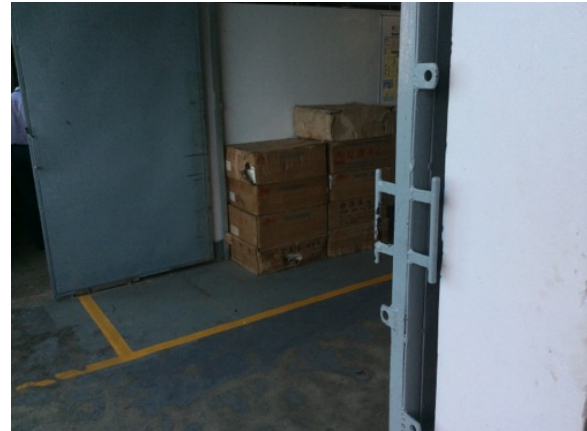
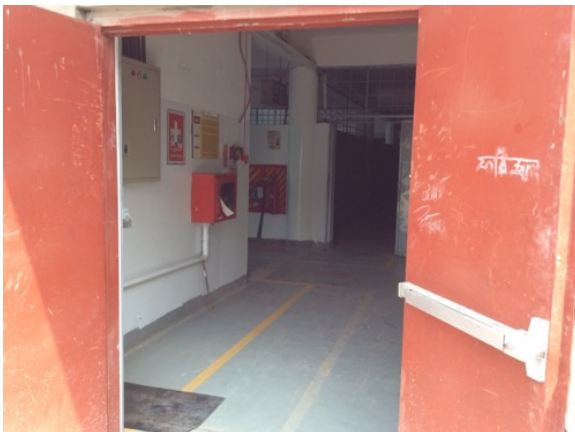
| F-6 | Egress | Egress doors and gates with locking features are provided at all exit stair openings and discharge. Only two doors are provided with panic hardware. | Remove locking features from all egress doors and gates.<br><br>If locks are required for security reasons, utilize special door locking features complying with NFPA 101. | Immediate |

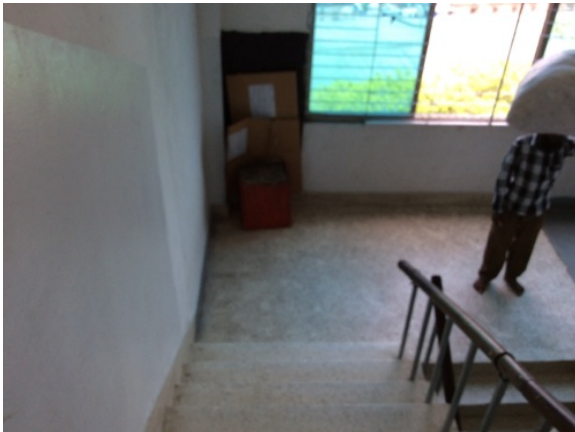
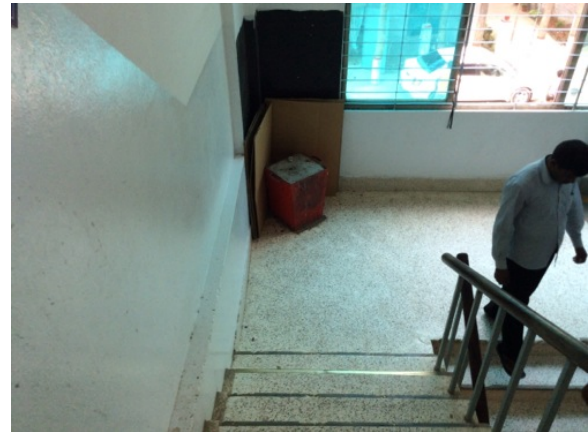
| F-7 | Egress | Dustbins and cardboard were located in the Southwest exit stair. | Remove all storage from exit stairs and egress paths. | Immediate |

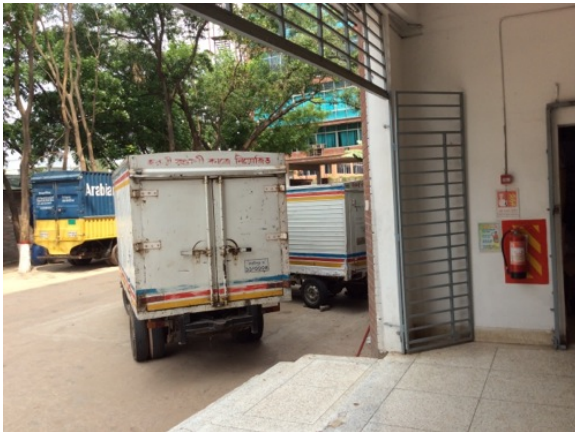
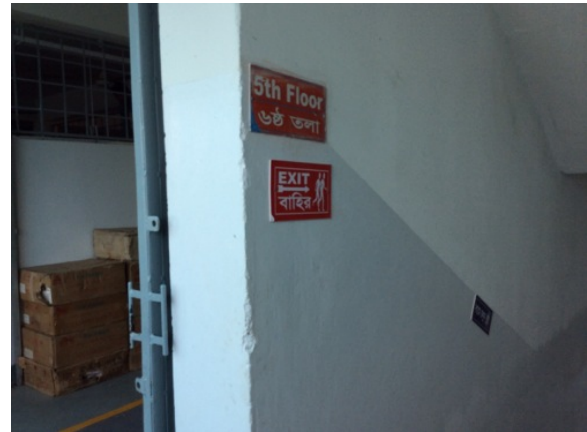
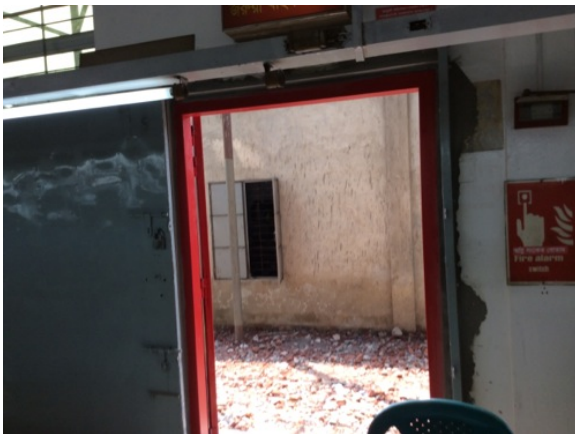
| F-9 | Egress | Collapsible gates or sliding doors are provided at all exit stair openings and discharge, including the openings that are also provided with fire-rated doors. | Replace all gates and sliding doors along the means of egress with side-hinged, swinging egress doors.<br><br>If locks are required for security reasons, utilize special door locking features complying with NFPA 101. | Within 1 month |

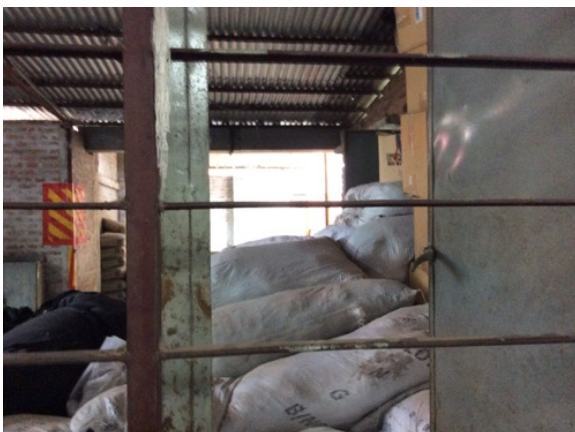
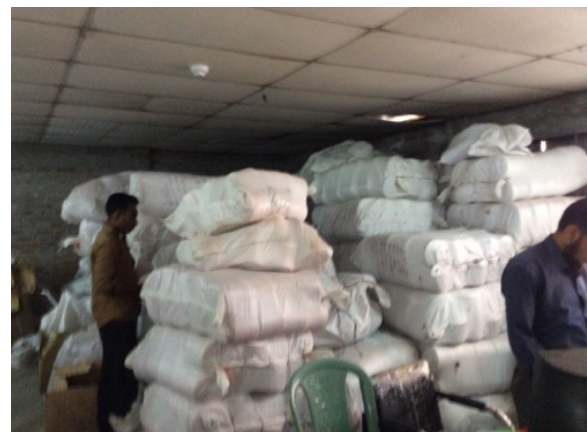
| No. | Category | Finding | Recommendation | Remediation Timeframe |
|---|---|---|---|---|
| F-1 | Fire Rated Construction | Areas used for combustible storage are not separated by fire-rated construction. | <p>Provide dedicated storage rooms separated by minimum 1-hr fire-rated construction.</p> <p>Where separate storage rooms are not feasible, provide defined storage areas and limit the storage arrangement as follows:</p> <ul style="list-style-type: none"> <li>- Maximum height of 2.4m and maximum area of 23m<sup>2</sup></li> <li>- If sprinkler protected: maximum height of 3.66m and maximum area of 93m<sup>2</sup></li> </ul> <p>Separate areas of unenclosed combustible storage by a minimum clear distance of 3m.</p> | Within 3 months |

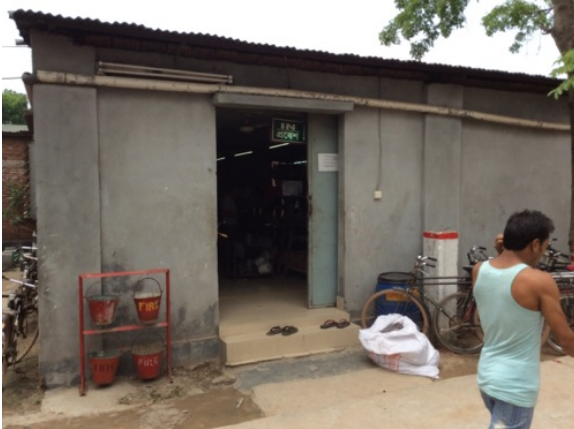
| F-2 | Egress | Egress doors with locking features are provided at all exits. | Remove locking features from all egress doors and gates.<br><br>If locks are required for security reasons, utilize special door locking features complying with NFPA 101. | Immediate |

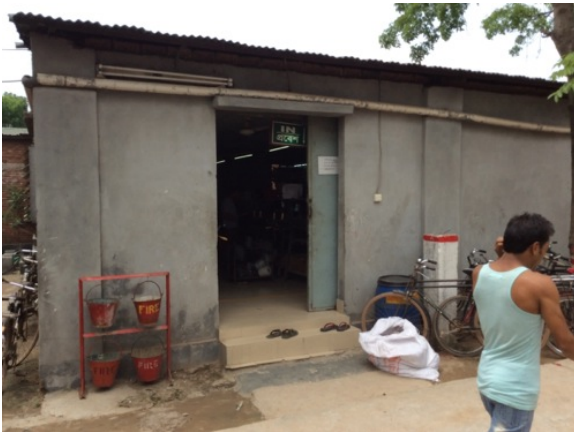
| F-3 | Egress | Sliding doors are provided at all exits. | Replace all gates and sliding doors along the means of egress with side-hinged, swinging egress doors.<br><br>If locks are required for security reasons, utilize special door locking features complying with NFPA 101. | Within 1 month |
