# INITIAL FIRE SAFETY INSPECTION REPORT

**PIMKIE APPARELS LTD. (New Building)**

**RSC ID: 24190**

**ADDRESS: Plot # 327, Block # F, Tongi, Industrial Area**

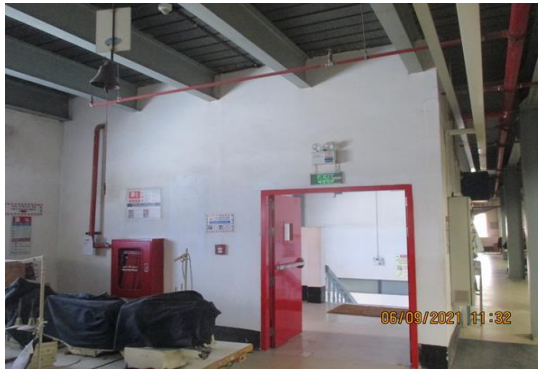
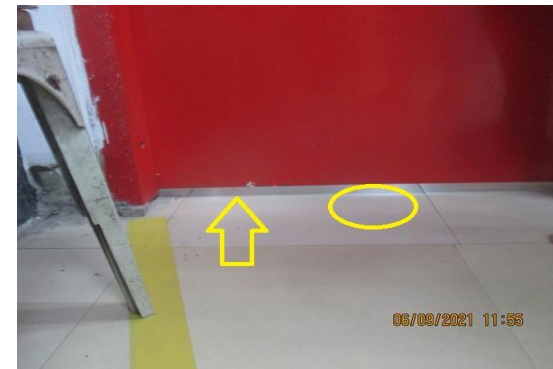
| SI No. | Category | Findings | Required Action | Remediation Time Frame |
|---|---|---|---|---|
| F-1 | Fire Rated Construction | <p>Exit Enclosures are not properly fire separated from other occupancy on each floor by fire rated construction.</p> <p>Location: New building</p> | <p>Provide minimum 2-hr fire rated separation exit enclosure. Provide minimum 1.5-hr fire rated doors and seal all unprotected openings and penetration to separate the exit stairs from work areas and other building spaces on all floor levels.</p> <p>The clearance under the bottom of a fire door shall be a maximum of 19mm.</p> <p>Ensure that the fire doors are self-closing and positive latching and that they are provided with fire exit (panic) hardware where serving production floors. If fire doors are required to be held open for functional reasons, provide automatic closing devices tied to the fire alarm system.</p> | Within 3 months |

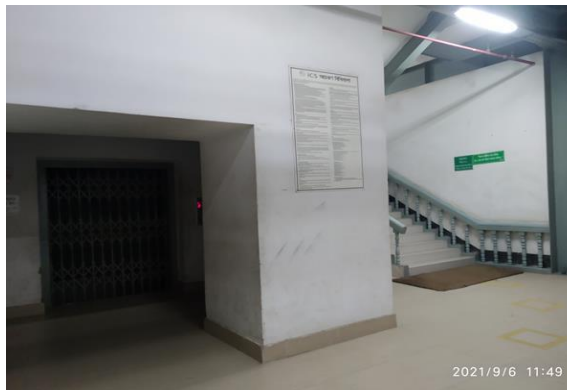
F-2

Elevator shafts are directly open into the exit  
enclosure without proper fire separation.

Location: New building

Ensure minimum 2-hr listed/3rd part certified fire  
rated lift landing doors for elevator shafts  
otherwise close the area of the shaft with a 2-hr  
fire-rated construction barrier.

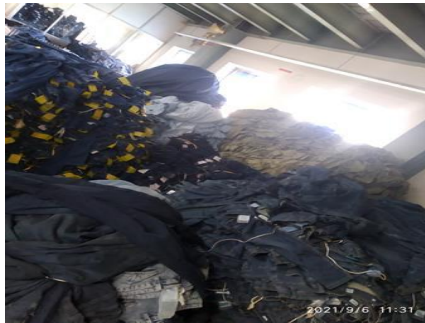
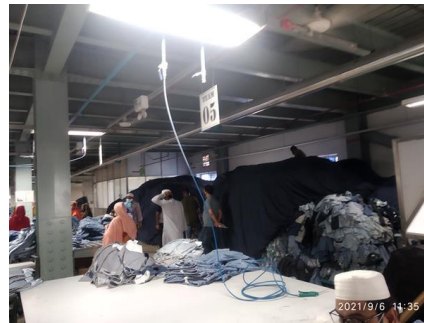
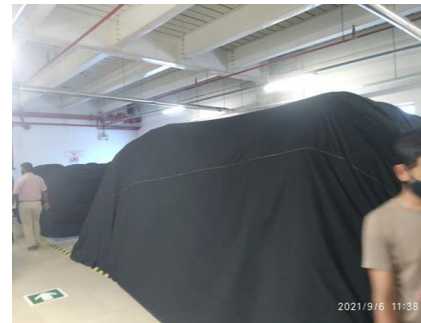
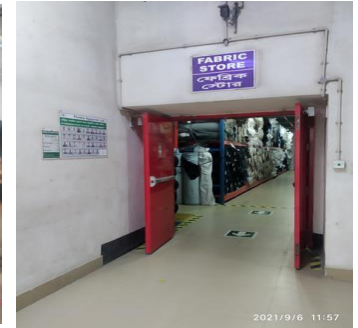
| F-3 | Fire Rated Construction | <p>Areas used for storage of combustible materials are open to the surrounding occupancy which are not separated by fire rated construction.</p> <p>Location: ground, 2nd &amp; 3rd floor of new building</p> | <p>Provide dedicated storage rooms separated by minimum 1-hr fire-rated construction.</p> <p>Or,</p> <p>Where separate storage rooms are not feasible, Provide defined storage areas and limit the storage arrangement as follows:-</p> <ol style="list-style-type: none"> <li>1. General Condition: Maximum height of 2.4m and maximum area of 23m<sup>2</sup>. Separate areas of unenclosed combustible storage by a minimum clear distance of 3m.</li> <li>2. If sprinkler protected: maximum height of 3.66m and maximum area of 93m<sup>2</sup>. Separate areas of unenclosed combustible storage by a minimum clear distance of 3m.</li> </ol> | Within 3 months |

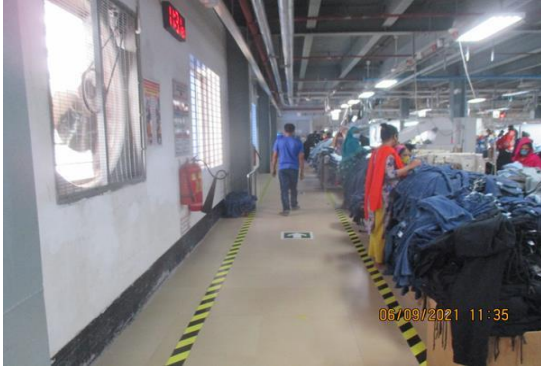
| F-4 | Fire Rated Construction | <p>The main structural elements of the buildings are constructed by steel which is non-rated and were found in exposed condition without any fire protection.</p> <p>Location: New building</p> | <p>The buildings are new steel structure which shall be type-I or II construction. So, provide require rating in the structural elements of the buildings. Consult with a qualified fire protection engineer. Follow BNBC 2006-Table 3.2.4, 3.1.9 and 3.3.1 as reference.</p> | Within 6 months |

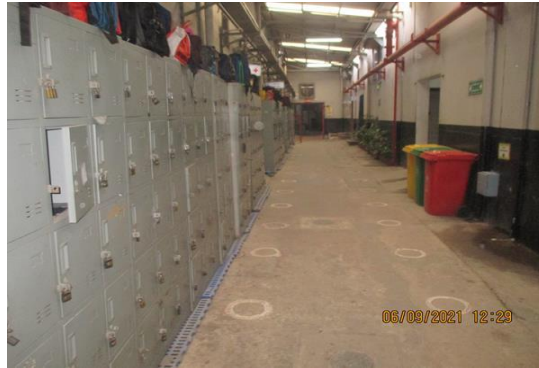
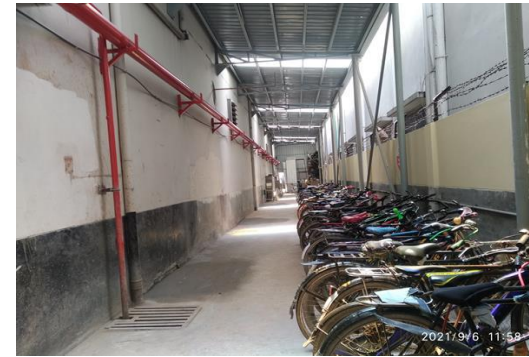
| F-5 | Fire Rated Construction | <p>The exit discharge path (Passageway) is not fire-rated separated as the non-rated roof is continuous.</p> | <p>Provide minimum 2 hr. fire rated exit discharge path which will lead directly outside.</p> | Within 3 months |

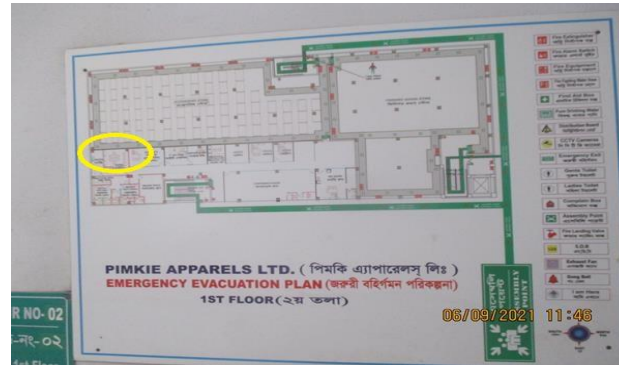
| F-6 | Fire Rated Construction | <p>The Dining area and prayer room are not separated by fire rated construction with the adjacent production occupancies.</p> <p>Location: 1st floor of new building</p> | <p>Separate the dining area and prayer room from production &amp; other occupancies by minimum 3-hr fire rated construction. Provide rated exit passageways leading directly to the exit stairs of the same resistance rating.</p> | Within 3 months |

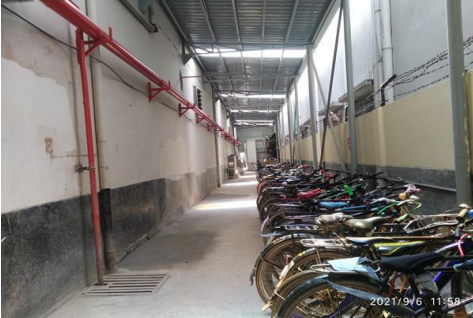
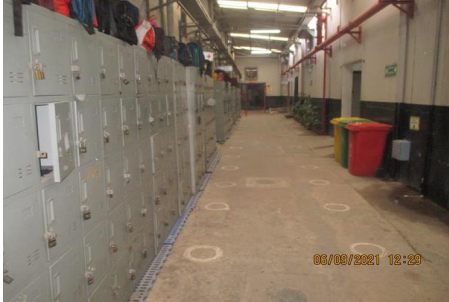
| F-7 | Means of Egress | <p>The exit discharge path (Egress Court) are obstructed by storage</p> <p>Location: West side of the building.</p> | Means of egress shall be maintained continuously free and clear of all obstructions | Within 1 months |

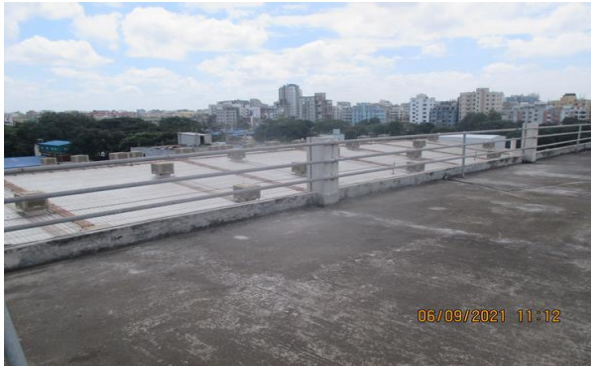
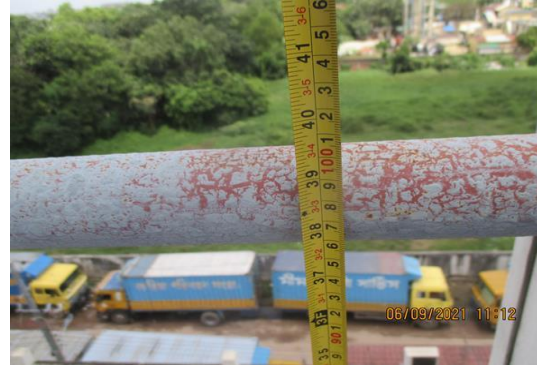
| F-8 | Means of Egress | <p>Parapets or guards are provided in occupied roof which is less than 1067mm (42 inch).</p> <p>Location: New Building</p> | Provide parapets or guards with a minimum height of 1067mm (42 inch.). | Within 3 months |

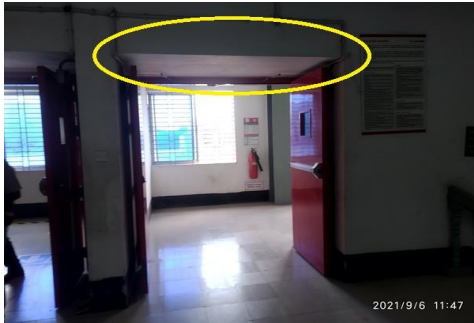
| F-9 | Egress lighting | Exit sign not provided at required location each location. | <p>Illuminated exit signs shall be placed at entrance to an exit. Additional exit signs shall be placed throughout the facility anywhere the continuation of the egress is not obvious. Illuminated exit signs shall be provided with either battery backup or uninterruptable power supply systems and shall be continuously illuminated.</p> | Within 1 month |

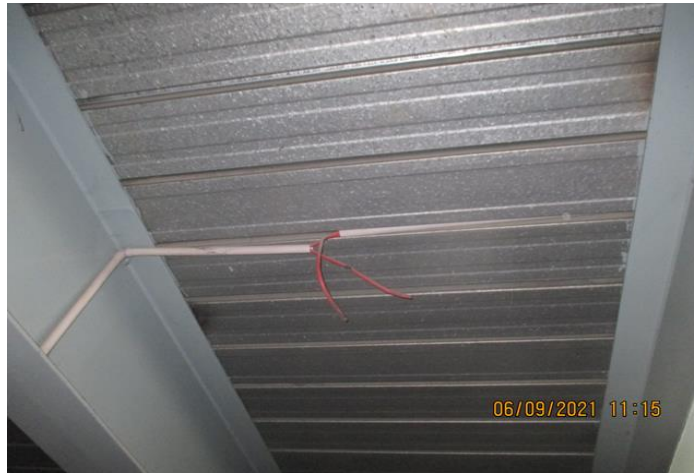
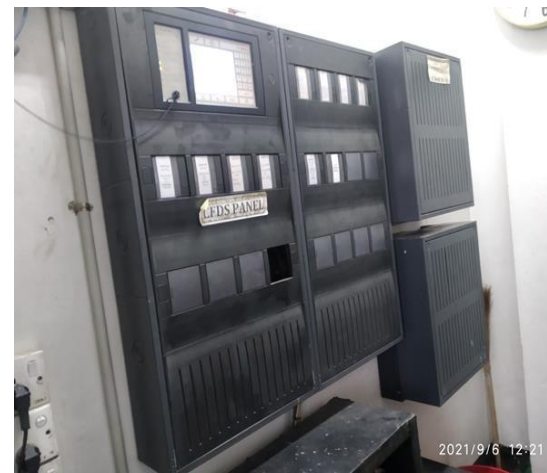
| F-12 | Fire Alarm & Detection System (FADS) | <p>An addressable fire alarm &amp; detection system installation was ongoing during inspection day. The Required Fire Alarm system is not installed in accordance with the ACCORD standard and NFPA-72.</p> <p>Location: New building &amp; Utility building 01</p> | <p>Design &amp; Installation of Fire Alarm system shall be in accordance with ACCORD standard and NFPA 72. Submit design, documents and calculations to RSC for review prior installation/modification.</p> <p>After installation the owner shall contact the RSC for witness of conducting the final acceptance testing of the fire detection &amp; alarm system installation.</p> <p>Also inspect, test and maintain the fire alarm system, and keep written records on-site, in accordance with NFPA 72.</p> | <p>Design within 2 months, Install within 4 months.</p> |

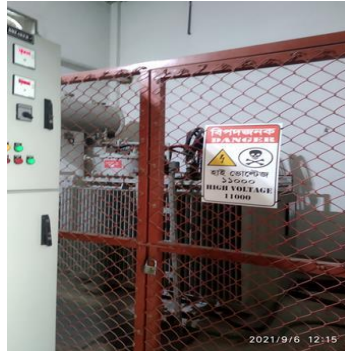
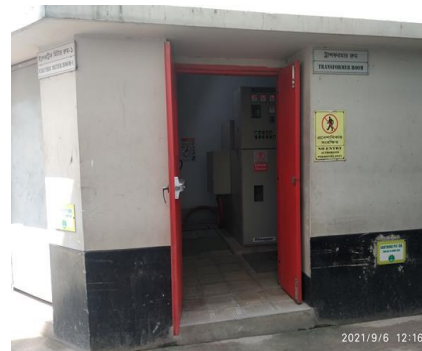
| F-18 | Fire Rated Construction | Generator, Transformer & Substation are not properly separated from each other by fire rated construction. | Generator, Transformer & substation shall be separated from each other by a minimum 2-hr fire-rated construction (wall, floor, slab, etc.). Seal all penetrations and openings (door, window, etc.) by minimum 1.5-hr fire-rated materials to maintain the fire separation as required. All exhaust systems shall discharge to the exterior of the building in a safe location. | Within 3months |
