# INITIAL FIRE SAFETY INSPECTION REPORT

## J.K. KNIT COMPOSITE LIMITED (EXTENSION)

RSC ID: 24173

Date: 09 June 2021

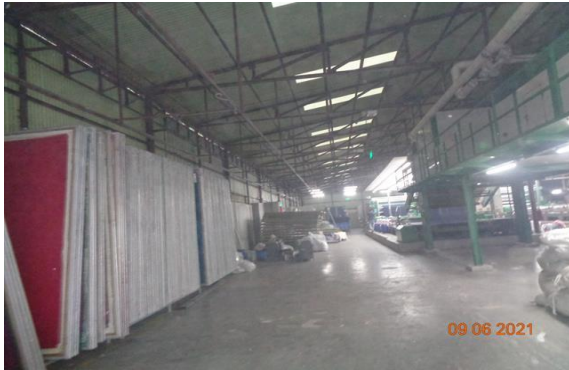
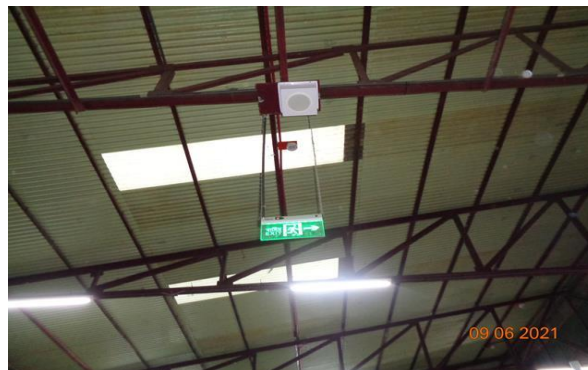
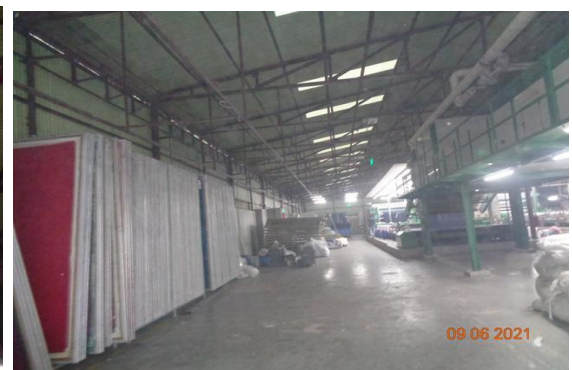
SI No.	Category	Findings	Required Action	Remediation Time Frame
F-1	Fire Rated Construction	<p>The main structural element of the building is constructed by steel which is non-rated and were found in exposed condition without any fire protection.</p> <p><b>Location:</b> All over Print shed (AOP).</p>	<p>Construction of new non high rise building containing G and/or H 2 occupancies shall be Type 1 or Type 2 construction as required in BNBC Part 2 Table 3. 2.4. Provide/ensure required fire rating on the structural elements by following Section 4.4 and Table 4.4.1 of the Accord Standard or Table 3.3.1 and Table 4.1.1 from BNBC. Consult a qualified fire protection engineer to design the rated construction barriers in between floors and in structural members.</p>	Within 6 months

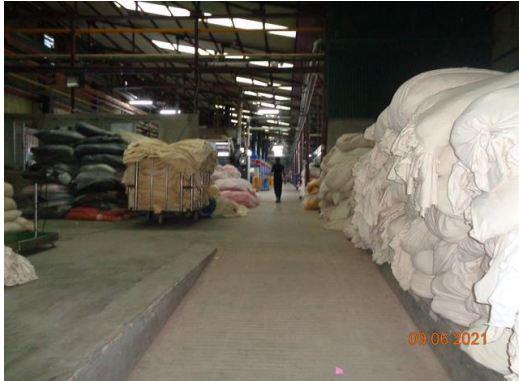
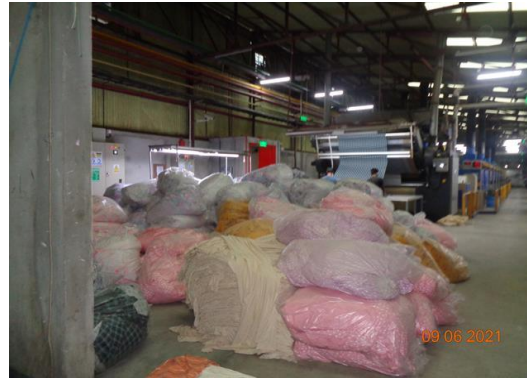
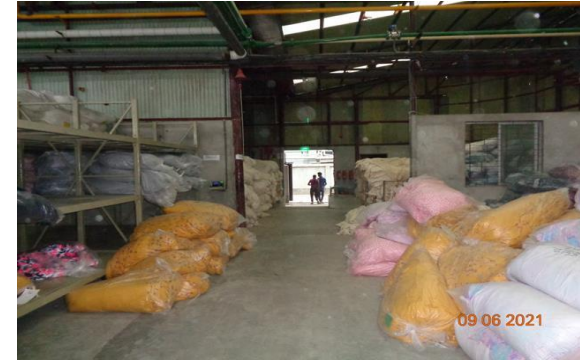
F-2	Fire Rated Construction	Areas used for combustible storage open to the floor are not properly defined and not within limits. <b>Location:</b> All over Print shed (AOP)	<p>Provide defined storage areas and limit the storage arrangement as follows:</p> <ul style="list-style-type: none"> <li>-Maximum height of 2.45m (8 ft) and maximum area of 23 m<sup>2</sup> (250 ft<sup>2</sup>).</li> <li>-If sprinkler protected: maximum height of 3.66m (12 ft) and maximum area of 93m<sup>2</sup> (1000 ft<sup>2</sup>).</li> </ul> <p>Separate the areas of unenclosed combustible storage by a minimum clear distance of 3 m (10 ft).</p>	Within 3 months
-----	-------------------------	---	--	-----------------

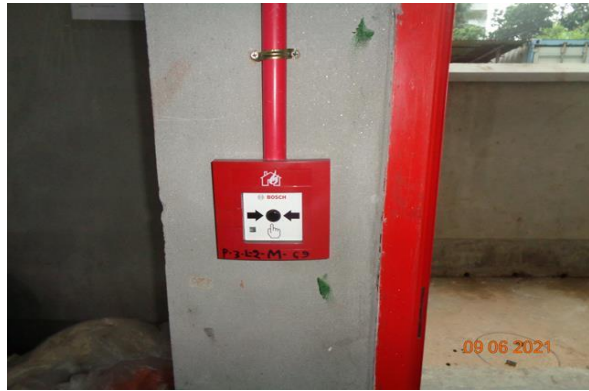
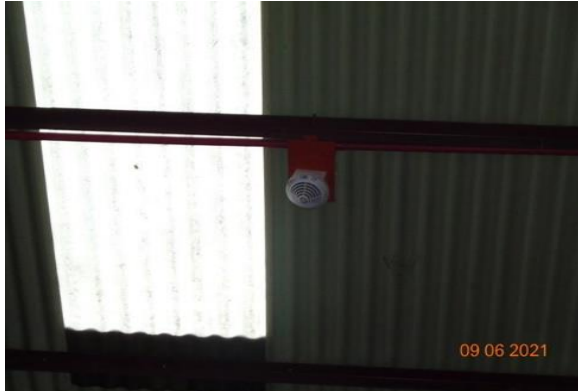
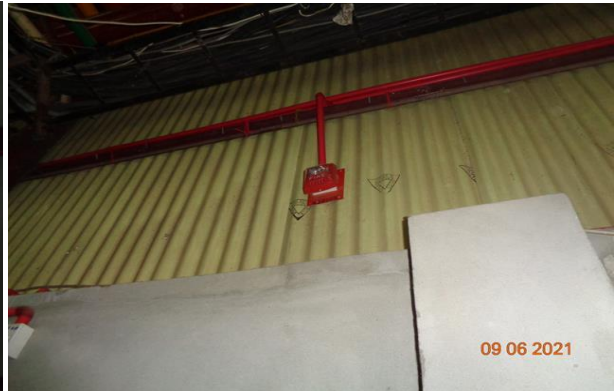
F-3	Fire Alarm & Detection system (FADS)	The addressable fire detection and alarm system is installed for the shed during inspection. The fire alarm system installation require detailed review to compliance with NFPA 72 and standard.	Design & Installation of Fire Alarm system shall be in accordance with ACCORD standard and NFPA 72. Submit design, documents and calculations to RSC for review prior installation/modification. After installation the owner shall contact the RSC for witness of conducting the final acceptance testing of the fire detection & alarm system installation. Also inspect, test and maintain the fire alarm system, and keep written records on-site, in accordance with NFPA 72.	Design submission within 1 month and installation modification within 3 months (If required).
-----	--------------------------------------	--	--	---
