INITIAL FIRE SAFETY INSPECTION REPORT

IRIS FABRICS LIMITED (Extension Building)

RSC ID: 24209

Date: 20-September -2021

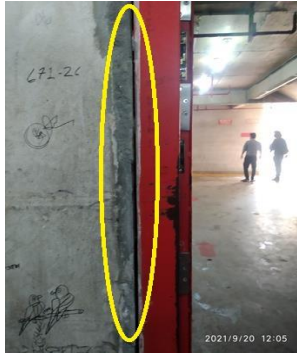
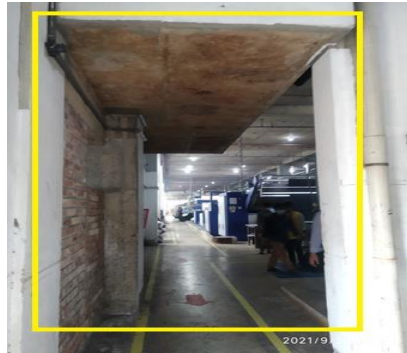
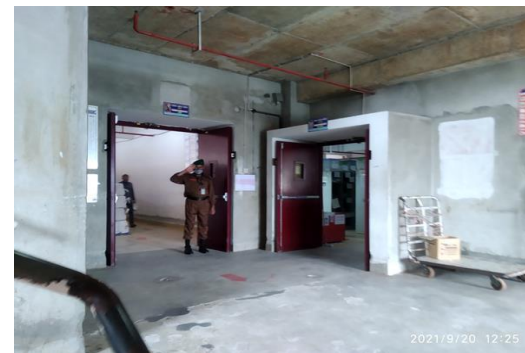
Sly No.	Category	Findings	Required Action	Remediation Time Frame
F-1	Fire Rated Construction	Exit Enclosures are not properly fire separated from other occupancy on each floor by fire rated construction.	Provide minimum 2-hr fire rated separation exit enclosure. Provide minimum 1.5-hr fire rated doors and seal all unprotected openings and penetration to separate the exit stairs from work areas and other building spaces on all floor levels. Ensure that the fire doors are self-closing and positive latching and that they are provided with fire exit (panic) hardware where serving production floors. If fire doors are required to be held open for functional reasons, provide automatic closing devices tied to the fire alarm system.	Within 3 months

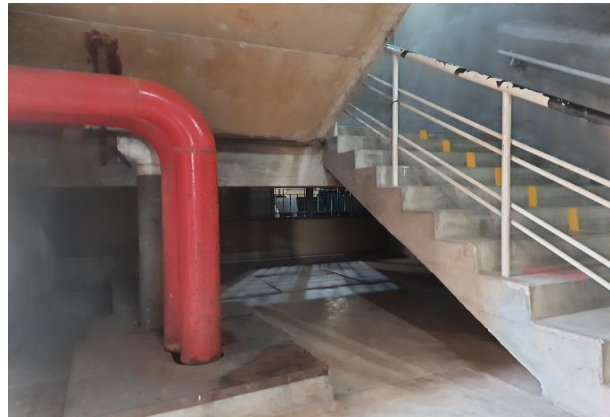
F-2	Fire Rated Construction	Unsealed penetrations and openings are located in exit stair enclosures.	Seal all penetrations and openings in the wall of exit enclosure walls (full thickness of the wall) by fire rated materials to maintain the fire resistance rating.	Within 3 months
-----	-------------------------	--------------------------------------------------------------------------	---------------------------------------------------------------------------------------------------------------------------------------------------------------------	-----------------

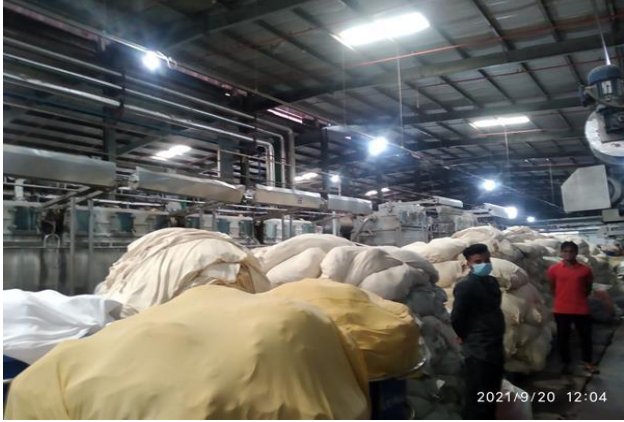
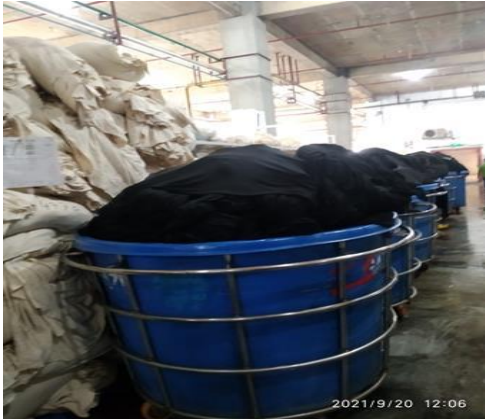
F-3	Fire Rated Construction	<p>Areas used for storage of combustible materials are open to the surrounding occupancy which are not separated by fire rated construction.</p> <p>Location: Ground floor of Dyeing & printing building 01</p>	<p>Provide dedicated storage rooms separated by minimum 1-hr fire-rated construction.</p> <p>Or, Where separate storage rooms are not feasible, Provide defined storage areas and limit the storage arrangement as follows:-</p> <ol style="list-style-type: none"> 1. General Condition: Maximum height of 2.4m and maximum area of 23m². Separate areas of unenclosed combustible storage by a minimum clear distance of 3m. 2. If sprinkler protected: maximum height of 3.66m and maximum area of 93m². Separate areas of unenclosed combustible storage by a minimum clear distance of 3m. 	Within 3 months

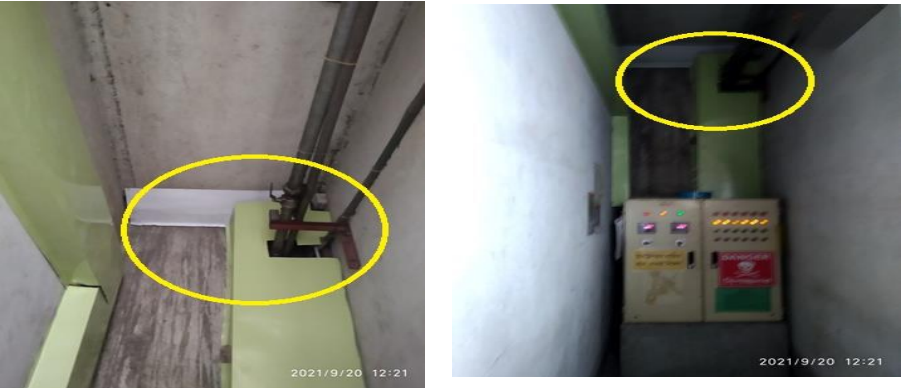
F-4	Fire Rated Construction	<p>Penetrations through fire rated floor/ceiling assemblies are not properly sealed all floor of levels.</p> <p>Location: Electrical cable riser of Dyeing & printing building.</p>	<p>Seal all penetrations and openings in floor/ceiling (full thickness of the floor/ceiling) assemblies by minimum 3-hr fire-rated materials to maintain the required fire-resistance rating.</p> <p>Provide a minimum 2-hr fire-rated shaft to separate the utility risers from each floor if required.</p>	Within 3 months

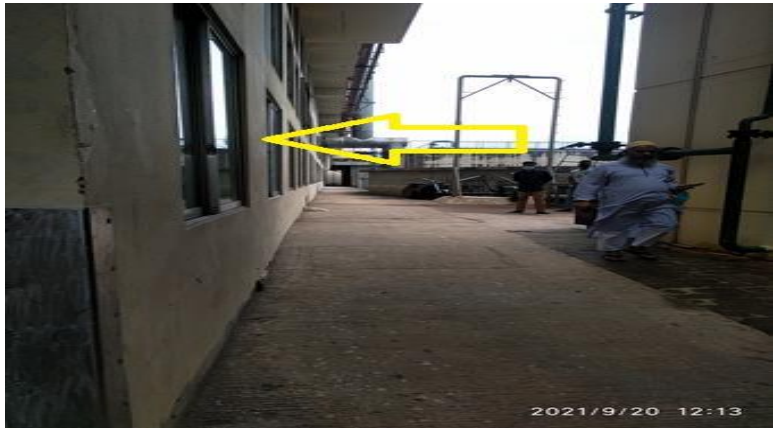
F-5	Fire Rated Construction	<p>The exit discharge path (Egress Court) was less than 10 ft wide and was not separated from the building interior.</p> <p>Location: North side of the building 01-Dyeing & printing</p>	<p>Seal all penetrations and openings to the interior of the building along the discharge path, up to a height of 10 ft. to provide a minimum 2-hr fire separation.</p>	Within 3 months

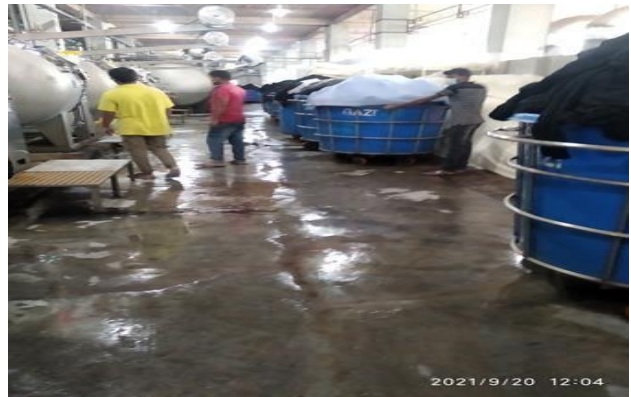
F-6	Means of Egress	The egress path along the means of egress has been interrupted by obstruction/storage and aisles are not marked at ground floor of building 01-Dyeing & printing	Means of egress shall be maintained continuously free and clear of all obstructions/storage. Or Aisles shall be provided with a minimum unobstructed clear- with of 0.9m (36 in).	within 1 month
-----	-----------------	------------------------------------------------------------------------------------------------------------------------------------------------------------------	-----------------------------------------------------------------------------------------------------------------------------------------------------------------------------------------	----------------

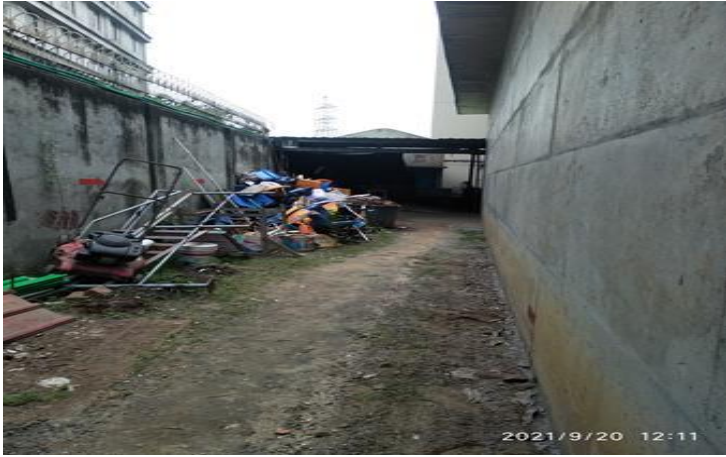
F-7	Means of Egress	<p>The exit discharge path are interrupted by obstruction/storage.</p> <p>Location: North side of the building 01-Dyeing &Printing</p>	Means of egress shall be maintained continuously free and clear of all obstructions	Within 1 month

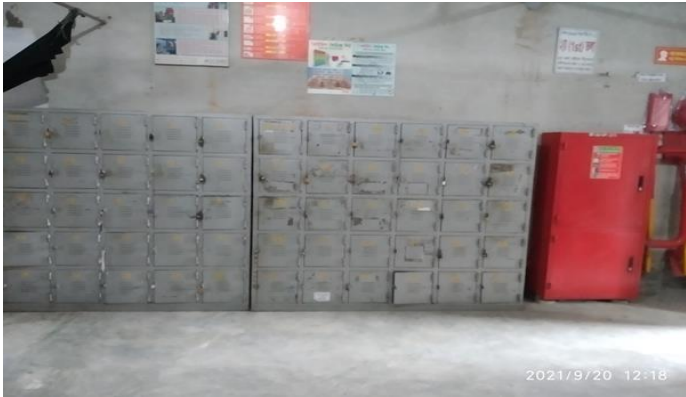
F-8	Means of Egress	Storage are located on the inside of Exit stair.	Remove Storage from exit stairs.	Immediately

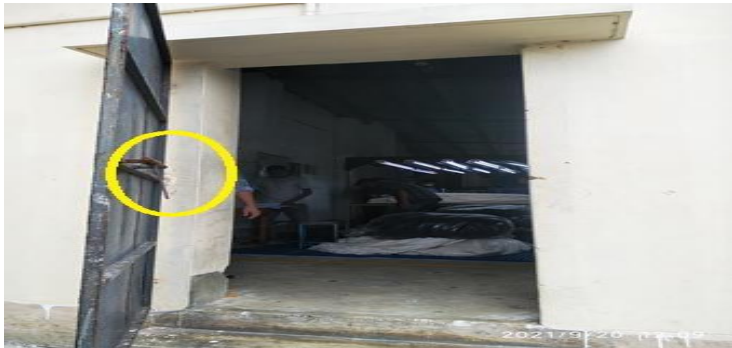
F-9	Means of egress	Egress gates with locking features are provided at several location north side exit discharge	Remove locking features from all egress gates. If locks are required for security reasons, utilize special door locking features complying with NFPA 101.	Immediately
-----	-----------------	-----------------------------------------------------------------------------------------------	-----------------------------------------------------------------------------------------------------------------------------------------------------------	-------------

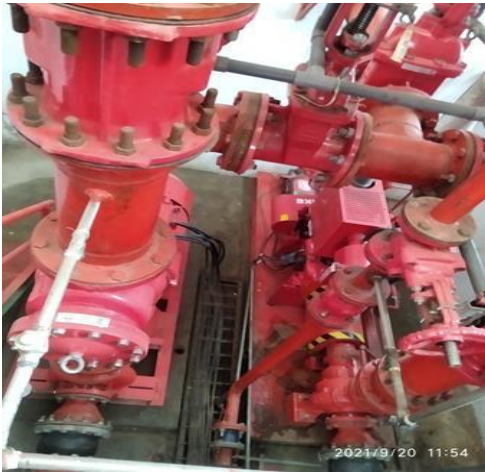
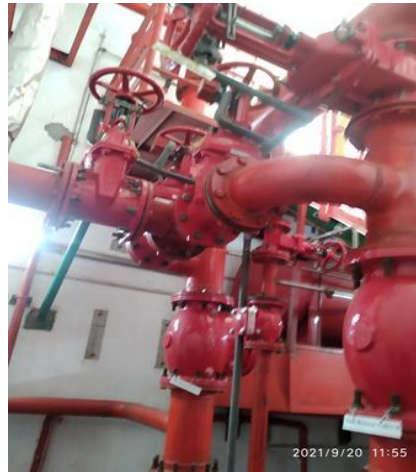
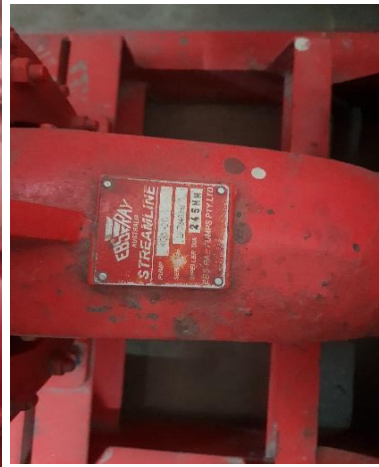
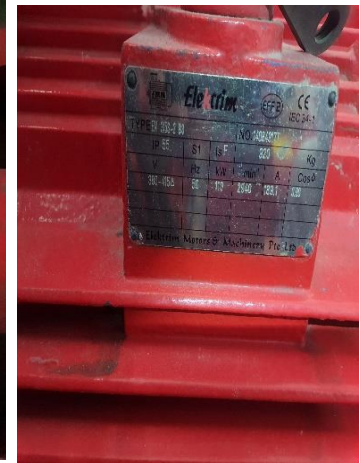
F-13	Fire Protection	The fire pump set installation requires detailed review to confirm compliance with NFPA 20. (Provide proper documentations and listing certificates)	Submit as-built drawings, testing records, equipment certification and other relevant documentation to the RSC for review and approval/acceptance test.	Design within 2 months, Install within 4 months.

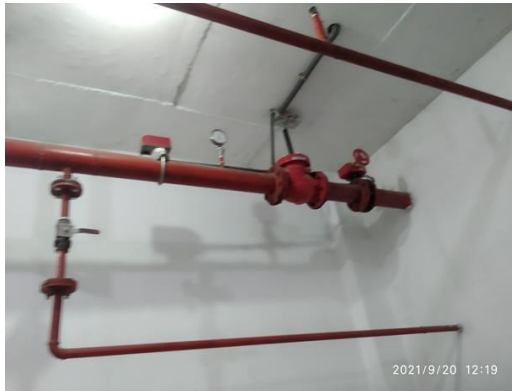
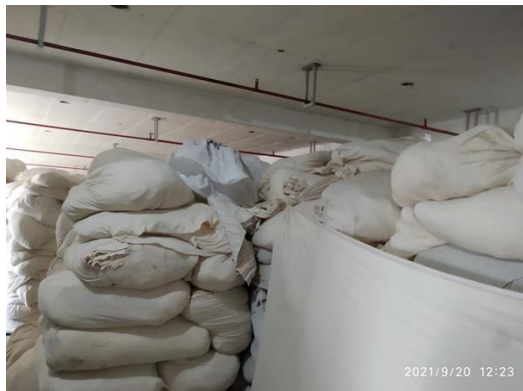
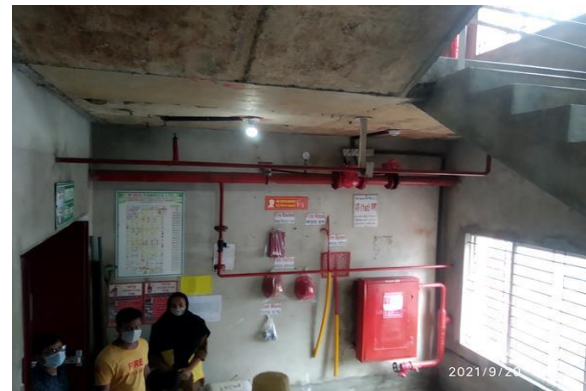
F-14	Fire Protection (Sprinkler)	Automatic sprinkler system installation requires detailed review to confirm compliance with NFPA 13.(Sprinkler based fire alarm system has been installed in the factory building)	Submit as-built drawings, testing records, equipment certification and other relevant documentation to the RSC for review and approval/acceptance test.	Design within 2 months, Install within 4 months
------	-----------------------------	------------------------------------------------------------------------------------------------------------------------------------------------------------------------------------	---------------------------------------------------------------------------------------------------------------------------------------------------------	-------------------------------------------------
