# INITIAL FIRE SAFETY INSPECTION REPORT

**Factory Name: CORTZ APPARELS LTD (UNIT 2) Extended Shed**

**ADDRESS: Hakim master complex, Newjor, kadda, Gazipur**

**Date: 19.09.2021**

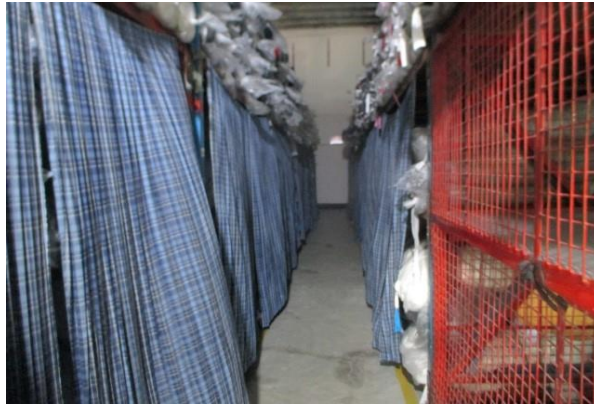
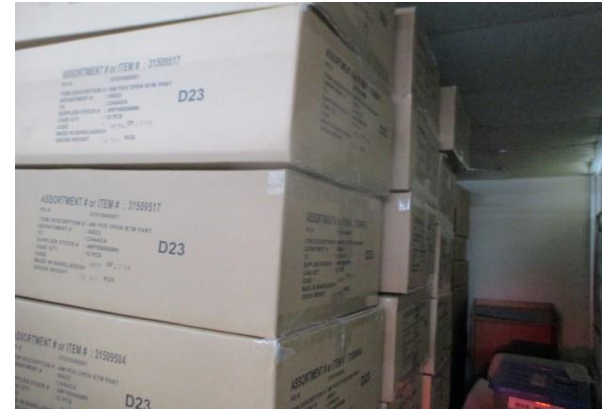
| SI No. | Category | Findings | Required Action | Remediation Time Frame |
|---|---|---|---|---|
| 1 | Fire Rated Construction | Room used for combustible storage are not separated by fire rated construction located at several floors | <p>Separate the storage room by a minimum 1- hr fire-rated construction. Seal and/or protect all openings to maintain the required fire separations.</p> <p>Openings from exit enclosure to storage spaces shall be provided with a vestibule with fire rated construction and openings.</p> <p>Provide a 1.5-hr. fire rated door on the exit stair side and a 1-hr. fire rated door on the storage room side. Ensure that the fire rating of the vestibule construction matches that of the exit stair enclosure</p> | Within 3 months |

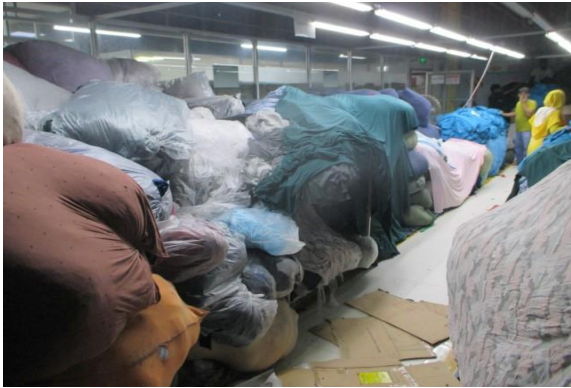
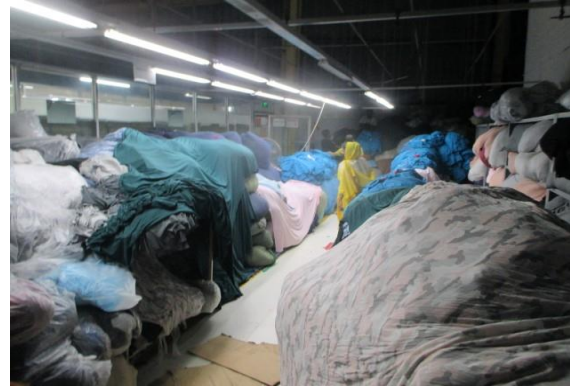
| 2 | Fire Rated Construction | Areas used for combustible storage are not separated by fire-rated construction located at several floors | <p>Provide dedicated storage rooms separated by minimum 1-hr fire-rated construction.</p> <p>Where separate storage rooms are not feasible, provide defined storage areas and limit the storage arrangement as follows:</p> <ul style="list-style-type: none"> <li>- Maximum height of 2.4m and maximum area of 23m<sup>2</sup></li> <li>- If sprinkler protected: maximum height of 3.66m and maximum area of 93m<sup>2</sup></li> </ul> <p>Separate areas of unenclosed combustible storage by a minimum clear distance of 3m</p> | Within 3 months |

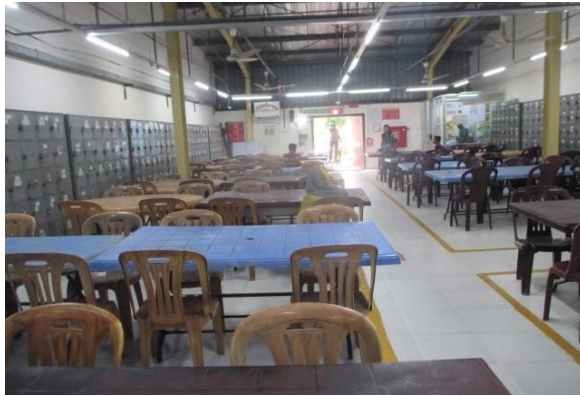
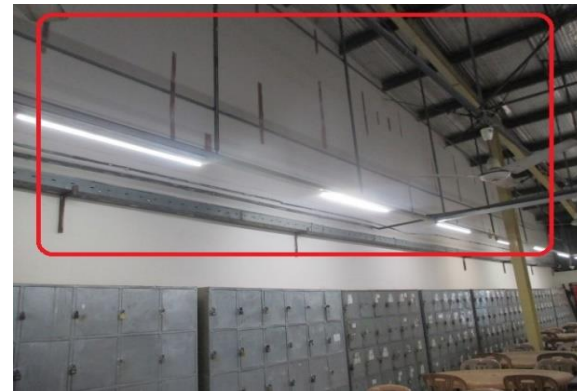
| 3 | Fire Rated Construction | Dining area is not separated from other occupancies with fire rated assemblies. | Re-locate the dining area or separate the dining area from other occupancies with 2-hr fire rated construction. | Within 3 months |

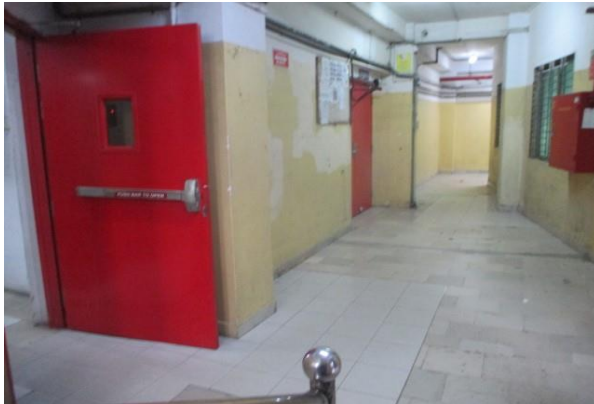
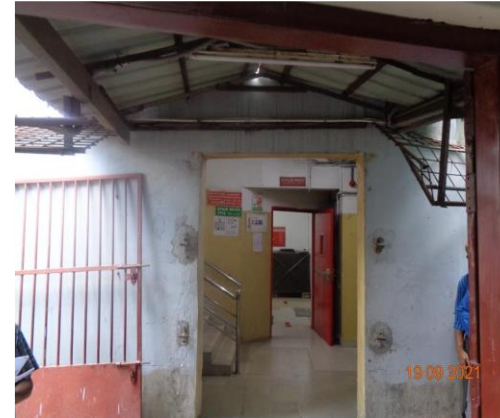
| 4 | Fire Rated Construction | South side exit discharge inside the main production building on the ground floor. | <p>Provide 2-hr fire-rated exit passageway leading directly outside.</p> <ul style="list-style-type: none"> <li>- Modify stair to discharge directly outside.</li> <li>- Provide 2-hr fire-rated exit passageway leading directly outside (vestibules to separate any storage areas).</li> <li>- Provide sprinkler protection for discharge floor in accordance with NFPA 13.</li> </ul> | Within 3 months |

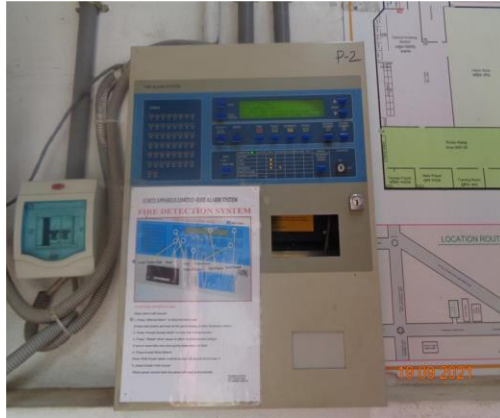
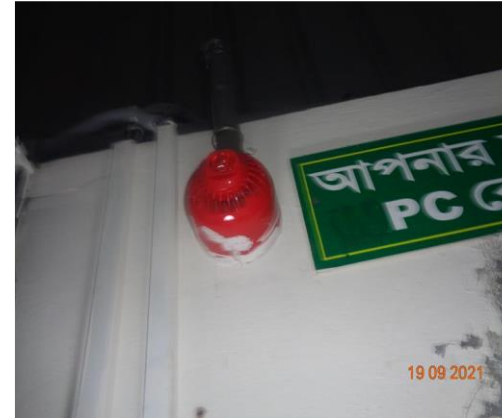
| 5 | Fire Alarm & Detection System | Fire detection system installation requires detailed review to confirm compliance with NFPA 72 and ACCORD standards | Submit as-built drawings, testing records, equipment certification and other relevant documentation to the RSC for review and approval | Design within 2 months, Install within 4 months (If modification required) |

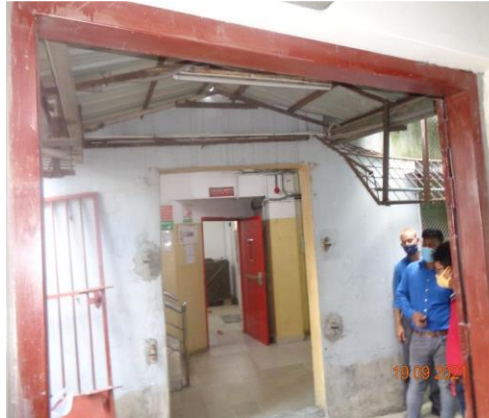
| 9 | Egress lighting | Exit sign and Directional Sign are not provided at and towards exit at several floors | Lighted exit signs shall be placed at entrance to an exit. Additional exit signs shall be placed throughout the facility anywhere the continuation of the egress is not obvious. Lighted exit signs shall be provided with either battery backup or uninterruptable power supply systems and shall be continuously illuminated. | Within 1 month |
