# **FIRE SAFETY INSPECTION REPORT**

## **KAC Fashion Wear Ltd. (Extension)**

**Factory ID: 24206**

**Date: 14 September 2021**

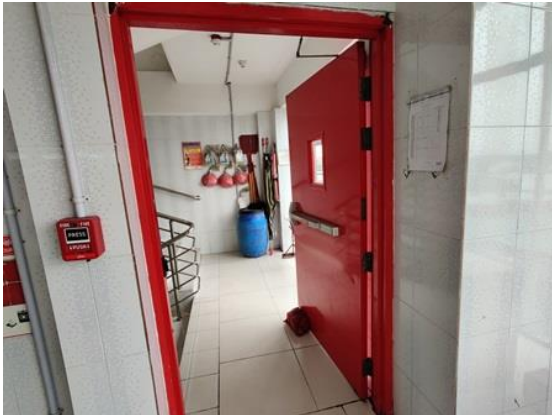
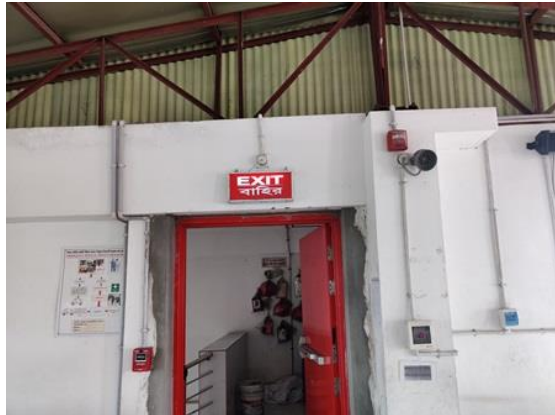
| No. | Category | Finding | Recommendation | Remediation Timeframe |
|---|---|---|---|---|
| F-1 | Fire Rated Construction | Proper certification was not available for fire rated doors installed in the factory on each floor for both exit stairs. | Submit proper certifications for installed fire doors to the RSC for approval. If not available, or certification is not approved, install new, properly certified fire rated doors in accordance with RSC direction. | Within 1 month |

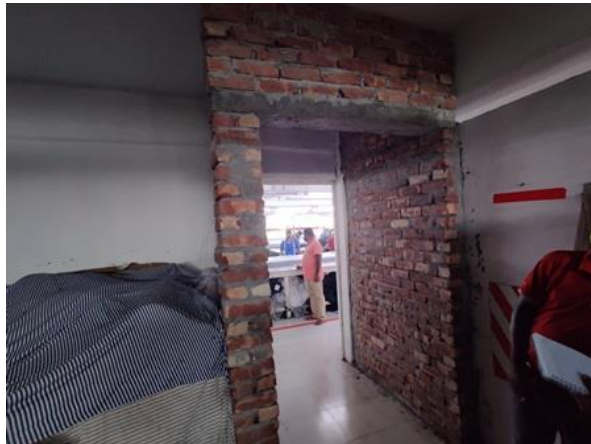
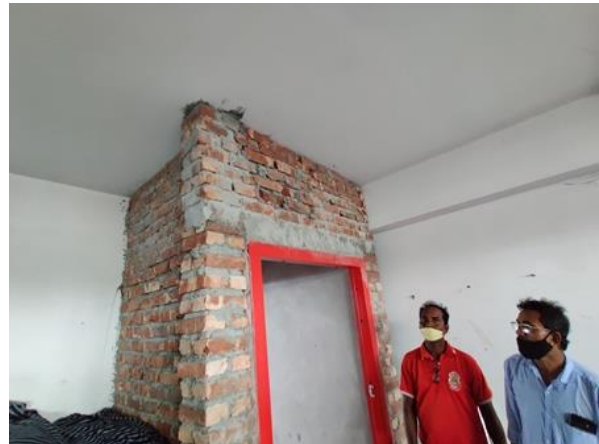
| No. | Category | Finding | Recommendation | Remediation Timeframe |
|---|---|---|---|---|
| F-2 | Fire Rated Construction | Room on the 2 <sup>nd</sup> floor used for combustible storage is not separated by a minimum 1-hr fire-rated construction. (Fashion-2 building) | Provide dedicated storage rooms separated by minimum 1-hr fire-rated construction. | Within 2 months |

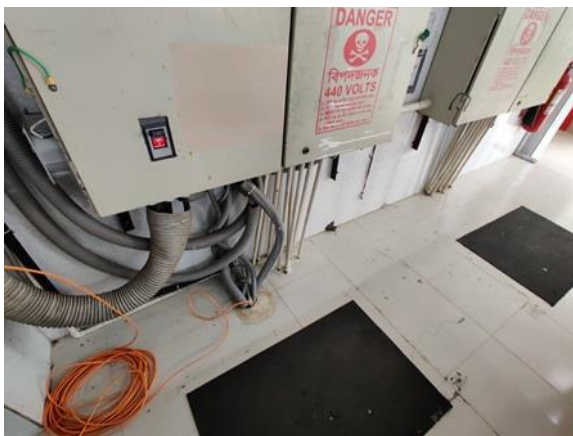
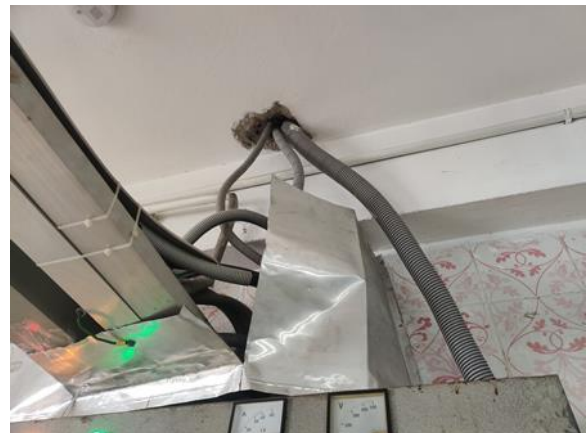
F-3 Fire Rated Construction

Unsealed electrical shaft is located in the fire-rated floor/ceiling assemblies.  
(Both Building)

Provide a minimum 2-hr fire-rated shaft to separate the utility risers from each floor level and seal all penetrations in floor/ceiling assemblies to maintain the fire separation.

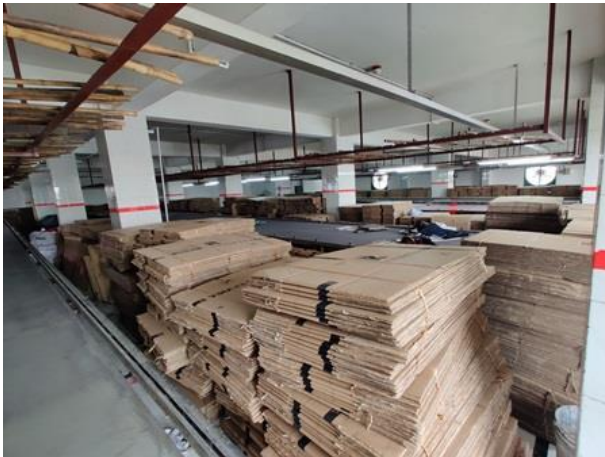
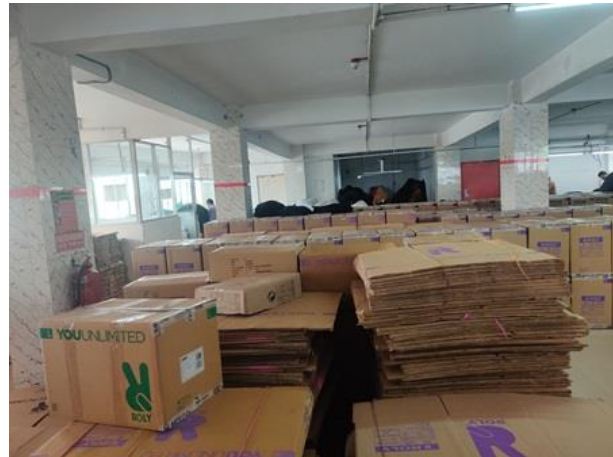
| F-4 | Fire Rated Construction | Areas on the 2nd and 4th floor used for combustible storage open to the factory are not properly defined and/or not within limits. (Fashion-3 building) | <p>Provide defined storage areas and limit the storage arrangement as follows:</p> <p>Maximum height of 2.45m (8 ft) and maximum area of 23 m<sup>2</sup> (250 ft<sup>2</sup>).</p> <p>If sprinkler protected: maximum height of 3.66m (12 ft) and maximum area of 93m<sup>2</sup> (1000 ft<sup>2</sup>).</p> <p>Separate the areas of unenclosed combustible storage by a minimum clear distance of 3 m (10 ft).</p> | Within 3 months |

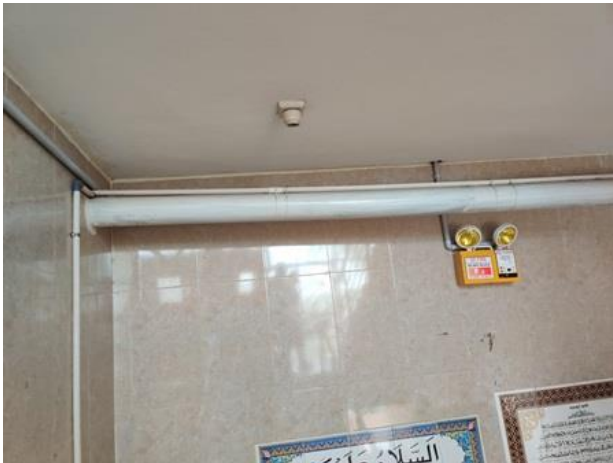
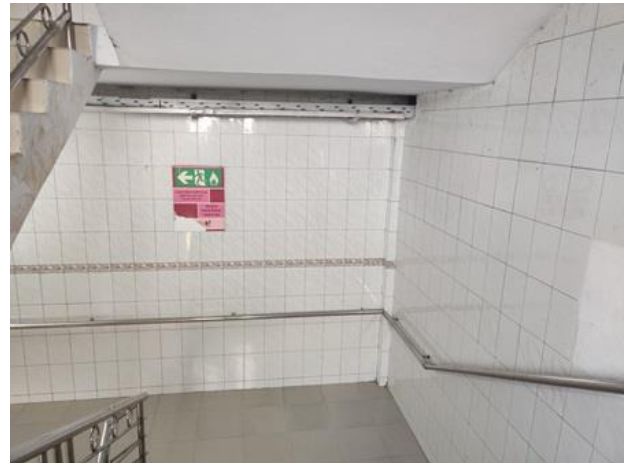
| F-5 | Fire Rated Construction | Electrical cable tray / channels are located in exit stair enclosures. (Both building) | <p>Penetration is prohibited into and through an exit enclosure. Re-route the cable raceway to comply Accord 6.14.4. Seal all penetrations and openings in exit stair enclosure walls to maintain the required fire separation.</p> | Within 3 months |

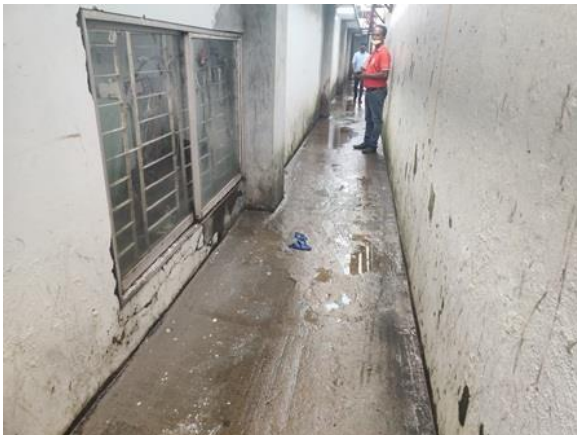
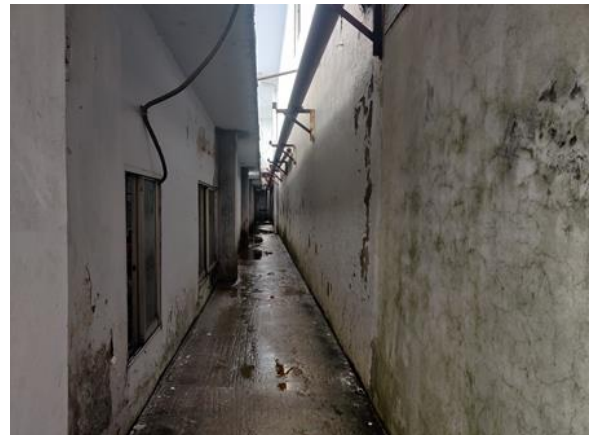
| F-6 | Fire Rated Construction | The exit discharge path serving the S-E exit is less than 10 ft wide and is not separated from the building interior.<br>(Fashion-3 building) | Seal all penetrations and openings to the interior of the building along the discharge path, up to a height of 10 ft, to provide a minimum 1-hr fire separation.<br>Alternatively, provide a second remote discharge path to the public way (only include this if feasible). | Within 3 months |

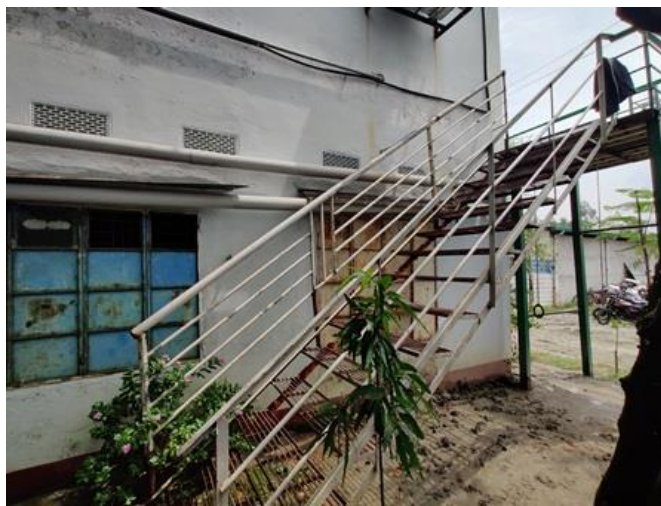
| F-7 | Fire Rated Construction | Exterior exit stair is not properly separated from the building.<br>(Dormitory building) | Exterior exit stairs shall be separated from the building with a rating requirement of 1 hr fire rating for 3 or fewer stories or 2 hr fire rating for 4 or more stories. The rating of the exterior wall shall be extended 10 ft beyond the ends of the stair structure. | Within 4 months |

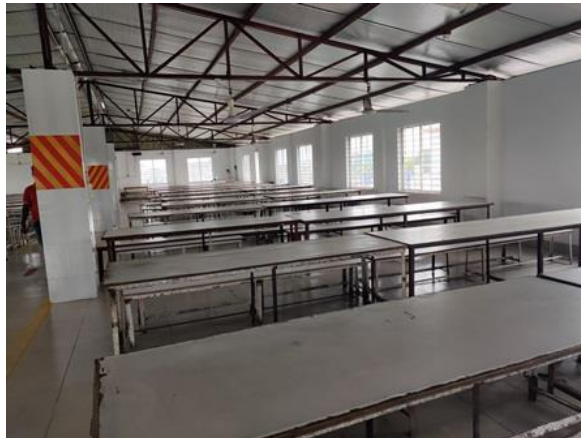
| F-8 | Egress | Exit capacity is not adequate for the occupant load.<br><br>Fashion-2 building, available capacity 504 and occupant load is. 720 at roof top dining. (Sitting capacity) | Reduce occupant load to not more than available exit capacity (504).<br>Provide additional exits in the future to increase exit capacity. | Within 1 month |

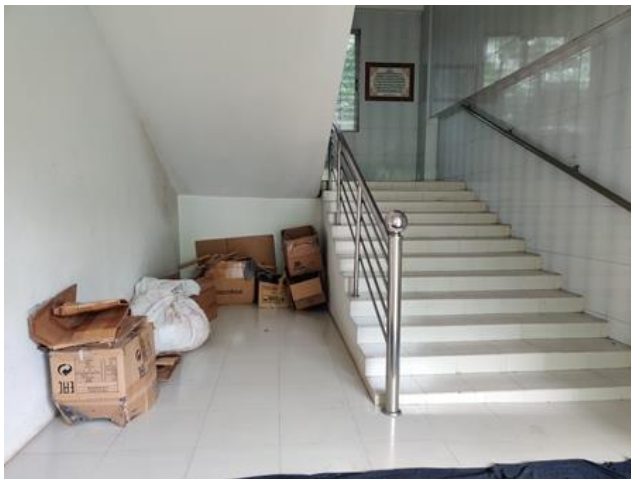
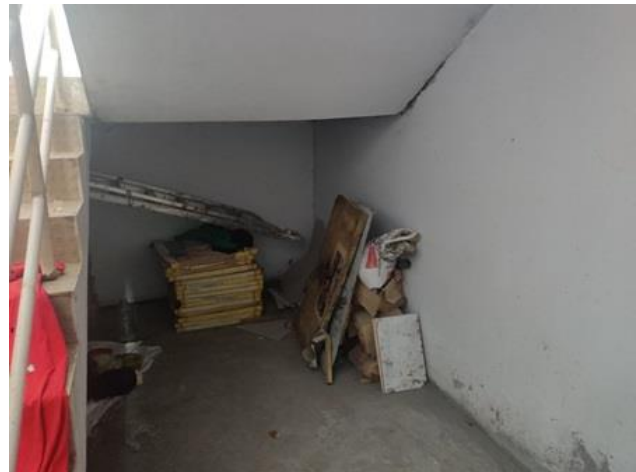
| F-9 | Egress | Storage was located in the exit stair. | Remove all storage from exit stairs. | Within 2 weeks |
| Both building | | | | |

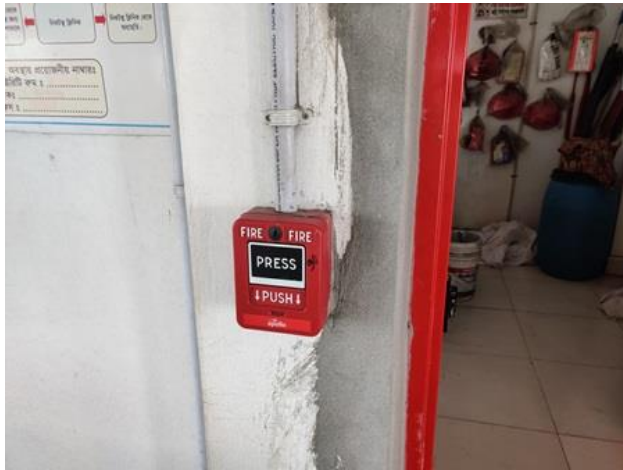
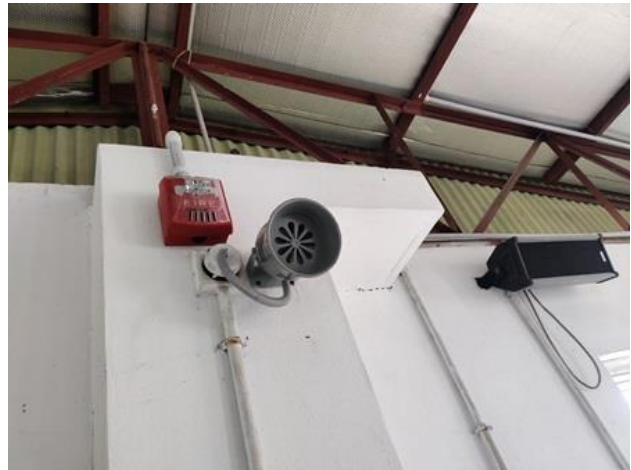
| F-10 | Fire Protection | Fire alarm system installation requires detailed review to confirm compliance with NFPA 72 and ACCORD standards. | Submit as-built drawings, testing records, equipment certification and other relevant documentation to the RSC for review and approval/acceptance test. | Within 2 months |

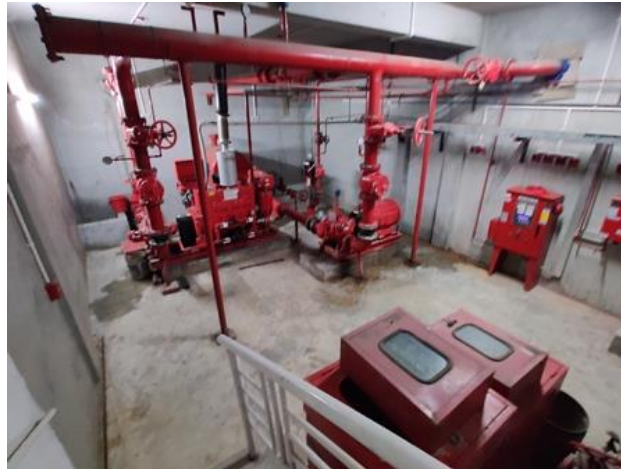
| F-15 | Fire Protection | The fire pump set installation requires detailed review to confirm compliance with NFPA 20 and ACCORD standard. | Submit as-built drawings, testing records, equipment certification and other relevant documentation to the RSC for review and approval/acceptance test. | Within 2 months |

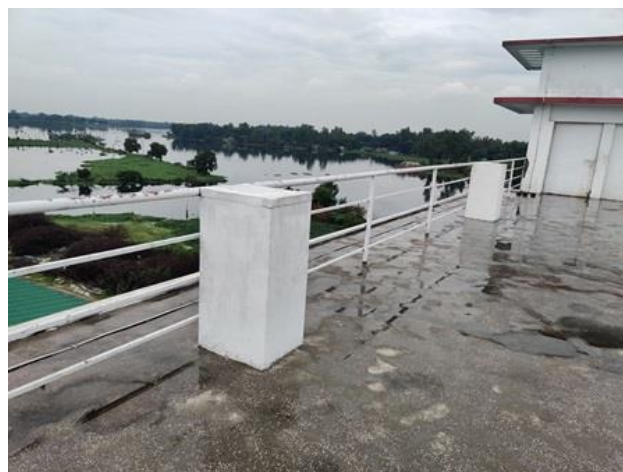
| F-16 | Egress | Occupiable roof is not provided with an adequate parapet / guard rail.<br>(Fashion-2 building) | All occupiable roofs shall be provided with parapets or guards with a minimum height of 1067 mm (42 in.) | Within 3 months |

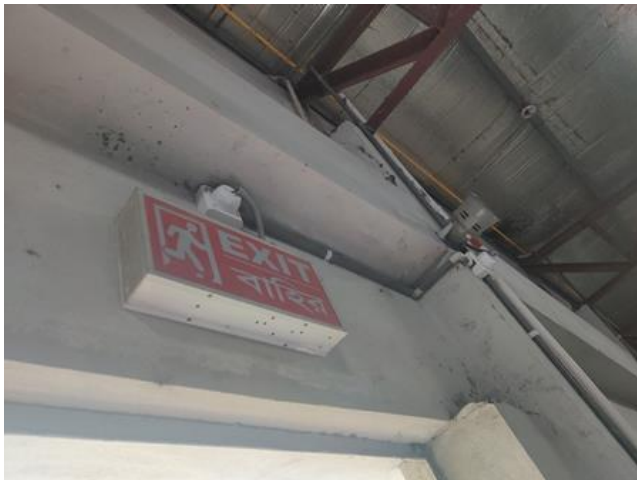
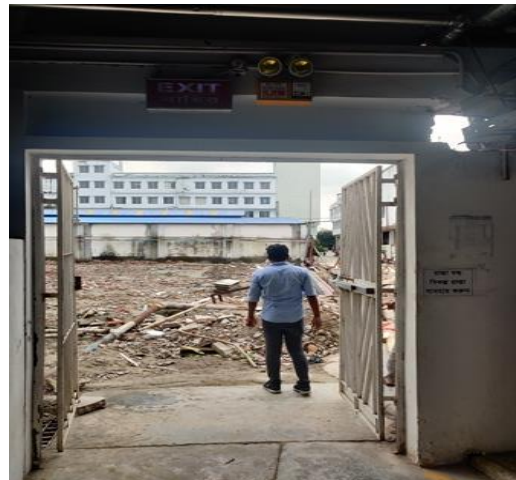
| F-17 | Egress Lighting | Exit signage not illuminated (burned out, broken, etc.).<br>(All building/shed) | Regularly inspect all exit signage and replace/install lights as needed to illuminate signs. The source of illumination shall provide not less than 50 lux at the illuminated surface with a contrast of not less than 0.5. Approved self-luminous signs which provide evenly illuminated letters having a minimum luminance of 0.2 cd/m <sup>2</sup> may also be used. | Within 1 month |

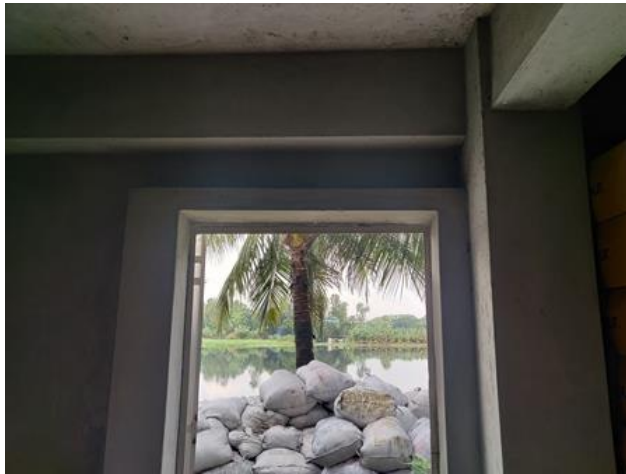
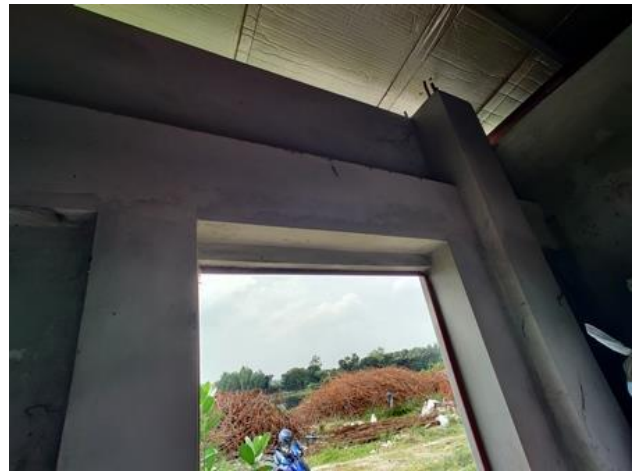
| F-18 | Egress Lighting | Exit signage was not provided at all the exits / along the path of egress / in a readily visible location.<br>(All building/shed) | Provide exit signs above all building exits to the exterior, all doors to the exit stairs and along all paths of travel where a change of direction is not obvious. | Within 1 month |

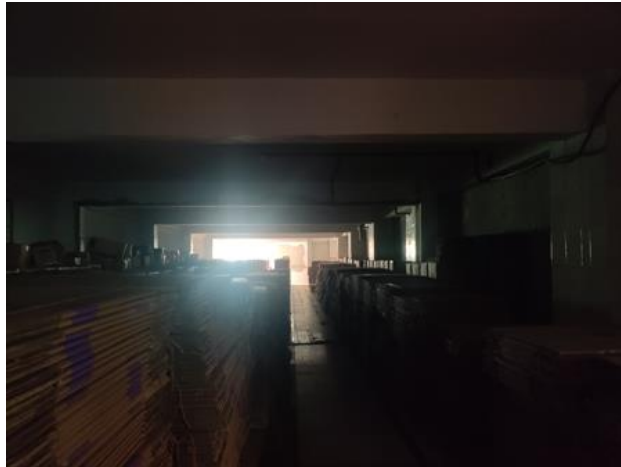
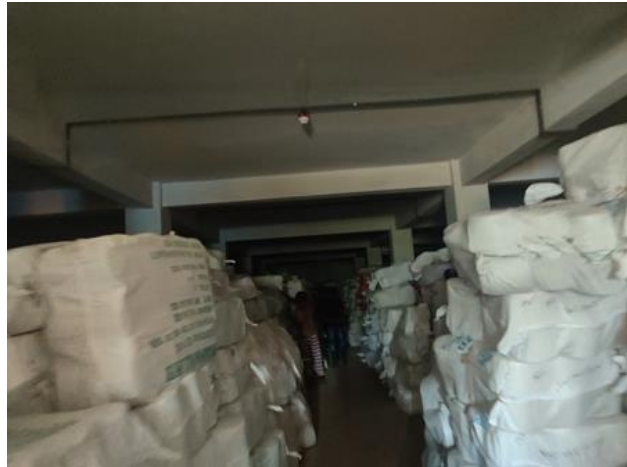
| F-20 | Egress Lighting | Based on the number and location of emergency lights observed, adequate illumination levels are not anticipated along egress routes.<br>(All building/shed) | Test the emergency lighting system on each floor and provide additional emergency fixtures to supply adequate illumination along the means of egress. Provide a minimum illumination of 10 lux at the floor level within exit stairs and along exit discharge paths and a minimum 2.5 lux along exit access aisles. | Within 1 month |

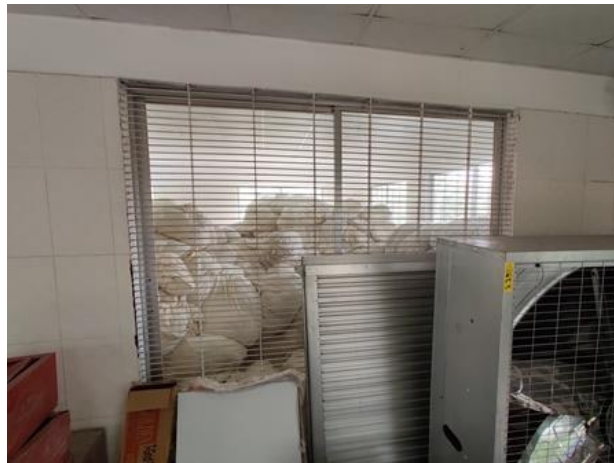
| F-24 | Fire Rated Construction | The fire pump room is not provided with adequate fire separation.<br>Ground floor of pump house building using as fabric storage. | Provide fire pump room with 2-hr rated fire separation when not sprinklered and 1-hr rated fire separation when provided with automatic sprinklers, in accordance with NFPA 20. | Within 3 months |

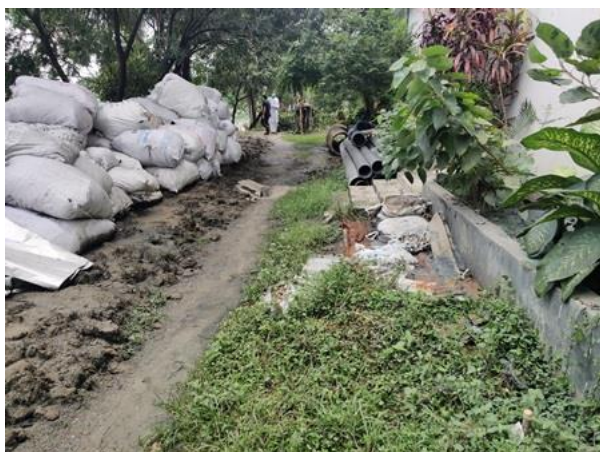
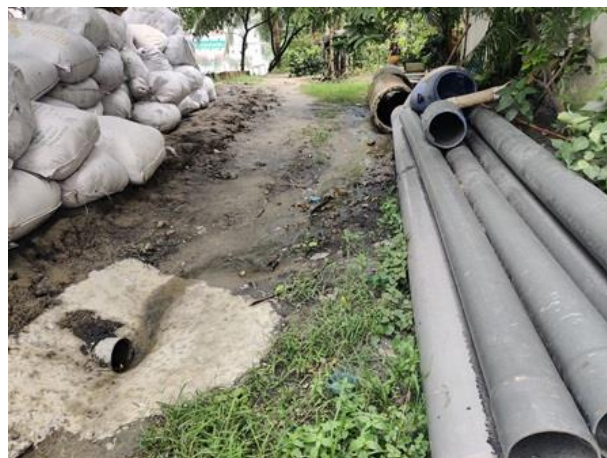
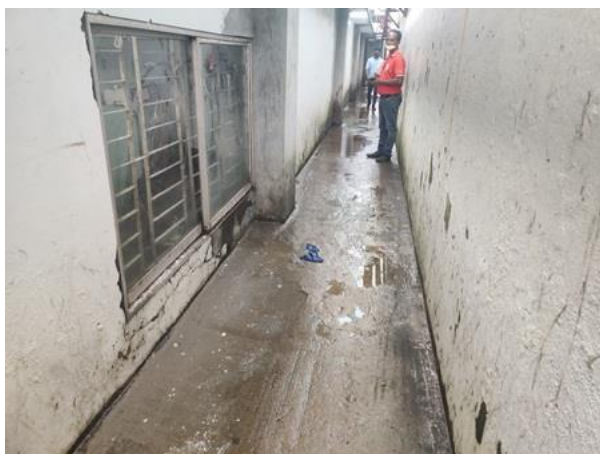
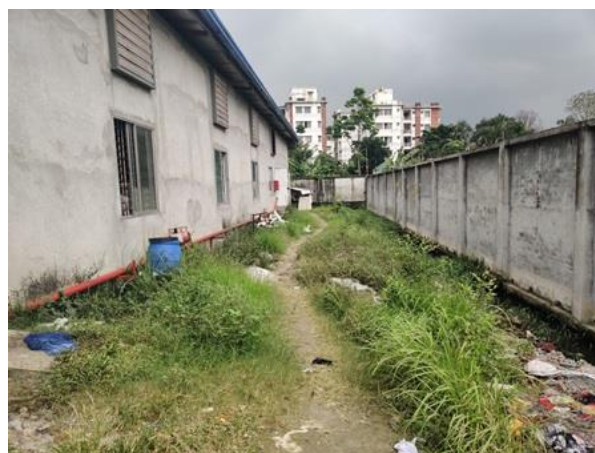
| F-25 | Egress | Exit discharge path is not slip resistant due to waterlogging also not smooth and leveled surface.<br>(Fashion-2, Fashion-3, Washing, Dyeing and Godown shed) | Level the exit discharge path to ensure smooth and safe evacuation and ensure that the path is slip resistant. | Within 1 month |

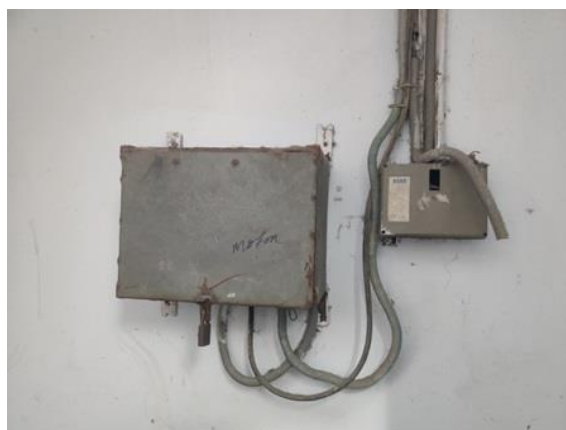
| F-26 | Fire Rated Construction | Electrical panel was located in the exit stair enclosure at Fashion-3. | Remove and re-locate all electrical panels from exit stair enclosures. | Within 2 months |

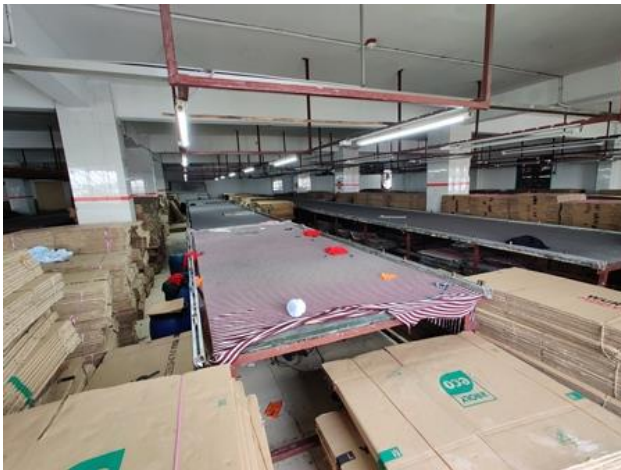
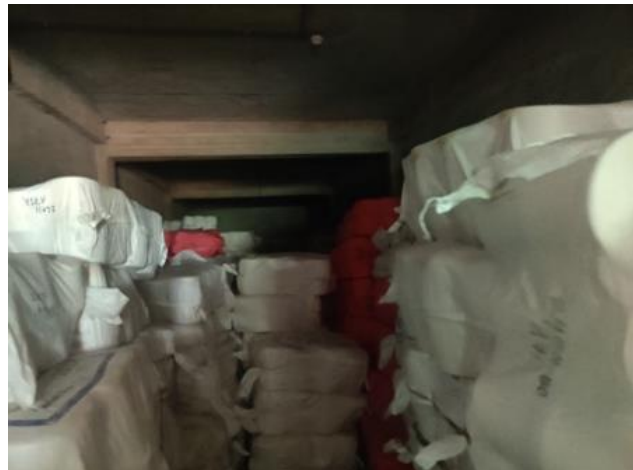
| F-27 | Egress | Egress aisles were not provided at ground and 3rd floor storage. | Reconfigure the storage arrangement to confirm unobstructed and clear 36-inch width. | Within 1 month |
