# INITIAL FIRE SAFETY INSPECTION REPORT

**AKH ECO APPARELS LTD.--Extended buildings**

**RSC ID: 24196**

**Date: 07 September 2021**

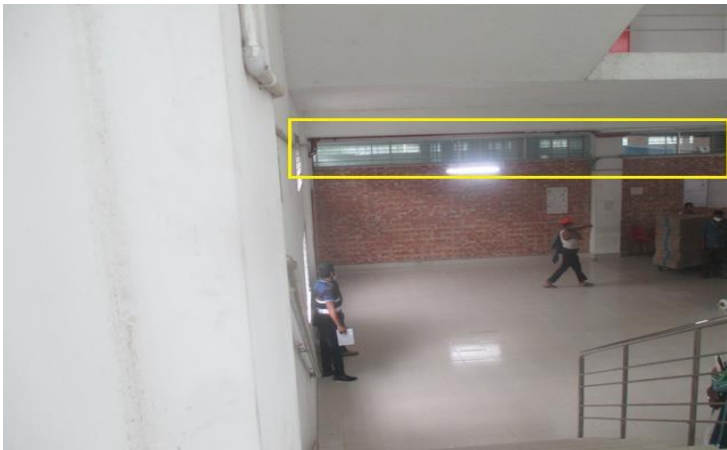
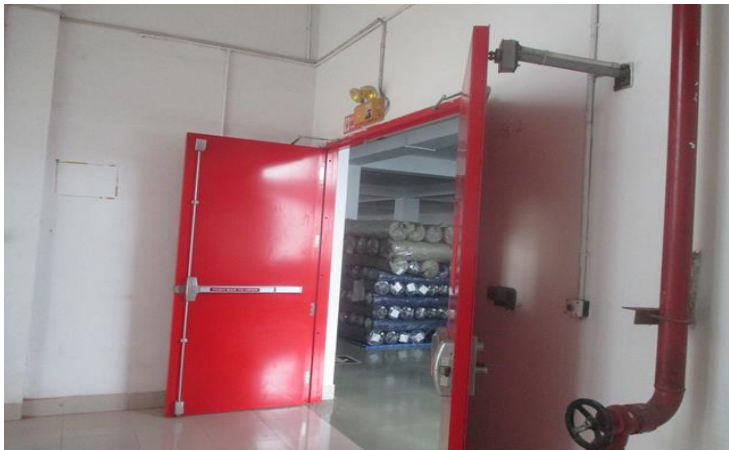
| SI No. | Category | Findings | Required Action | Remediation Time Frame |
|---|---|---|---|---|
| 1 | Fire Rated Construction | Exit Enclosures are not properly fire separated from other occupancy on each floor by fire rated construction due to glass opening on ground floor and non-functionality of installed fire rated doors.<br><br>Location: Building 3. | Provide minimum 2-hr fire rated separation in exit enclosures with minimum 1.5-hr fire rated doors and seal all unprotected openings and penetration to separate the exit stairs from work areas and other building spaces on all floor levels with similar rating of fire door.<br><br>Ensure that the fire doors are self-closing and positive latching and that they are provided with fire exit (panic) hardware where serving production floors. If fire doors are required to be held open for functional reasons, provide automatic closing devices tied to the fire alarm system. | Within 3 months |

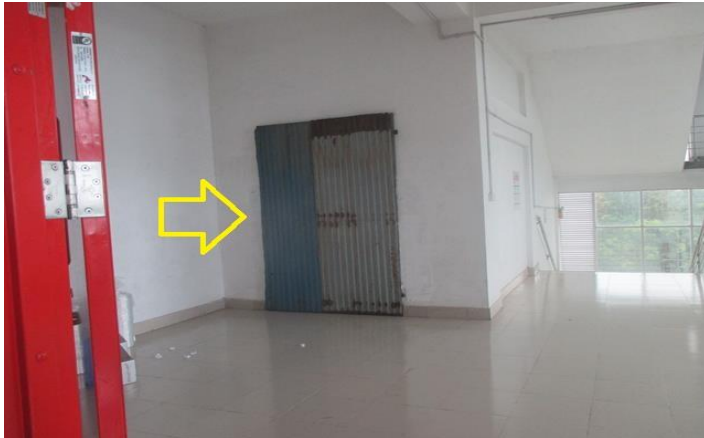
| 2 | Fire Rated Construction | <p>Elevator shafts are directly open into the inside of stair-3.</p> <p>Located: Building 3.</p> | <p>For new construction, elevators shall not open into an exit enclosure as per ACCORD Standard-6.14.3. So, ensure separate enclosures for the elevator shafts with minimum 2 hr. fire rating. If elevator is not being installed then the door opening can be sealed by minimum 2-hr fire rated construction.</p> | Within 3 month |

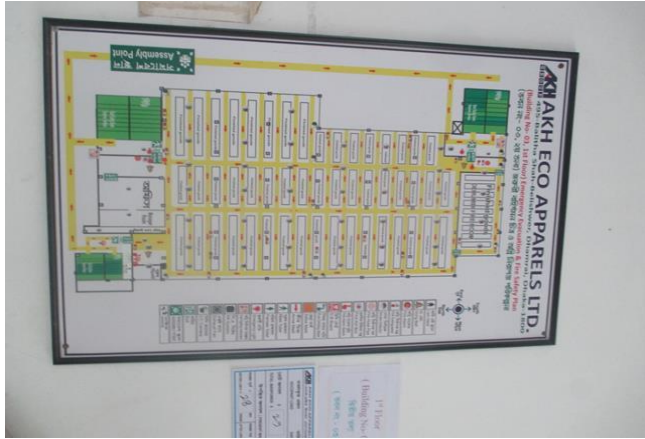
| 3 | Means of Egress | Common path of egress travel was more than more than 30 m for normal storage on every floor of the building-3. The same scenario is for Shed-1 also. | The maximum common path of travel for the general storage shall be 30 where occupant load is not more than 30 . So, Reconfigure the egress arrangement to reduce the maximum tolerable common path of travel. | Within 1 month |

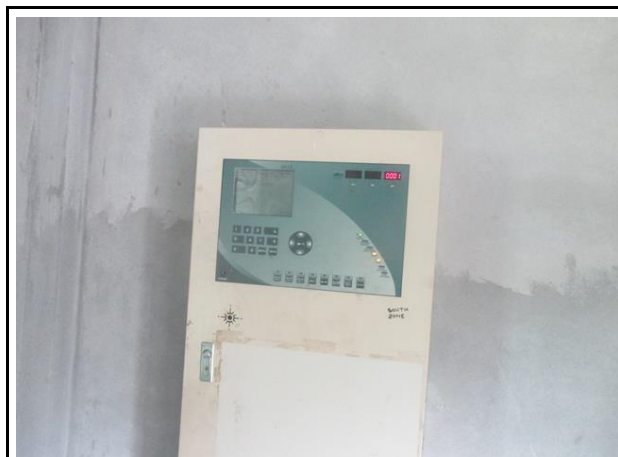
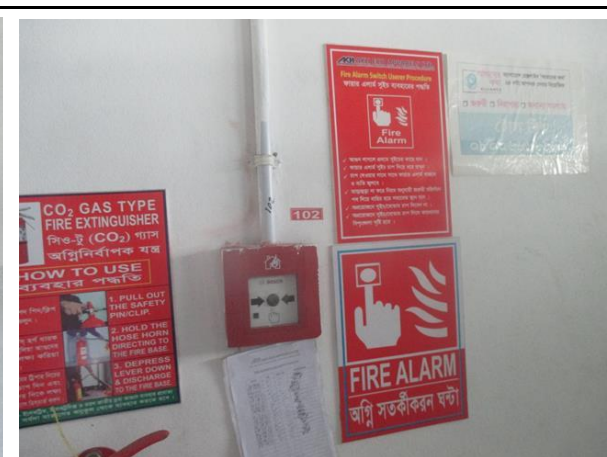
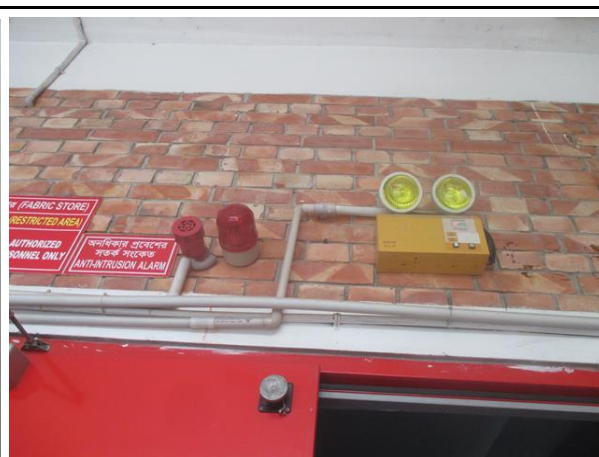
| 4 | Fire Alarm & Detection System (FADS) | <p>Addressable fire alarm &amp; detection system installation requires detailed review to confirm compliance with NFPA 72 and ACCORD standards.</p> <p>Location: Building-3.</p> | <p>Submit design, documents and calculations to RSC for review prior and based on the review modify the system if there is any.</p> <p>After installation the owner shall contact the RSC for witness of conducting the final acceptance testing of the fire detection &amp; alarm system installation.</p> <p>Also inspect, test and maintain the fire alarm system, and keep written records on-site, in accordance with NFPA 72.</p> | Design Review within 2 months and modification within 4 months (If require). |

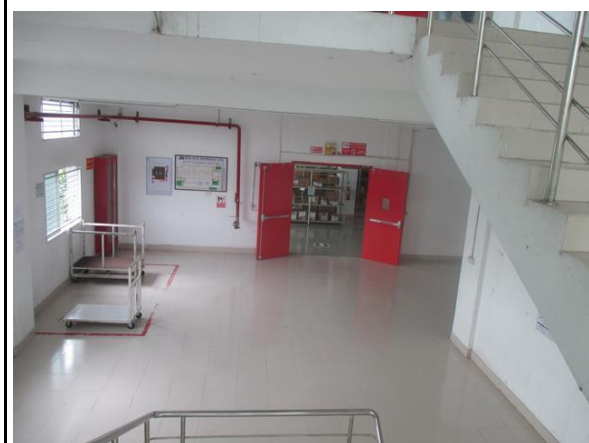
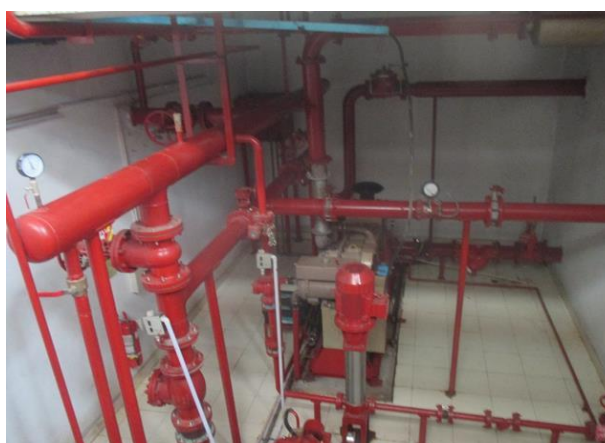
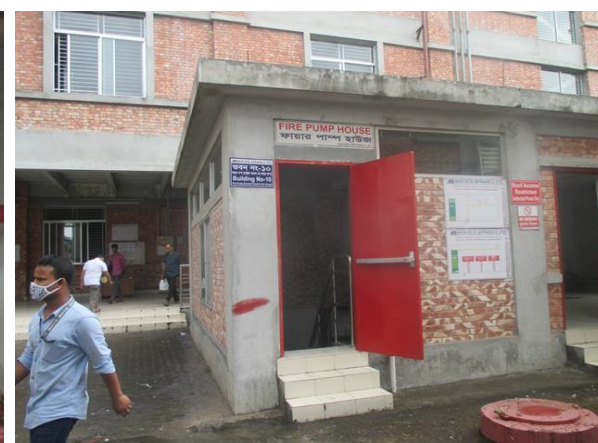
| 6 | Fire Protection System (Standpipe System). | <p>Standpipe system and fire pump installation requires detailed review to confirm compliance with NFPA 14, 20, 22, 24 and ACCORD standard.</p> <p>Location: Building-3.</p> | <p>Submit the standpipe system drawing to RSC for review. Once reviewed, install or modify the standpipe system throughout the building in accordance with Accord standard and NFPA 14 and 20. The factory management shall contact RSC to conduct the final acceptance testing after the installation, testing &amp; commissioning.</p> | <p>Design Review within 2 months and modification within 4 months (If require).</p> |

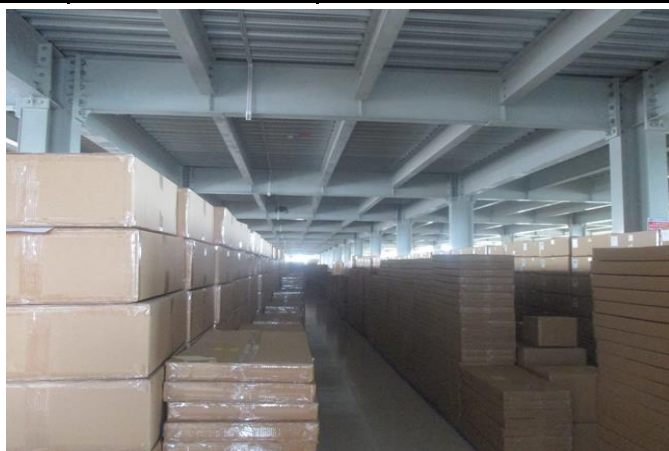
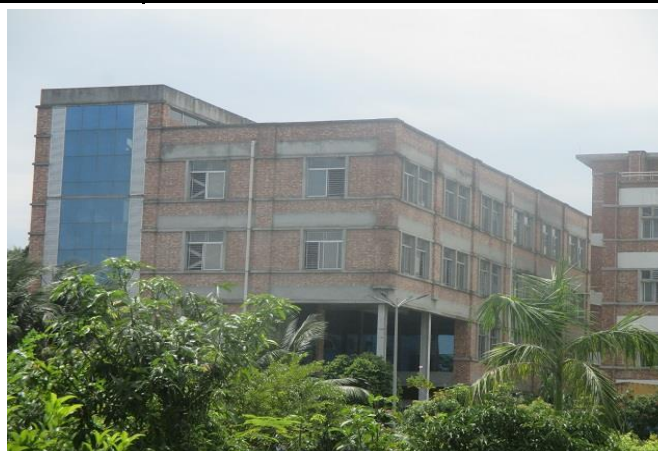
| SI No. | Category | Findings | Required Action | Remediation Time Frame |
|---|---|---|---|---|
| 9 | Fire Rated Construction | The main structural element of the building is constructed by steel which is non-rated and were found in exposed condition without any fire protection.<br><br>Building-9 & Shed-1. | The building shall be type-I or II construction. So, provide require rating in the structural elements of the building. Consult with a qualified fire protection engineer. Follow BNBC 2006-Table 3.2.4, 3.1.9 and 3.3.1 as reference. | Within 6 months |

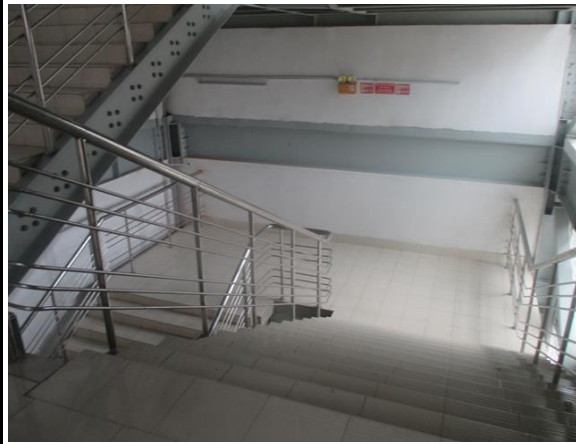
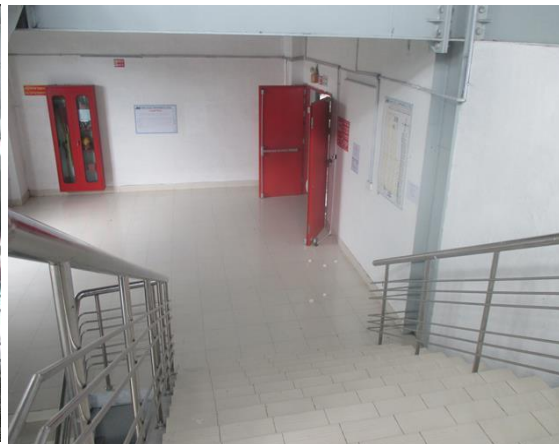
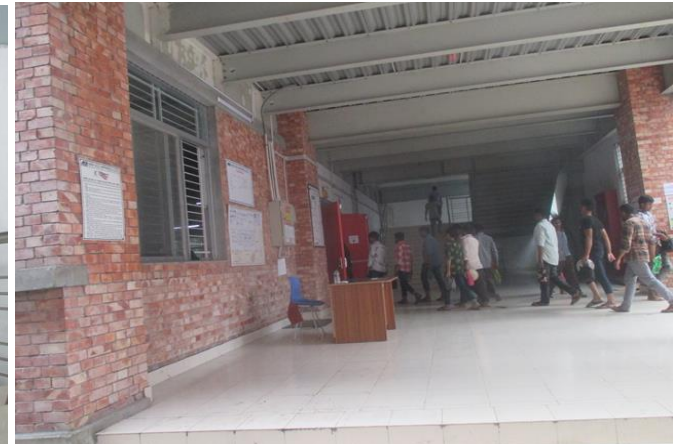
| 10 | Fire Rated Construction | <p>Exit Enclosures are not properly fire separated from other occupancy on each floor by fire rated construction due to glass opening on ground floor and non-functionality of installed fire rated doors.</p> <p>Location: Building 9.</p> | <p>Provide minimum 2-hr fire rated separation in exit enclosures with minimum 1.5-hr fire rated doors and seal all unprotected openings and penetration to separate the exit stairs from work areas and other building spaces on all floor levels with similar rating of fire door.</p> <p>Ensure that the fire doors are self-closing and positive latching and that they are provided with fire exit (panic) hardware where serving production floors. If fire doors are required to be held open for functional reasons, provide automatic closing devices tied to the fire alarm system.</p> | Within 3 months |

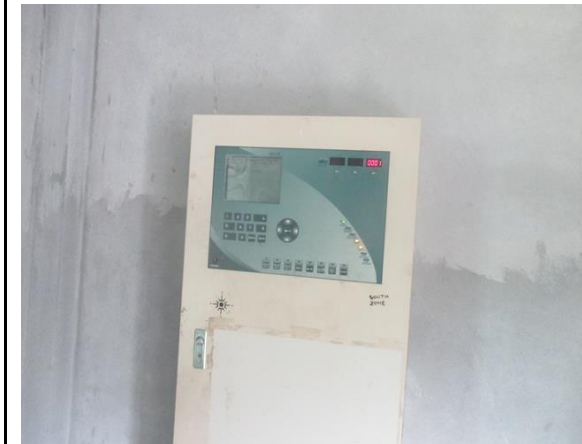
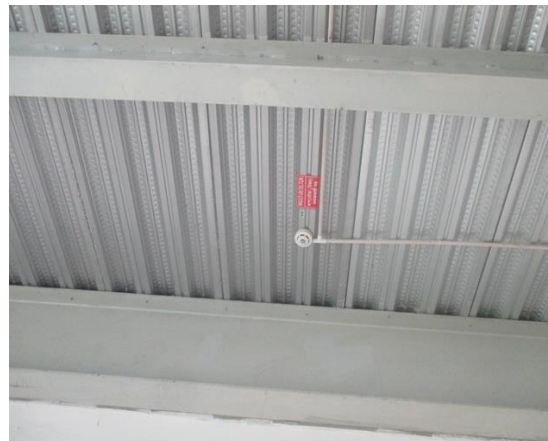
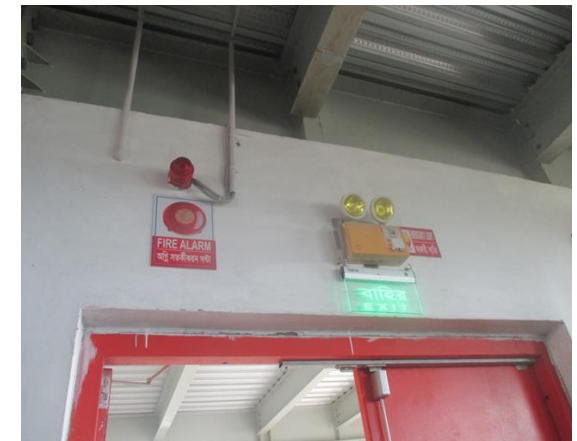
| 12 | Fire Alarm & Detection System (FADS) | <p>Addressable fire alarm &amp; detection system installation requires detailed review to confirm compliance with NFPA 72 and ACCORD standards.</p> <p>Location: Building-9 and Shed-1.</p> | <p>Submit design, documents and calculations to RSC for review prior and based on the review modify the system if there is any.</p> <p>After installation the owner shall contact the RSC for witness of conducting the final acceptance testing of the fire detection &amp; alarm system installation.</p> <p>Also inspect, test and maintain the fire alarm system, and keep written records on-site, in accordance with NFPA 72.</p> | Design Review within 2 months and modification within 4 months (If require). |

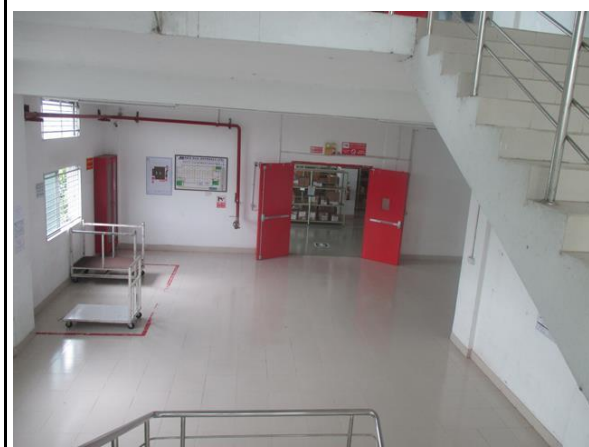
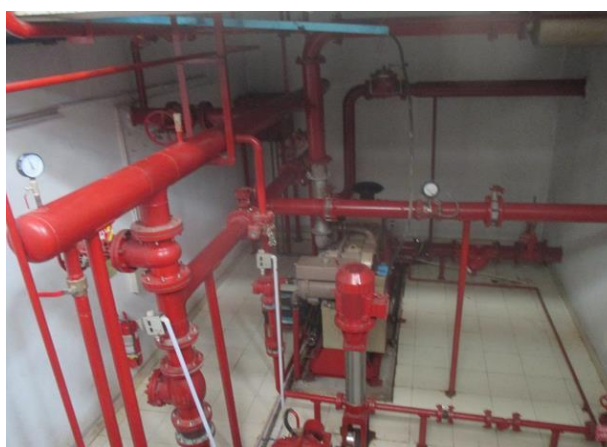
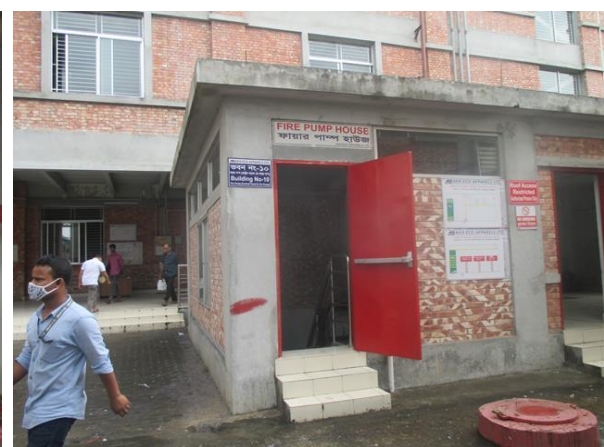
| 14 | Fire Protection System (Standpipe System). | Standpipe system and fire pump installation requires detailed review to confirm compliance with NFPA 14, 20, 22, 24 and ACCORD standard.<br><br>Location: Building-9. | Submit the standpipe system drawing to RSC for review. Once reviewed, install or modify the standpipe system throughout the building in accordance with Accord standard and NFPA 14 and 20. The factory management shall contact RSC to conduct the final acceptance testing after the installation, testing & commissioning. | Design Review within 2 months and modification within 4 months (If require). |
