# INITIAL FIRE SAFETY INSPECTION REPORT

## JL SWEATER LIMITED--EXTENDED BUILDING

RSC ID: 24171

Bishmail Road,Zirabo,Savar,Dhaka

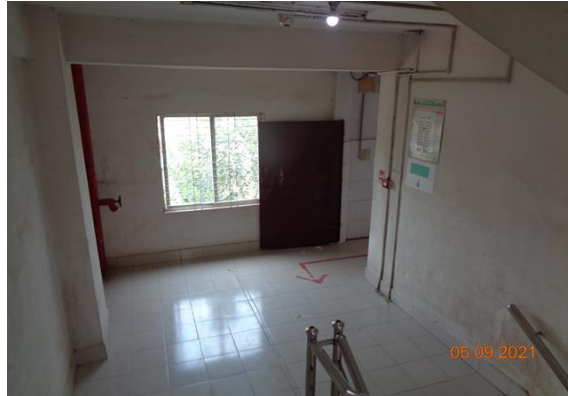
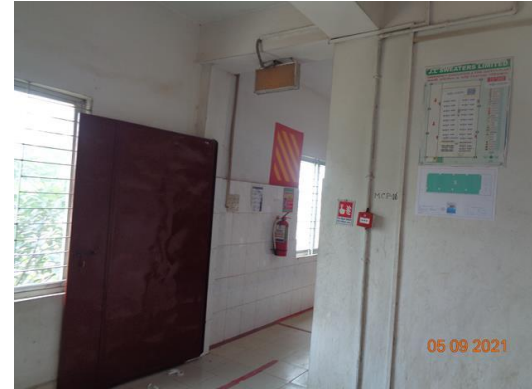
SI No.	Category	Findings	Required Action	Remediation Time Frame
F-1	Fire-Rated Construction	The exit stair enclosures are not separated from work areas and other spaces on each floor by fire-rated construction due to unprotected openings.	<p>Stair shall be enclosed with a minimum 2-hr fire-rated construction. Seal all unprotected openings and provide minimum 1.5 -hr. fire rated doors to separate the exit stairs from work areas and other building spaces on all floor levels. Ensure that the fire doors are self-closing, positive latching and that they are provided with fire exit (panic) hardware where serving production floors.</p> <p>If fire doors are required to be held open for functional reasons, provide automatic-closing devices tied to the fire alarm system.</p>	Within 3 months

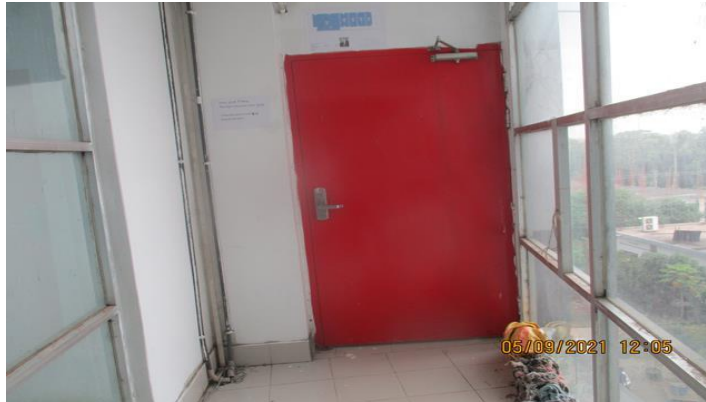
F-2	Fire-Rated Construction	Unsealed penetrations and openings due to electric cable riser and window are located in north-west exit stair enclosure in building-1.	Seal all penetrations and openings in exit stair enclosure walls to maintain the fire separation as per Accord standard 6.3.1.3.	Within 1 month
-----	-------------------------	---	--	----------------

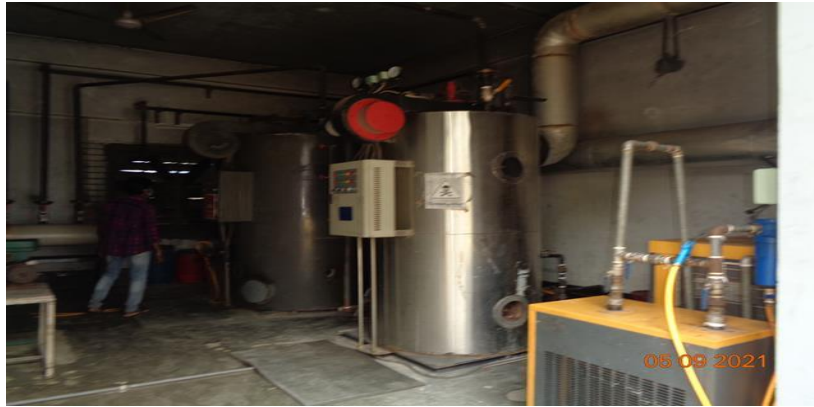
F-3	Fire-Rated Construction	The boiler and compressor are not separated by fire-rated construction. <b>Location:</b> Utility, Building-2.	Separate the boiler and compressor rooms by a minimum 1-hr fire rated construction. Seal and/or protected all openings to maintain the required fire separations.	Within 3 months
-----	-------------------------	---	---	-----------------

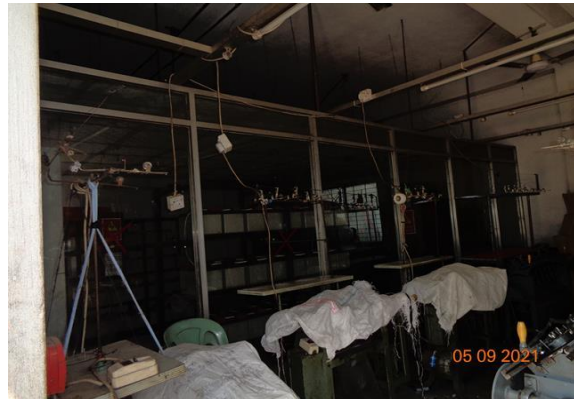
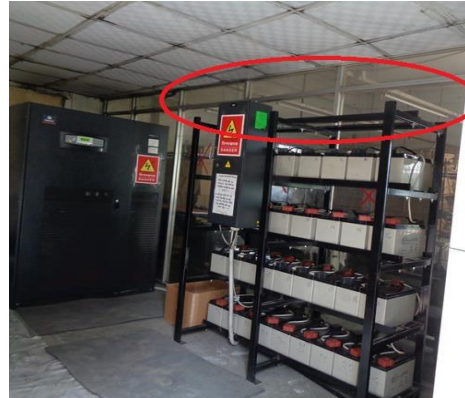
F-4	Fire-Rated Construction	The UPS and auto placket rooms are not separated by fire-rated construction. <b>Location:</b> Utility, Building-2.	Separate the UPS and auto placket rooms by a minimum 2-hr fire rated construction. Seal and/or protected all openings to maintain the required fire separations.	Within 3 months
-----	-------------------------	--	--	-----------------

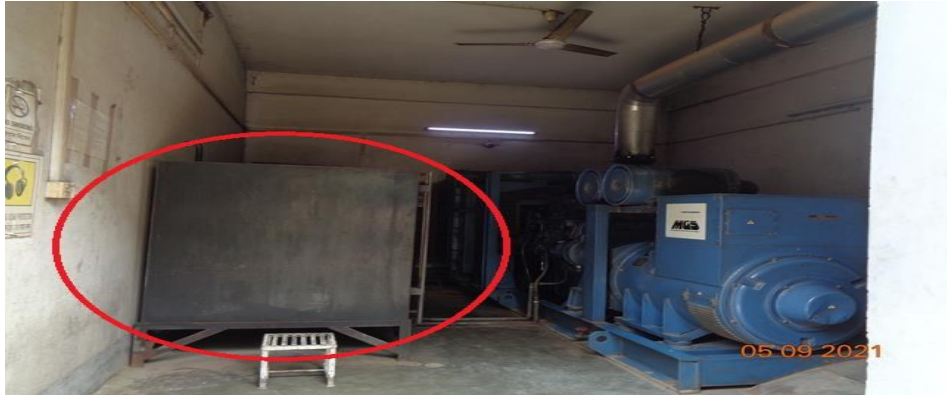
F-5	Fire Rated Construction	Diesel fuel storage was located inside the generator room.	Remove all diesel fuel storage from generator room and relocate to the exterior such that the diesel fuel storage is at least 10 ft from required egress paths. Separate the diesel fuel storage with 2- hr. fire rated construction.	Within 3 months
-----	-------------------------	--	---	-----------------

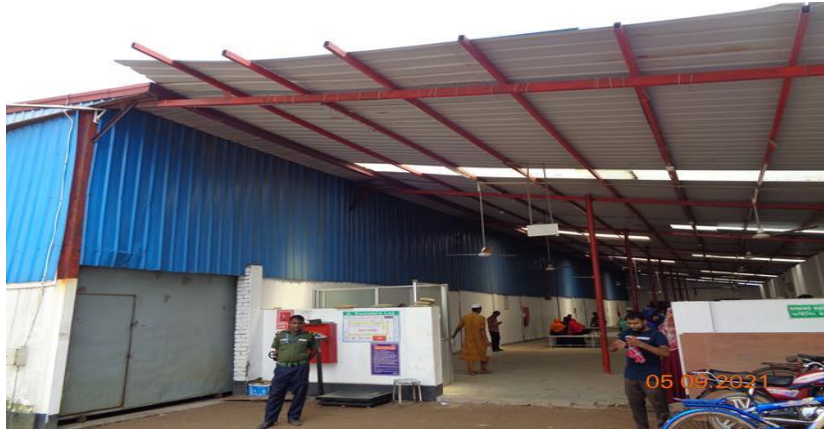
F-6	Fire Rated Construction	Dining is not separated from yarn store at shed-1.	Separate the dining facility by 3-hr rated construction and opening protection. Provide at least two exit leading directly outside of the building or exit stair.	Within 3 months
-----	-------------------------	--	---	-----------------

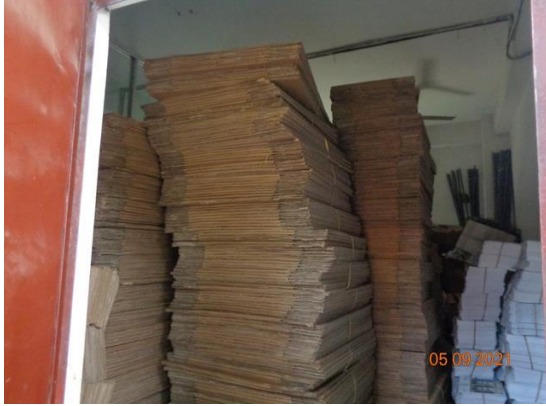
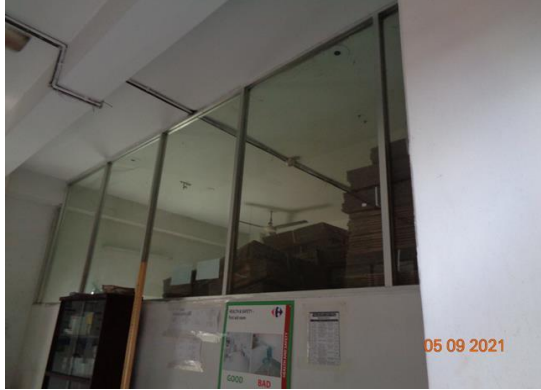
F-7	Fire Rated Construction	Storage room is not separated by fire rated construction from other occupancies. <b>Location:</b> medical at ground floor building-1.	<p>Provide dedicated storage rooms separated by minimum 1-hr fire-rated construction. Seal all penetrations and openings to maintain the fire resistance rating.</p> <p>Where separate storage rooms are not feasible, provide defined storage areas and limit the storage arrangement as follows: - Maximum height of 2.45m (8ft.) and maximum area of 23m<sup>2</sup> (250 ft<sup>2</sup>).</p> <p>If sprinkler protected: maximum height of 3.66m (12ft.) and maximum area of 93m<sup>2</sup> (1,000 ft<sup>2</sup>). Separate areas of unenclosed combustible storage by a minimum clear distance of 3m (10ft.).</p>	Within 3 months
-----	-------------------------	---	--	-----------------

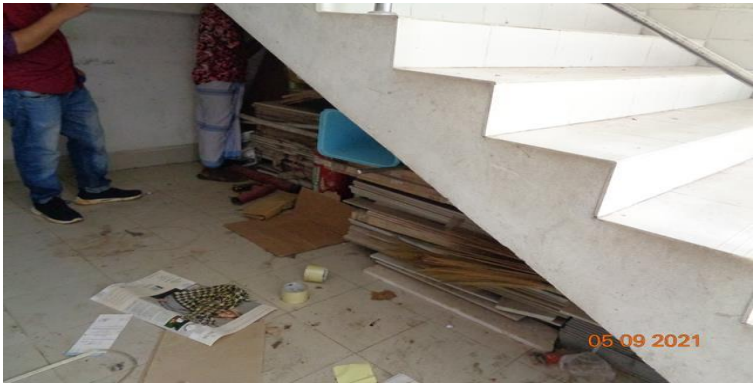
F-8	Mean of Egress	Storage was observed inside exit stair on ground floor, building-1.	Remove all storage from beneath of stair.	Immediately
-----	----------------	---	---	-------------

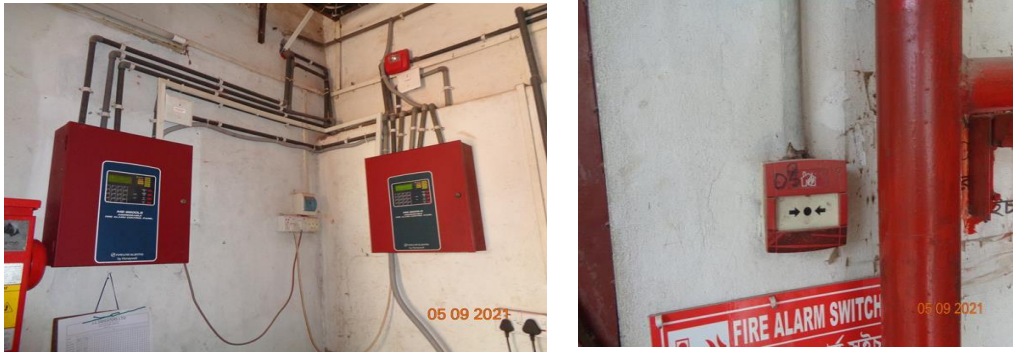
F-9	Means of Egress	Building did not have stair designation signs and occupant load signs at required exit stair entrances.	Provide stair designation sign and occupant load sign at each floor entrance from the stair to the floor in English and Bengali. Signs shall indicate the name of the stair and the floor level. Signs shall be posted adjacent to the door.	Within 1 month
F-10	Fire Alarm & Detection system (FADS)	The addressable fire alarm and detection system is installed for the building. The fire alarm and detection system installation requires detailed review to confirm compliance with NFPA 72 and relevant Standard.	Submit the Fire Alarm and Detection system design to RSC for review and modify the system as per the recommendation. The equipment shall be listed and 3rd party certified. The installation shall be as per NFPA -72.	Design submission within 1 month and installation modification within 4 months
