# INITIAL FIRE SAFETY INSPECTION REPORT

**Prudent Fashions Ltd**

**RSC ID: 24189**

# Fire Safety Inspection Summary Report

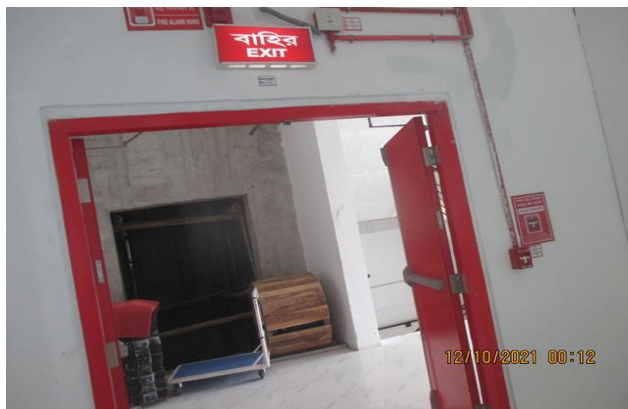
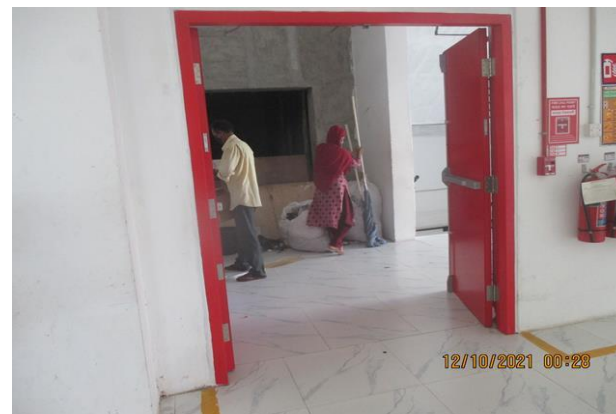
| SI No. | Category | Findings | Required Action | Remediation Time Frame |
|---|---|---|---|---|
| F-1 | Fire Rated Construction | Elevator shafts are directly open into the exit stair enclosure. <b>Located:</b> Main Factory Building, Stair-1 & 2. | For new construction, elevators shall not open into an exit enclosure as per ACCORD Standard- 6.14.3. So, ensure separate enclosures for the elevator shafts with minimum 2 hr. fire rating. If elevator is not being installed/mandatory then the door opening can be sealed by minimum 2-hr fire rated construction. | Within 3 months |

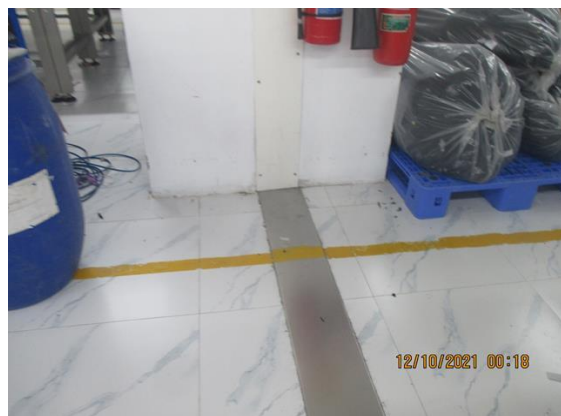
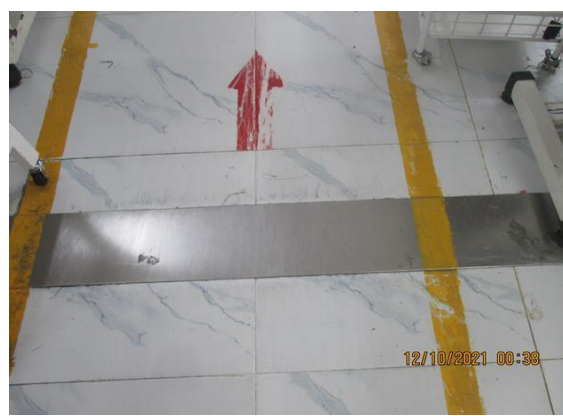
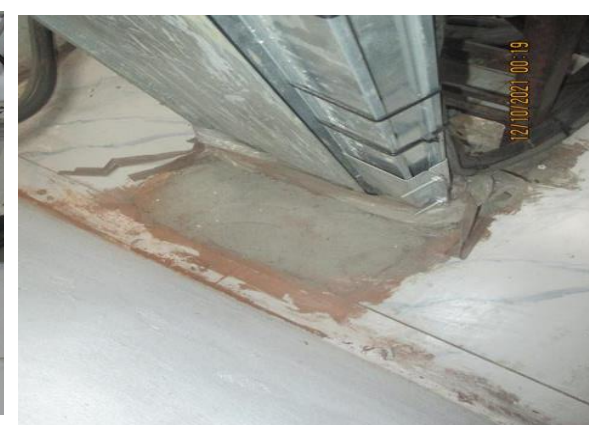
| F-2 | Fire Rated Construction | <p>Unsealed penetrations and openings are located in the fire-rated floor/ceiling assemblies.</p> <p>Expansion joints and Electrical Bus-bar.</p> | <p>Seal the expansion joints by 2-hr fire rated materials to ensure the required fire separation as well as to maintain structural characteristic for the expansion joint.</p> <p>If sealed by listed rated material, provide all the relevant documents and certificate during follow-up and ensure checking facility with expert if required.</p> | Within 3 months |

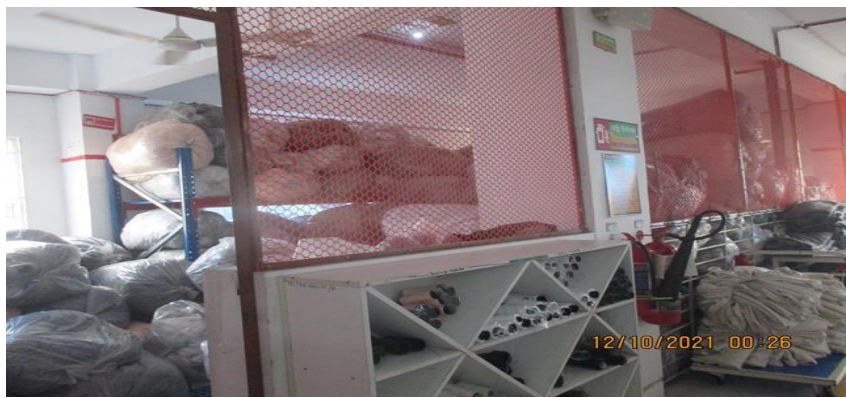
| F-3 | Fire Rated Construction | Areas used for combustible storage open to the factory are not separated by fire rated construction. <b>Location:</b> 3rd floor, main Factory Building | <p>Provide defined storage areas and limit the storage arrangement as follows:</p> <ul style="list-style-type: none"> <li>- Maximum height of 2.45m (8ft.) and maximum area of 23m<sup>2</sup> (250 ft<sup>2</sup>).</li> <li>- If sprinkler protected: maximum height of 3.66m (12ft.) and maximum area of 93m<sup>2</sup> (1,000 ft<sup>2</sup>).</li> </ul> <p>Separate areas of unenclosed combustible storage by a minimum clear distance of 3m (10ft.).</p> | Within 3 months |

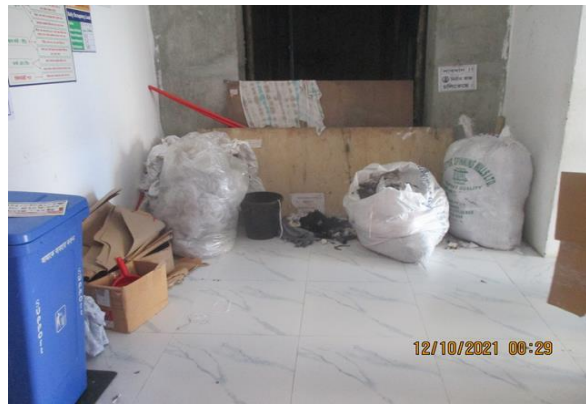
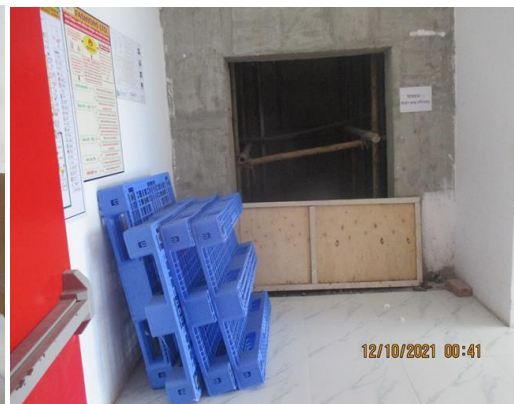
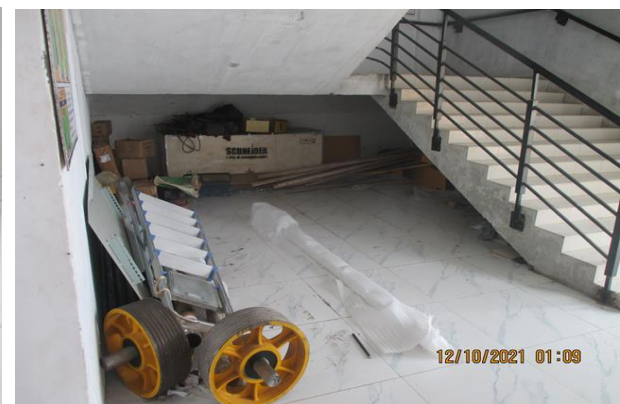
| F-4 | Means of Egress | Storage was located in the exit stair enclosure and underneath the stair. | Remove all storage from exit stairs and egress paths. | Immediately |

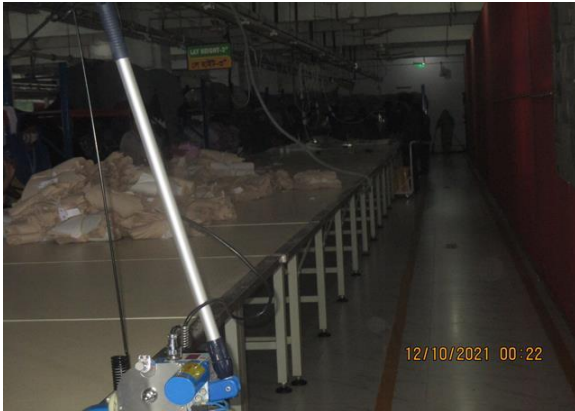
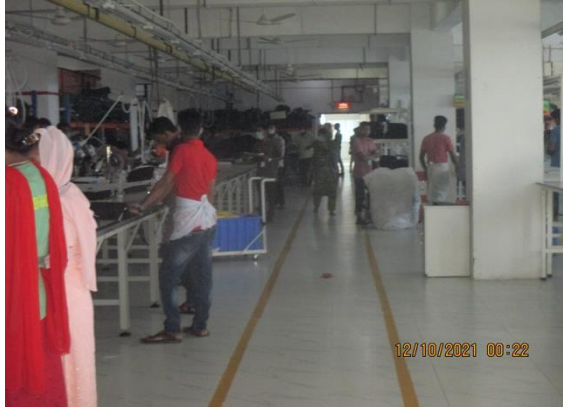
| F-5 | Egress Lighting | Based on the number and location of emergency lights observed, adequate illumination levels are not anticipated along egress routes. | Test the emergency lighting system on each floor and provide additional emergency fixtures to provide adequate illumination along the means of egress. Provide a minimum illumination of 10 lux at the floor level within exit stairs and exit discharge paths and minimum 2.5 lux along exit access aisles. | Within 1 months |

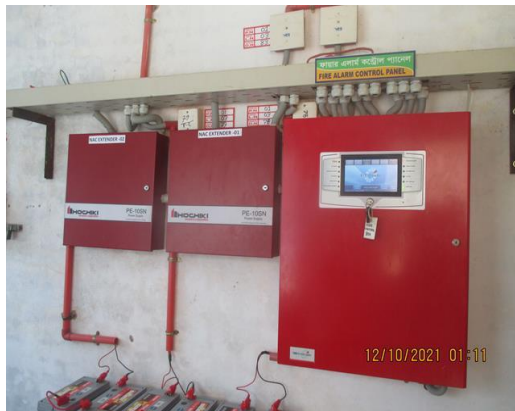
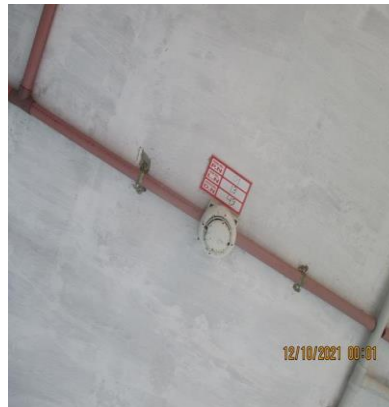
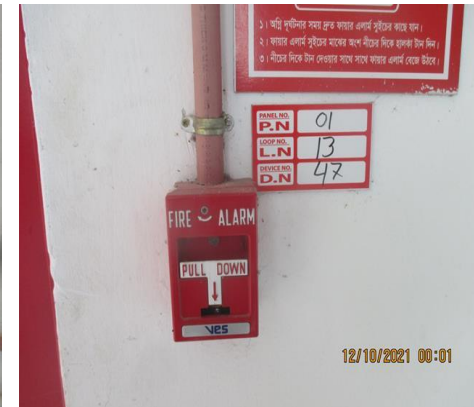
| F-7 | Fire Alarm & Detection System (FADS) | Addressable fire alarm & detection system installation requires detailed review to confirm compliance with NFPA 72 and ACCORD standards. | <p>Submit design, documents and calculations to RSC for review prior and based on the review modify the system if there is any.</p> <p>After installation the owner shall contact the RSC for witness of conducting the final acceptance testing of the fire detection &amp; alarm system installation.</p> <p>Also inspect, test and maintain the fire alarm system, and keep written records on-site, in accordance with NFPA 72.</p> | Design Review within 2 months and modification within 4 months (If require). |

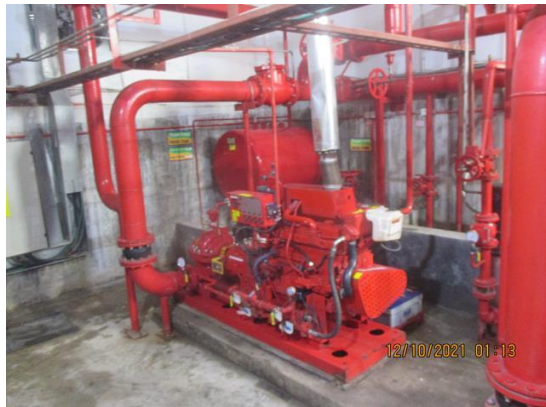
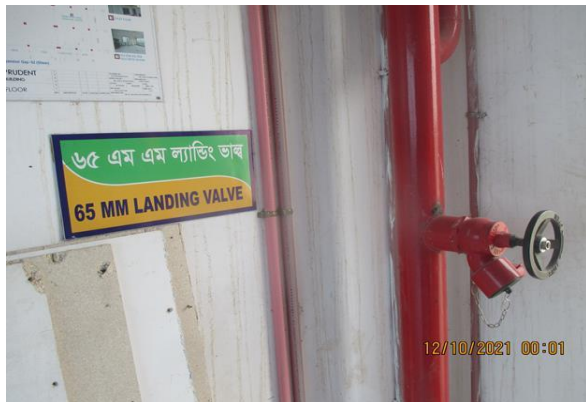
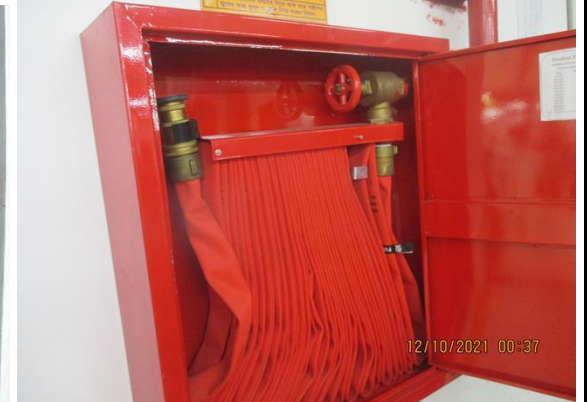
| F-8 | Fire Protection System (Standpipe System). | Standpipe system and fire pump installation requires detailed review to confirm compliance with NFPA 14, 20, 22, 24 and ACCORD standard. | <p>Submit the standpipe system drawing to RSC for review. Once reviewed, install or modify the standpipe system throughout the building in accordance with Accord standard and NFPA 14 and 20.</p> <p>The factory management shall contact RSC to conduct the final acceptance testing after the installation, testing &amp; commissioning.</p> | Design Review within 2 months and modification within 4 months (If require). |
