INITIAL FIRE SAFETY INSPECTION REPORT

Muazuddin Textile Ltd. (Sheds)

RSC ID: 24287

235/236, EAST CHANDURA, SHOFIPUR, KALIAKOR, GAZIPUR

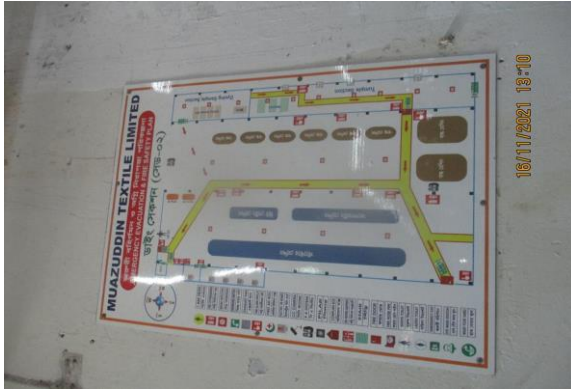
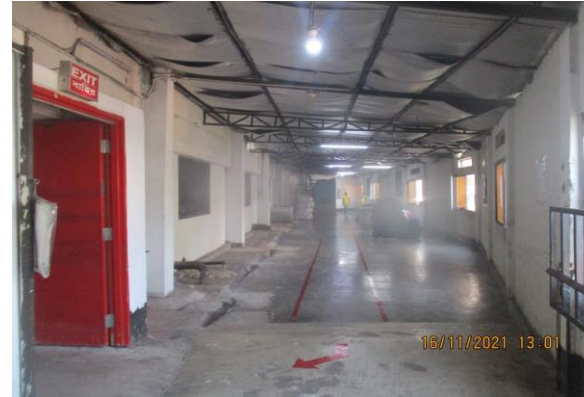
SI No.	Category	Findings	Required Action	Remediation Time Frame
F-1	Egress	Directional signs are not provided where direction of the path of travel to an exit has changed.	Illuminated directional signs shall be provided where there is a change in the direction for the path of travel and the direction to an exit is not obvious.	Within 3 months
F-2	Egress	Common path of egress travel exceeds 23 m. Location: Tumble Shed Occupancy/Process: G2	Reconfigure the egress arrangement to reduce the maximum common path of travel to not more than 23m.	Within 3 months

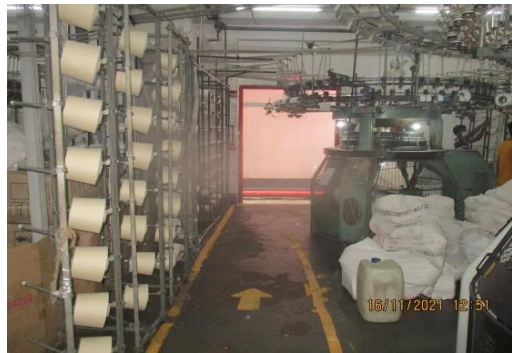
F-3	Egress	Headroom is found less than 6 feet 8 inches when occupant passing through ground floor of 7 storied building. [Knitting shed]	All means of egress shall have a minimum ceiling height of 2.3 m (7 ft 6 in.) with projections from the ceiling not less than 2.03 m (6 ft 8 in.). The minimum ceiling height shall be maintained for at least 2/3 of the space or room as long as the remaining area shall be not less than 2.03m (6 ft 8 in.). Headroom on stairs shall not be less than 2.03 m (6 ft 8 in.).	Within 3 month
-----	--------	---	---	----------------

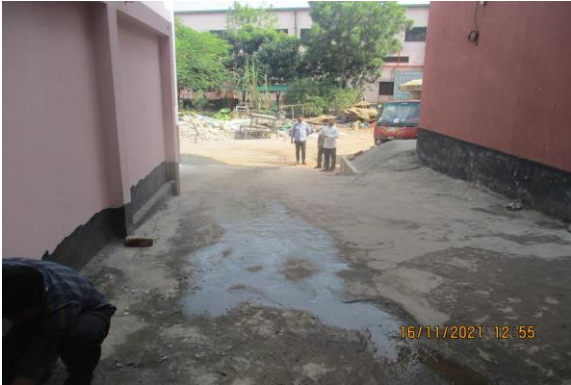
F-4	Egress	Abrupt change in elevation of walking surface was more than 1/4 in. [Shed 09-Knitting shed]	Abrupt changes in elevation of walking surfaces shall not exceed 1/4 in. (6.3 mm). Changes in elevation exceeding 1/4 in. (6.3 mm), but not exceeding 1/2 in. (13 mm), shall be beveled with a slope of 1 in 2. Changes in elevation exceeding 1/2 in. (13 mm) shall be considered a change in level and shall be subject to the requirements of 7.1.7. [NFPA 101, 2015]	Within 3 month
