# INITIAL FIRE SAFETY INSPECTION REPORT

## KNITEX DRESSES LTD.

RSC ID: 12075

Sultan Market, Sharodagonj, Kashimpur, Gazipur

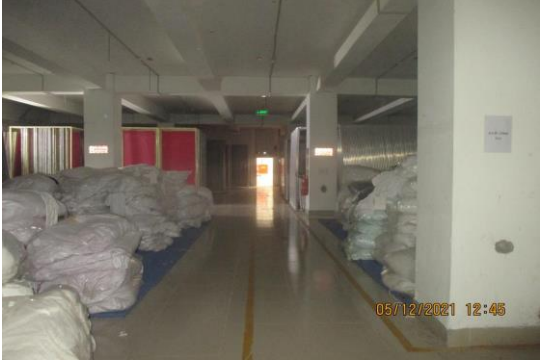
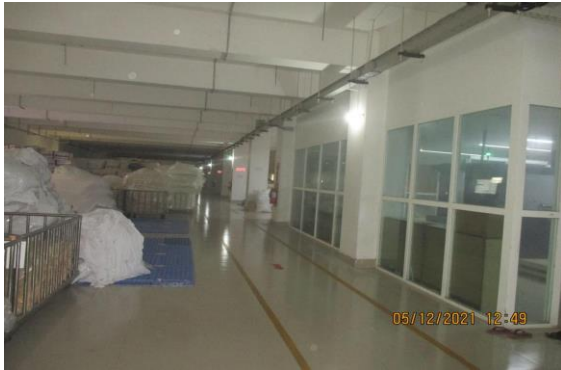
| SI No. | Category | Findings | Required Action | Remediation Time Frame |
|---|---|---|---|---|
| F-1 | Fire Rated Construction | <p>Rooms used for storage of combustible materials are not separated from the surrounding</p> <p>Location: Building 1, 3rd floor</p> | Rooms used for storage of combustible materials shall be separated from the surrounding occupancy with a minimum 1 hour construction. | Within 3 months |

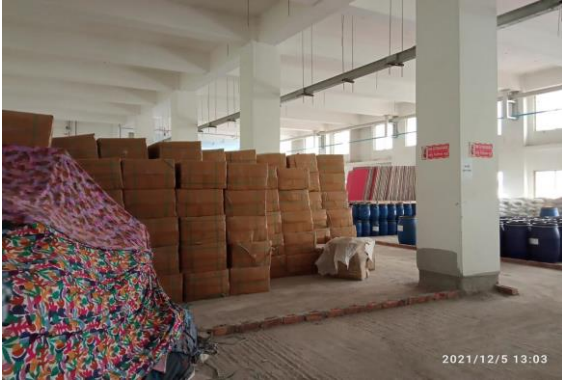
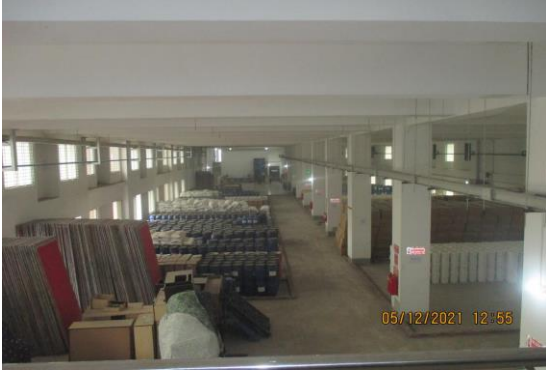
| F-2 | Fire Rated Construction | <p>Areas used for in-process storage of combustible materials are open to the surrounding occupancy.</p> <p>Located: Building 1, 2nd Floor</p> | <p>Provide dedicated storage rooms separated by minimum 1-hr fire-rated construction.</p> <p>Or,</p> <p>Where separate storage rooms are not feasible, Provide defined storage areas and limit the storage arrangement as follows:-</p> <p>1. General Condition: Maximum height of 2.4m and maximum area of 23m<sup>2</sup>. Separate areas of unenclosed combustible storage by a minimum clear distance of 3m.</p> <p>2. If sprinkler protected: maximum height of 3.66m and maximum area of 93m<sup>2</sup>. Separate areas of unenclosed combustible storage by a minimum clear distance of 3m.</p> | Within 3 month |

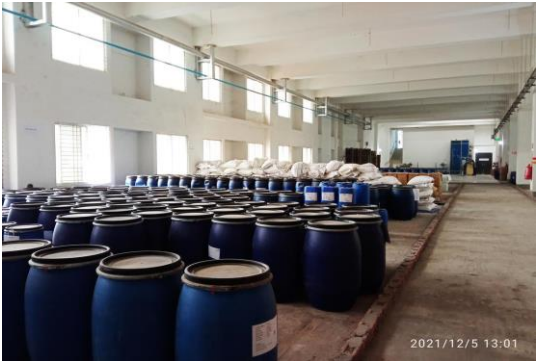
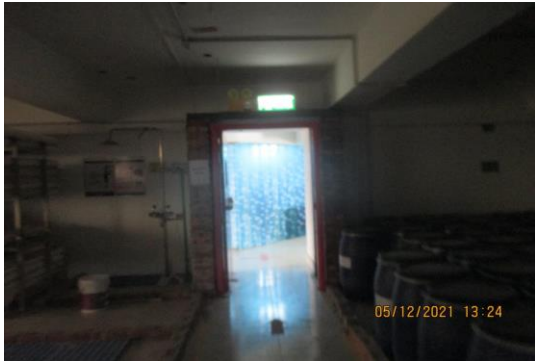
| F-3 | Fire Rated Construction | <p>Chemical storage area is not properly separated by fire-rated construction with other process.</p> <p>Location: Building-1 ( 1st, 2nd and 5th floor)</p> | <p>Separate the chemical storage room by minimum 4-hr fire rated construction. Seal all penetrations and protect the openings to maintain the required fire separations. Keep 16-points SDS of all chemicals in the storage area.</p> <p>** As per BNBC, chemical storage room shall be Type-1 construction. Follow section-2.13 and Table 3.2.1 of BNBC-2006 for the guideline.</p> | Within 3 months |

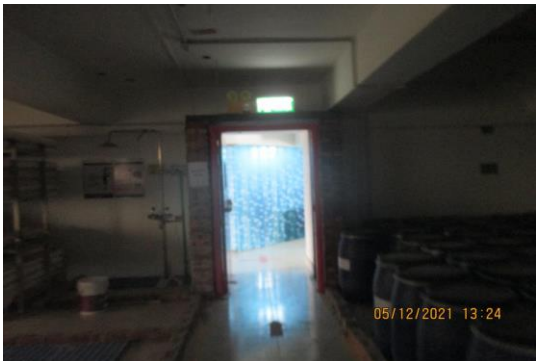
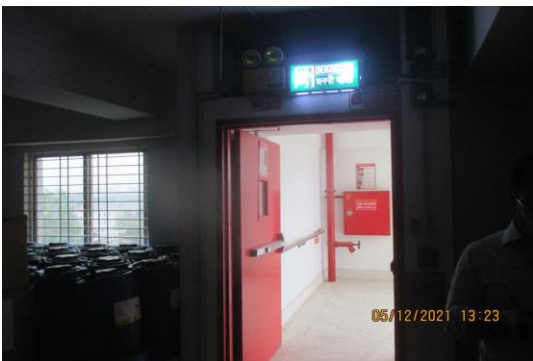
| F-4 | Fire Rated Construction | <p>Chemical Storage discharged directly into the exit stair enclosures.</p> <p>Location: Building-1 ( 1st, 2nd and 5th floor)</p> | <p>Provide vestibule in-between chemical store and stair enclosure with fire rating for minimum 3-hr or ensure maximum exempt quantity of hazardous materials/chemical following table 3.2.7 of BNBC 2006 and clause 2.13 with 2-hr fire rated stair enclosure.</p> | Within 3 month |

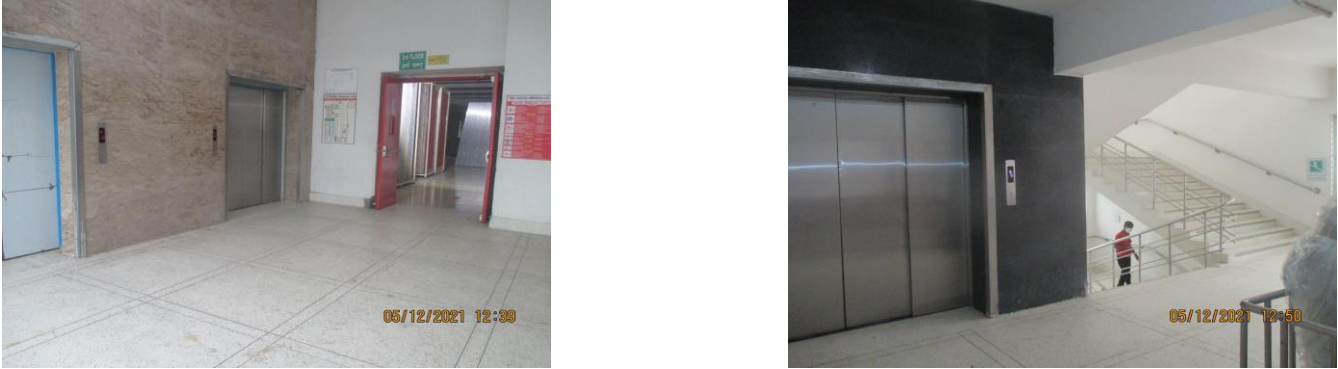
| F-5 | Fire Rated Construction | <p>Elevator shafts are directly open into exit enclosure which is a violation of ACCORD Standard-6.14.3.</p> <p>Location: Building 01 (Stair 1 &amp; 5).</p> | <p>For new construction, elevators shall not open into an exit enclosure as per ACCORD-6.14.3. So, provide separate enclosures for elevator and stair.</p> | Within 3 months |

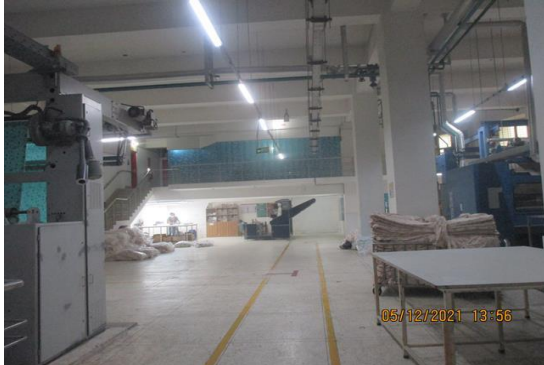
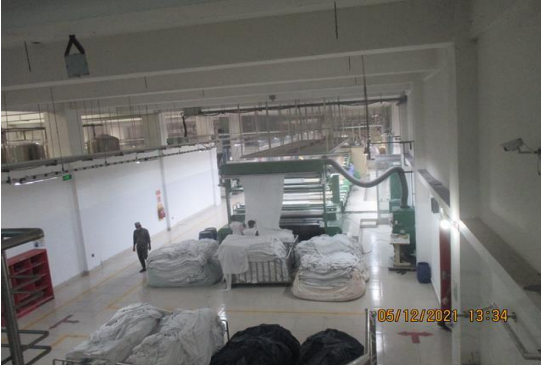
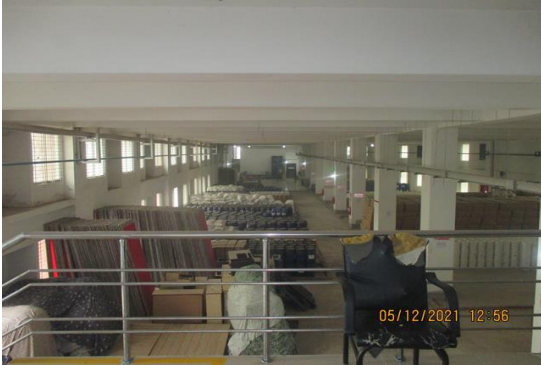
| F-6 | Fire Rated Construction | <p>Mezzanine floors are defined as main floor as the area exceeds 1/3rd of main floor area, where no floor to floor fire separation was provided for 1st, 3rd and 5th floors.</p> <p>Building-1</p> | Provide minimum 3-hr floor to floor fire separation on every floors following table 3.3.1 of BNBC-2006. | Within 3 Months |

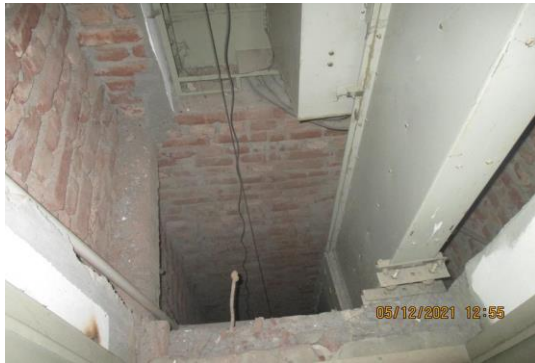
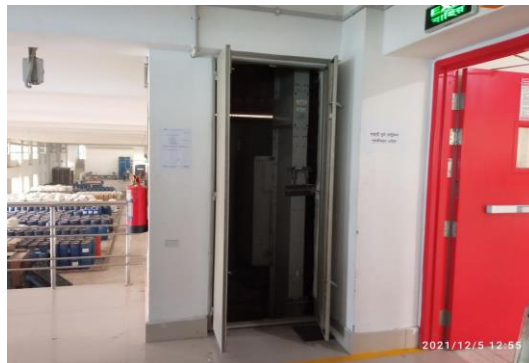
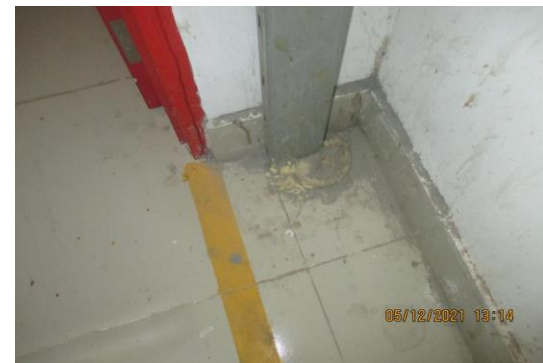
| F-7 | Fire Rated Construction | <p>Penetrations through floor/ceiling assemblies are found unsealed.</p> <p>Location: Building-1 (All Floor)</p> | <p>Seal all penetrations and openings in floor/ceiling assemblies to maintain the fire separation at least by 3-hr. The used sealer shall be 3rd party certified and installation shall be as per manufacturer's datasheet.</p> <p>or,</p> <p>Provide a minimum 2-hr fire rated shaft to separate the utility risers from each floor if required.</p> | Within 3 months |

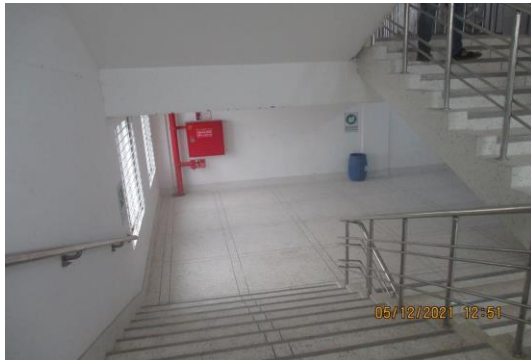
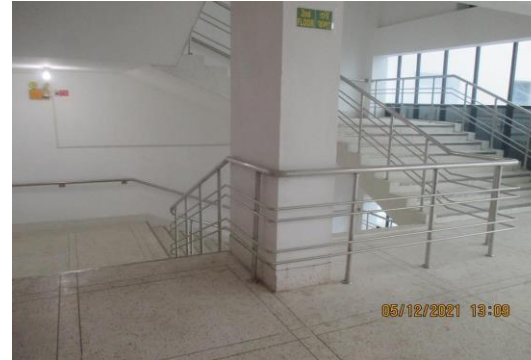
| F-8 | Means of Egress | <p>Intermediate handrails were not provided when the stair width exceeds 2.2 m (87 in.)</p> <p>Location : Building 1 (Stair 1 &amp; 5)</p> | <p>Intermediate handrails shall be provided when the stair width exceeds 2.2 m (87 in.). New handrails shall have a minimum height of 865 mm (34 in.) and a maximum height of 965 mm (38 in.) as measured from the leading edge of the tread.</p> | Within 1 month |

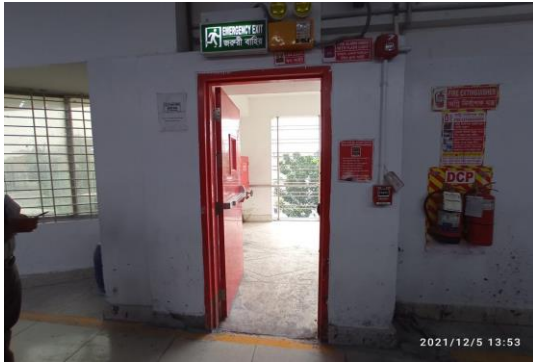
| F-9 | Means of Egress | <p>The clear exit door width was measured only 28 inch where the requirement is minimum 39.5 inch (1 Meter).</p> <p>Location: Building-1 (1st floor, Stair-2)</p> | New exit doors along the means of egress shall have a minimum width of 1 m (39.5 in.). ACCORD Standard : 6.5.6.1.2 | Within 3 months |

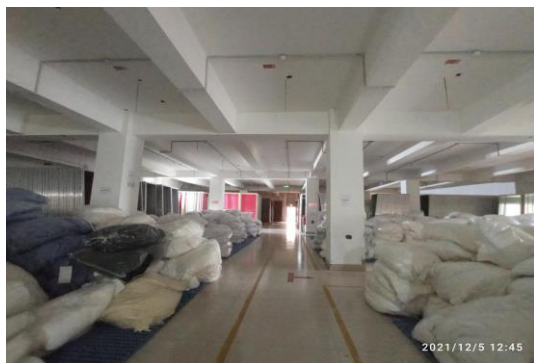
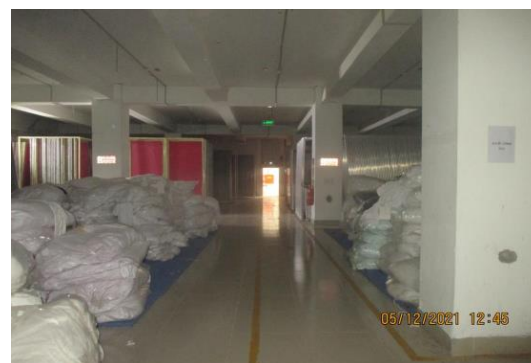
| F-10 | Egress Lighting | <p>Based on the number and location of emergency lights observed, adequate illumination levels are not anticipated along egress routes.</p> <p>Location: Building 1 (3rd floor)</p> | Test the emergency lighting system on each floor and provide additional emergency fixtures to provide adequate illumination along the means of egress. Provide a minimum illumination of 10 lux at the floor level within exit stairs and exit discharge paths and minimum 2.5 lux along exit access aisles. | Within 3 months |

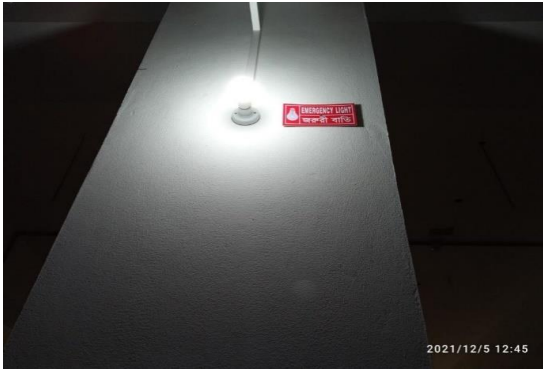
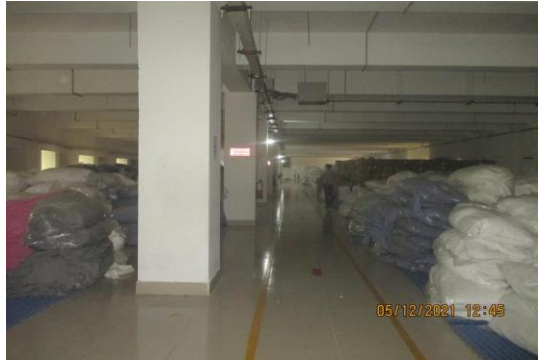
| F-11 | Egress lighting(ITM) | Inspection, testing, and maintenance for the exit sign and emergency lighting system was not in accordance with The ACCORD standard. | Inspect, test and maintain the exit sign and emergency lighting system in the accordance with The ACCORD standard. Keep written records on-site. | Within 1 months |

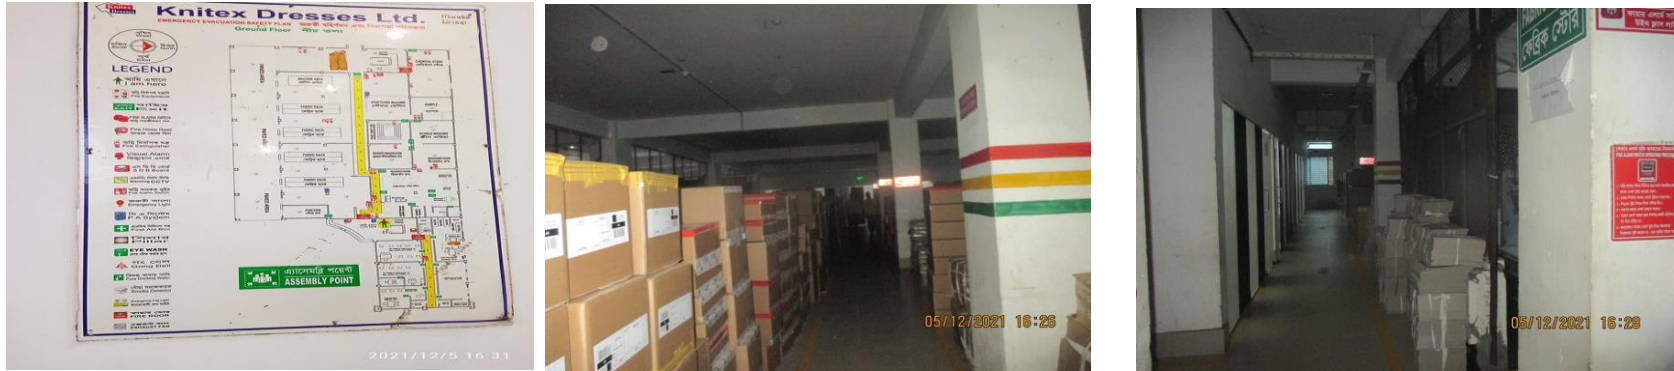
| SI No. | Category | Findings | Required Action | Remediation Time Frame |
|---|---|---|---|---|
| F-17 | Fire Rated Construction | <p>Rooms used for storage of combustible materials are not separated from the office &amp; engraving section at ground floor And from inspection room &amp; office at 1st floor.</p> <p>Location: Building 4, ground floor</p> | Rooms used for storage of combustible materials shall be separated from the surrounding occupancy with a minimum 1 hour construction. | Within 3 months |

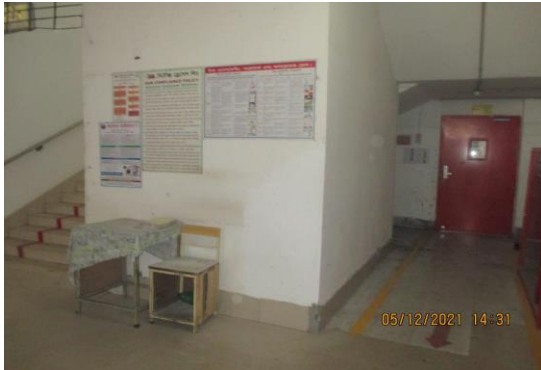
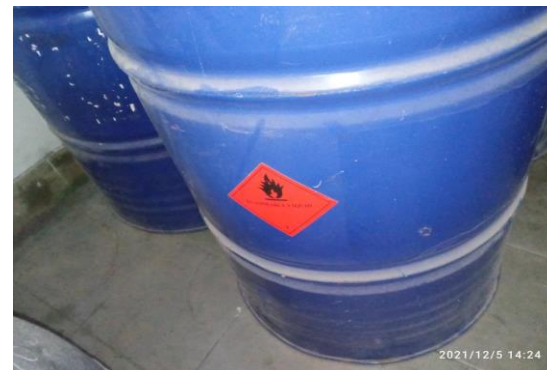
| SI No. | Category | Findings | Required Action | Remediation Time Frame |
|---|---|---|---|---|
| F-18 | Fire Rated Construction | <p>Chemical Storage where hazardous chemical were strode discharged directly into the exit stair enclosure/passageway. (Connected with AOP shed)</p> <p>Location: Building-4 (Ground Floor)</p> | Provide vestibule in-between chemical store and stair enclosure with minimum fire rating 3-hr. | Within 3 month |

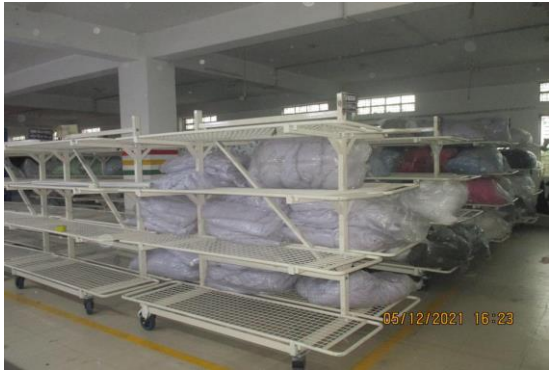
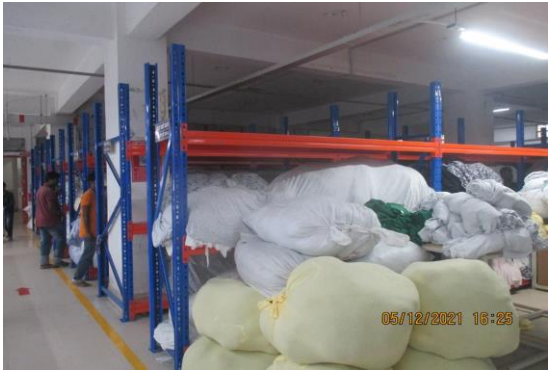
| F-19 | Fire Rated Construction | <p>Areas used for in-process storage of combustible materials are open to the surrounding occupancy.</p> <p>Located: Building 4, 1st floor cutting</p> | <p>Provide dedicated storage rooms separated by minimum 1-hr fire-rated construction.</p> <p>Or,</p> <p>Where separate storage rooms are not feasible, Provide defined storage areas and limit the storage arrangement as follows:-</p> <ol style="list-style-type: none"> <li>1. General Condition: Maximum height of 2.4m and maximum area of 23m<sup>2</sup>. Separate areas of unenclosed combustible storage by a minimum clear distance of 3m.</li> <li>2. If sprinkler protected: maximum height of 3.66m and maximum area of 93m<sup>2</sup>. Separate areas of unenclosed combustible storage by a minimum clear distance of 3m.</li> </ol> | Within 3 month |

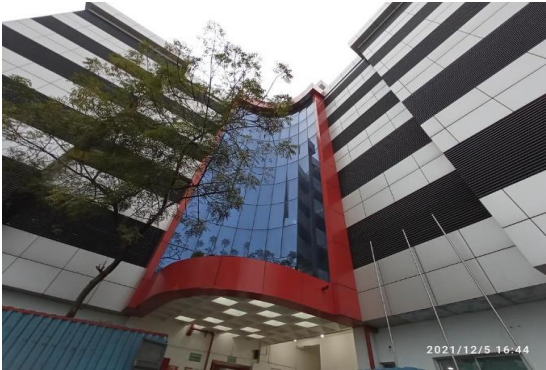
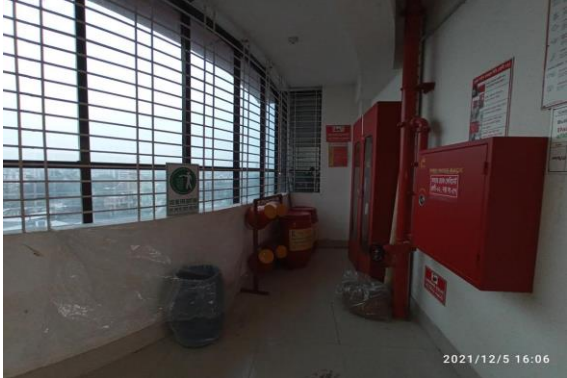
| F-20 | Fire Rated Construction | <p>The exit stairs are not separated from work areas on each floor by fire-rated construction. Stair Connected with floor by glass partition.</p> <p>Location: Building-4 (1st floor to 5th floor)</p> | <p>The exit stair enclosure shall be provided with a minimum 2- hr. fire resistance rating. Provide 1.5 hr. fire rated door and seal all penetrations and openings by 2 hr. fire rated fire rated barrier construction.</p> <p>Provide a fire-resistive rated assembly between the exterior exit stairs and the building up to 10 ft. beyond the end of the stair to achieve the required separation. The rated assembly shall be approved and/or designed by a qualified fire protection engineer.</p> <p>Ensure that the fire doors are self-closing and positive latching and that they are provided with fire exit (panic) hardware where serving production floors. If fire doors are required to be held open for functional reasons, provide automatic closing devices tied to the fire alarm system.</p> | Within 3 month |

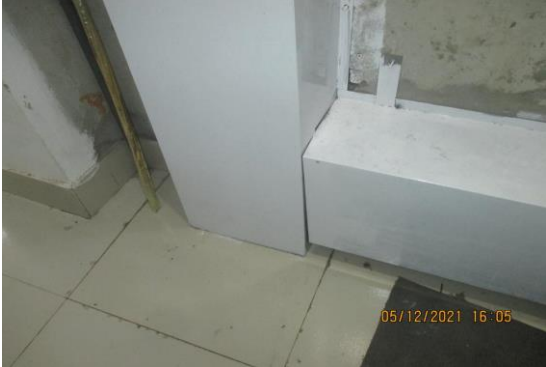
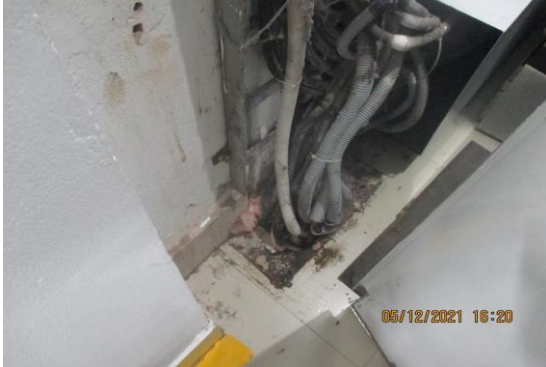
| F-21 | Fire Rated Construction | <p>Penetrations through fire rated floor/ceiling assemblies are not properly sealed.</p> <p>Location: Building-4 (all floor)</p> | <p>Seal all penetrations and openings in floor/ceiling assemblies to maintain the fire separation at least by 3-hr. The used sealer shall be 3rd party certified and installation shall be as per manufacturer's guideline.</p> <p>or,</p> <p>Provide a minimum 2-hr fire rated shaft to separate the utility risers from each floor if required.</p> | Within 3 months |

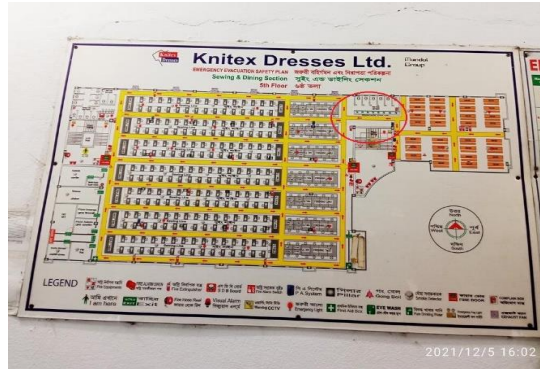
| F-22 | Fire Rated Construction | <p>The Dining area is not separated by fire rated construction with the adjacent production occupancies.</p> <p>Location: Building-4 (5th floor)</p> | <p>Separate the dining area from production &amp; other occupancies by minimum 3-hr fire rated construction. Provide rated exit passageways leading directly to the exit stairs of the same resistance rating.</p> | Within 3 months |

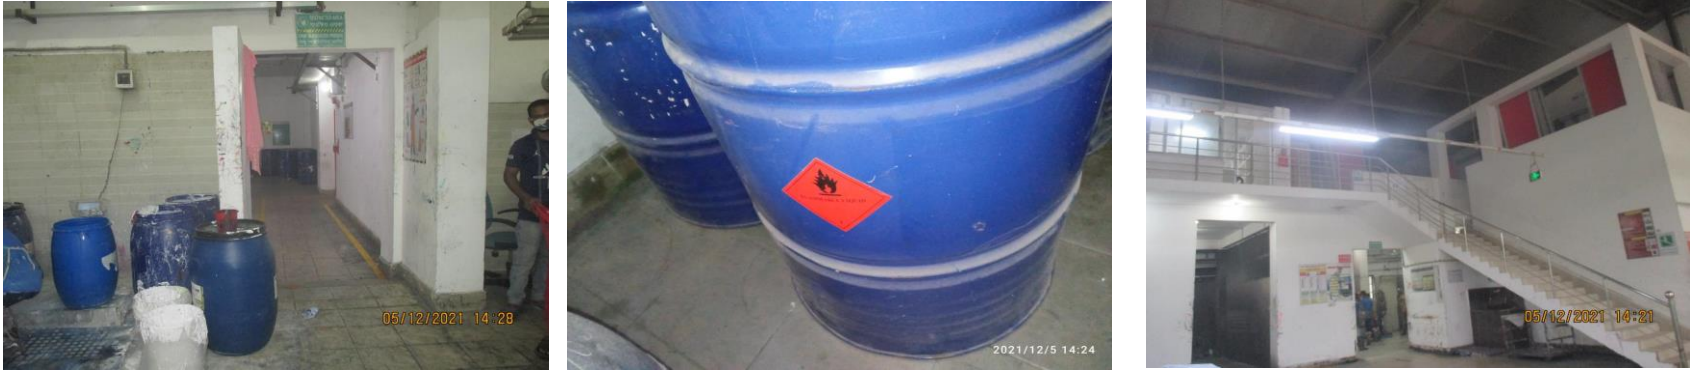
| Sl No. | Category | Findings | Required Action | Remediation Time Frame |
|---|---|---|---|---|
| F-31 | Fire Rated Construction | <p>Chemical storage area is not properly separated by fire-rated construction with other process.</p> <p>Location: Building-3 AOP &amp; Buildin-4 ground floor attached</p> | <p>Separate the chemical storage room by minimum 4-hr fire rated construction. Seal all penetrations and protect the openings to maintain the required fire separations. Keep 16-points MSDS of all chemicals in the storage area.</p> <p>** As per BNBC, chemical storage room shall be Type-1 construction. Follow section-2.13 and Table 3.2.1 of BNBC-2006 for the guideline.</p> | Within 3 months |

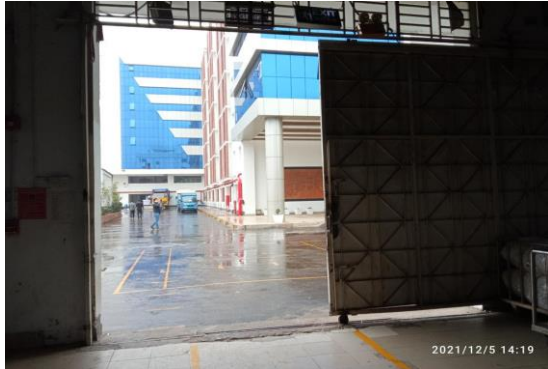
| F-32 | Means of Egress | <p>Sliding type doors have been provided along the exit way. A pocket door was observed but during inspection it was found locked.</p> <p>Location: Building-3, AOP</p> | <p>Replace sliding type doors &amp; gates by the side-hinged swinging type doors.</p> <p>If locks are required for security reasons, utilize special door locking features complying with NFPA 101.</p> | Within 1 month |

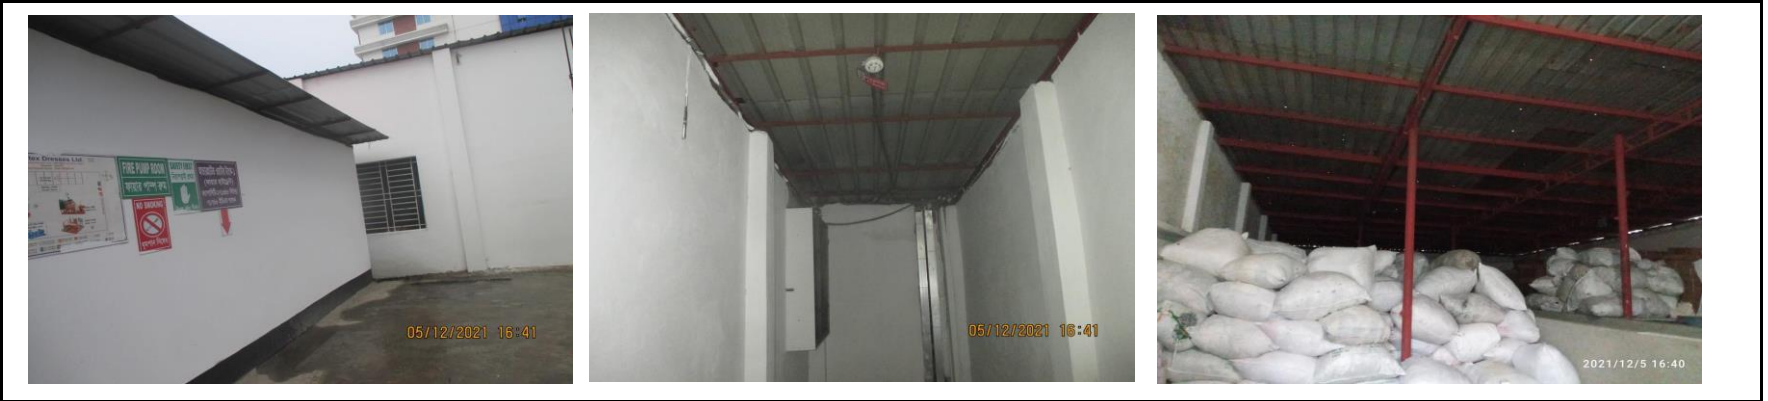
| F-35 | Fire Rated Construction | <p>The fire pump room is not provided with adequate fire separation with adjacent wastage store, where non-rated openings on both wall are available. Moreover, the roof for both structure is non-rated where the distance is only 5 ft approximately.</p> <p>Location: Building-5 (Fire pump room)</p> | <p>Provide fire pump room with 2 hr. rated fire separation when not sprinklered and 1 hr. rated fire separation when provided with automatic sprinklers in accordance with NFPA 20 Or, Physically separate the pump room from the protected building by a minimum of 50 ft. (15.3 m) in accordance with NFPA 20</p> | Within 3 months |
