INITIAL FIRE SAFETY INSPECTION REPORT

Victoria Intimate Limited

RSC ID: 24298

Dakkhin Vangnahati, Boiragirchala, Sreepur Gazipur

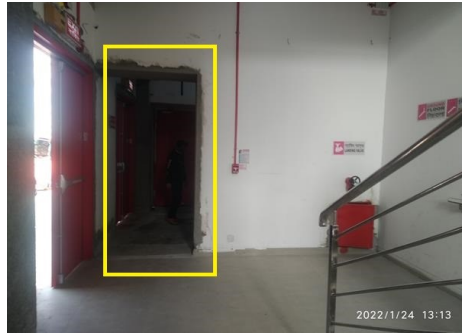
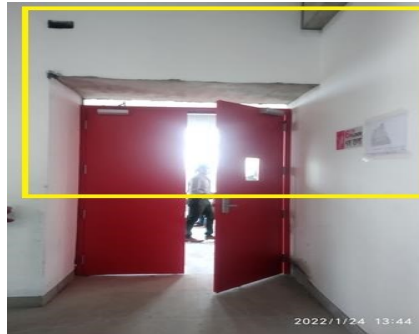
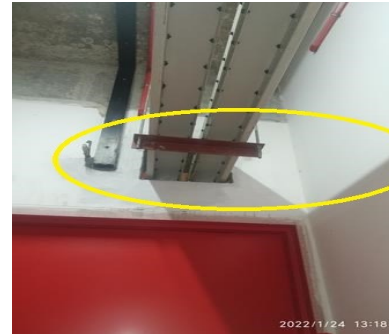
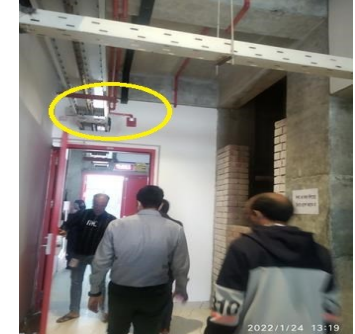
SI No.	Category	Findings	Required Action	Remediation Time Frame
F-1	Fire Rated Construction	<p>The exit stairs are not separated from work areas and other spaces on each floor as the installed fire rated doors was not functional properly and unprotected opening & penetrations with non-rated cable channel.</p> <p>Location: Production building-01, Admin building 02 & Utility building 03.</p>	<p>Provide minimum 2-hr fire rated separation exit enclosure. Provide minimum 1.5-hr fire rated doors and seal all unprotected openings and penetration to separate the exit stairs from work areas and other building spaces on all floor levels.</p> <p>Ensure that the fire doors are self-closing and positive latching and that they are provided with fire exit (panic) hardware where serving production floors. If fire doors are required to be held open for functional reasons, provide automatic closing devices tied to the fire alarm system.</p> <p>Once fire doors are installed, every door in a stair enclosure serving more than 5 stories shall be provided with re-entry unless it meets ACCORD standard 6.8.3.1.</p>	Within 3 months

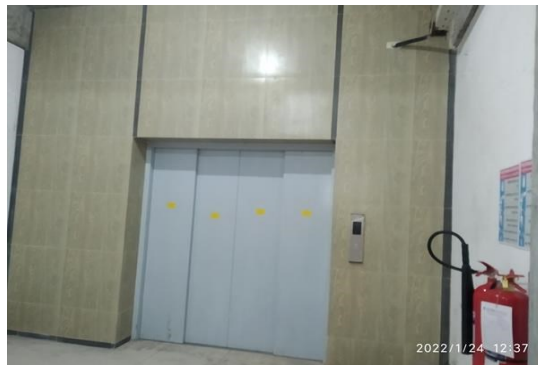
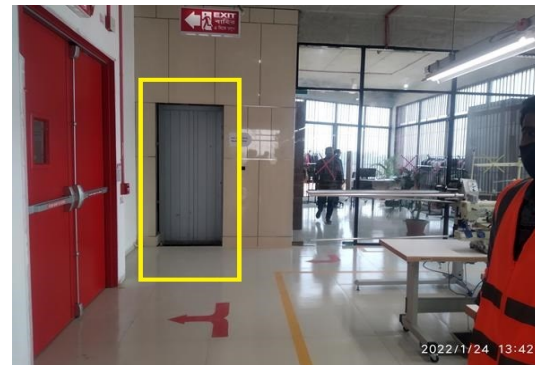
F-2	Fire Rated Construction	<p>Elevator shafts are directly open into the production floor without proper fire separation.</p> <p>Location: Production building 01 & Admin building 02.</p>	<p>Ensure minimum 2-hr listed/3rd part certified fire rated lift landing doors for elevator shafts otherwise close the area of the shaft with a 2-hr fire-rated construction barrier.</p>	Within 3 months
-----	-------------------------	---	---	-----------------

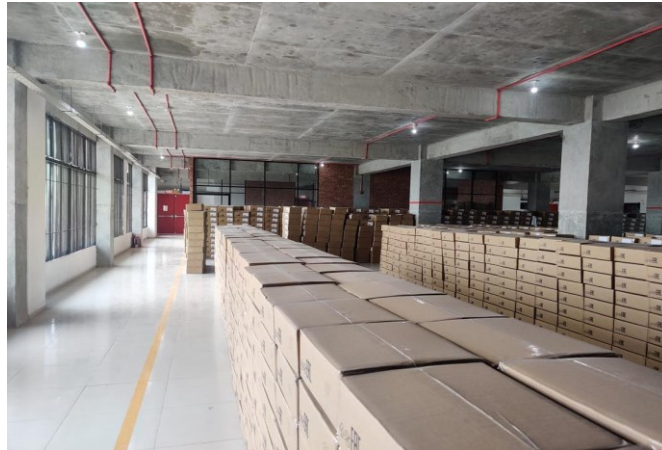
F-3	Fire rated construction.	Storage room discharges directly into exit stair enclosure. Location: 5th & ground floor of production building 01.	Openings from exit enclosure to storage spaces shall be provided with a vestibule with fire rated construction and openings. Provide a 1.5-hr. fire rated door on the exit stair side and a 1-hr. fire rated door on the storage room side. Ensure that the fire rating of the vestibule construction matches that of the exit stair enclosure.	Within 3 months
-----	--------------------------	--	---	-----------------

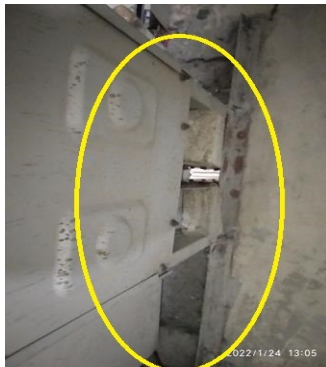
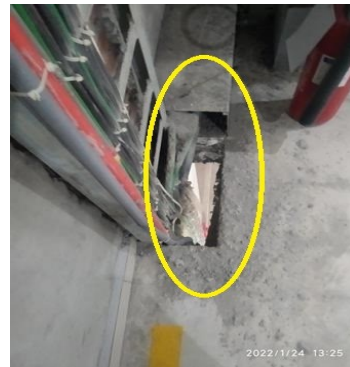
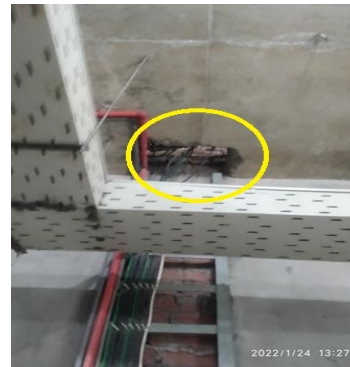
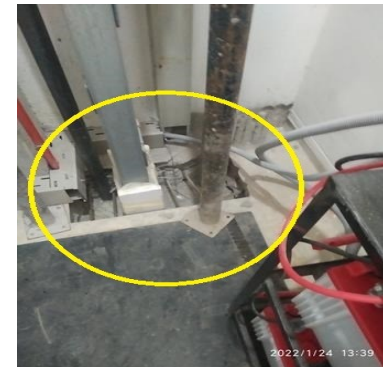
F-4	Fire Rated Construction	<p>Unsealed penetrations and openings are located in the fire-rated floor/ceiling assemblies.</p> <p>Location: Electrical riser of production building 01, Admin building 02 & Utility building 03</p>	<p>Seal all penetrations and openings in floor/ceiling assemblies to maintain the fire separation at least by 3-hr. The used sealer shall be 3rd party certified and installation shall be as per manufacturer's datasheet.</p> <p>Or</p> <p>Provide a minimum 2-hr fire rated shaft to separate the utility risers from each floor if required.</p>	Within 3 months
-----	-------------------------	--	--	-----------------

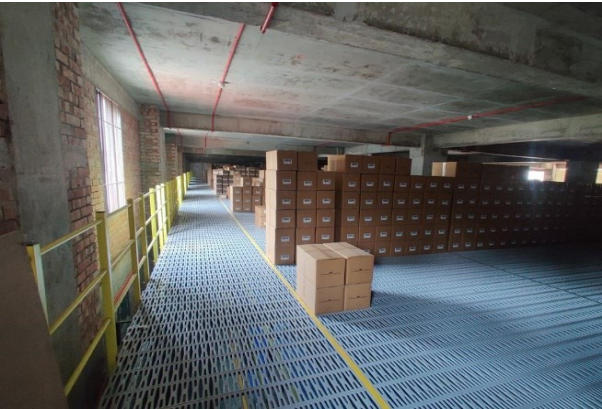
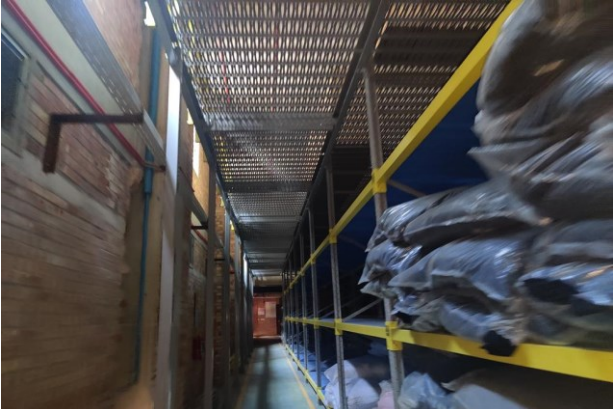
F-5	Fire rated construction.	<p>It has been observed that the ground floor to first floor (claimed mezzanine) are not separated from each other of production building 01. Ground floor exit is from ground level and 1st floor exit from 1st floor level. Factory Claimed Mezzanine floor which is occupying more than 33.33% of the building plinth area (measure full plinth area) are not properly separated from the ground floor thus the 1st floor finished goods area appears more vulnerable regarding fire safety as well as property/material safety.</p>	<p>Mezzanine floor shall not exceed 33.33% of the building plinth area as per BNBC-2006, clause 1.12.6.1.</p> <p>Separate each floors by fire rated construction as per BNBC, Part-3, chapter-3 and Table 3.3.1.</p> <p>2-hr fire rated separation is required from claimed mezzanine floor (actually first floor) to ground floor other surroundings as well as separation is needed at required number of exit stairs.</p>	Within 3 months

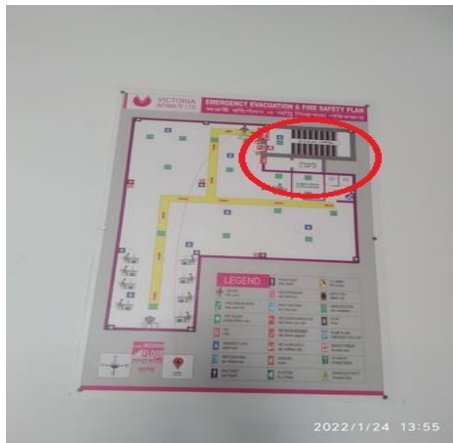
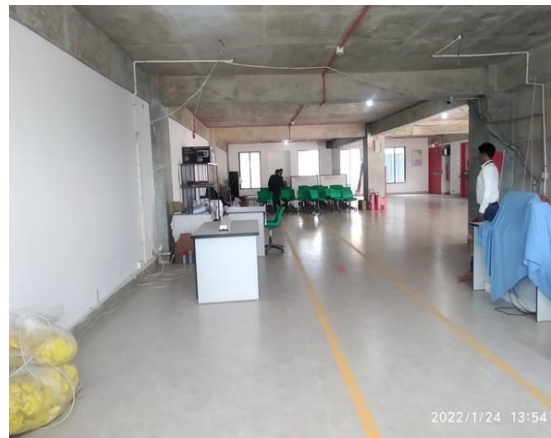
F-6	Means of Egress	<p>A single means of egress is provided from first floor north side of production building 01 where travel exceed the limit.</p>	<p>Ground or basement story is allowed a maximum of 50 occupants and 23 m (75ft) travel distance.</p> <p>The second story is allowed a maximum of 30 occupants and 23 m (75ft) travel distance.</p> <p>All other stories require a minimum of 2 egress exits.</p> <p>Provide additional means of egress from first floor north side of production building 01</p>	<p>Within 3 months</p>
-----	-----------------	--	---	------------------------

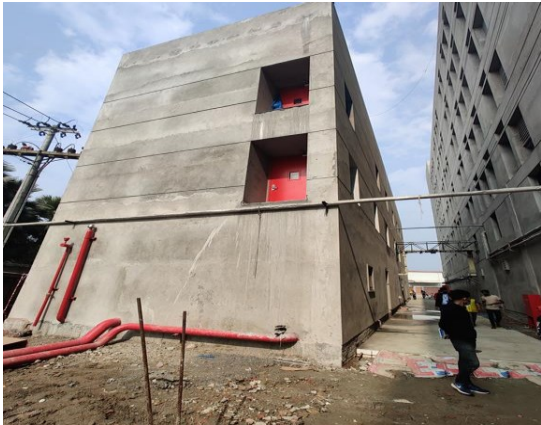
F-7	Means of Egress	The 3-storied Utility building 03 is provided with only one exit stair.	Provide at least one additional exit stair for evacuation purpose in case of emergency. All requirements shall be met for stairs in new building construction as per BNBC.	Within 3 months

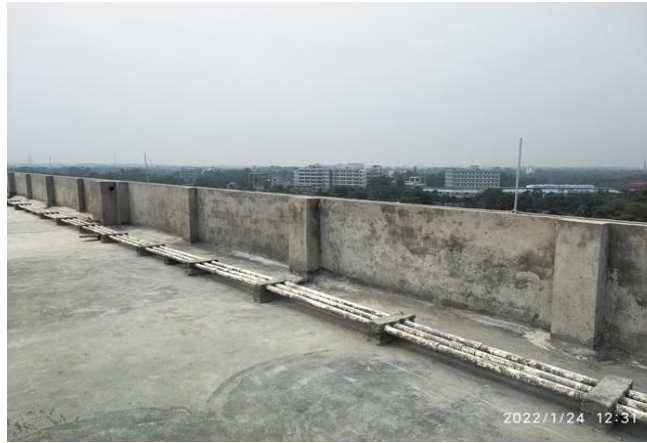
F-8	Means of Egress	<p>Parapets or guards are provided in occupied roof which is less than 1067mm (42 inch).</p> <p>Location: Building 01, Building 02 & building 03</p>	Provide parapets or guards with a minimum height of 1067mm (42 inch.).	Within 3 months

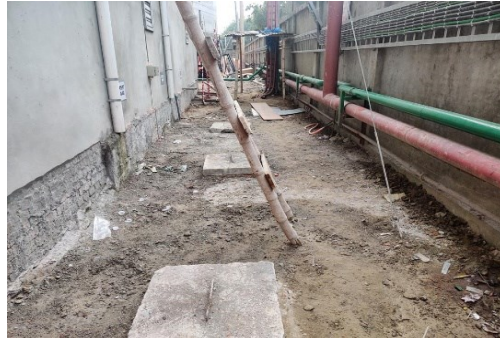
F-9	Means of Egress	<p>Building did not have stair designation signs at required locations.</p> <p>Location: Admin building 02 & Utility building.</p>	<p>Provide stair designation sign & exit designation sign at each floor entrance from the stair to the floor in English and Bengali. Signs shall indicate the name of the stair and the floor level. Signs shall be posted adjacent to the door.</p>	Within 1 month
F-10	Means of Egress	<p>Uneven path of travel and blockage in exit access due to construction purpose.</p> <p>Location: West side exit discharge of utility building..</p>	<p>Remove unnecessary items and level exit path to the public way.</p>	Within 1 month

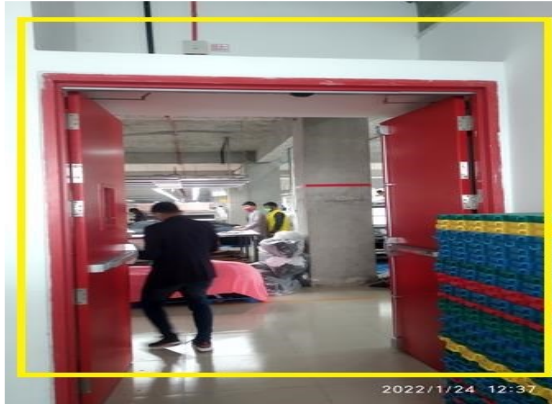
F-11	Egress Lighting	<p>Exit sign not provided at required exit.</p> <p>Location: Several location of all building.</p>	<p>Lighted exit signs shall be placed at entrance to an exit. Additional exit signs shall be placed throughout the facility anywhere the continuation of the egress is not obvious.</p> <p>Lighted exit signs shall be provided with either battery backup or uninterruptable power supply systems and shall be continuously illuminated.</p>	Within 1 month
------	-----------------	--	---	----------------

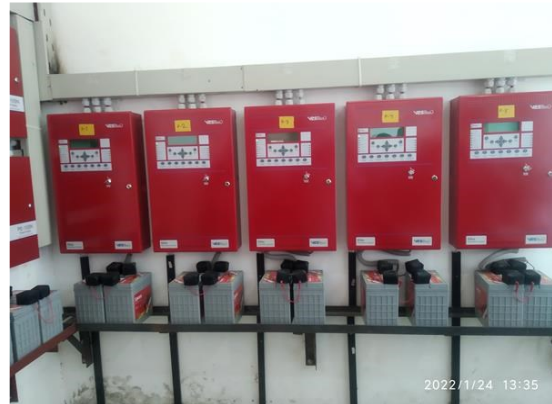
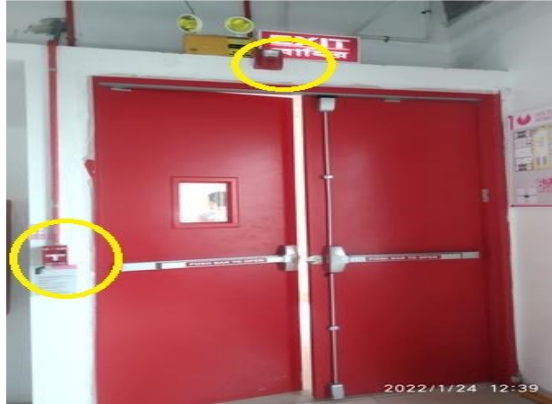
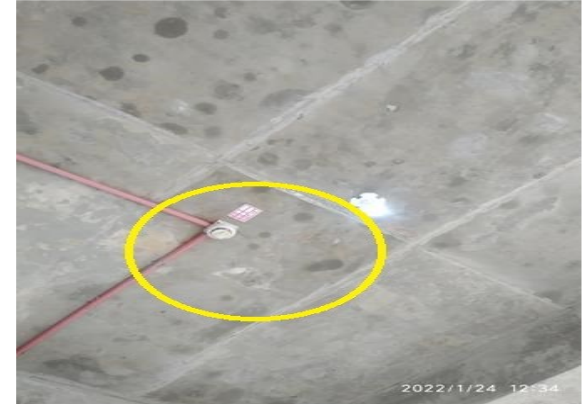
F-12	Egress lighting(ITM)	Inspection, testing, and maintenance for the exit sign and emergency lighting system was not in accordance with The ACCORD standard.	Inspect, test and maintain the exit sign and emergency lighting system in the accordance with The ACCORD standard. Keep written records on-site.	Within 3 months
F-13	Fire Alarm & Detection System (FADS)	The fire alarm and detection system installation requires detailed review to confirm compliance with NFPA 72.	Submit as-built drawings, testing records, equipment certification and other relevant documentation to the RSC for review and approval/acceptance test.	Design within 2 months, Install within 4 months.

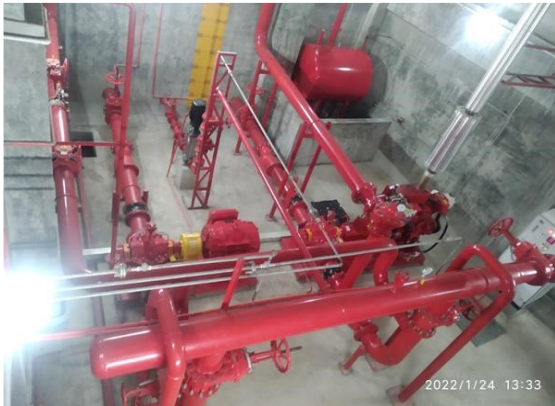
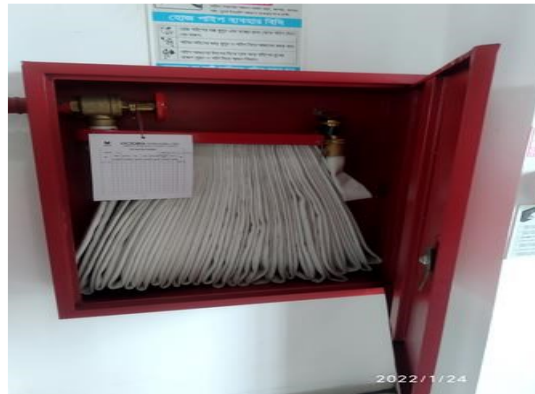
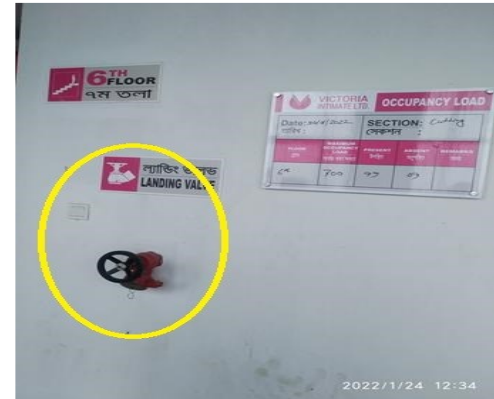
F-14	Fire Protection System(Standpipe)	Standpipe system installation requires detailed review to confirm compliance with NFPA 14 ,20 ,22 & 24	Submit as-built drawings, testing records, equipment certification and other relevant documentation to the RSC for review and approval/acceptance test.	Design within 2 months, Install within 4 months.
------	-----------------------------------	--	---	--
