INITIAL FIRE SAFETY INSPECTION REPORT

Factory Name: Crosswear Industries Limited

Date: 20 February 2022

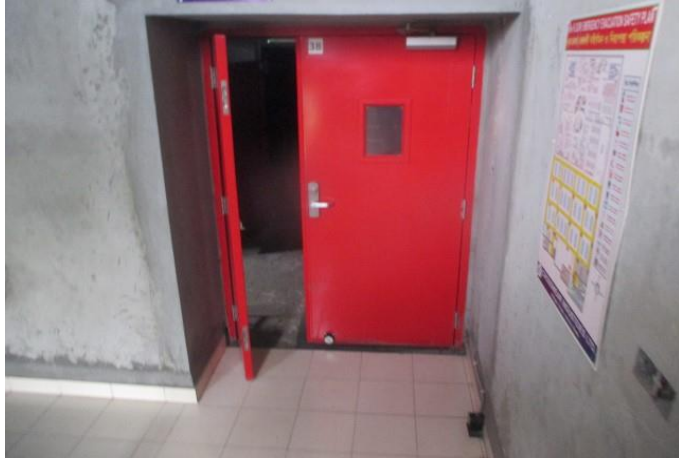
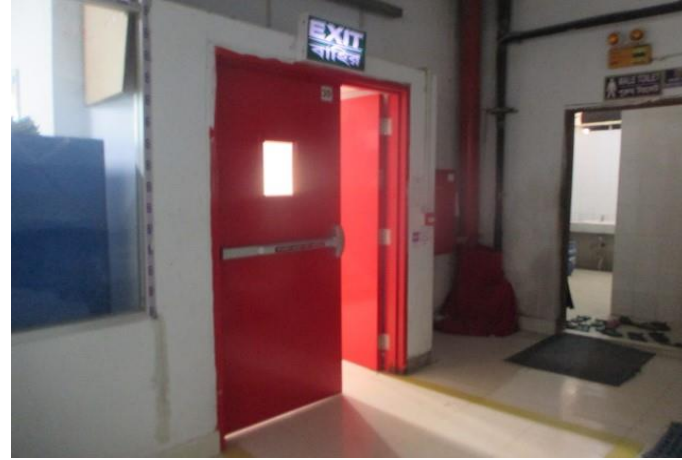
SI No.	Category	Findings	Required Action	Remediation Time Frame
1	Fire Rated Construction	The exit stairs are not separated from other occupancy on each floor by fire rated construction.	Provide minimum 1.5-hr fire rated doors for buildings that are 4 or more stories. Seal all unprotected openings to separate the exit stairs from work areas and other building spaces on all floor levels. Ensure that the fire doors are self-closing and positive latching and that they are provided with fire exit (panic) hardware where serving production floors. If fire doors are required to be held open for functional reasons, provide automatic closing devices tied to the fire alarm system. Once fire doors are installed, every door in a stair enclosure serving more than 5 stories shall be provided with re-entry unless it meets accord standard 6.8.3.1.	Within 3 months

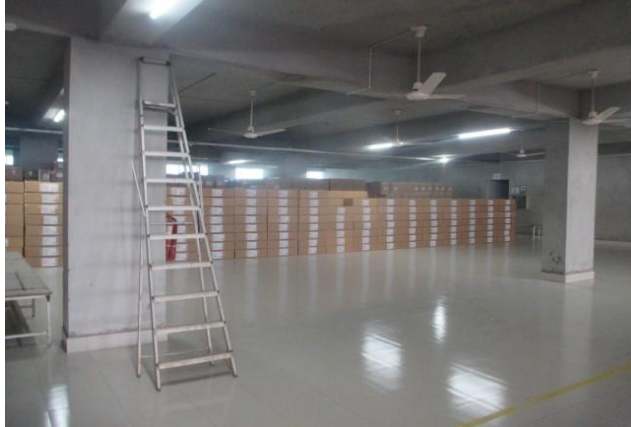
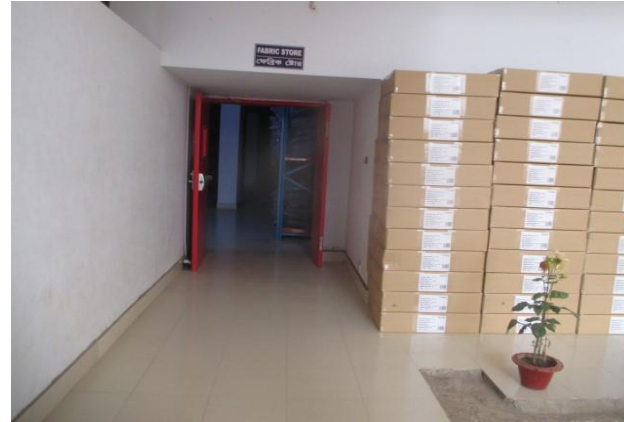
2	Fire Rated Construction	Rooms used for storage of combustible materials are not separated from the surrounding occupancy/areas & floors. Location: 7th Floor	Rooms used for storage of combustible materials shall be separated from the surrounding occupancy with a minimum 1 hour construction.	Within 3 months
---	-------------------------	-----------------------------------------------------------------------------------------------------------------------------------------	---------------------------------------------------------------------------------------------------------------------------------------	-----------------

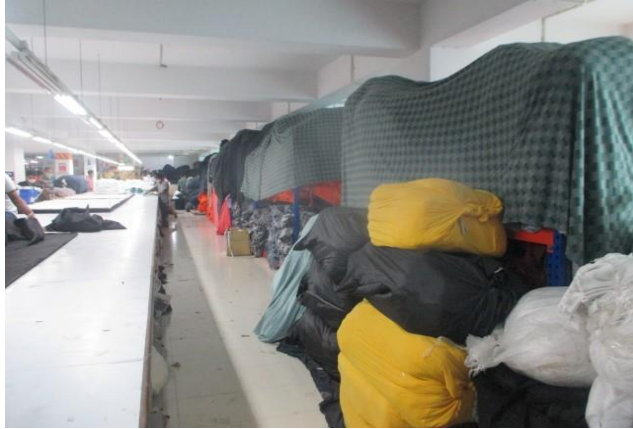
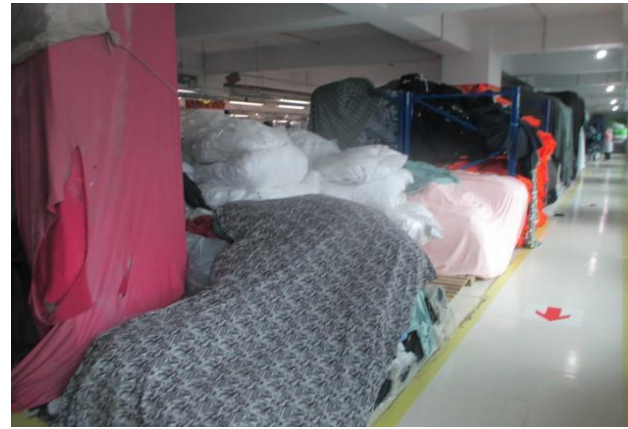
3	Fire Rated Construction	Areas used for combustible storage are not separated by fire rated construction. Store room on seventh floor.	Provide dedicated storage rooms separated by minimum 1-hr fire-rated construction. Where separate storage rooms are not feasible, provide defined storage areas and limit the storage arrangement as follows: - Maximum height of 2.4m and maximum area of 23m ² - If sprinkler protected: maximum height of 3.66m and maximum area of 93m ² . Separate areas of unenclosed combustible storage by a minimum clear distance of 3m.	Within 3 months
---	-------------------------	---------------------------------------------------------------------------------------------------------------	----------------------------------------------------------------------------------------------------------------------------------------------------------------------------------------------------------------------------------------------------------------------------------------------------------------------------------------------------------------------------------------------------------------------------------------------------------	-----------------

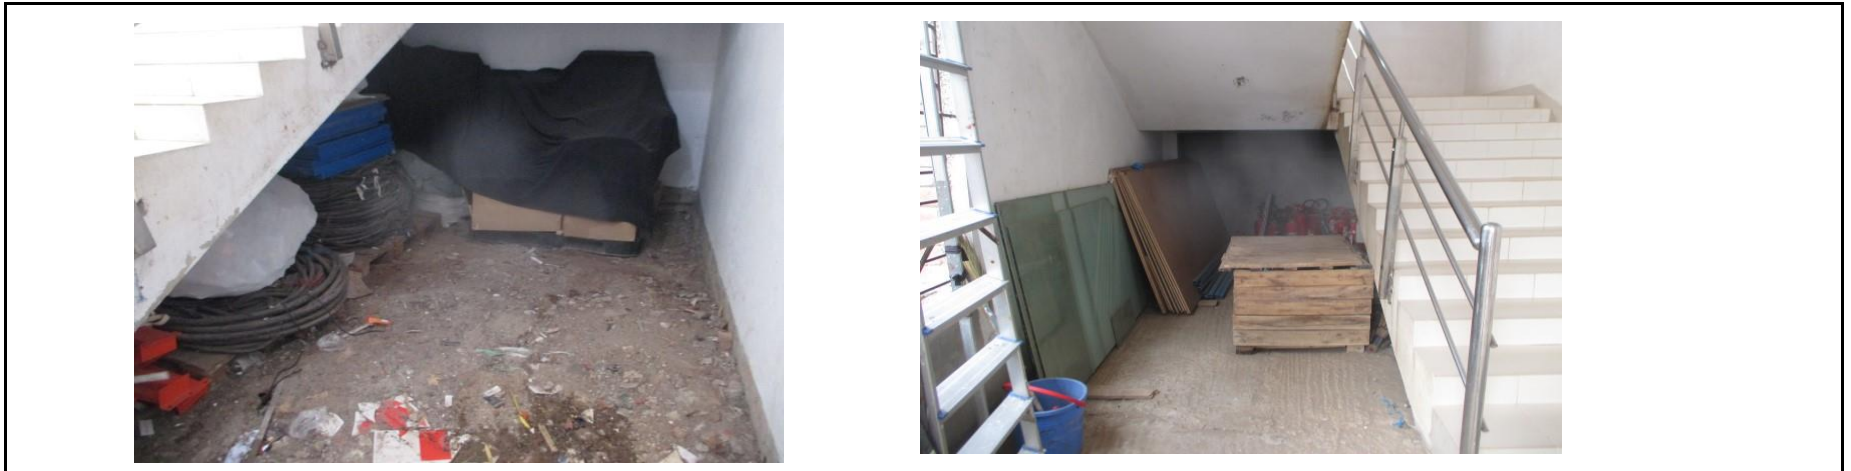
4	Storage	Storage was located in the exit stair. Location: North-East and North-west exit stair	Remove all storage from exit stairs.	Immediate
---	---------	------------------------------------------------------------------------------------------	--------------------------------------	-----------

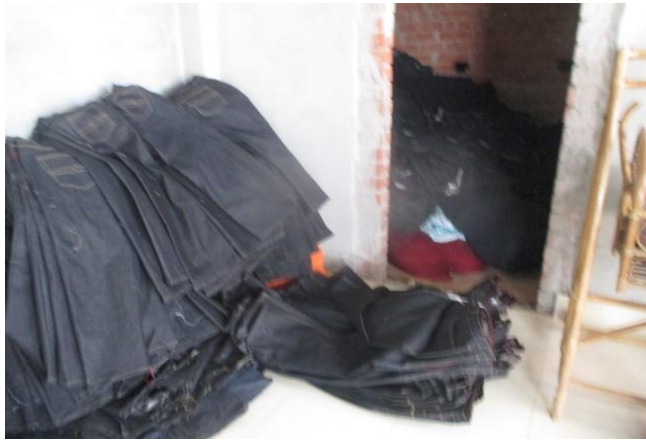
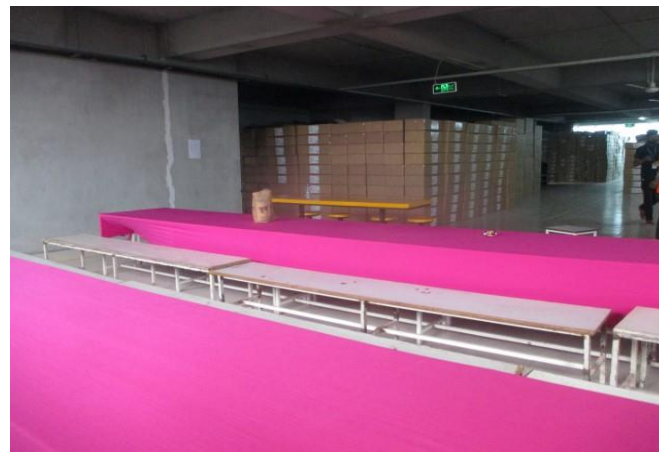
5	Storage	Storage was located in the dining room and childcare area. Location: 6th floor	Remove all storage from dining room and childcare area.	Immediate
---	---------	-----------------------------------------------------------------------------------	---------------------------------------------------------	-----------

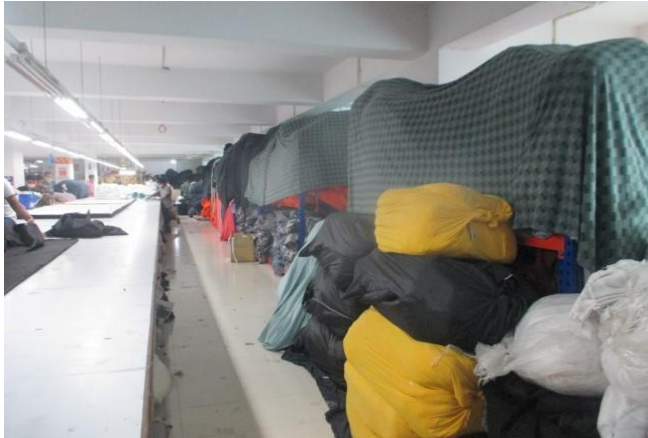
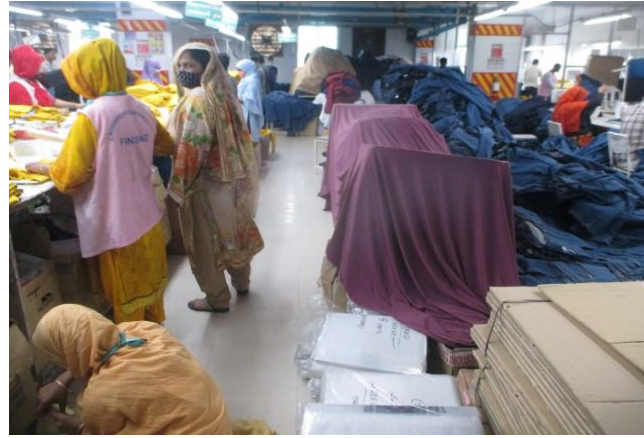
6	Aisle	Aisle was missing/ blocked at several location.	Aisles shall be provided with a minimum unobstructed clear-width of 0.9 m (36 in.).	Immediate
---	-------	-------------------------------------------------	-------------------------------------------------------------------------------------	-----------

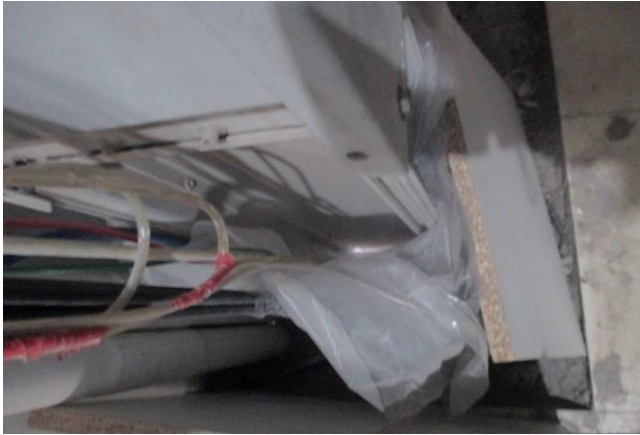
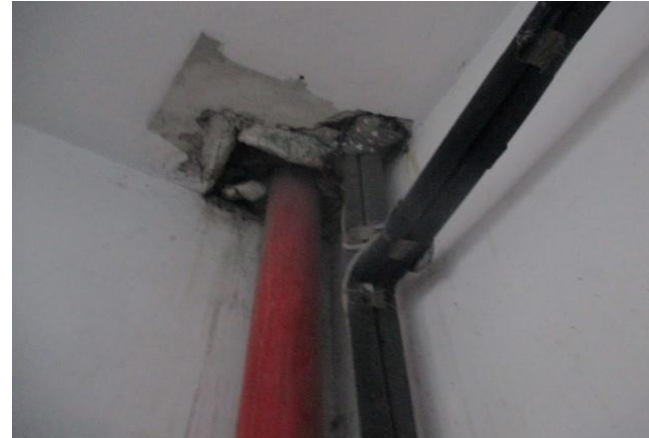
7	Evacuation Map	Fire evacuation maps is not posted at the entrance of all exit stair. Location: South-east exit stair.	Fire evacuation maps shall be posted at the entrance to each exit stair.	Within 2 weeks
8	Fire Rated Construction	Penetrations through floor/ceiling assemblies are found unsealed.	Seal all penetrations and openings in floor/ceiling (full thickness of the floor/ceiling) assemblies by fire rated materials to maintain the fire resistance rating. Provide a minimum 2-hr fire rated shaft to separate the utility risers from each floor if required.	Within 3 months

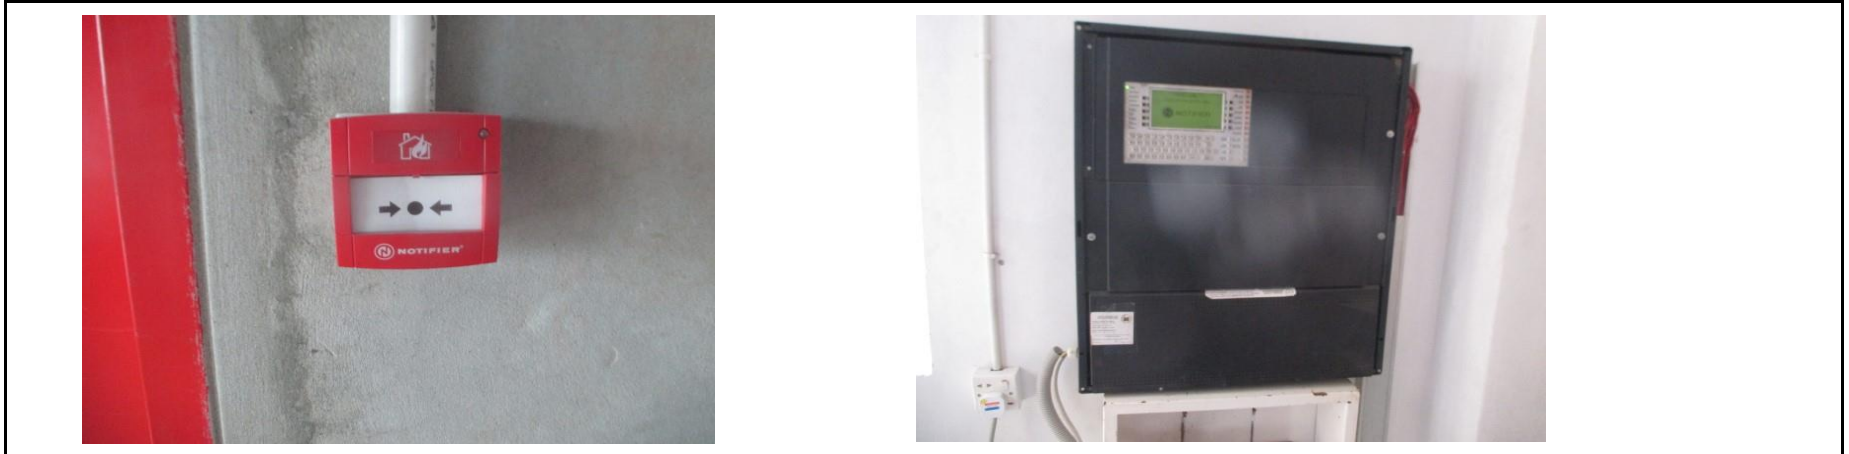
10	Fire Alarm System	Fire alarm system installation requires detailed review to confirm compliance with NFPA 72 and ACCORD standards.	Submit as-built drawings, testing records, equipment certification and other relevant documentation to the ACCORD for review and approval.	Design within 2 months, install within 4 months
----	-------------------	------------------------------------------------------------------------------------------------------------------	--------------------------------------------------------------------------------------------------------------------------------------------	-------------------------------------------------

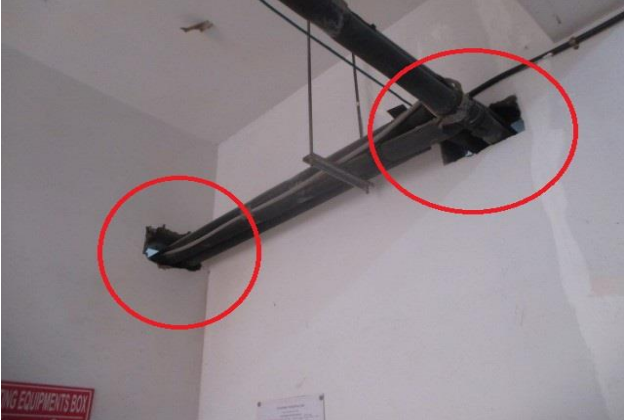
11	Fire Rated Construction	Unsealed penetrations and openings are located in exit stair enclosures.	Seal all penetrations and openings in the wall of exit enclosure walls (full thickness of the wall) by fire rated materials to maintain the fire resistance rating.	Within 3 months

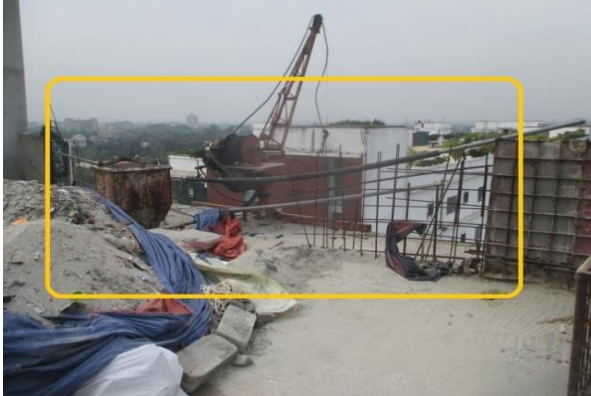
13	Parapets or Guards	Parapets or guards are not provide in occupiable roof.	Provide parapets or guards with a minimum height of 1067mm (42 inch.).	Within 2 months
