INITIAL FIRE SAFETY INSPECTION REPORT

Silken Sewing Ltd (New) (Extension Building).

Baniarchala (Member Bari), Vobanipur Joydebpur, Gazipur

Date: 14 March 2022

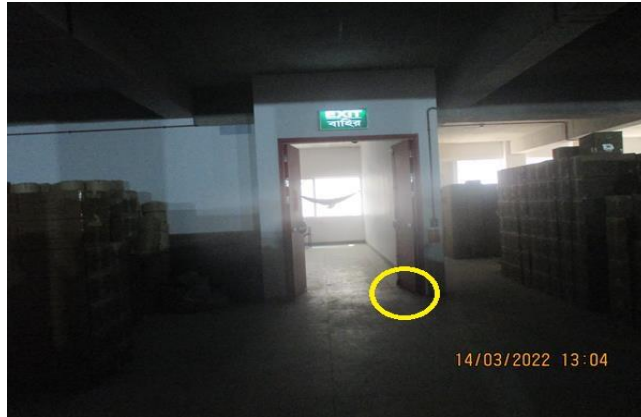
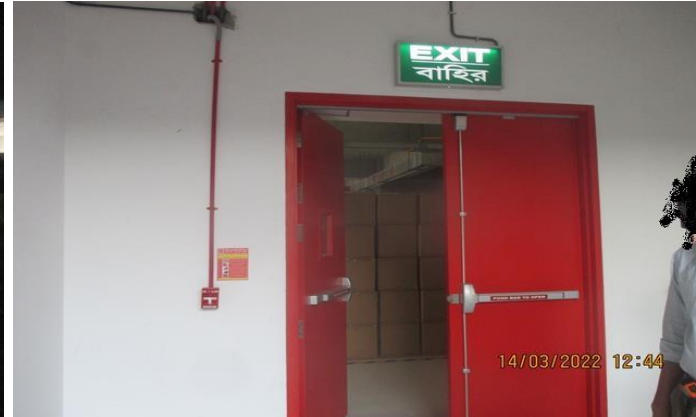
F-3	Fire Rated Construction	<p>Rooms used for storage of combustible materials are not separated from the surrounding occupancy/areas by fire rated construction due to non functionality of fire door.</p> <p>Location: Ground & First floor</p>	<p>Provide dedicated storage rooms separated by minimum 1 hr. fire rated construction.</p> <p>Ensure that the fire doors are self-closing and positive latching and that they are provided with fire exit (panic) hardware where serving production floors.</p>	Within 3 months

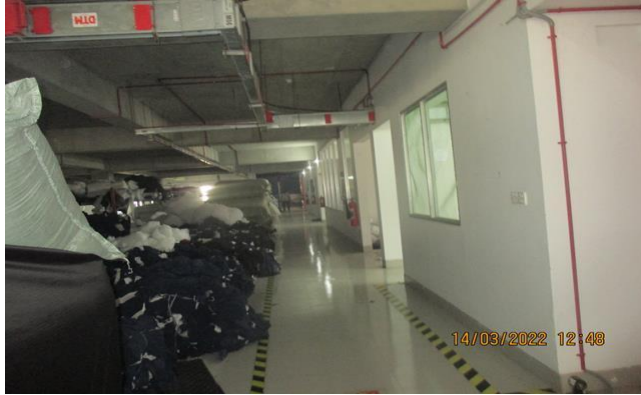
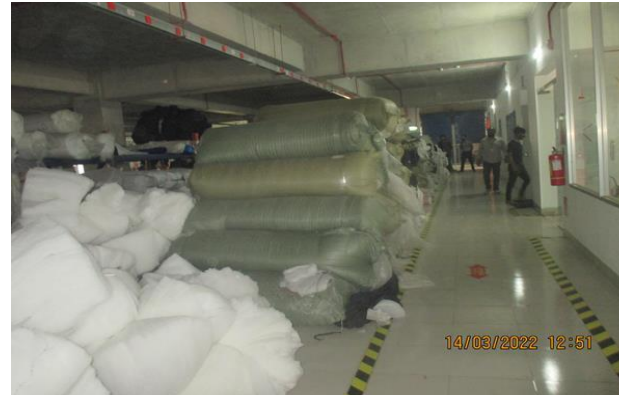
F-4	Fire rated construction	<p>Areas used for in-process storage of combustible materials are open to the surrounding occupancy.</p> <p>Location: 2nd & 3rd floor of building.</p>	<p>Provide defined storage areas and limit the storage arrangement as follows: Maximum height of 2.45 m and maximum area of 23 m² and is separated by a minimum 3.0 m (10ft) from other storage areas and they do not exceed 10 percent of the building area of the story in which they occur. If sprinkler protected, Maximum height 12 ft (3.66 m) and maximum area of 1000 ft² (93 m²) and separated by a at least 25 ft (7.62 m) from other storage areas and does not constitute more than 10 percent of the building area or 4000 ft² (372 m²) of the sprinklered area, whichever is greater. or, Enclose the storage area from the surrounding occupancy with a minimum 1 hour fire rated construction.</p>	Within 3 months
-----	-------------------------	--	--	-----------------

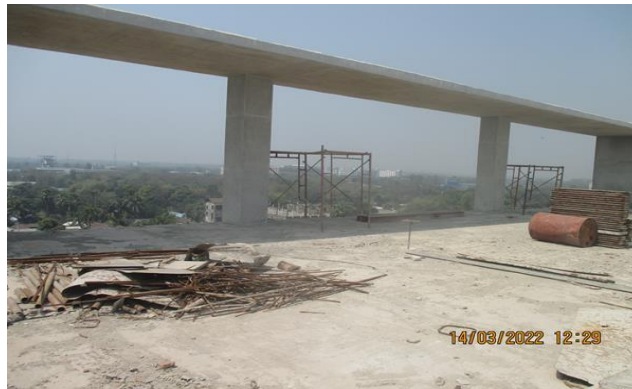
F-5	Means of Egress	Parapets or guards are provided in occupied roof which is less than 1067mm (42 inch).	Provide parapets or guards with a minimum height of 1067mm (42 inch.).	Within 3 months
-----	-----------------	---	--	-----------------

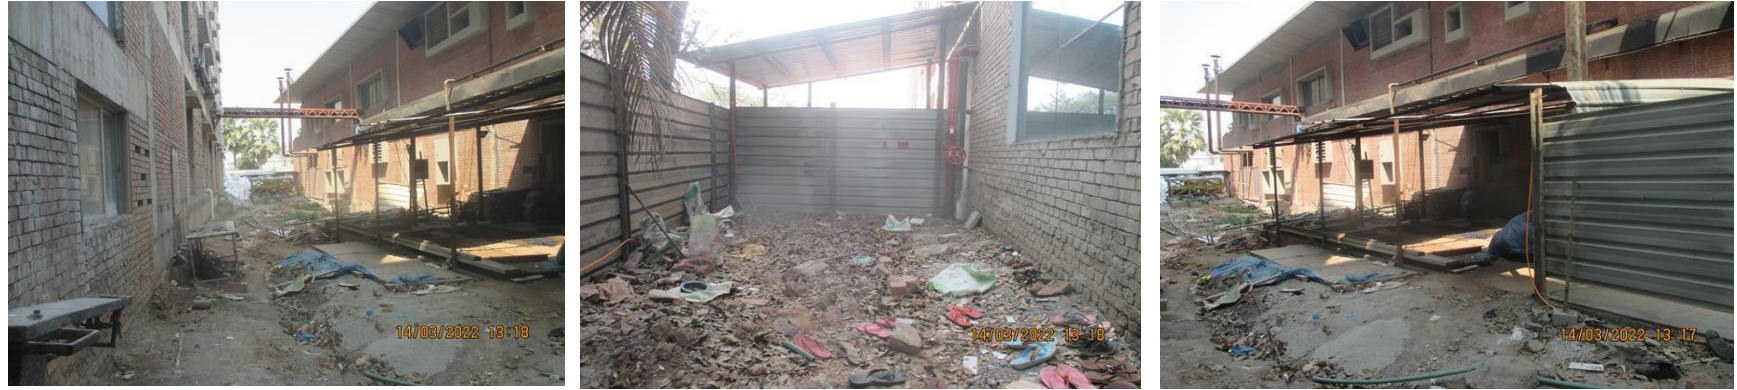
F-6	Means of Egress	<p>The exit discharge path (Egress Court) are obstructed by construction materials.</p> <p>Location: Discharge path of stair-3.</p>	<p>Means of egress shall be maintained continuously free and clear of all obstructions.</p>	<p>Immediately</p>
-----	-----------------	---	---	--------------------

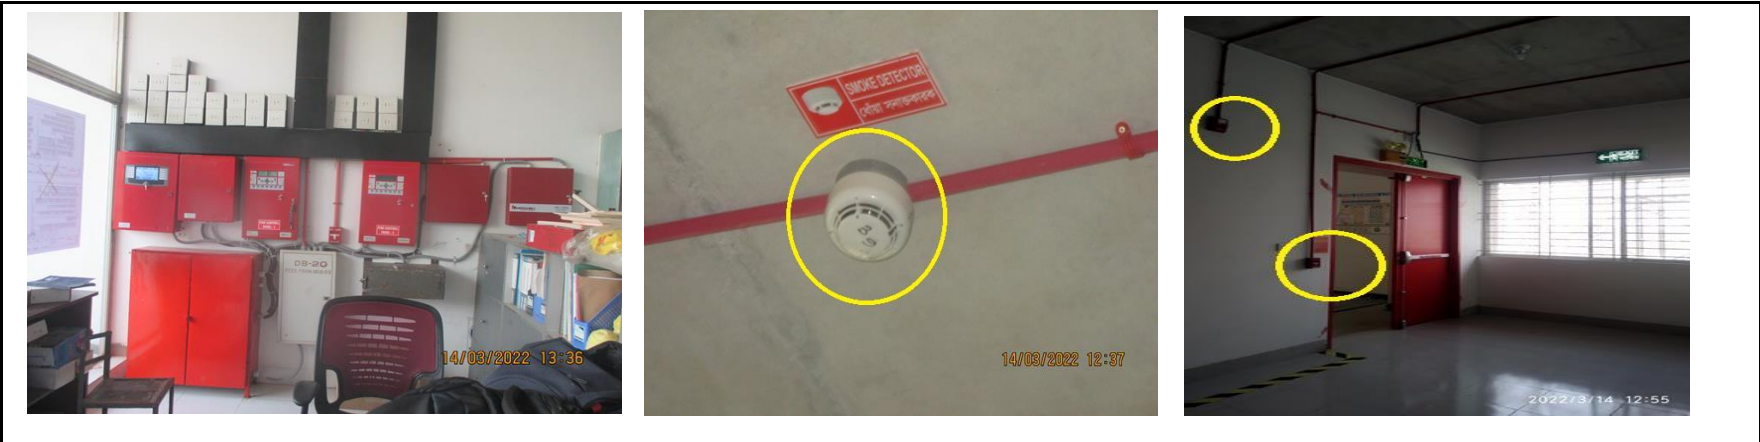
F-8	Egress lighting	Based on the number and location of emergency lights observed, adequate illumination levels are not anticipated along egress routes .	Test the emergency lighting system on each floor and provide additional emergency fixtures to provide adequate illumination along the means of egress. Provide a minimum illumination of 10 lux at the floor level within exit stairs and exit discharge paths and minimum 2.5 lux along exit access aisles.	Within 1 month
F-9	Fire Alarm & Detection System (FADS)	Addressable fire alarm & detection system installation requires detailed review to confirm compliance with NFPA 72 and ACCORD standard.	<p>Submit design, documents and calculations to RSC for review prior and based on the review modify the system if there is any.</p> <p>After installation the owner shall contact the RSC for witness of conducting the final acceptance testing of the fire detection & alarm system installation.</p> <p>Also inspect, test and maintain the fire alarm system, and keep written records on-site, in accordance with NFPA 72.</p>	Design Review within 2 months and modification within 5 months (If require).
