# INITIAL FIRE SAFETY INSPECTION REPORT

**Purbasha Composite Tex Ltd.**

**RSC ID: 24341**

# Fire Safety Inspection Report

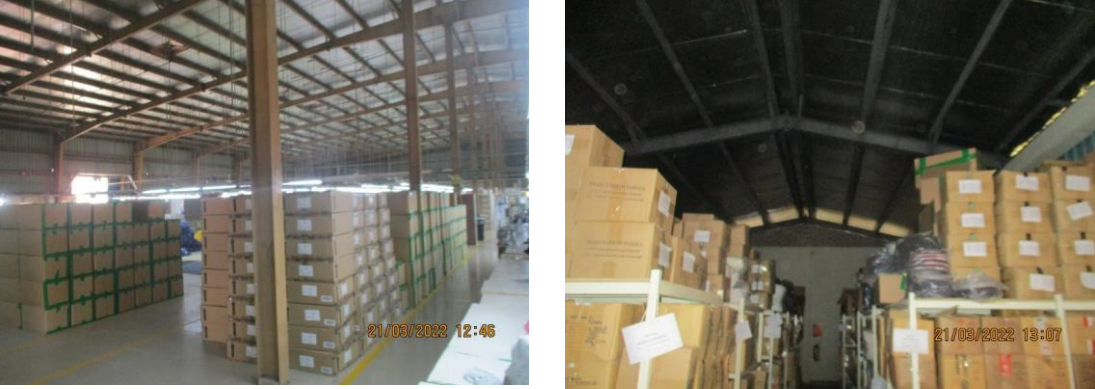
Sl No.	Category	Findings	Required Action	Remediation Time Frame
F-1	Fire Rated Construction	The main structural element of the building is constructed by steel which is non-rated and were found in exposed condition. Locations: Shed-1 (Factory building), Shed-2 (Compliance building).	The building shall be type-I or II construction. So, provide require rating in the structural elements of the building. Consult with a qualified fire protection engineer. BNBC 2006-Table 3.2.4	Within 9 months

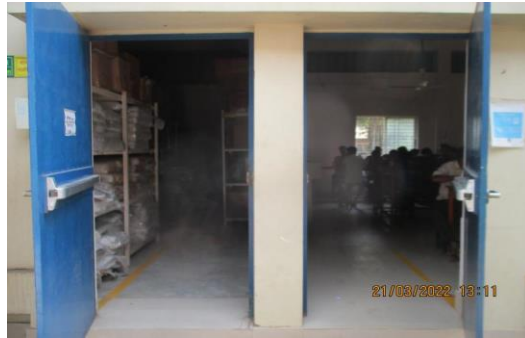
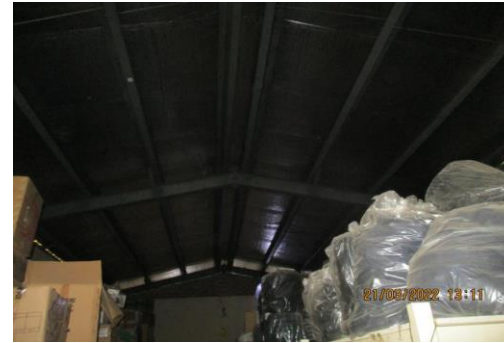
F-4	Fire Rated Construction	Dining room is not properly fire separated from other occupancy(Combustible storage room ) by fire rated construction. Location: Shed-2 (Compliance building).	Separate the dining area by a minimum 2-hr fire rated construction having a direct access to exit. Seal and/or protected all openings to maintain the required fire separations.	Within 3 months
-----	-------------------------	---	---	-----------------

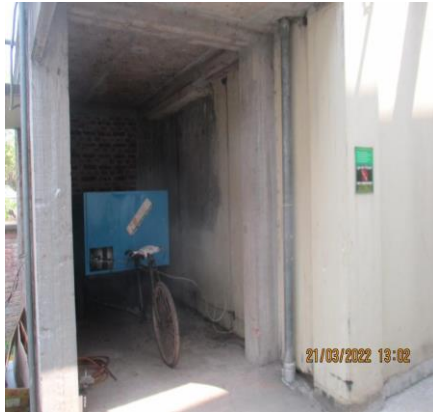
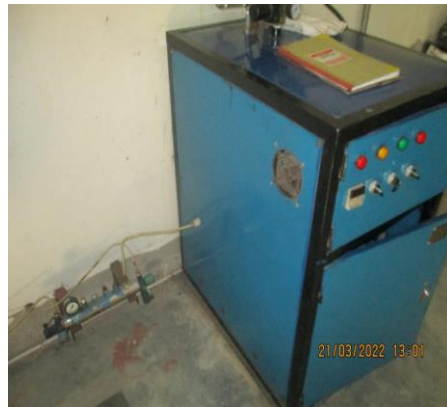
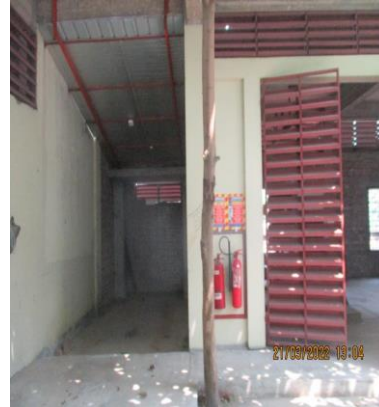
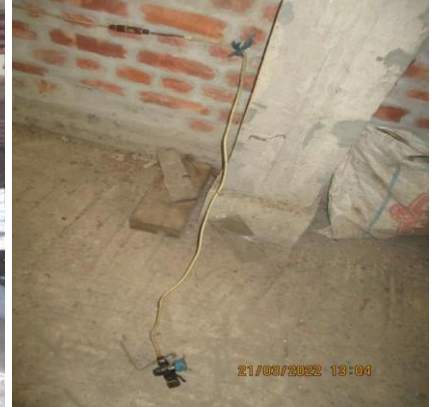
F-5	Fire Rated Construction	Liquefied or compressed gas cylinders are located within the factory. Location: Utility building.	<p>The Accord/RSC Standard 3.4.2.1.11 prohibits the storage or use of liquefied or compressed flammable gas (LPG/CNG) cylinders within the factory building.</p> <p>LPG/CNG cylinders are permitted to be stored in a separate dedicated building on the factory premises within its boundaries if the building meets the following conditions.</p> <ol style="list-style-type: none"> <li>1. The storage building must be at least 3 meters away from any other building and boundaries.</li> <li>2. The exterior walls of the building must have a fire resistance rating of 3 hours using noncombustible construction.</li> <li>3. Doors and other openings in the exterior walls must be protected with suitable closing devices having a fire protection rating of 3 hours.</li> <li>4. The building is to be used for no other purpose than the storage of LPG/CNG cylinders.</li> <li>5. The building must be mechanically ventilated to control the accumulation of flammable vapors.</li> <li>6. The installations must be approved and accepted by the requirements of the AHJ, Gas supply company regulations, manufacturers/supplier's instructions/guidance, CIOB and all other applicable agencies, codes, and standards.</li> </ol>	Within 3 months

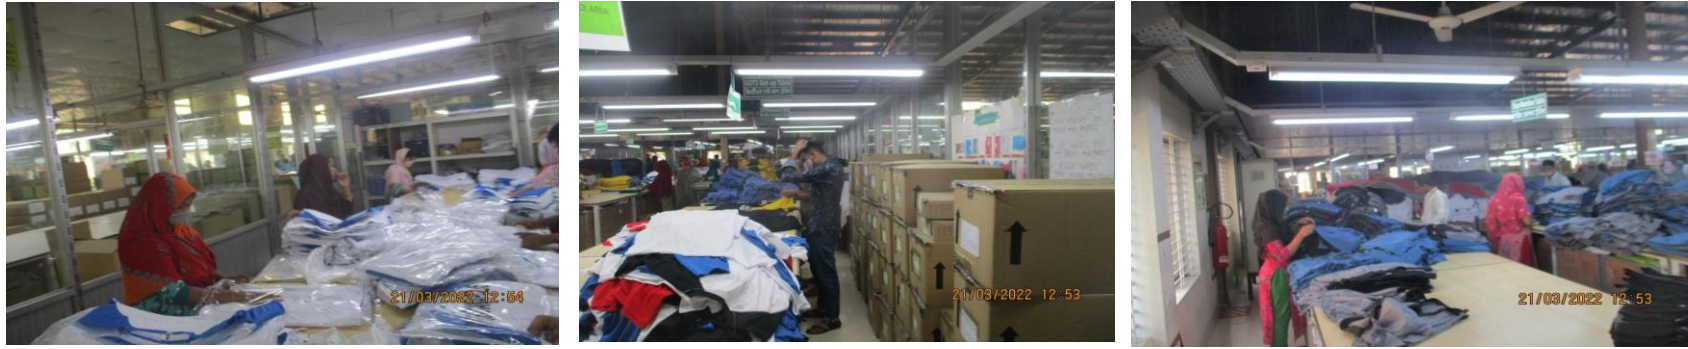
F-6	Means of egress	Width of aisles is less than 0.9m (36-in.). Location: Shed-1 (Factory building).	Aisles shall be provided with a minimum unobstructed clear-width of 0.9 m (36 in.).	Within 3 months

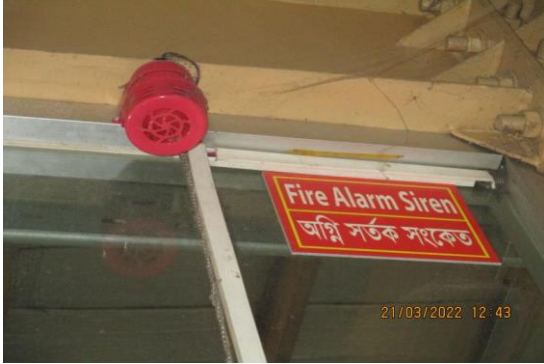
F-7	Fire Alarm & Detection System (FADS)	No fire alarm system available during inspection.	Provided automatic addressable listed fire alarm system in accordance with NFPA 72 and ACCORD/RSC standards.	Design Review within 2 months and installation within 4 months.
F-8	Fire Alarm & Detection System (FADS)	Visible and audible notification was not provided for the building in accordance with NFPA 72.	Provide visible and audible notification for the building in accordance with NFPA 72.	Design Review within 2 months and installation within 4 months.

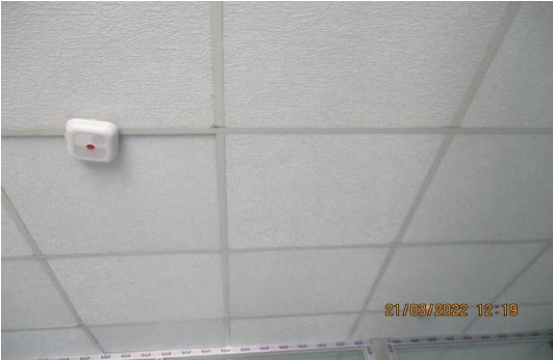
F-9	Fire Alarm & Detection System (FADS)	The building is equipped with single-station smoke alarms. Smoke alarm activation sounds only a local alarm and does not provide automatic fire alarm notification of occupants.	Remove single-station smoke alarms. Provide automatic smoke detection throughout the building, tied into the fire alarm system, in accordance with NFPA 72 and ACCORD/RSC standards.	Within 3 months
