# INITIAL FIRE SAFETY INSPECTION REPORT

**Factory Name: Integra Design Ltd.**

**Date: 16 May 2022**

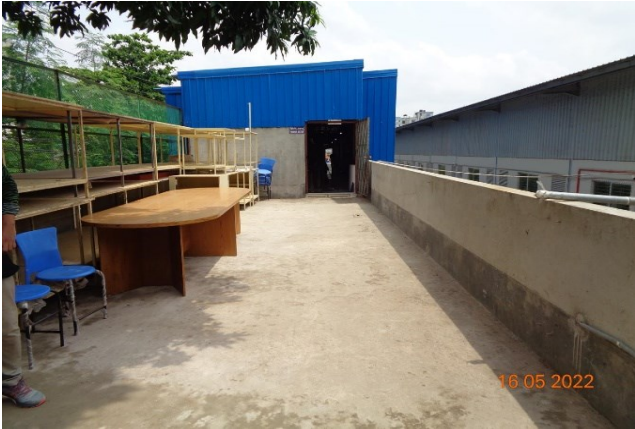
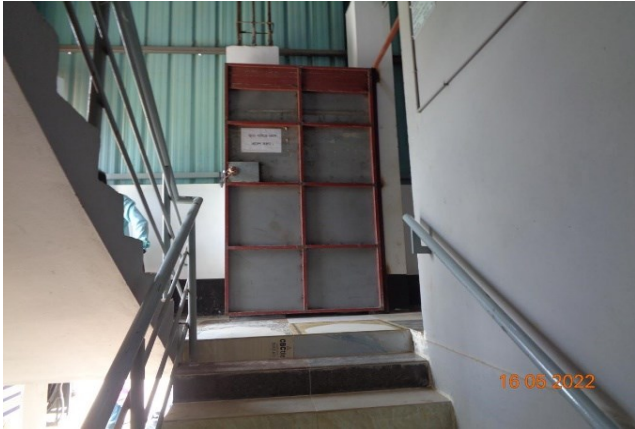
| SI No. | Category | Findings | Required Action | Remediation Time Frame |
|---|---|---|---|---|
| 1 | Fire Rated Construction | Building-2: The exit stairs are not separated from work areas and other spaces on first floor by fire rated construction. | Provide minimum 1.5-hr fire rated doors for buildings that are 4 or more stories. Seal all unprotected openings to separate the exit stairs from work areas and other building spaces on all floor levels. Ensure that the fire doors are self-closing and positive latching and that they are provided with fire exit (panic) hardware where serving production floors. If fire doors are required to be held open for functional reasons, provide automatic closing devices tied to the fire alarm system. | Within 3 months |

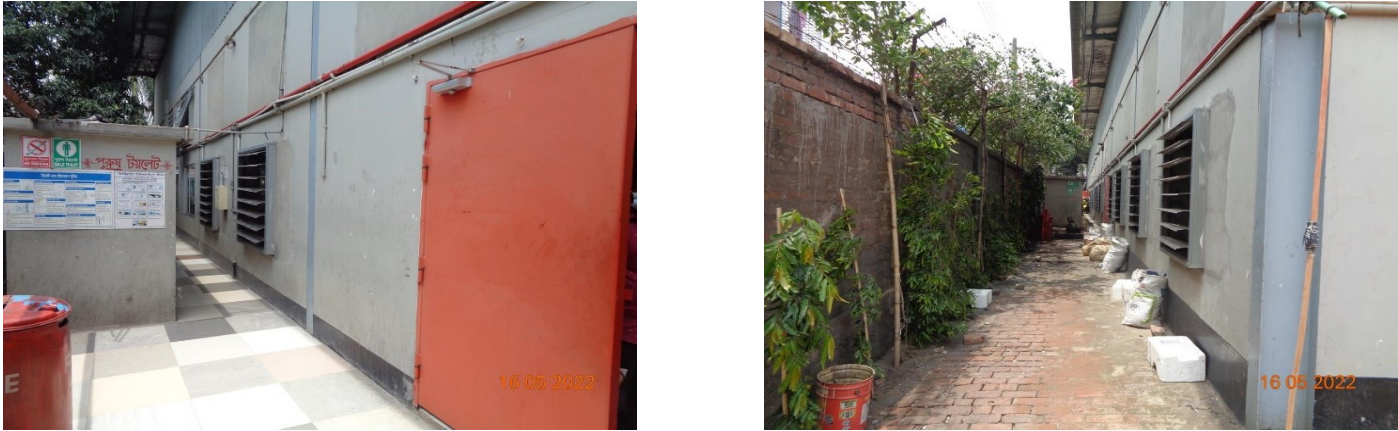
| 2 | Fire Rated Construction | The exit discharge path serving west exit is less than 10 ft wide and is not separated from the building-1 interior. | Seal all penetrations and openings to the interior of the building along the discharge path, up to a height of 10 ft., to provide a minimum 1-hr fire separation. Alternatively, provide a second remote discharge path to the public way (only include this if feasible). | Within 6 months |

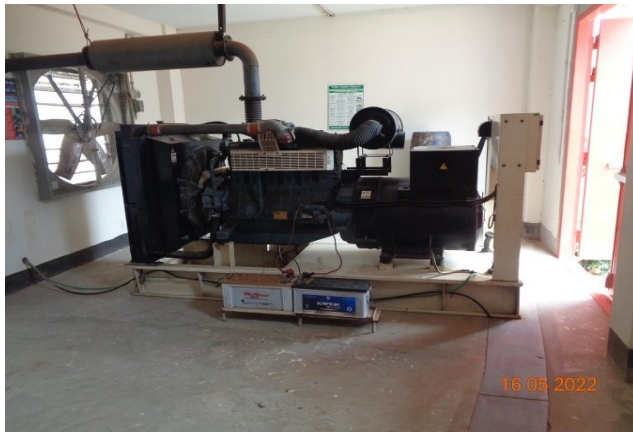
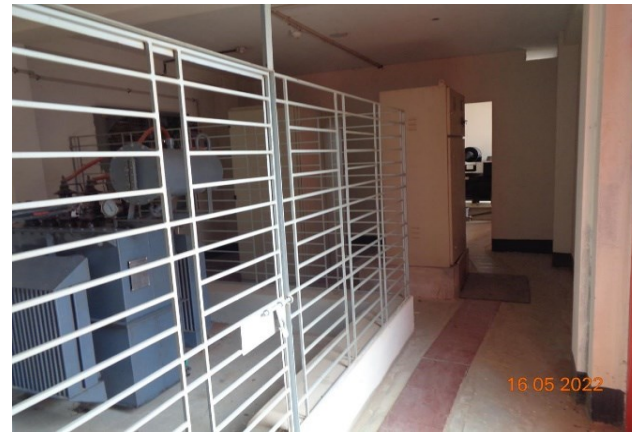
| 3 | Fire Rated Construction | Generator and transformer rooms are not separated from each other by fire rated construction (openings, non-rated doors, penetrations) in utility & substation building-5. | Separate generator and transformer rooms by a minimum 2-hr fire-rated construction. Seal and/or protected all openings to maintain the required fire separations. | Within 3 months |

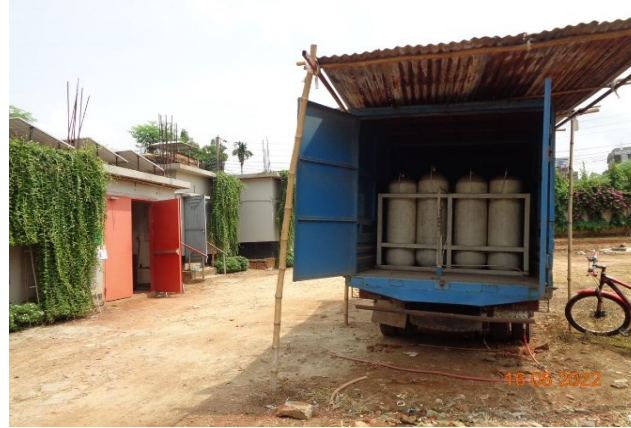
| 4 | Fire Rated Construction | Gas cylinders (CNG) are not separated by fire-rated construction located near the boiler room on the ground floor. | <p>The factory Shall follow TECHNICAL GUIDANCE NOTE FOR USE OF LIQUIFIED OR COMPRESSED FLAMMABLE GAS IN THE FACTORY PREMISES.</p> <p>LPG/CNG cylinders are permitted to be stored in a separate dedicated building on the factory premises within its boundaries if the building meets the following conditions.</p> <ol style="list-style-type: none"> <li>1. The storage building must be at least 3 meters away from any other building and boundaries.</li> <li>2. The exterior walls of the building must have a fire resistance rating of 3 hours using noncombustible construction.</li> <li>3. Doors and other openings in the exterior walls must be protected with suitable closing devices having a fire protection rating of 3 hours.</li> <li>4. The building is to be used for no other purpose than the storage of LPG/CNG cylinders.</li> <li>5. The building must be mechanically ventilated to control the accumulation of flammable vapors.</li> <li>6. The installations must be approved and accepted by the requirements of the AHJ, Gas supply company regulations, manufacturers/supplier's instructions/guidance, CIOB and all other applicable agencies, codes and standards.</li> </ol> | Within 3 months |

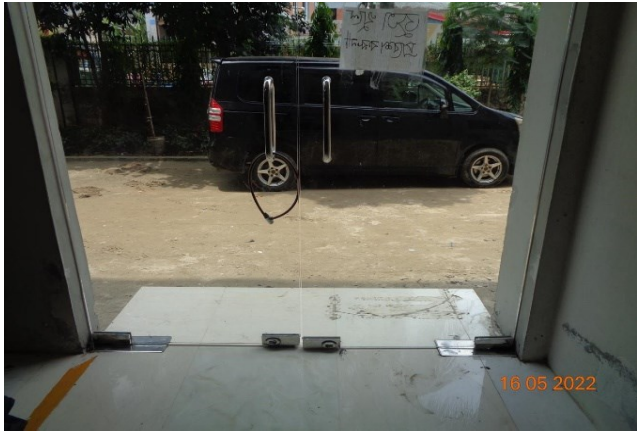
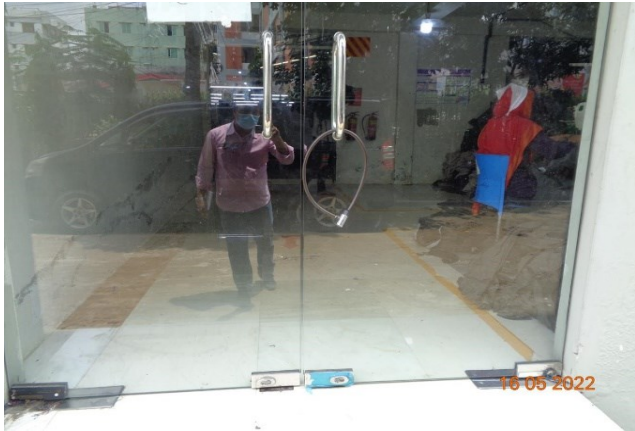
| 5 | Egress | <p>Building-1: Egress doors with locking features are provided along egress routes. Egress gates with locking features are provided at building exits, exit stairs and exit discharge. All doors were open and unlocked during the inspection.</p> | <p>Remove locking features from all egress doors and gates. If locks are required for security reasons, utilize special door locking features complying with NFPA 101 and RSC Technical Guidelines Standard (standard) 6.8.2.</p> | Immediately |

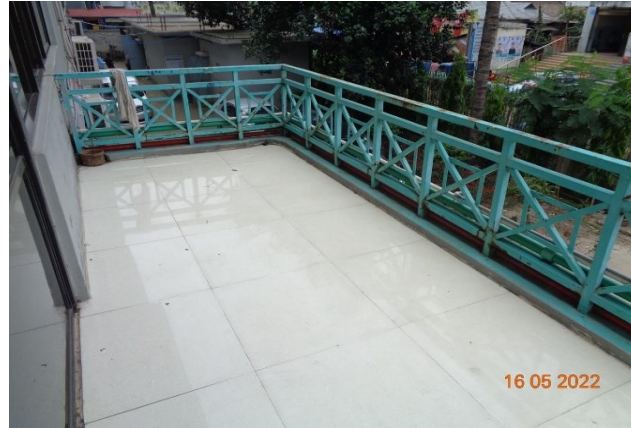
| 6 | Egress | Parapet height was found 28 inches in the building-1 on mezzanine. | Provide parapets or guards for all occupied roofs of a minimum height of 1067 mm (42 in.) as required. | Within 3 months |

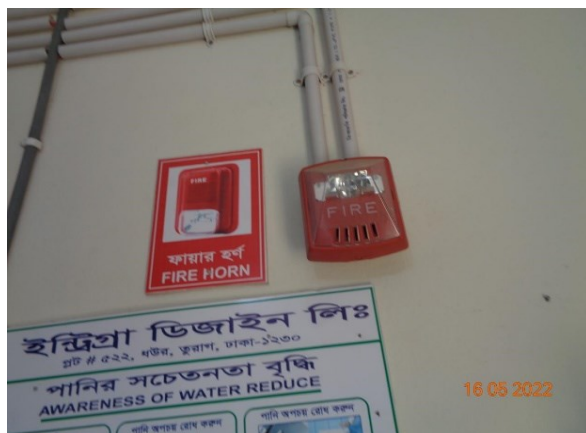
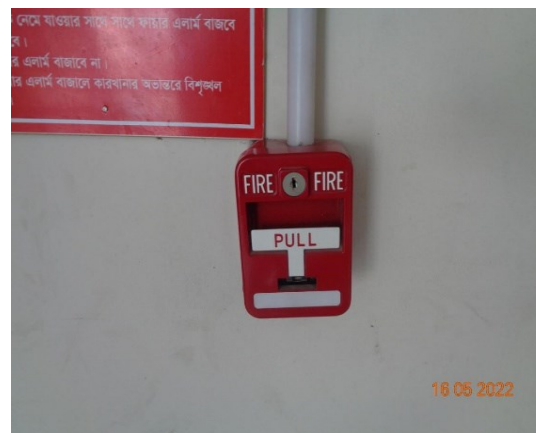
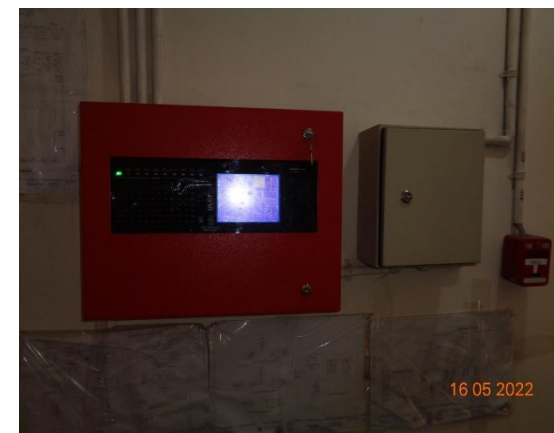
| 7 | Fire Detection & Alarm System | <p><b><u>All buildings in the factory premises:</u></b> An addressable fire alarm system has installed in the factory building premises. Fire detection system installation requires to detailed review to confirm compliance with NFPA 72 and Accord standard for all buildings in the factory premises.</p> | Submit as-built drawings, testing records, equipment certification and other relevant documentation to the RSC for review and approval. | Design submission (Within 2 months), Modification within 4 months (if required) |
