# INITIAL FIRE SAFETY INSPECTION REPORT

**Nasa Hitech Style Limited**

**RSC ID: 24413**

**Date: 22 May 2022**

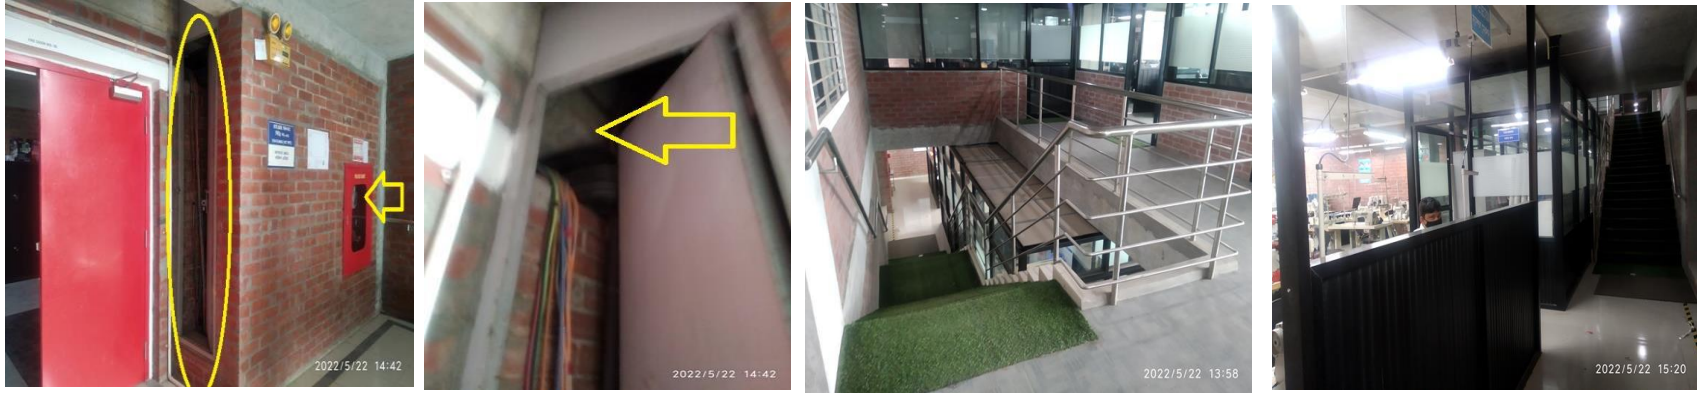
| Sly No. | Category | | Required Action | Remediation Time Frame |
|---|---|---|---|---|
| F-1 | Fire Rated Construction | The exit stairs are not separated from work areas and other spaces on each floor by fire-rated construction due to unprotected opening & penetration. | <p>Provide minimum 2-hr fire rated separation exit enclosure. Provide minimum 1.5-hr fire rated doors and seal all unprotected openings and penetration to separate the exit stairs from work areas and other building spaces on all floor levels.</p> <p>Ensure that the fire doors are self-closing and positive latching and that they are provided with fire exit (panic) hardware where serving production floors. If fire doors are required to be held open for functional reasons, provide automatic closing devices tied to the fire alarm system.</p> | Within 3 months |

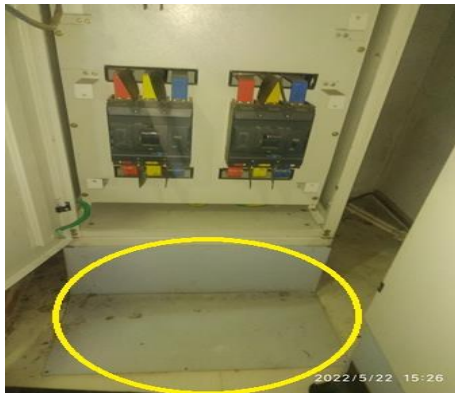
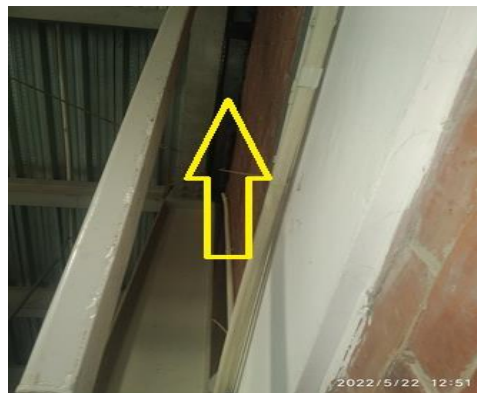
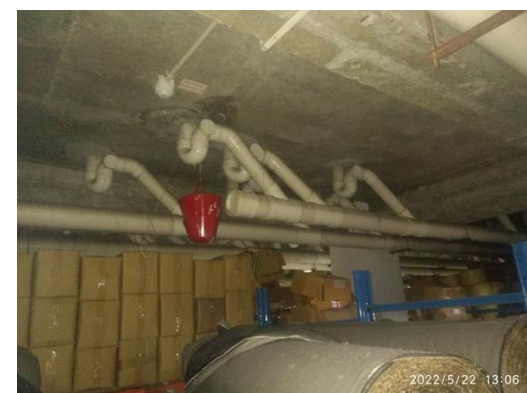
| F-2 | Fire Rated Construction | <p>Unsealed penetrations and openings are located in the fire-rated floor/ceiling assemblies.</p> <p>Location: Electrical riser ,Expansion joint of south side office &amp; north sided facilities building side and sewage line .</p> | <p>Seal all penetrations and openings in floor/ceiling assemblies to maintain the fire separation at least by 3-hr. The used sealer shall be 3rd party certified and installation shall be as per manufacturer's datasheet.</p> <p>Or</p> <p>Provide a minimum 2-hr fire rated shaft to separate the utility risers from each floor if required.</p> | Within 3 months |

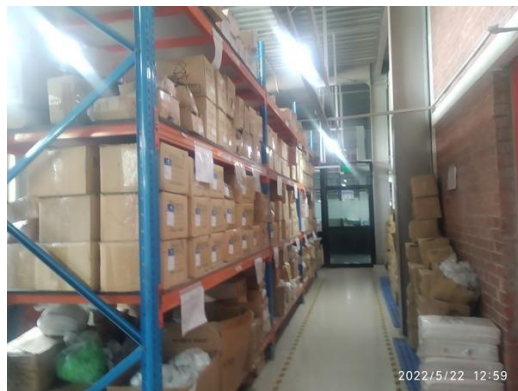
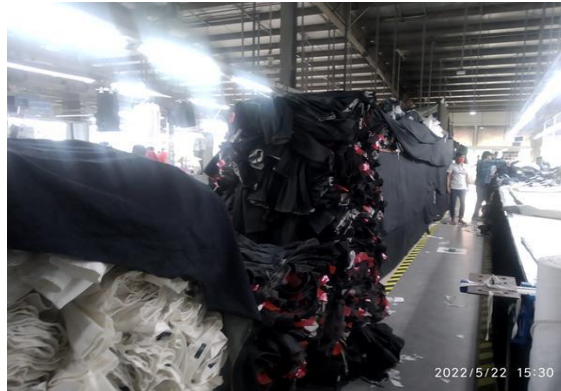
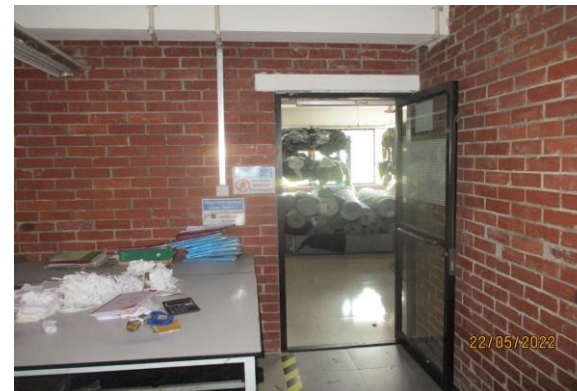
| F-3 | Fire rated construction. | Areas used for combustible materials are open to the surrounding occupancy.<br>Location: Ground floor fabric store & first floor of production. | <p>Provide dedicated storage rooms separated by minimum 1 hr. fire rated construction.</p> <p>OR</p> <p>Provide defined storage areas and limit the storage arrangement as follows:</p> <p>Maximum height of 2.45 m and maximum area of 23 m<sup>2</sup> and is separated by a minimum 3.0 m (10ft) from other storage areas and they do not exceed 10 percent of the building area of the story in which they occur. If sprinkler protected, Maximum height 12 ft (3.66 m) and maximum area of 1000 ft<sup>2</sup> (93 m<sup>2</sup>) and separated by a at least 25 ft (7.62 m) from other storage areas and does not constitute more than 10 percent of the building area or 4000 ft<sup>2</sup> (372 m<sup>2</sup>) of the sprinklered area, whichever is greater</p> | Within 3 months |

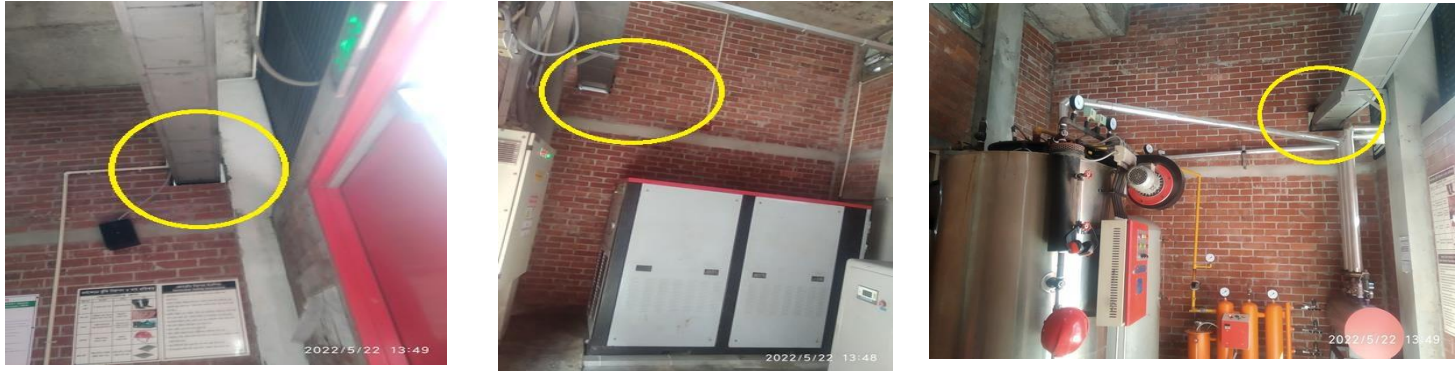
| F-4 | Fire Rated Construction | <p>Transformer, Generator ,boiler &amp; compressor rooms are not separated from each other due to unprotected opening &amp; penetrations.</p> <p>Location : Utility building.</p> | <p>Transformer, Generator Boiler &amp; Compressor room shall be separated from each other by a minimum 2-hr fire-rated construction (wall, floor, slab, etc.). Seal all penetrations and openings (door, window, etc.) by minimum 1.5-hr fire-rated materials to maintain the fire separation as required. All exhaust systems shall discharge to the exterior of the building in a safe location.</p> | Within 3 months |

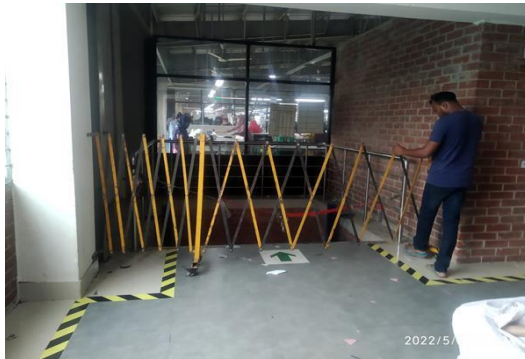
| F-5 | Fire Rated Construction | <p>Elevator shaft (Vertical opening) is open into production floor without proper fire separation.</p> | <p>Ensure elevator minimum 2.0-hr fire rating for the doors of elevator shafts otherwise close the area of the shaft with a 2-hr fire-rated construction barrier.</p> | Within 6 months |

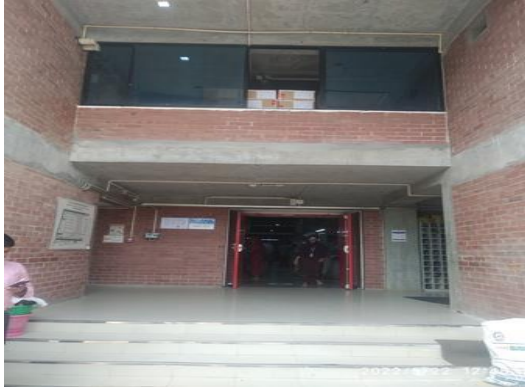
| F-6 | Fire Rated Construction | <p>Unsealed opening from first floor located at exit enclosure.</p> <p>Location: North-West side of exit.</p> | Seal all penetrations and openings in the wall of exit enclosure walls (full thickness of the wall) by fire rated materials to maintain the fire resistance rating. | Within 3 months |

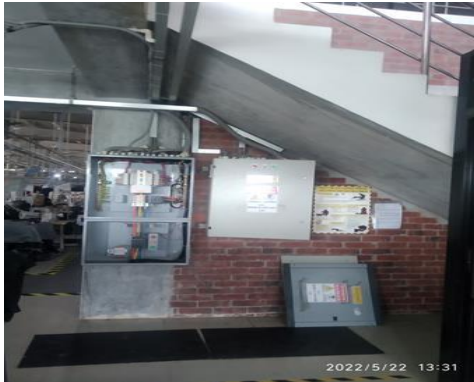
| F-8 | Means of Egress | Electrical panel boards (DB) are located on the Exit stair .<br><br>Location: First floor of the office building side. | Remove electrical panel boards from exit stairs.<br>Or<br>Relocate the electrical panel boards to a suitable location. | Within 1 month |

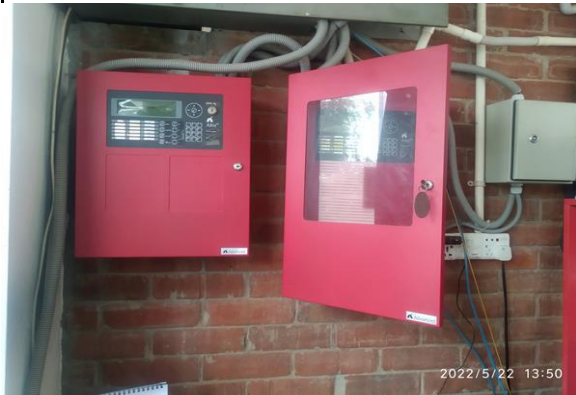
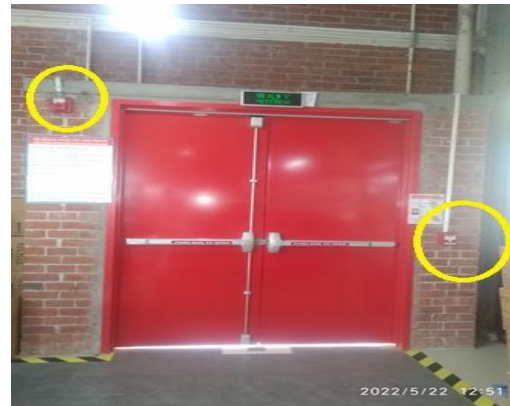
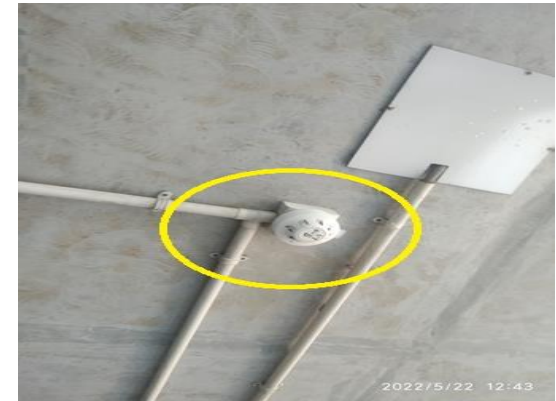
| F-13 | Fire Alarm & Detection System (FADS) | The fire alarm and detection system installation requires detailed review to confirm compliance with NFPA 72. | Submit as-built drawings, testing records, equipment certification and other relevant documentation to the RSC for review and approval/acceptance test. | Design within 2 months, modification within 4 months (if required). |
