INITIAL FIRE SAFETY INSPECTION REPORT

KSS Knit Composite Ltd. (Extension buildings)

RSC ID: 24422

Date: 29 May 2022

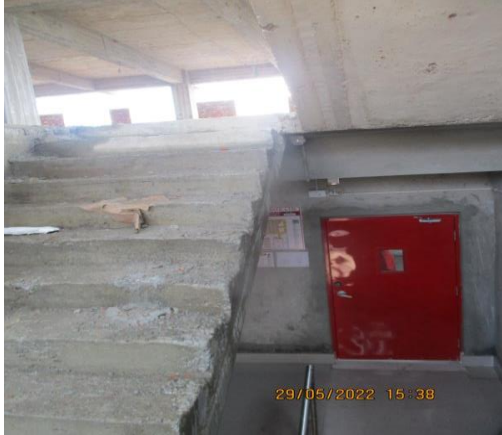
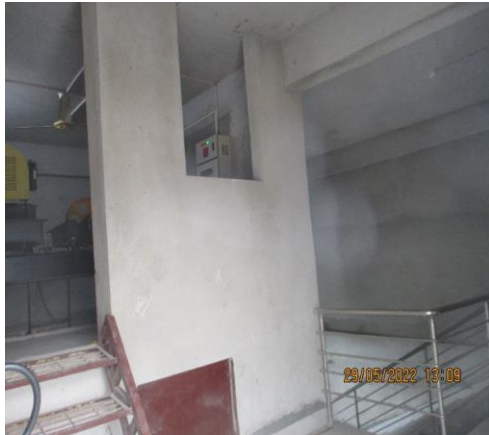
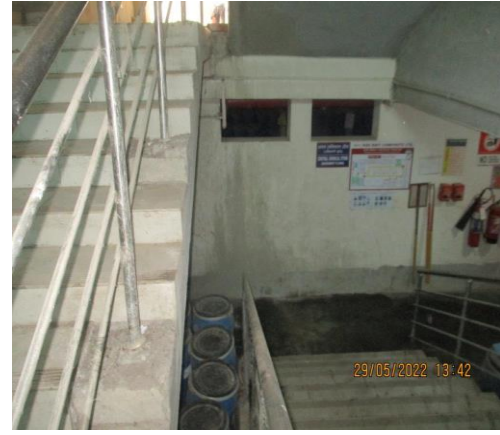
SI No.	Category	Findings	Required Action	Remediation Time Frame
1	Fire Rated Construction	The exit stairs are not separated from work areas and other spaces on each floor by fire-rated construction. During inspection it was observed that the factory has installed fire doors at exit. Locations: All Buildings.	The exit stair enclosure shall be provided with a minimum 1-hr fire resistance rating for buildings with 3 or fewer stories and a minimum of 2- hr. fire resistance rating for buildings 4 or more stories. Provide 0.75 hr. fire rated door and seal all penetrations and openings by 1 hr. fire rated fire rated barrier construction for building with 3 or fewer stories. Provide 1.5 hr. fire rated door and seal all penetrations and openings by 2 hr. fire rated fire rated barrier construction for building with 4 or more stories. Provide a fire-resistive rated assembly between the exterior exit stairs and the building up to 10 ft. beyond the end of the stair to achieve the required separation. The rated assembly shall be approved and/or designed by a qualified fire protection engineer. Ensure that the fire doors are self-closing and positive latching and that they are provided with fire exit (panic) hardware where serving production floors. If fire doors are required to be held open for functional reasons, provide automatic closing devices tied to the fire alarm system. Once fire doors are installed, every door in a stair enclosure serving more than 5 stories shall be provided with re-entry unless it meets ACCORD/RSC standard 6.8.3.1	Within 3 months

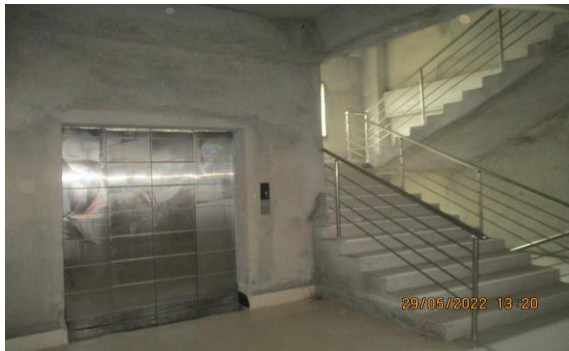
2	Fire Rated Construction	<p>Elevator shafts are directly open into the exit Enclosure.</p> <p>Location: Building-09(Stair-1/SE side)</p>	<p>For new construction, elevators shall not open into an exit enclosure as per ACCORD/RSC-6.14.3. So, separate the stair enclosure from elevator shaft although the building.</p>	Within 3 months
---	-------------------------	-----------------------------------------------------------------------------------------------------------------	------------------------------------------------------------------------------------------------------------------------------------------------------------------------------------	-----------------

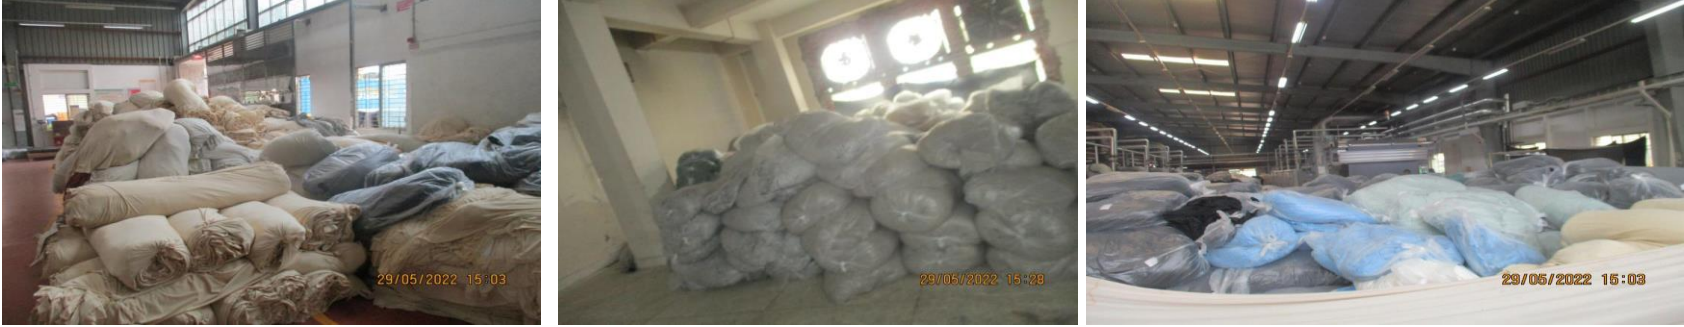
5	Fire Rated Construction	Areas used for combustible storage located at several locations are not separated by fire rated construction.	Provide dedicated storage rooms separated by minimum 1-hr fire-rated construction. Where separate storage rooms are not feasible, provide defined storage areas and limit the storage arrangement as follows: - Maximum height of 2.4m and maximum area of 23m ² - If sprinkler protected: maximum height of 3.66m and maximum area of 93m ²	Within 3 months

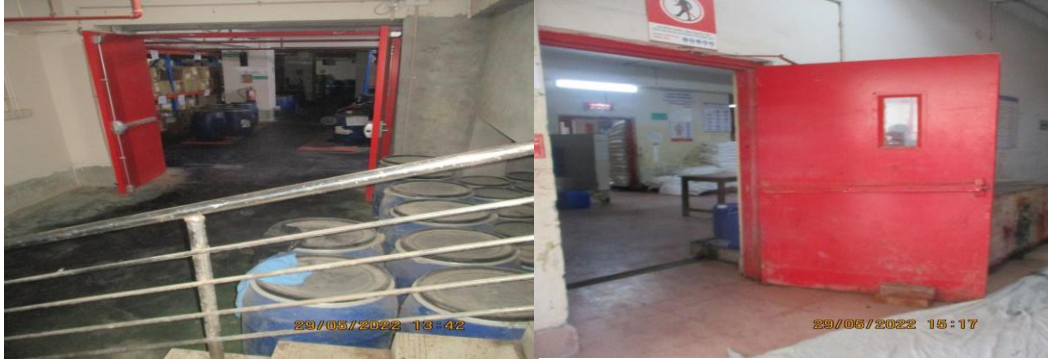
7	Fire Rated Construction	Chemical storage area is not separated by fire-rated construction due to unsealed penetrations and openings. Location : Building-09 (Basement); Building-06 (Ground Floor)	Separate the chemical storage room by 4-hr fire rated construction. Seal all penetrations and protect the openings to maintain the required fire separations. Keep 16-points MSDS of all chemicals in the storage area. Ensure that the building/room houses chemical is Type-1 construction. As per BNBC, chemical storage room shall be Type-1 construction (Table-3.2.4 of BNBC-2006). Follow section-2.13 and Table 3.2.1 of BNBC-2006 for the guideline.	Within 3 Months
