# INITIAL FIRE SAFETY INSPECTION REPORT

**GMS Trims Ltd.**

**RSC ID: 24260**

**Sardaganj, Kashimpur, Gazipur-1346, Bangladesh.**

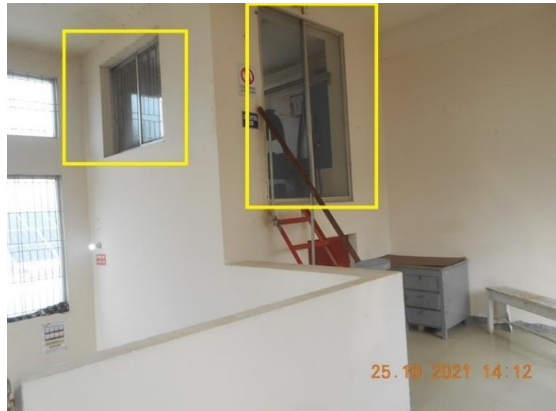
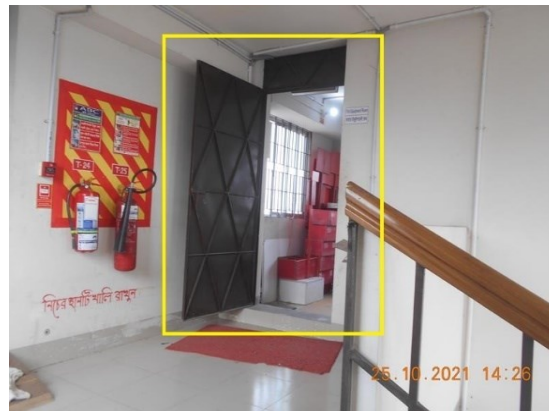
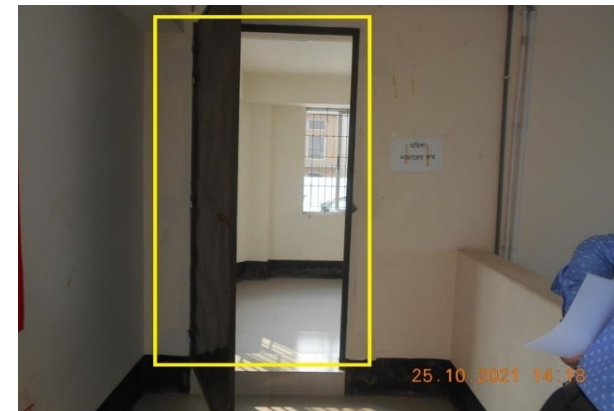
| SI No. | Category | Findings | Required Action | Remediation Time Frame |
|---|---|---|---|---|
| F-1 | Fire Rated Construction | Exit enclosures are not properly fire separated from other occupancy specially at roof floor by fire rated construction.<br>Location: Trims building | <p>Provide minimum 2-hr fire rated separation exit enclosure. Provide minimum 1.5-hr fire Provide minimum 2-hr fire rated separation exit enclosure. Provide minimum 1.5-hr fire rated doors and seal all unprotected openings and penetration to separate the exit stairs from work areas and other building spaces on all floor levels.</p> <p>Ensure that the fire doors are self-closing and positive latching and that they are provided with fire exit (panic) hardware. If fire doors are required to be held open for functional reasons, provide automatic closing devices tied to the fire alarm system.</p> <p>Once fire doors are installed, every door in a stair enclosure serving more than 5 stories shall be provided with re-entry unless it meets ACCORD standard 6.8.3.1</p> | Within 3 months |

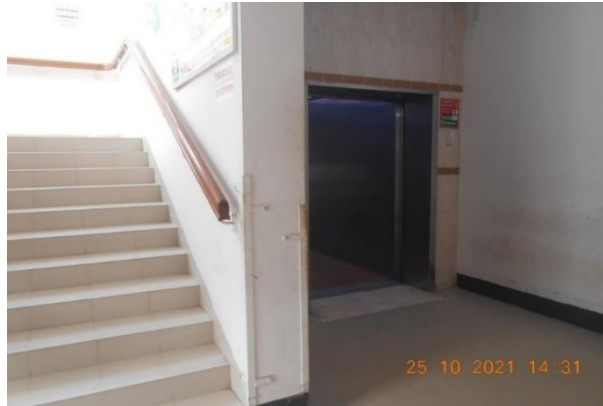
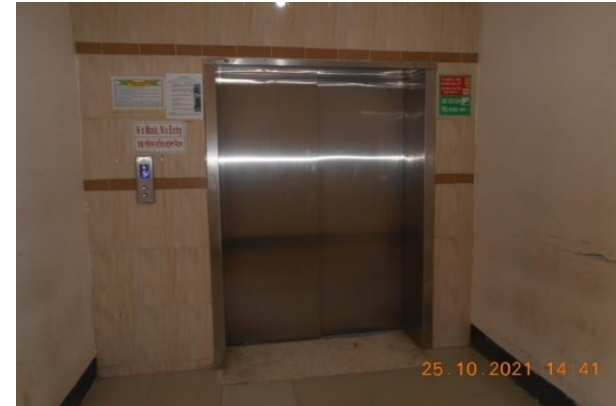
| F-2 | Fire Rated Construction | Elevator shafts are directly open into the inside of the stairs.<br>Located: Trims Building | For new construction, elevators shall not open into an exit enclosure as per ACCORD-6.14.3. So, separate the stair enclosure from elevator shaft although the building. | Within 3 months |

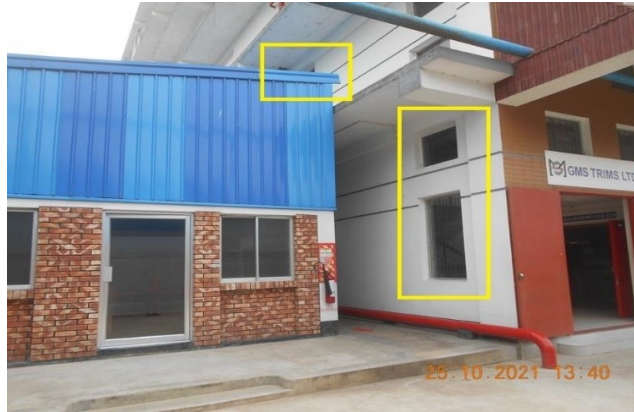
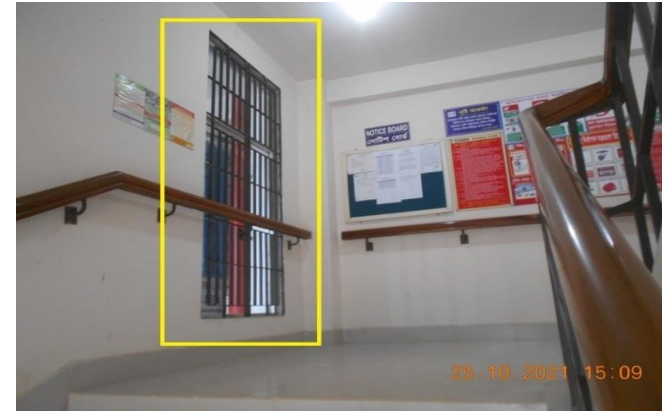
| F-3 | Fire Rated Construction | Unsealed penetrations and openings are located in the exit stair enclosures.<br>Location: North-east stair (stair-3) of Trims building | Seal all penetrations and openings in exit stair enclosure walls to maintain minimum 2-hrs fire separation. | Within 3 months |

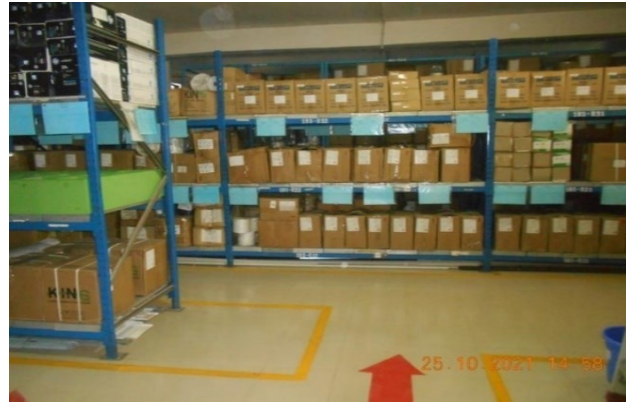
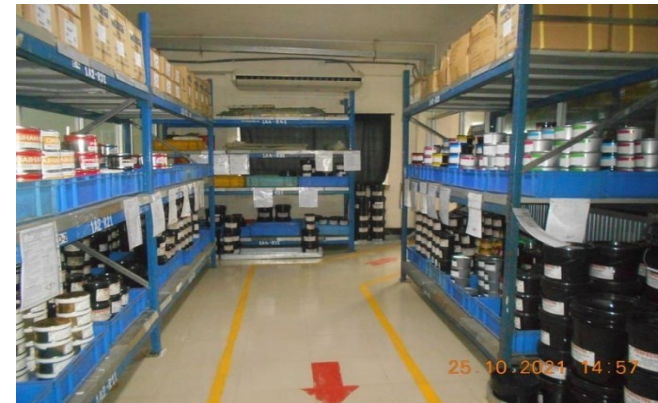
| F-4 | Fire Rated Construction | <p>Rooms used for combustible storage are not separated by fire rated construction.</p> <p>Location: Accessories store on 1st floor of Trim building</p> | <p>Separate the dedicated storage rooms by minimum 1-hr fire-rated construction. Provide 0.75 hr. fire rated door and seal all penetrations and openings by 1 hr. fire rated fire rated barrier construction.</p> | Within 3 months |

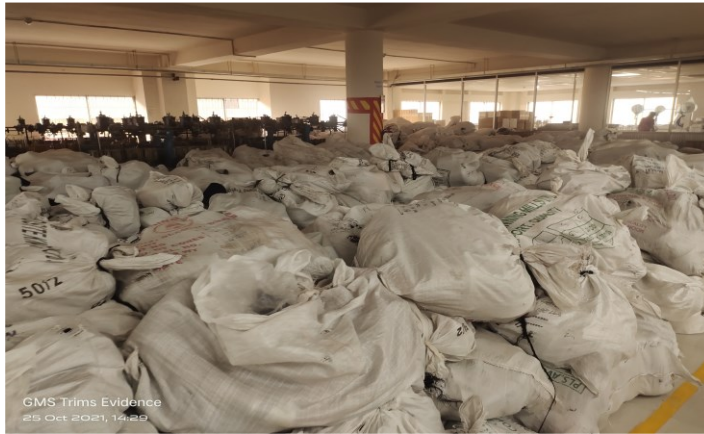
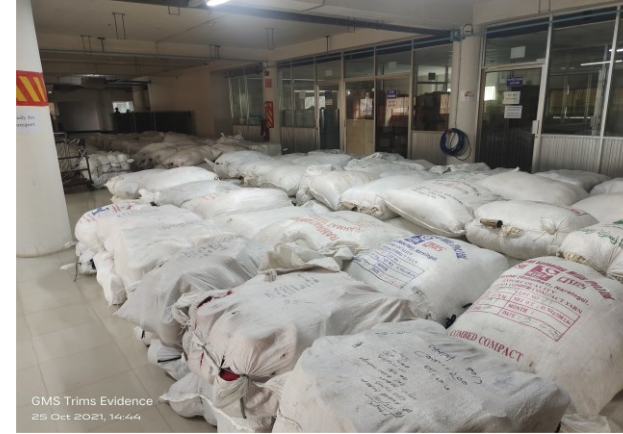
| F-5 | Fire Rated Construction | <p>Areas used for combustible storage are not separated by fire-rated construction.<br/>Location: On 2nd, 5th &amp; 6th floor.</p> | <p>Provide dedicated storage rooms separated by minimum 1-hr fire-rated construction.<br/>Or,<br/>Where separate storage rooms are not feasible, Provide defined storage areas and limit the storage arrangement as follows:-</p> <p>1. General Condition: Maximum height of 2.4m and maximum area of 23m<sup>2</sup>. Separate areas of unenclosed combustible storage by a minimum clear distance of 3m.</p> <p>2. If sprinkler protected: maximum height of 3.66m and maximum area of 93m<sup>2</sup>. Separate areas of unenclosed combustible storage by a minimum clear distance of 3m.</p> | Within 3 months |

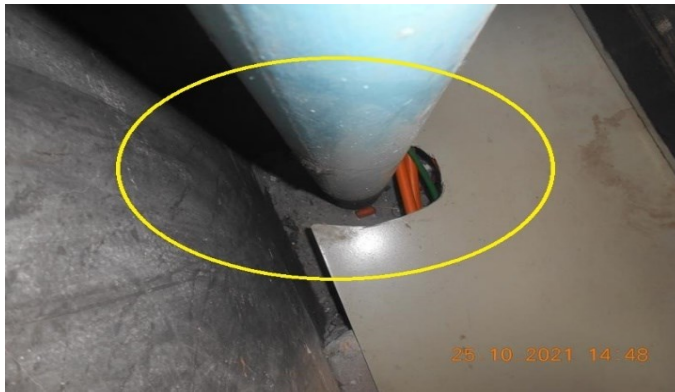
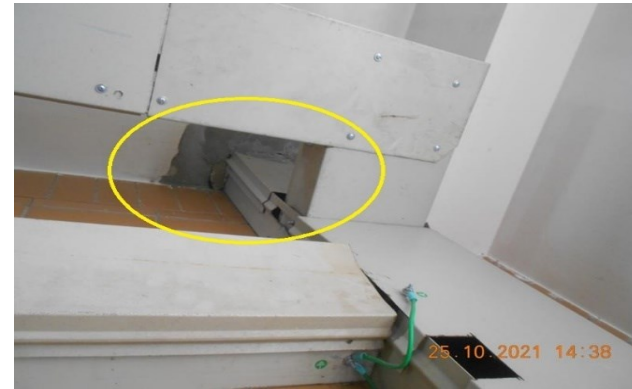
| F-6 | Fire Rated Construction | <p>Unsealed penetrations and openings (electrical cable riser) are located in the fire rated floor/ceiling assemblies.</p> <p>Location: All floors of Trims building</p> | <p>Provide a minimum 2-hr fire rated shaft to separate the utility risers from each floor level.</p> <p>or</p> <p>Seal all penetrations and openings in floors/ceiling assemblies by listed fire stop materials to maintain the fire separation.</p> | Within 3 months |

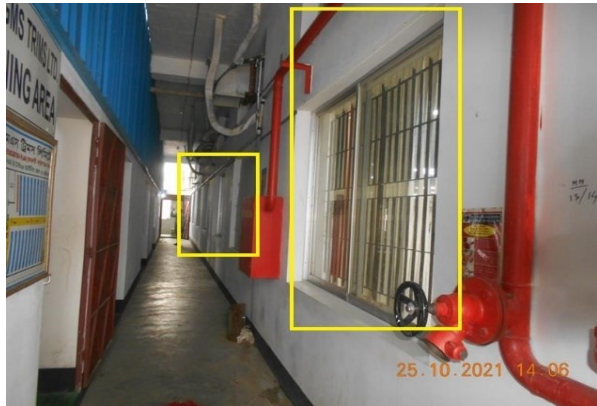
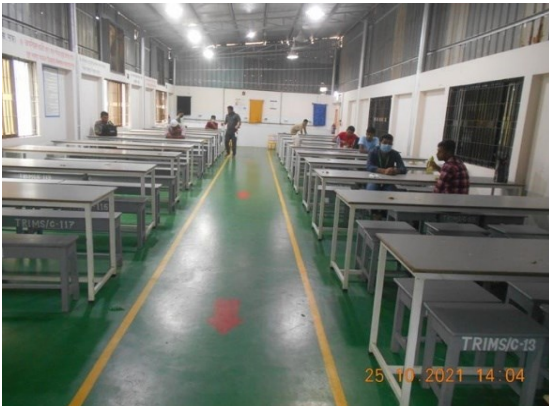
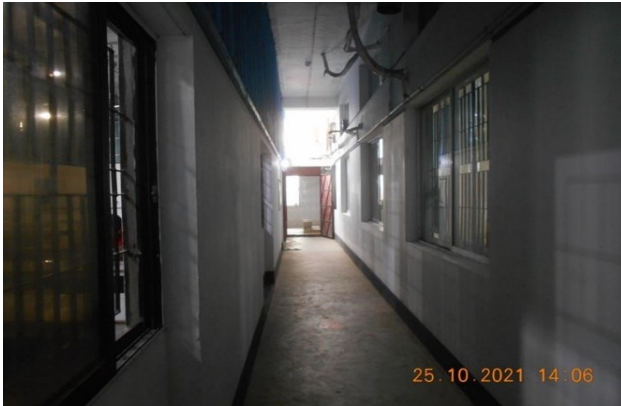
| F-7 | Fire Rated Construction | <p>Dining shed/area is not separated by fire-rated construction from production floor of Trims Building on ground floor (openings and penetrations).</p> <p>Location: Trims Worker Dining &amp; Office Shed</p> | <p>Separate the dining area from others occupancy by a minimum 3-hr fire-rated construction. Seal and/or protect all openings to maintain the required fire separations.</p> | Within 3 months |

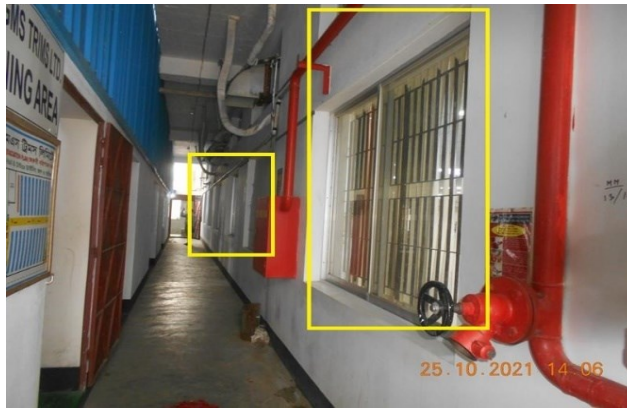
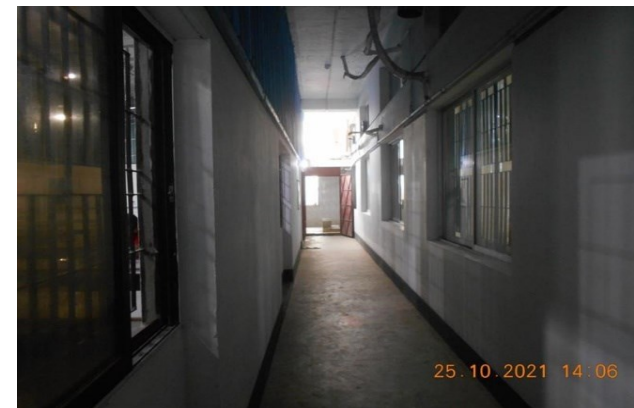
| F-8 | Fire Rated Construction | <p>The exit discharge path serving the exit discharge from dining shed is less than 10 ft. wide and is not separated from the building interior.</p> <p>Location: Trims Worker Dining &amp; Office Shed</p> | <p>Seal all penetrations and openings to the interior of the building along the discharge path, up to a height of 10 ft., to provide a minimum 1-hr fire separation.</p> <p>Alternatively, provide a second remote discharge path to the public way.</p> | Within 6 months |

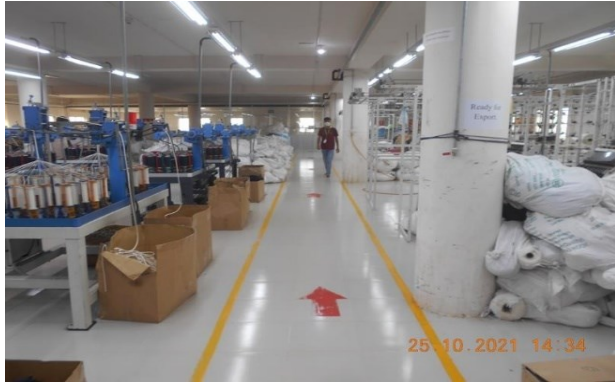
| F-9 | Egress lighting | <p>Directional exit signs are not provided where direction of the path of travel to an exit is not obvious.</p> <p>Location: All floors of Trims Building</p> | <p>Illuminated directional signs shall be provided where there is a change in the direction for the path of travel and the direction to an exit is not obvious.</p> | Within 1 month |

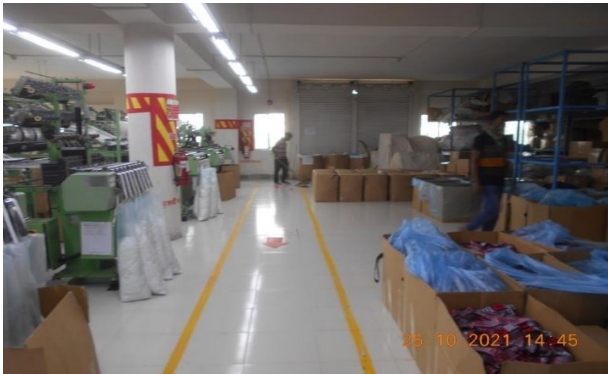
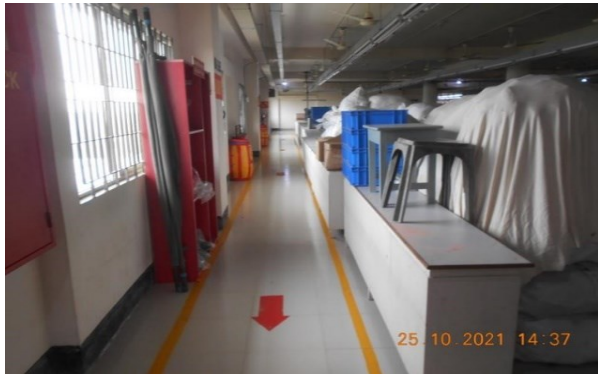
| F-10 | Egress lighting | Based on the number and location of emergency lights observed, adequate illumination levels are not anticipated along egress routes located at each level.<br>Location: All floors of Trims building. | Test the emergency lighting system on each floor and provide additional emergency fixtures to provide adequate illumination along the means of egress. Provide a minimum illumination of 10 lux at the floor level within exit stairs and exit discharge paths and minimum 2.5 lux along exit access aisles. | Within 3months |

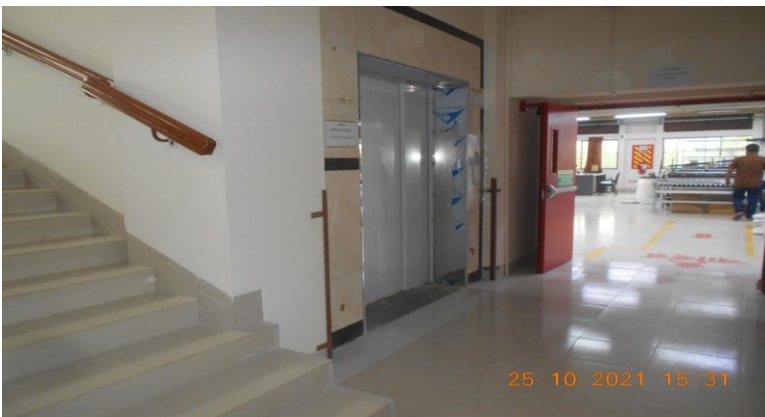
| SI No. | Category | Findings | Required Action | Remediation Time Frame |
|---|---|---|---|---|
| F-1 | Fire Rated Construction | Elevator shaft directly opens into the inside of the East Stair (stair-1).<br>Located: Poly Dana Building | For new construction, elevators shall not open into an exit enclosure as per ACCORD-6.14.3.<br>Rearrange the facility to provide separate lobby or enclosure for lifts. | Within 6 months |

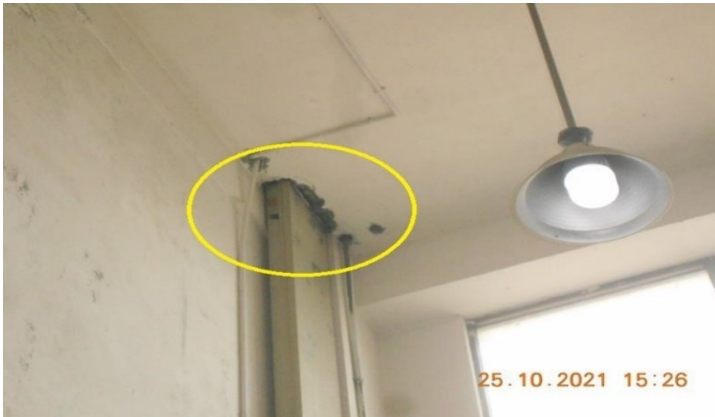
| F-2 | Fire Rated Construction | Unsealed penetrations and openings (electrical riser) are located in the fire rated floor/ceiling assemblies.<br>Location: Poly Building | Provide a minimum 2-hr fire rated shaft to separate the utility risers from each floor level.<br>or<br>Seal all penetrations and openings in floors/ceiling assemblies by listed fire stop materials to maintain the fire separation. | Within 3 months |

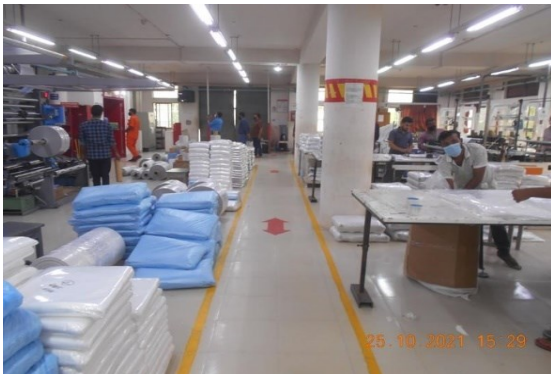
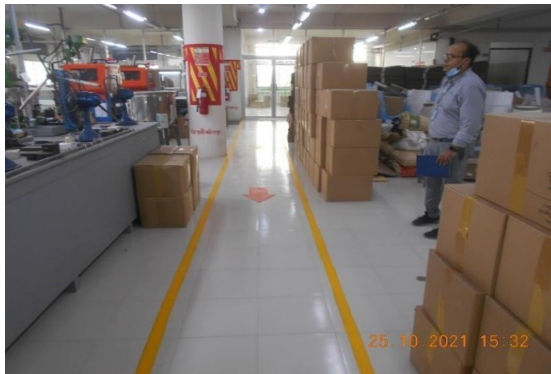
| F-3 | Egress lighting | Directional signs are not provided where direction of the path of travel to an exit has changed.<br>Location: Poly Dana building and Poly Dana shed | Illuminated directional signs shall be provided where there is a change in the direction for the path of travel and the direction to an exit is not obvious. | Within 1 months |

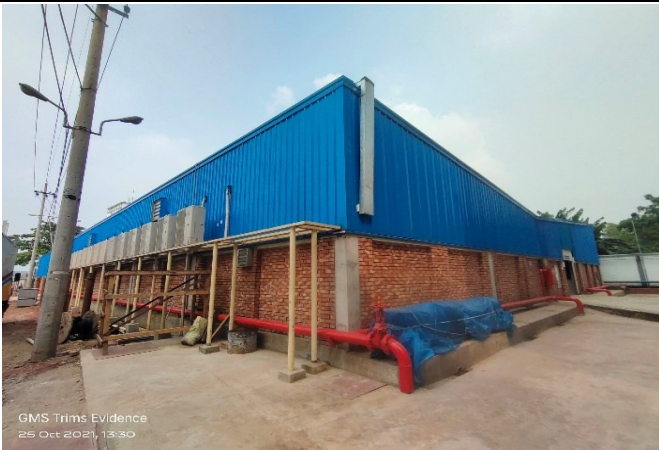
| SI No. | Category | Findings | Required Action | Remediation Time Frame |
|---|---|---|---|---|
| F-1 | Fire Rated Construction | <p>The main structural elements of the shed building are constructed by steel which is non-rated and were found in exposed condition without any fire protection.</p> <p>Location: Bonded Warehouse Shed</p> | <p>The new construction is a steel structure which shall be type-I or II construction. So, provide required rating of the structural elements of the shed. Consult with a qualified fire protection engineer. Follow BNBC 2006-Table 3.2.4, 3.1.9 and 3.3.1 as reference.</p> | Within 6 months |

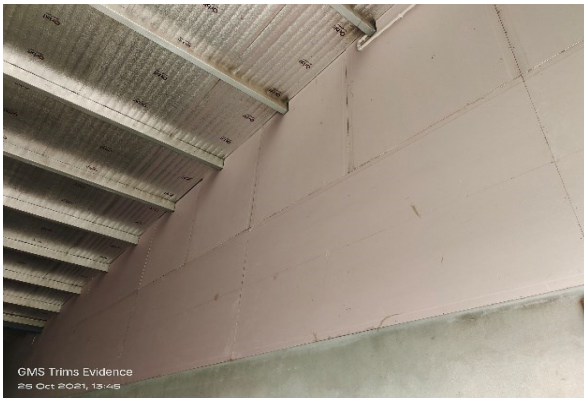
| F-2 | Fire Rated Construction | <p>The raw material store is not separated by fire rated construction from the adjacent woven label &amp; jacquard elastic section.</p> <p>Location: Bonded Warehouse Shed</p> | <p>Separate the dedicated storage room by minimum 1-hr fire-rated construction. Provide 0.75 hr. fire rated door and seal all penetrations and openings by 1 hr. fire rated fire rated barrier construction.</p> | Within 3 months |

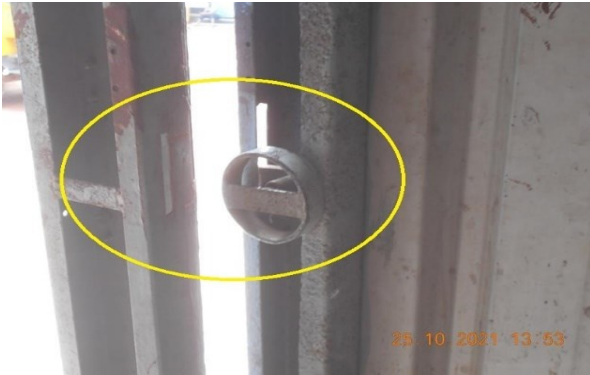
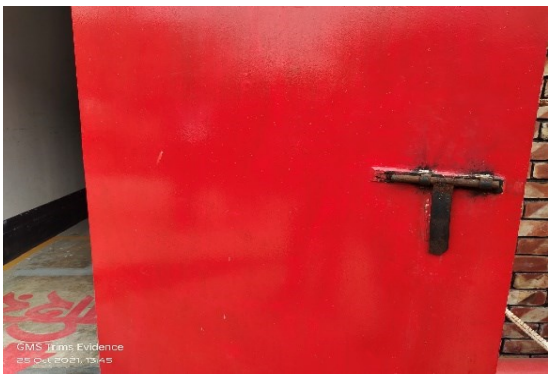
| F-3 | Egress | <p>Egress doors/gates with locking features not complying with NFPA101 are provided at building exits.</p> <p>Location: Bonded warehouse and oven label jacquard elastic shed</p> | <p>Provide push bar or panic exit hardware fitted with the doors instead of any double motion disengaging locks.</p> | Within 1 month |

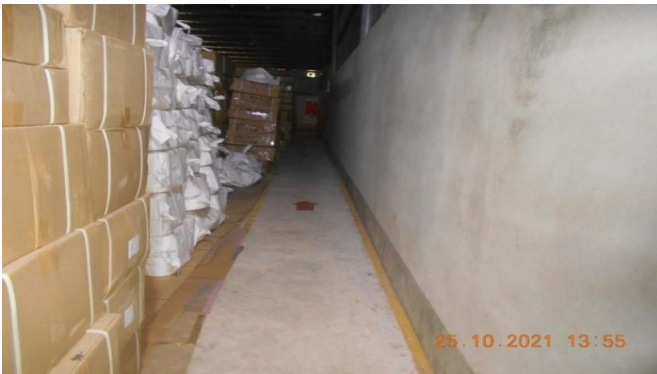
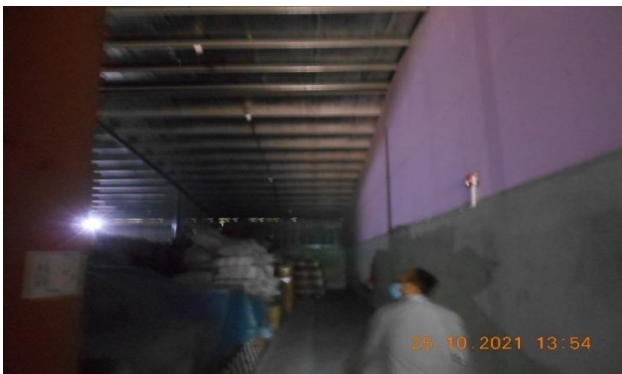
| F-4 | Egress lighting | <p>Directional signs are not provided where direction of the path of travel to an exit is not obvious</p> <p>Location: Bonded Warehouse Shed</p> | <p>Illuminated directional signs shall be provided where there is a change in the direction for the path of travel and the direction to an exit is not obvious.</p> | Within 1 months |

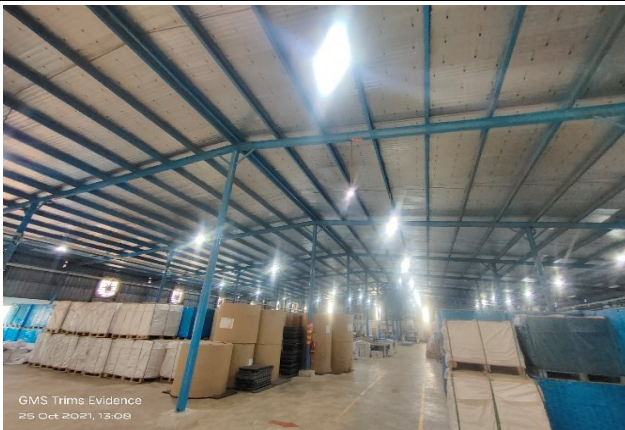
| SI No. | Category | Findings | Required Action | Remediation Time Frame |
|---|---|---|---|---|
| F-1 | Fire Rated Construction | <p>The main structural elements of the shed building are constructed by steel which is non-rated and were found in exposed condition without any fire protection.</p> <p>Location: Poly Recycle Shed</p> | <p>The new construction is a steel structure which shall be type-I or II construction for RMG use. So, provide required rating of the structural elements of the shed. Consult with a qualified fire protection engineer. Follow BNBC 2006-Table 3.2.4, 3.1.9 and 3.3.1 as reference.</p> | Within 6 months |

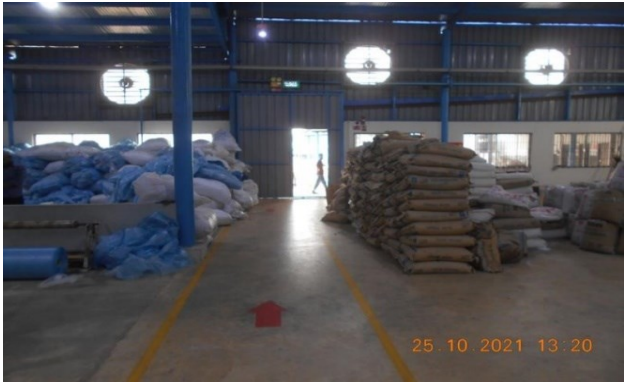
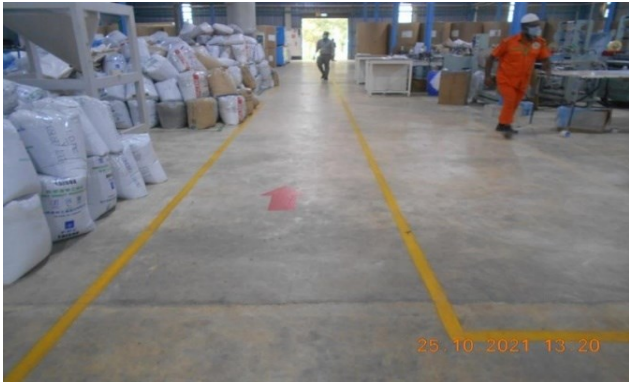
| F-2 | Fire Rated Construction | <p>Areas used for combustible storage are not separated by fire-rated construction.<br/>Location: Poly Recycle Shed</p> | <p>Provide dedicated storage rooms separated by minimum 1-hr fire-rated construction.</p> <p>Where separate storage rooms are not feasible, provide defined storage areas and limit the storage arrangement as follows:</p> <ul style="list-style-type: none"> <li>- Maximum height of 2.4m and maximum area of 23m<sup>2</sup></li> <li>- If sprinkler protected: maximum height of 3.66m and maximum area of 93m<sup>2</sup></li> </ul> <p>Separate areas of unenclosed combustible storage by a minimum clear distance of 3m.</p> | Within 3 months |

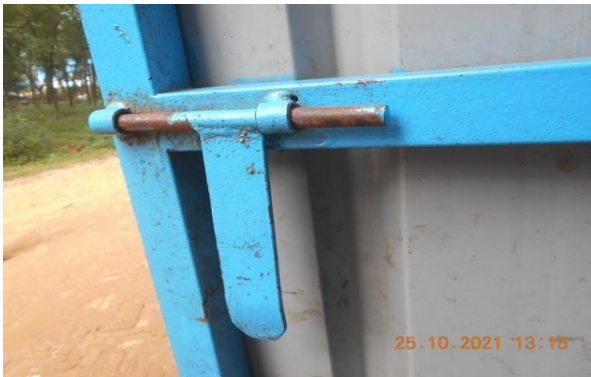
| F-3 | Egress | <p>Egress doors/gates with locking features not complying with NFPA101 are provided at building exits.</p> <p>Location: Poly Recycle Shed</p> | <p>Remove locking features from all egress doors/gates.</p> <p>If locks are required for security reasons, utilize specialized door locking features complying with NFPA101.</p> <p>or,</p> <p>Provide push bar or panic exit hardware fitted with the doors instead of any double motion disengaging locks.</p> | Within 1 month |
