# INITIAL FIRE SAFETY INSPECTION REPORT

**Alliance Knit Composite Ltd**

**RSC ID: 24255**

**ADDRESS: Holding-08/118, Pukurpar, Ashulia, Savar, Dhaka**

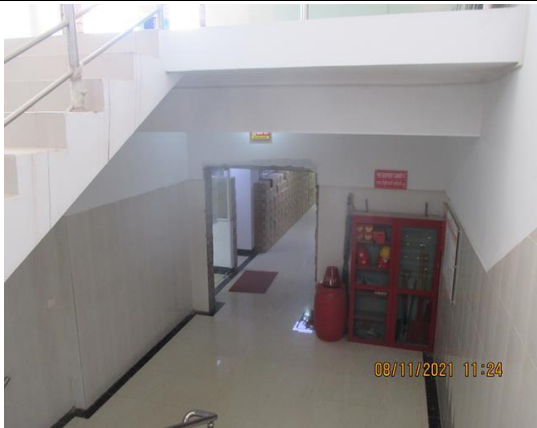
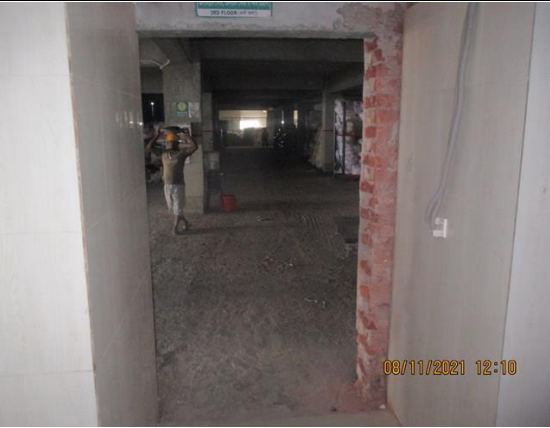
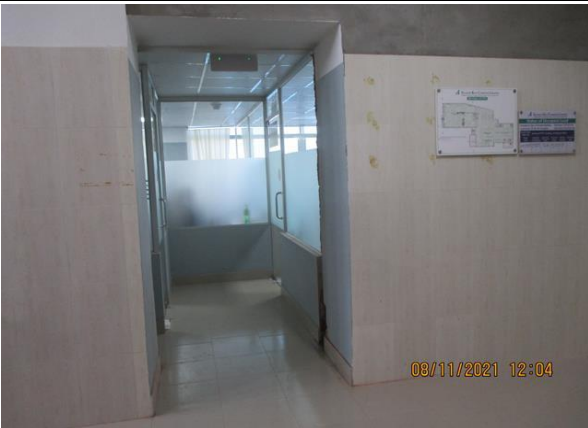
| F-1 | Fire Rated Construction | <p>Exit Enclosures are not properly fire separated from other occupancy on each floor by fire rated construction.</p> <p>Location: Main Building and Utility Building.</p> | <p>Provide minimum 2-hr fire rated separation exit enclosure. Provide minimum 1.5-hr fire rated doors and seal all unprotected openings and penetration to separate the exit stairs from work areas and other building spaces on all floor levels.</p> <p>The clearance under the bottom of a fire door shall be a maximum of 19mm.</p> <p>Ensure that the fire doors are self-closing and positive latching and that they are provided with fire exit (panic) hardware where serving production floors. If fire doors are required to be held open for functional reasons, provide automatic closing devices tied to the fire alarm system.</p> <p>Openings from exit enclosure to storage spaces shall be provided with a vestibule with fire rated construction and openings.</p> <p>Provide a 1.5-hr. fire rated door on the exit stair side and a 1-hr. fire rated door on the storage room side. Ensure that the fire rating of the vestibule construction matches that of the exit stair enclosure.</p> | Within 3 months |

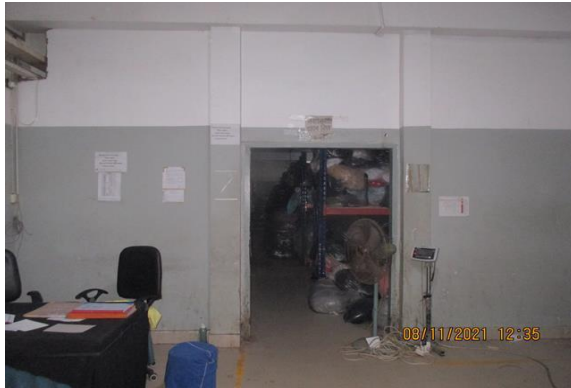
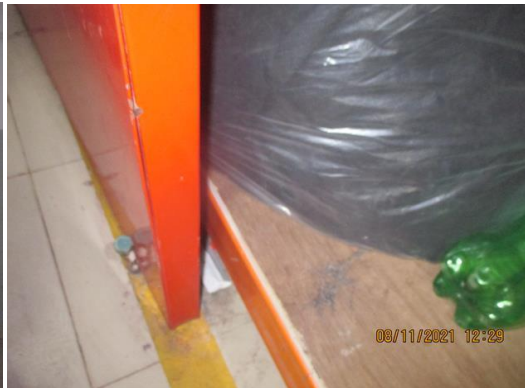
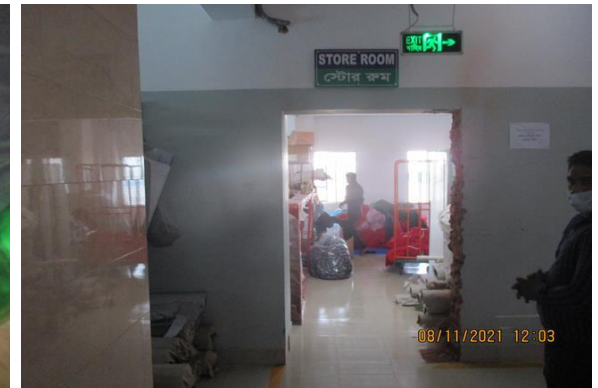
| F-2 | Fire Rated Construction | <p>Room used for combustible storage are not separated by fire rated construction.</p> <p>Location: Main building: Dyes store, Finished fabric stores. Yarn store, Gray fabric store.</p> | <p>Separate the storage room by a minimum 1- hr fire-rated construction. Seal and/or protected all openings to maintain the required fire separations.</p> | Within 3 months |

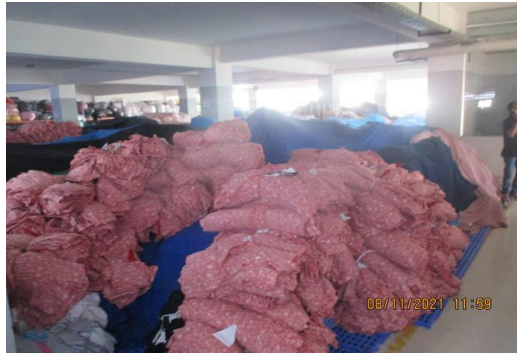
| F-5 | Fire Rated Construction | <p>Areas used for combustible storage are not separated by fire-rated construction.<br/>Location: 5th floor, main building.</p> | <p>Provide dedicated storage rooms separated by minimum 1-hr fire-rated construction.</p> <p>Where separate storage rooms are not feasible, provide defined storage areas and limit the storage arrangement as follows:</p> <ul style="list-style-type: none"> <li>- Maximum height of 2.4m and maximum area of 23m<sup>2</sup></li> <li>- If sprinkler protected: maximum height of 3.66m and maximum area of 93m<sup>2</sup></li> </ul> <p>Separate areas of unenclosed combustible storage by a minimum clear distance of 3m</p> | Within 3 months |

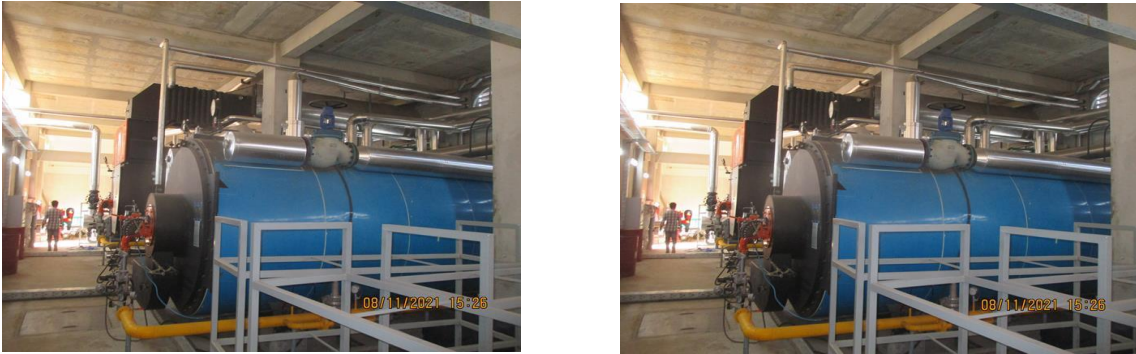
| F-6 | Fire Rated Construction | The boiler is not separated by fire rated construction by openings to the storage.<br>Location: Utility building. | Separate the boiler room by a minimum 2-hr fire rated construction (for high rise building)/ 1-hr fire rated construction (for low rise building). Seal and/or protected all openings to maintain fire separations. | Within 3 months |

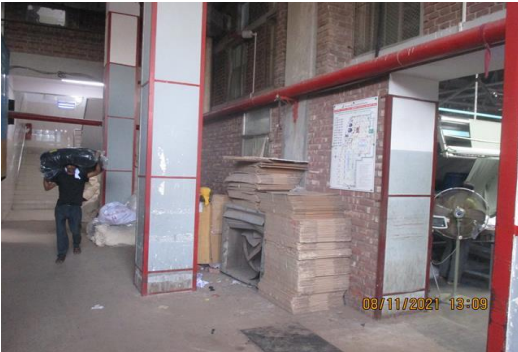
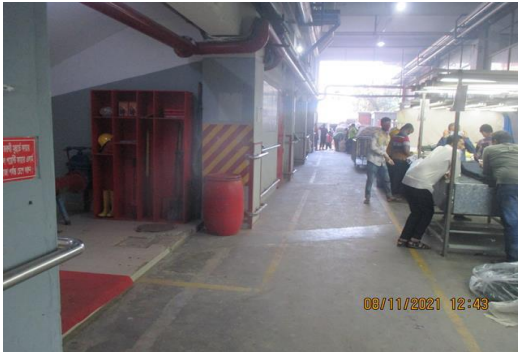
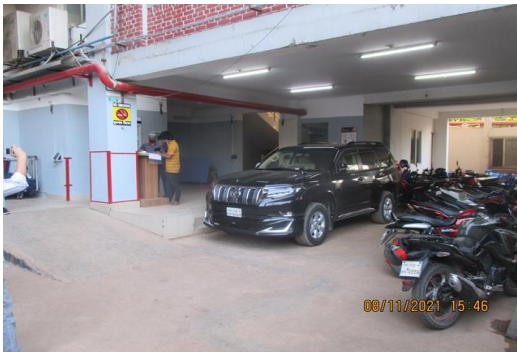
| F-7 | Fire Rated Construction | Exit stairs do not discharge the occupant directly to the outside | Modify stair to discharge directly outside.<br>Or<br>Provide 2-hr fire-rated exit passageway leading directly outside (vestibules to separate any storage areas).<br>Or<br>Provide sprinkler protection for discharge floor in accordance with NFPA 13. | Within 3 months |

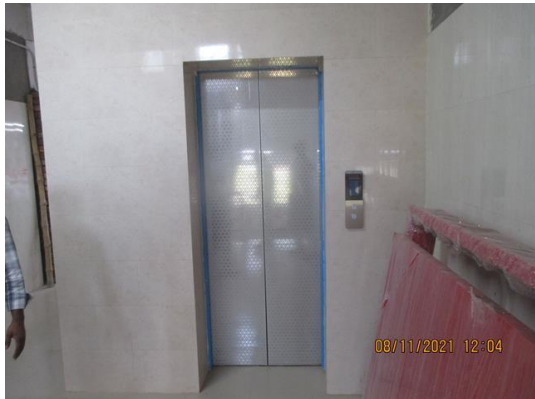
| F-8 | Fire Rated Construction | Elevator shafts are open into production floor and exit stair enclosure without proper fire separation.<br>Location: Main building. | Elevators shall not open into an exit enclosure as per ACCORD-6.14.3. Separate the stair enclosure from elevator shaft of the building.<br>or<br>Modify/Separate the elevator and stair enclosure arrangement in a way to satisfy Accord building standard 6.14.3 and 4.5.3. | Within 3 months |

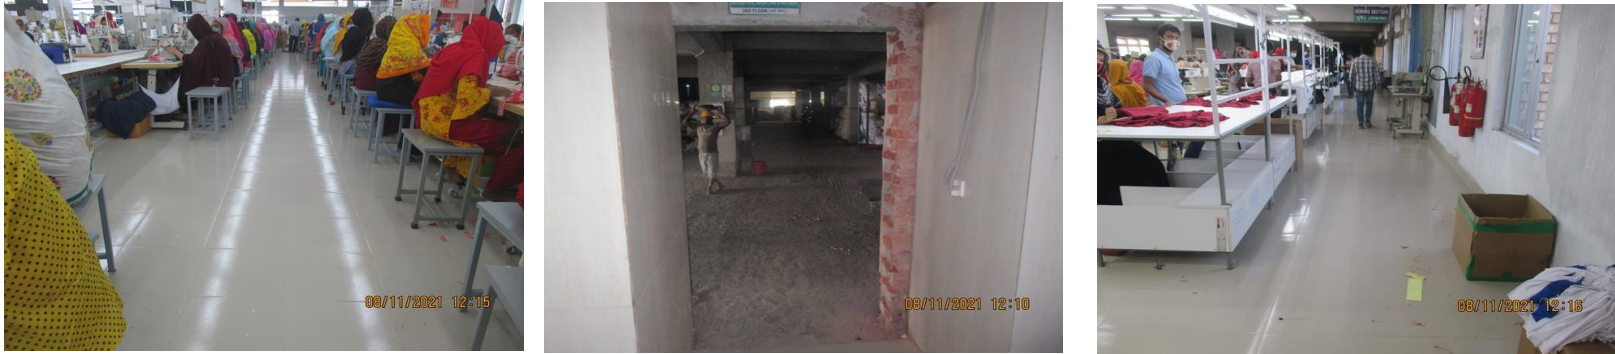
| F-9 | Means of Egress | Width of aisles is less than 0.9m (36-in.) or not marked properly at several floors. | Aisles shall be provided with a minimum unobstructed clear- width of 0.9m (36 in). | Within 1 month |

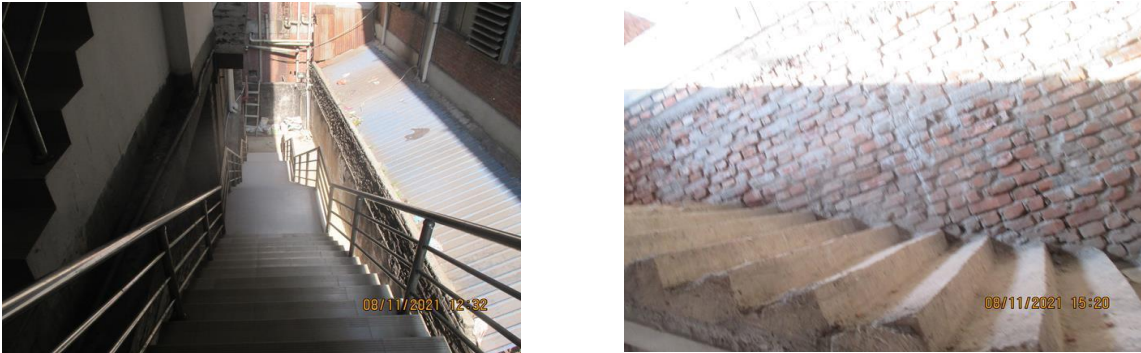
| F-10 | Means of Egress | Handrails are not provided on both sides of the exit stair. Height of handrail is less than 34 inch.<br>Location: Main building & New utility building | Provide handrails on both sides of the exit stair. New handrails shall have a minimum height of 865 mm (34 in.) and a maximum height of 965 mm (38 in.) as measured from the leading edge of the tread. Intermediate handrails shall be provided when the stair width exceeds 2.2 m (87 in.). | Within 3 months |

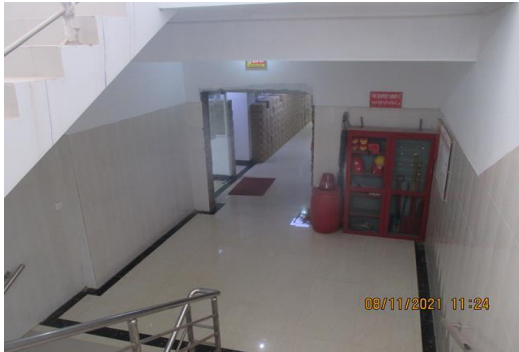
| F-11 | Means of Egress | Building did not have stair designation signs or occupant load signs at the required locations.<br>Location: Main building | Provide stair designation signs and occupant load signs at the required locations. | Within 1 month |

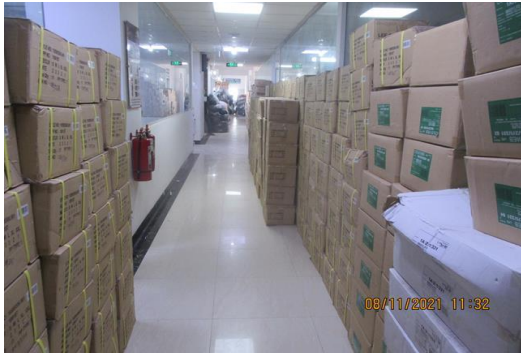
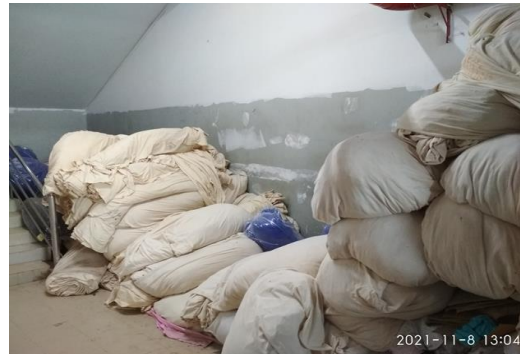
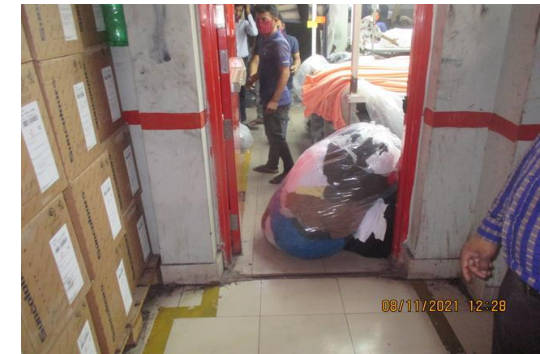
| F-12 | Means of Egress | Storage was located on the egress path on 5th floor, 2nd floor, 1st floor.<br>Location: Main building | Keep egress path and stair clear of storage. | Immediately |

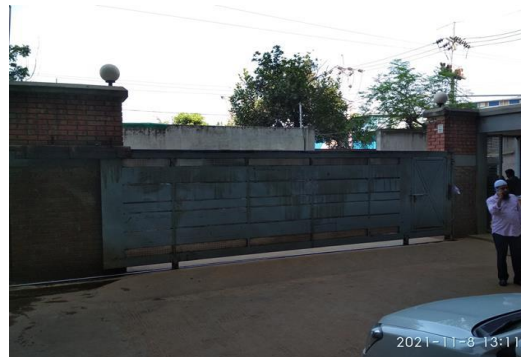
F-13

Non complaint locking features were present in the building exits along exit discharge.

Remove locking features from all egress doors/gates. If locks are required for security reasons, utilize specialized door locking features complying with NFPA101.

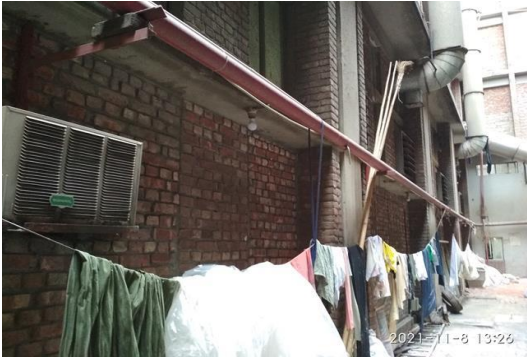
| F-14 | Means of Egress | The exit discharge path is less than 10 ft. wide and is not separated from the building interior. | Seal all penetrations and openings to the interior of the building along the discharge path, up to a height of 10 ft. to provide a minimum 1-hr fire separation. | Within 3 months |

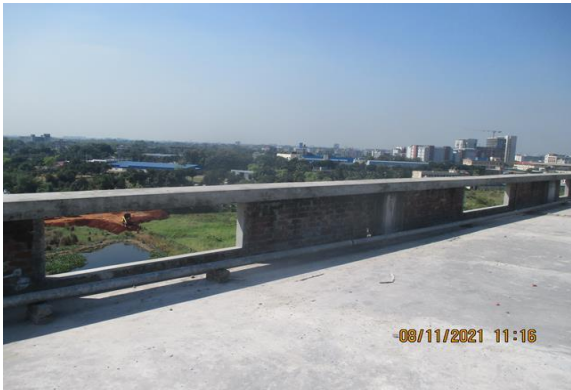
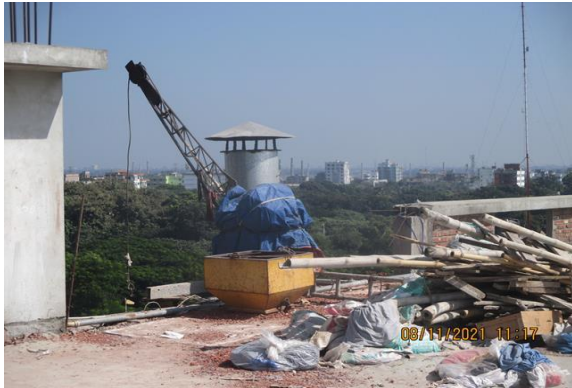
| F-15 | Means of Egress | Parapets or guards are not provided at some locations. Parapet provided on the roof is less than 42 inch and improper.<br>Location: Main Building | Provide parapets or guards with a minimum height of 1067mm (42 inch.). | Within 3 months |

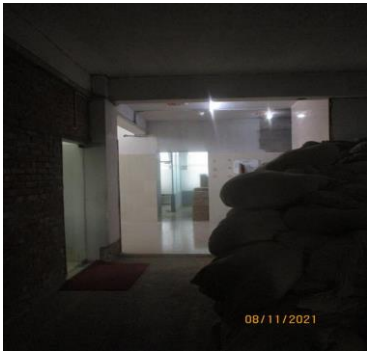
| F-16 | Egress lighting | Exit signs are not provided at several locations on 3rd floor.<br>Location: Main building | Illuminated exit signs shall be placed at entrance to an exit. Additional exit signs shall be placed throughout the facility anywhere the continuation of the egress is not obvious. Illuminated exit signs shall be provided with either battery backup or uninterruptable power supply systems and shall be continuously illuminated. | Within 1 month |

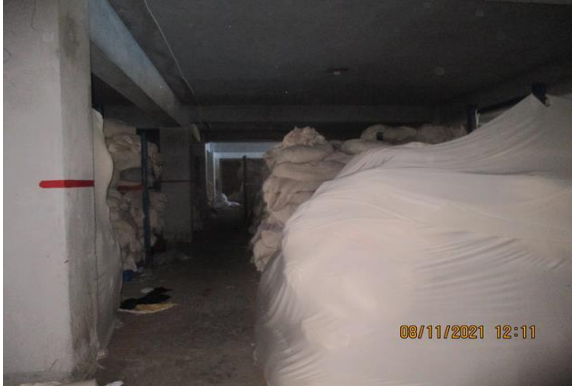
| F-17 | Egress lighting | Based on the number and location of emergency lights observed, adequate illumination levels are not anticipated along egress routes . | Test the emergency lighting system on each floor and provide additional emergency fixtures to provide adequate illumination along the means of egress. Provide a minimum illumination of 10 lux at the floor level within exit stairs and exit discharge paths and minimum 2.5 lux along exit access aisles. | Within 3 months |

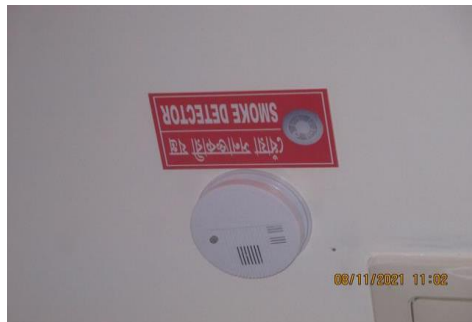
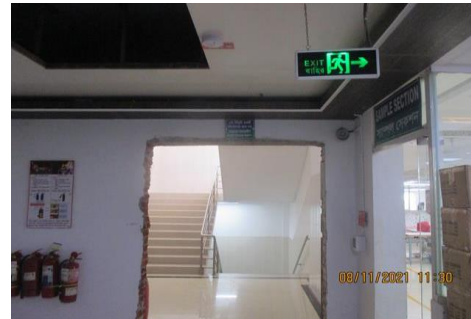
| F-19 | Fire Alarm & Detection System (FADS) | The building is equipped with single-station smoke alarms on 3rd, 4th and 5th floors. Smoke alarm activation sounds only a local alarm and does not provide automatic fire alarm notification of occupant. | Remove single-station smoke alarms. Provide automatic smoke detection throughout the building, tied into the fire alarm system, in accordance with NFPA 72. | Design within 2 months, Install within 4 months. |

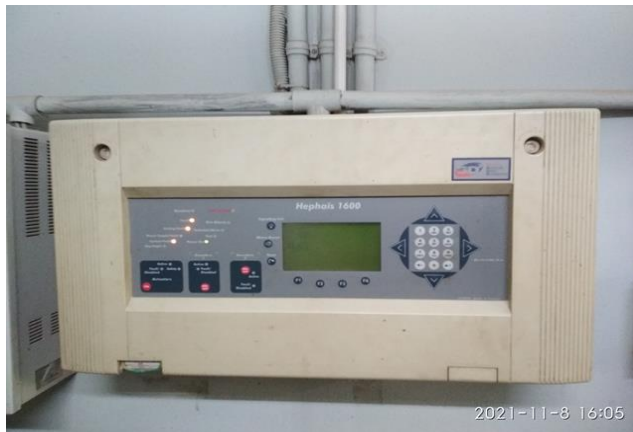
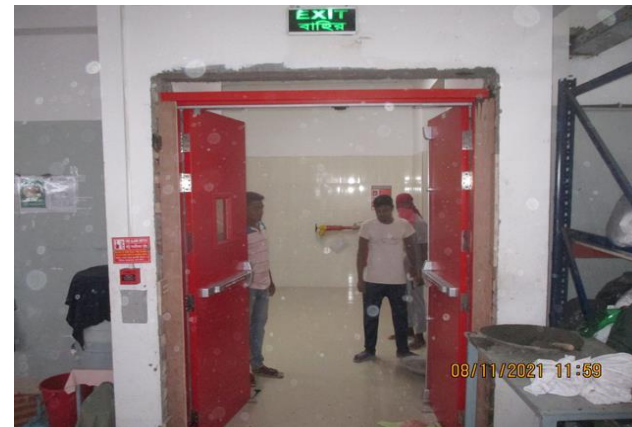
| F-20 | Fire Alarm & Detection System (FADS) | <p>The Required Fire Alarm system is not installed in accordance with the ACCORD standard and NFPA-72.</p> <p>Location: Main building &amp; new utility building</p> | <p>Design &amp; Installation of Fire Alarm system shall be in accordance with ACCORD standard and NFPA 72. Submit design, documents and calculations to RSC for review prior installation/modification.</p> <p>After installation the owner shall contact the RSC for witness of conducting the final acceptance testing of the fire detection &amp; alarm system installation.</p> <p>Also inspect, test and maintain the fire alarm system, and keep written records on-site, in accordance with NFPA 72.</p> | Design within 2 months, Install within 4 months. |
