# Alliance Knit Composite Ltd.

Holding-08/118, Pukurpar, Ashulia, Savar, Dhaka  
(23.910103, 90.311687)  
8<sup>th</sup> November 2021

# Buildings Information

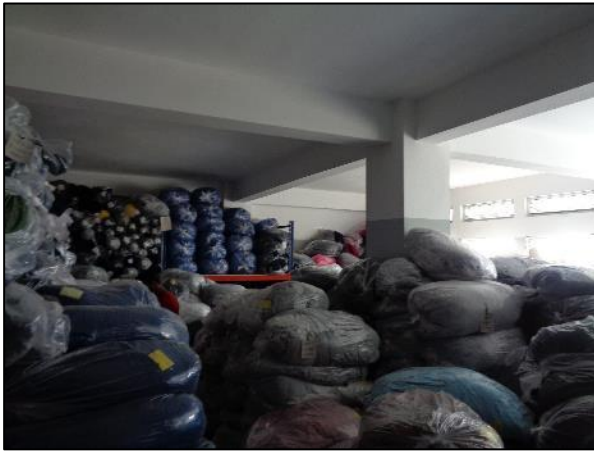
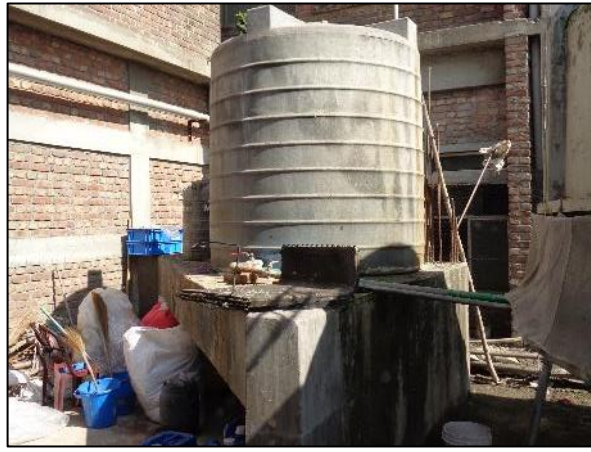
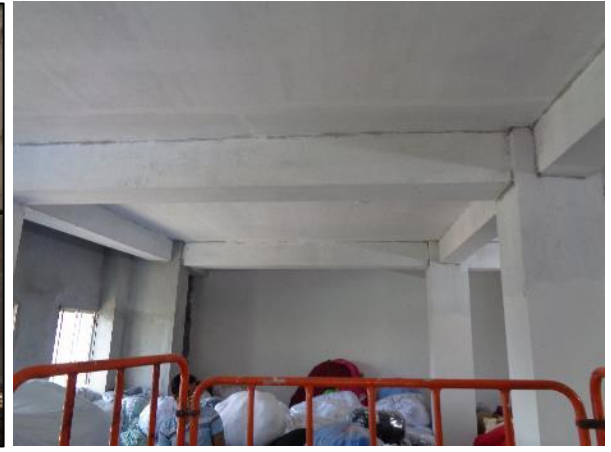
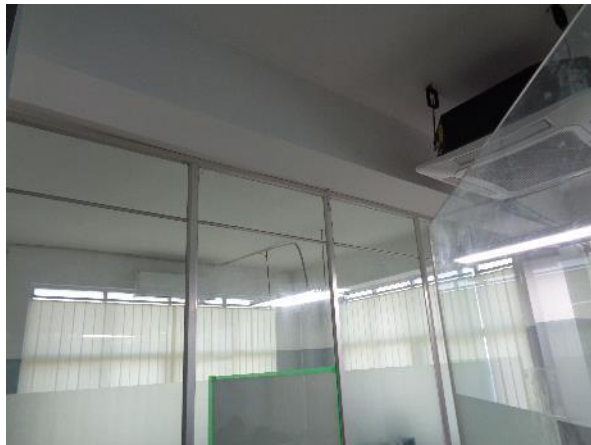
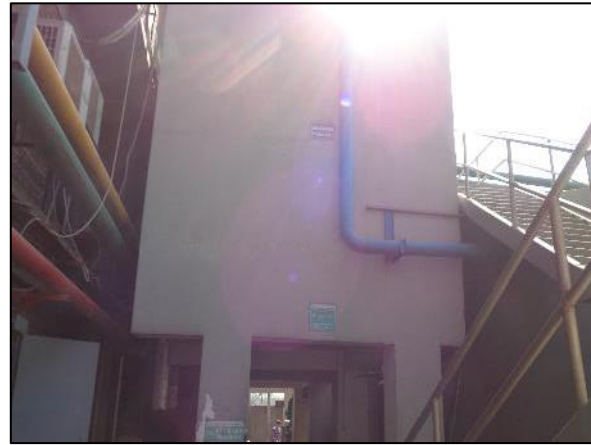
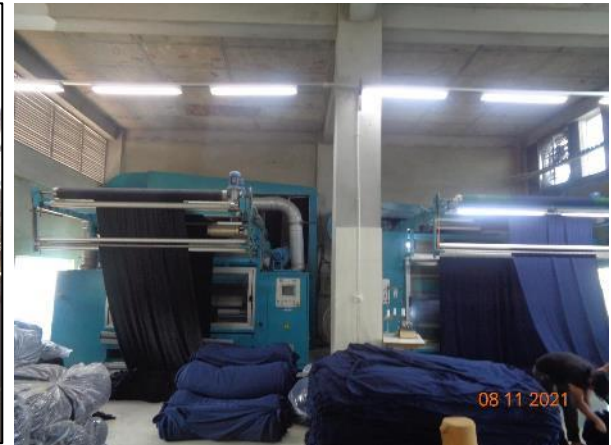
**Floor load plan not available**

Load plan of these buildings were not produced. Also, load management program was not implemented. Produce and actively manage a loading plan for all floor plates within the factory considering the floor capacity and column capacity.

| Item No. | Observation | Recommended Action Plan | Recommended Timeline |
|---|---|---|---|
| 05 | Floor load plan not available (Building-1, 2, 3, 4, 5 & 9) | The factory engineer is required to produce floor loading plan for each floor considering floor & column capacity. | 6-weeks |
| 06 | Floor load plan not available (Building-1, 2, 3, 4, 5 & 9) | Implement floor load management program (Posting load plan, load restriction height marking, signage, maintaining load resister). | 6-weeks |

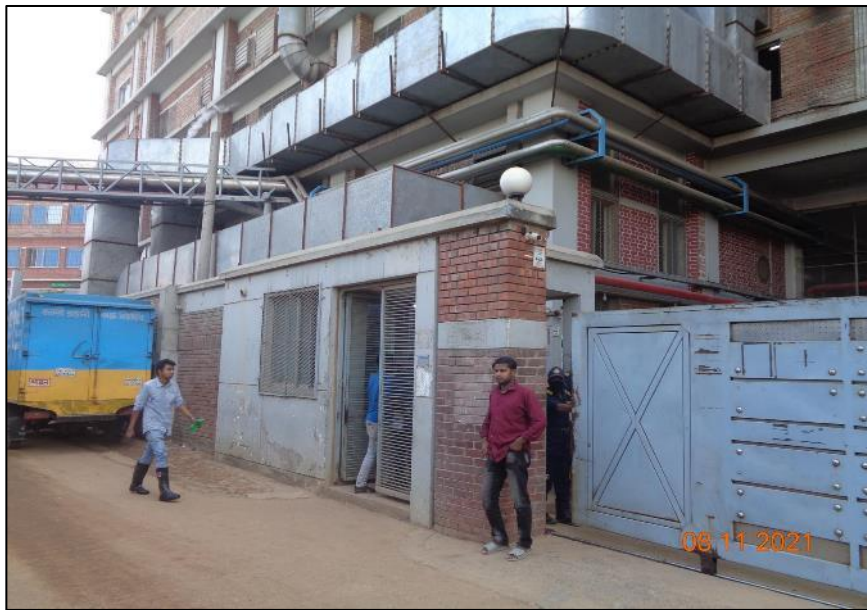
Building-2

**No design report was available**

As per BNBC every building or structure designed shall have its design documents prepared in accordance with the provision of Section 1.9.1. The design document shall include a design report, and a set of structural drawings, which shall be prepared in compliance with section 1.9.1.1 and section 1.9.1.2 as per BNBC. During the inspection, design report was not available which is required to be prepared in compliance with section 1.9.1 (part-6, BNBC).

| Item No. | Observation | Recommended Action Plan | Recommended Timeline |
|---|---|---|---|
| 07 | No design reports were available. (Building-2, Building-5, Building-9) | Factory engineer to prepare the design Report for the structures in compliance with section 1.9.1.1 as per BNBC. | 6-weeks |
| 08 | No design reports were available. (Building-2, Building-5, Building-9) | Complete implementation of any remedial works deemed necessary by the design report. | 6-months |

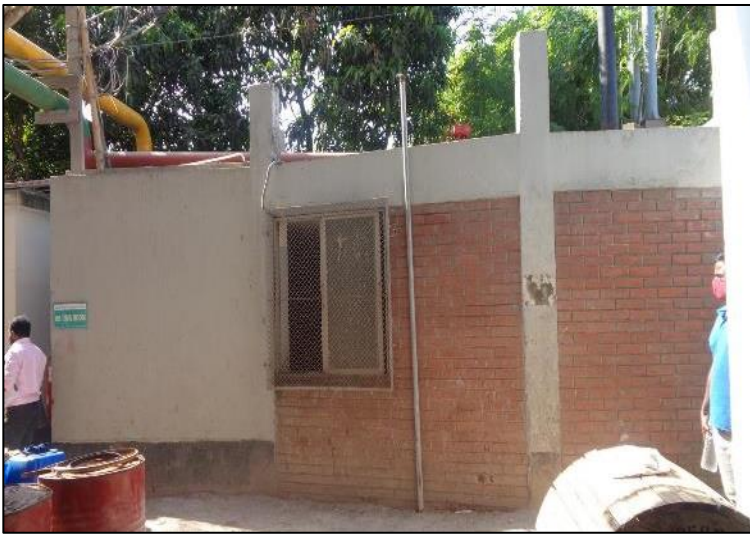
Building-6 (RMS)

## **Lack of as-built drawing**

No as-built drawing was provided for those aforementioned structures. Factory engineer is required to prepare full set of as-built drawing for all of these structures.

| Item No. | Observation | Recommended Action Plan | Recommended Timeline |
|---|---|---|---|
| 09 | Lack of as-built drawing (Building-6, Building-7, Building-8) | Factory engineer is required to prepare full set of as-built drawing for all these structures. | 6-weeks |
