# INITIAL FIRE SAFETY INSPECTION REPORT

## Cotton Club (BD) Ltd. (Extension)

RSC ID: 24250

Date: 19-October-2021

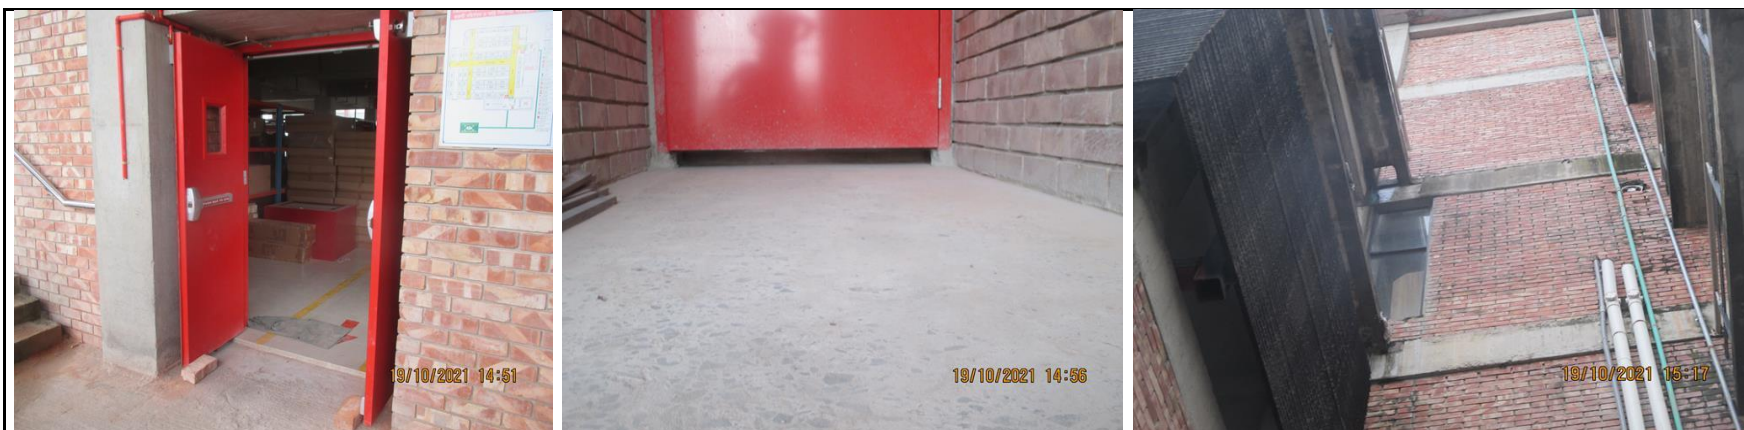
| Sl No. | Category | Findings | Required Action | Remediation Time Frame |
|---|---|---|---|---|
| F-1 | Fire Rated Construction | <p>Exit Enclosures are not properly fire separated from other occupancy on each floor by fire rated construction.</p> <p>Location: RO building</p> | <p>Provide minimum 2-hr fire rated separation exit enclosure. Provide minimum 1.5-hr fire rated doors and seal all unprotected openings and penetration to separate the exit stairs from work areas and other building spaces on all floor levels.</p> <p>The clearance under the bottom of a fire door shall be a maximum of 19mm.</p> <p>Ensure that the fire doors are self-closing and positive latching and that they are provided with fire exit (panic) hardware where serving production floors. If fire doors are required to be held open for functional reasons, provide automatic closing devices tied to the fire alarm system.</p> | Within 3 months |

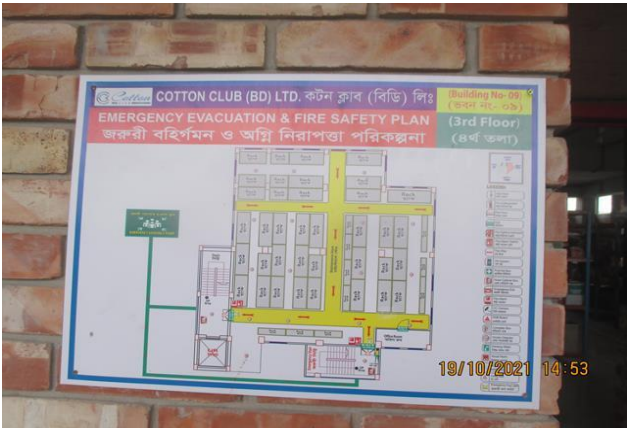
| F-2 | Fire Rated Construction | <p>Storage room discharges directly into east exit stair enclosure.</p> <p>Location: RO building</p> | <p>Openings from exit enclosure to storage spaces shall be provided with a vestibule with fire rated construction and openings.</p> <p>Provide a 1.5-hr. fire rated door on the exit stair side and a 1-hr. fire rated door on the storage room side. Ensure that the fire rating of the vestibule construction matches that of the exit stair enclosure.</p> | Within 3 months |

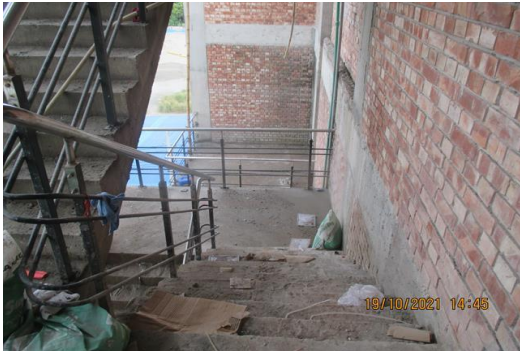
| F-3 | Means of Egress | Handrails are not provided on both sides of the exit stair. | Provide handrails on both sides of the exit stair. New handrails shall have a minimum height of 865 mm (34 in.) and a maximum height of 965 mm (38 in.) as measured from the leading edge of the tread. Intermediate handrails shall be provided when the stair width exceeds 2.2 m (87 in.). | Within 3 months |

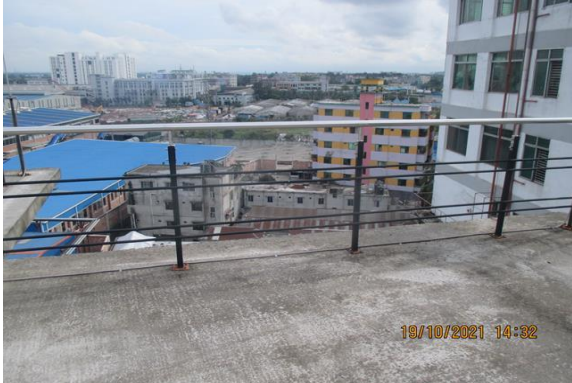
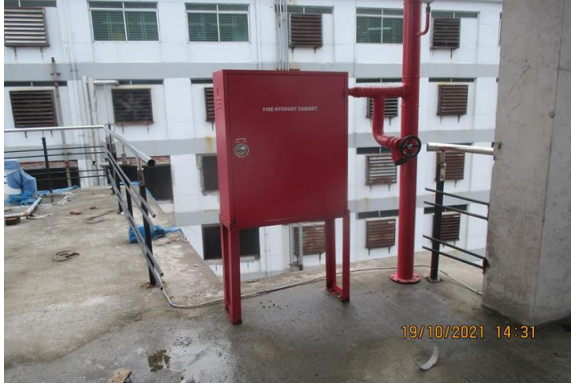
| F-4 | Means of Egress | Parapets or guards are not provided at some locations. Parapet provided on the roof is improper.<br>Location: RO Building | Provide parapets or guards with a minimum height of 1067mm (42 inch.). | Within 3 months |

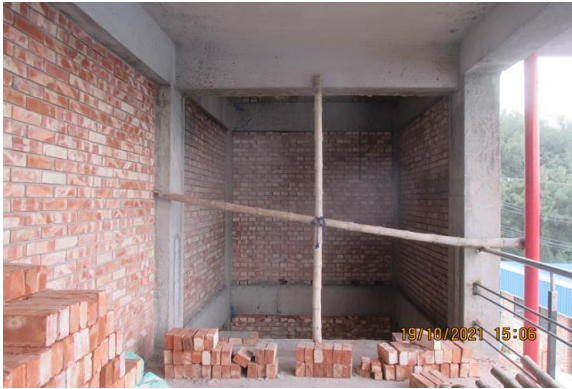
| F-5 | Means of Egress | Falling hazard was observed on exit stair shaft that may lead to severe injury.<br>Location: RO building. | Guards shall be provided with minimum height of 1067 mm (42 in.). | Within 1 month |

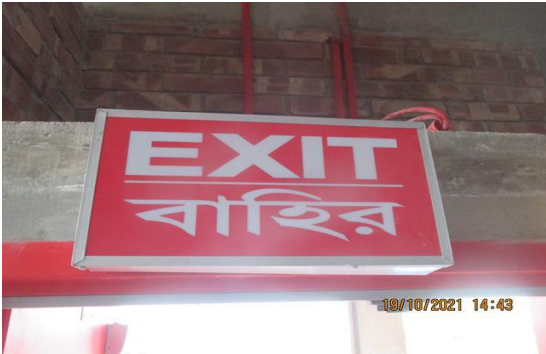
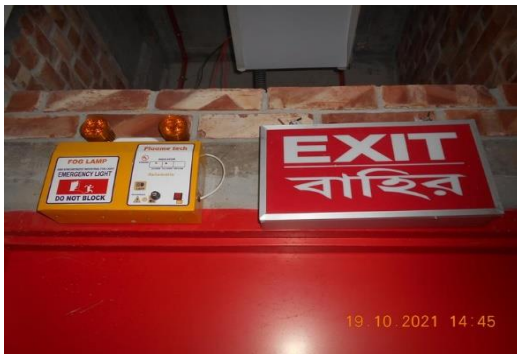
| F-6 | Egress lighting | Several exit signs are not illuminated at different floors. | <p>Illuminated exit signs shall be placed at entrance to an exit. Additional exit signs shall be placed throughout the facility anywhere the continuation of the egress is not obvious. Illuminated exit signs shall be provided with either battery backup or uninterruptable power supply systems and shall be continuously illuminated.</p> | Within 1 month |

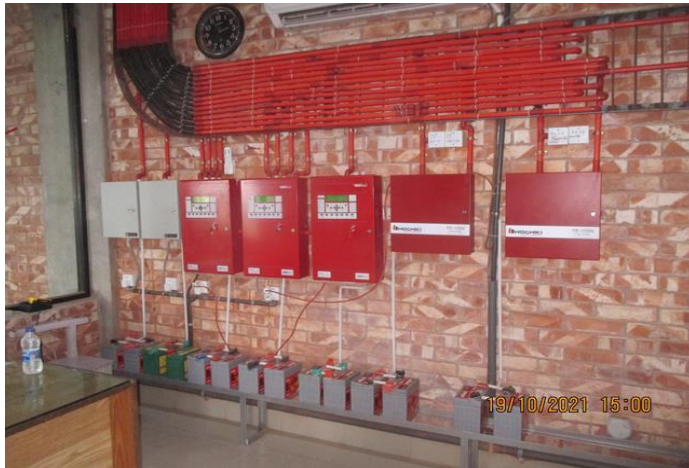
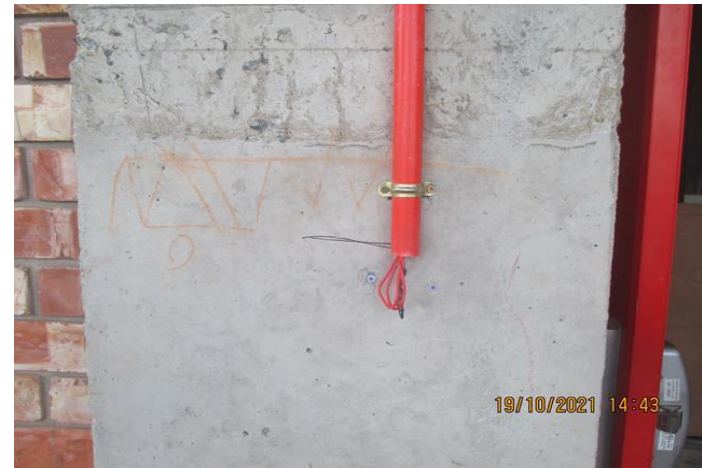
| F-9 | Fire Alarm & Detection System (FADS) | <p>Addressable fire alarm &amp; detection system installation was ongoing during inspection day. The Required Fire Alarm system is not installed in accordance with the ACCORD standard and NFPA-72.</p> <p>Location: RO building</p> | <p>Design &amp; Installation of Fire Alarm system shall be in accordance with ACCORD standard and NFPA 72. Submit design, documents and calculations to RSC for review prior installation/modification.</p> <p>After installation the owner shall contact the RSC for witness of conducting the final acceptance testing of the fire detection &amp; alarm system installation.</p> <p>Also inspect, test and maintain the fire alarm system, and keep written records on-site, in accordance with NFPA 72.</p> | Design within 2 months, Install within 4 months. |

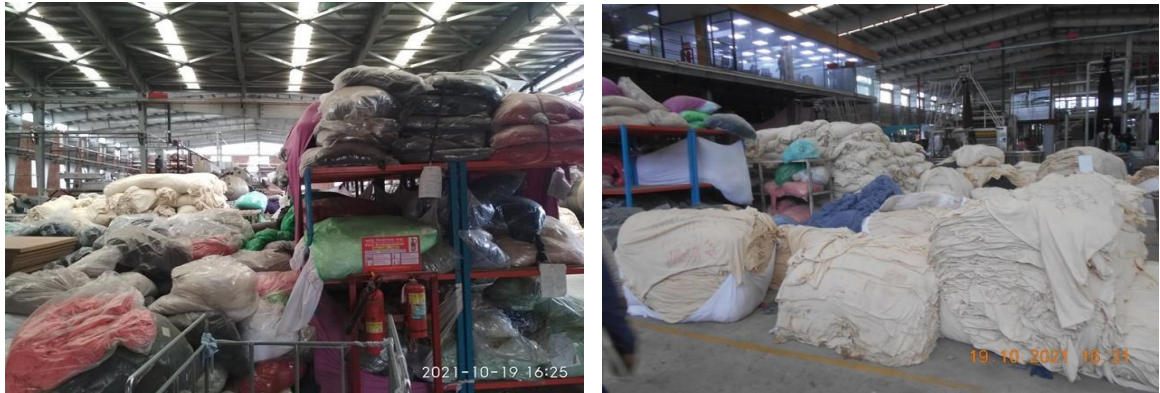
| Sl No. | Category | Findings | Required Action | Remediation Time Frame |
|---|---|---|---|---|
| F-1 | Fire Rated Construction | Areas used for combustible storage are not separated by fire-rated construction.<br>Location: Shed 11 | <p>Provide dedicated storage rooms separated by minimum 1-hr fire-rated construction.</p> <p>Where separate storage rooms are not feasible, provide defined storage areas and limit the storage arrangement as follows:</p> <ul style="list-style-type: none"> <li>- Maximum height of 2.4m and maximum area of 23m<sup>2</sup></li> <li>- If sprinkler protected: maximum height of 3.66m and maximum area of 93m<sup>2</sup></li> </ul> <p>Separate areas of unenclosed combustible storage by a minimum clear distance of 3m.</p> | Within 3 months |

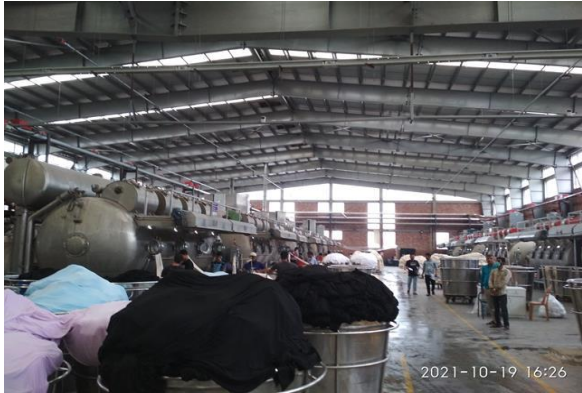
| F-2 | Fire Rated Construction | <p>The main structural elements of the shed building are constructed by steel which is non-rated and were found in exposed condition without any fire protection.</p> <p>Location: Shed 08, 10, 11, 12, 14</p> | <p>The buildings are new steel structure which shall be type-I or II construction. So, provide require rating in the structural elements of the buildings. Consult with a qualified fire protection engineer. Follow BNBC 2006-Table 3.2.4, 3.1.9 and 3.3.1 as reference.</p> | Within 6 months |

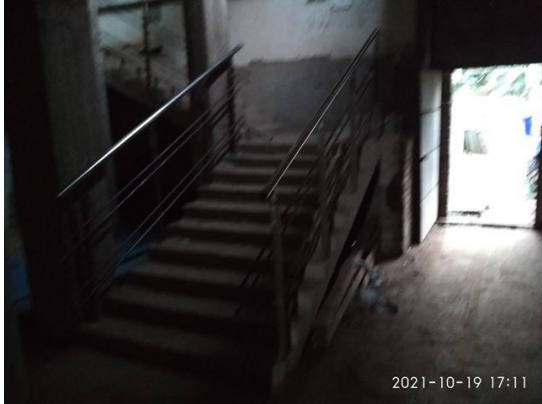
| F-3 | Fire Rated Construction | <p>Exit Enclosures are not properly fire separated from other occupancy on each floor by fire rated construction.</p> <p>Location: Building no 08</p> | <p>Provide minimum 2-hr fire rated separation exit enclosure. Provide minimum 1.5-hr fire rated doors and seal all unprotected openings and penetration to separate the exit stairs from work areas and other building spaces on all floor levels.</p> <p>The clearance under the bottom of a fire door shall be a maximum of 19mm.</p> <p>Ensure that the fire doors are self-closing and positive latching and that they are provided with fire exit (panic) hardware where serving production floors. If fire doors are required to be held open for functional reasons, provide automatic closing devices tied to the fire alarm system.</p> | Within 3 months |

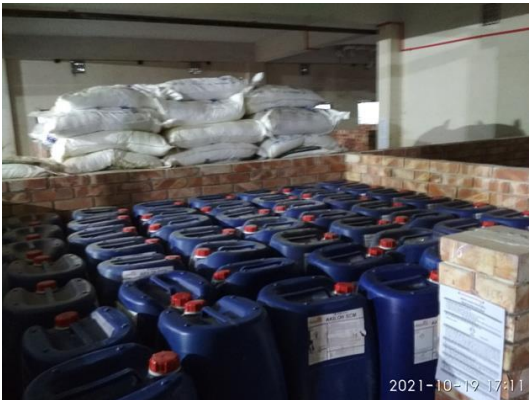
| F-4 | Fire Rated Construction | <p>The three hazardous materials / flammable liquid storage rooms, after discharge from the northwest exit stair, were not separated by fire-rated construction due to nonrated doors. The nonrated tin roofs did not provide adequate separation to the interior of the building on the ground floor.</p> <p>Location: Building no 08</p> | <p>Separate the hazardous materials / flammable liquid storage rooms by a minimum 2-hr fire-rated construction. Seal and/or protected all openings to maintain the required fire separations.</p> | Within 3 months |

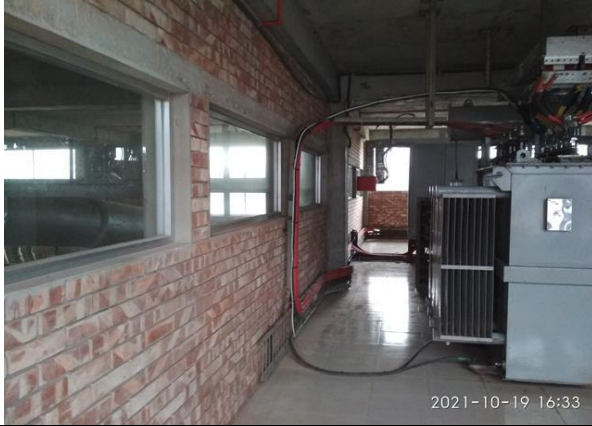
| F-5 | Fire Rated Construction | The boiler and transformer room is not separated by fire rated construction (openings, non-rated doors, penetrations)<br>Location: Building no 14 | Specify appropriate upgrade based on conditions:<br>-Separate the boiler room by a minimum 2-hr fire rated construction (for high rise building)/ 1-hr fire rated construction (for low rise building). Seal and/or protected all openings to maintain fire separations.<br>-Separate the transformer room by a minimum 2-hr fire rated construction. Seal and/or protected all fire separations. | Within 3 months |

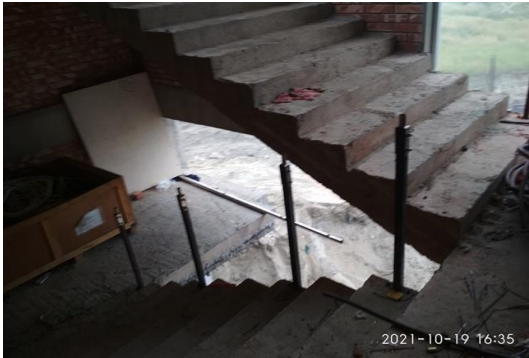
| F-6 | Means of Egress | Falling hazard was observed on exit stair shaft that may lead to severe injury.<br>Location: Building no 14 | Guards shall be provided with minimum height of 1067 mm (42 in.). | Within 1 month |

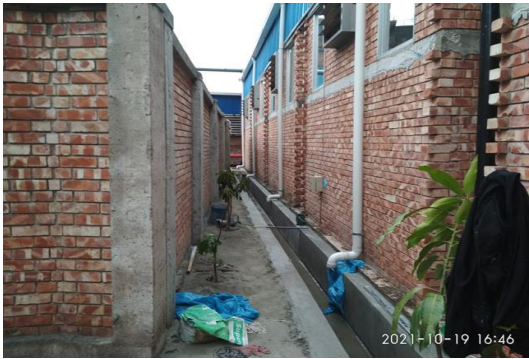
| F-7 | Means of Egress | <p>The exit discharge path is less than 10 ft. wide and is not separated from the building interior.<br/>Location: Building no 12</p> | <p>Seal all penetrations and openings to the interior of the building along the discharge path, up to a height of 10 ft. to provide a minimum 1-hr fire separation.</p> | |

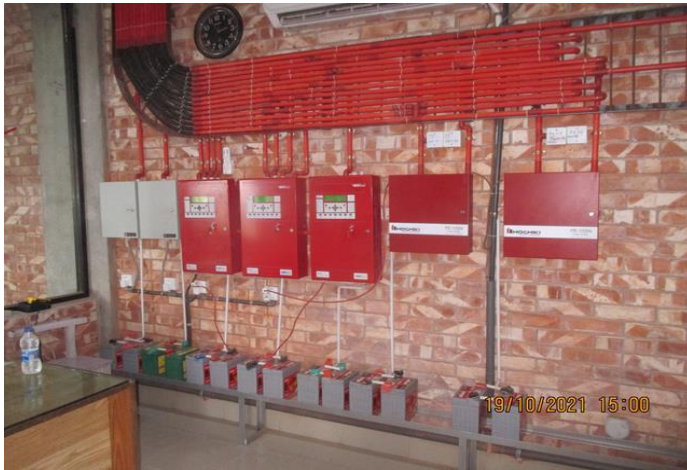
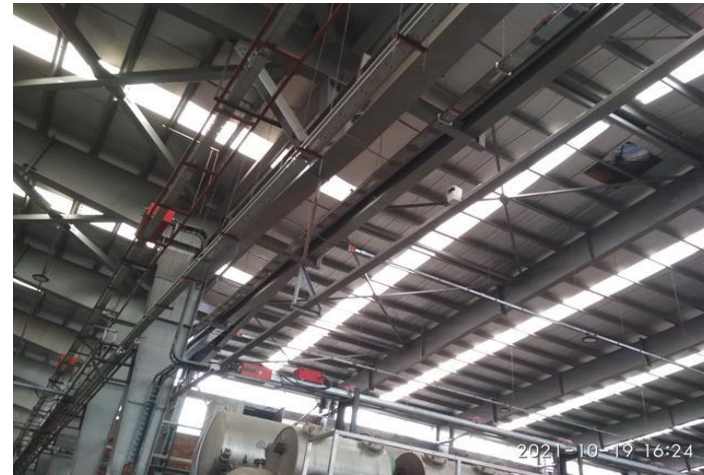
| F-10 | Fire Alarm & Detection System (FADS) | <p>Addressable fire alarm &amp; detection system installation was ongoing during inspection day. The Required Fire Alarm system is not installed in accordance with the ACCORD standard and NFPA-72.</p> <p>Location: Shed 08, 10, 11, 12, 14</p> | <p>Design &amp; Installation of Fire Alarm system shall be in accordance with ACCORD standard and NFPA 72. Submit design, documents and calculations to RSC for review prior installation/modification.</p> <p>After installation the owner shall contact the RSC for witness of conducting the final acceptance testing of the fire detection &amp; alarm system installation.</p> <p>Also inspect, test and maintain the fire alarm system, and keep written records on-site, in accordance with NFPA 72.</p> | Design within 2 months, Install within 4 months. |
