# INITIAL FIRE SAFETY INSPECTION REPORT

**Debonair Limited (extension)**

**RSC ID: 24090**

**ADDRESS: Gorat, Sarker Market Road, Ashulia, Dhaka-1341.**

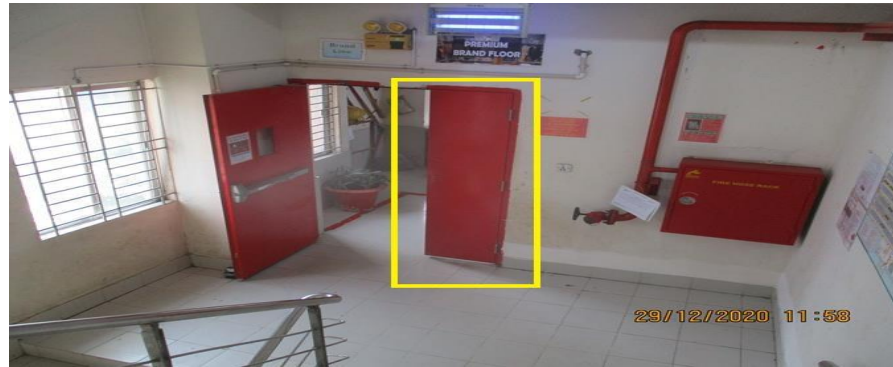
| SI No. | Category | Findings | Required Action | Remediation Time Frame |
|---|---|---|---|---|
| F-1 | Fire Rated Construction | Exit stair enclosures are not properly fire-rated construction (Fire doors are not properly functioning, small leaf of fire-rated doors are not interfaced with FACP). | Provide minimum 2-hr fire rated separation enclosure. Provide minimum 1.5-hr fire rated doors and seal all unprotected openings to separate the exit stairs from work areas and other building spaces on all floor levels. Ensure that the fire doors are self-closing and positive latching and that they are provided with fire exit (panic) hardware where serving production floors. If fire doors are required to be held open for functional reasons, provide automatic closing devices tied to the fire alarm system. | Within 3 months |

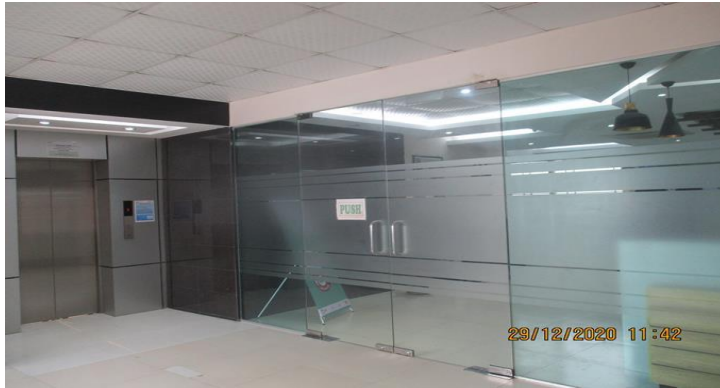
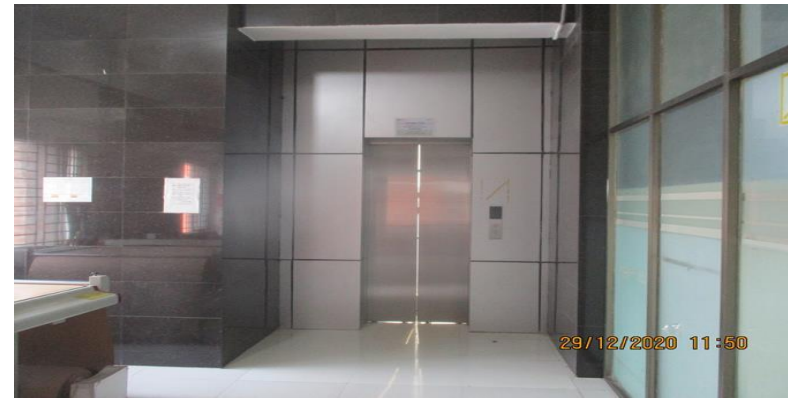
| F-2 | Fire Rated Construction | Elevator shafts are directly open into the production floor without proper fire separation (Doors are not fire rated). | Ensure minimum 1.5-hr fire rating the doors of elevator shafts otherwise close the area of the shaft with a 2-hr fire-rated construction barrier. | Within 3 month |

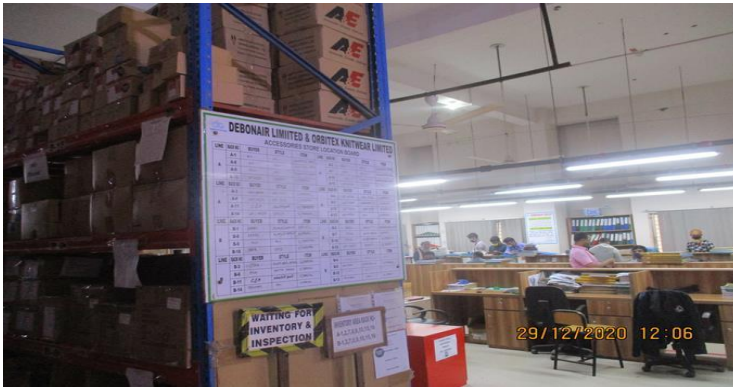
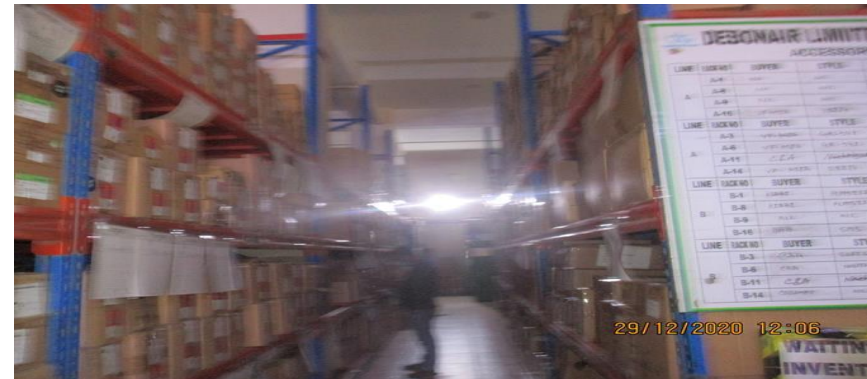
| F-3 | Fire Rated Construction | Rooms used for storage of combustible materials are not separated from the surrounding occupancy/areas & Office room<br>Location: Ground floor of Office Building. | Rooms used for storage of combustible materials shall be separated from the surrounding occupancy with a minimum 1 hour construction. | Within 3 months |

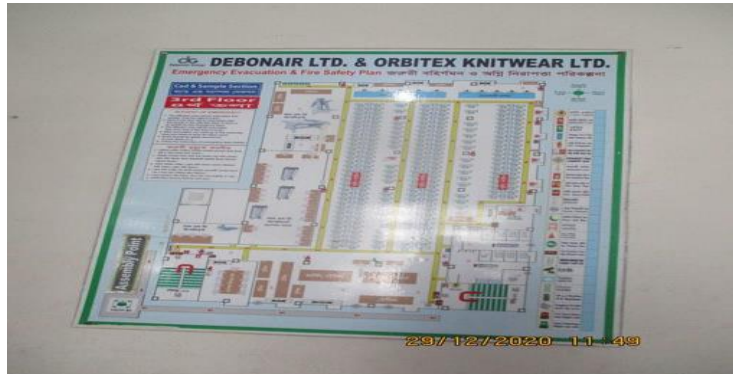
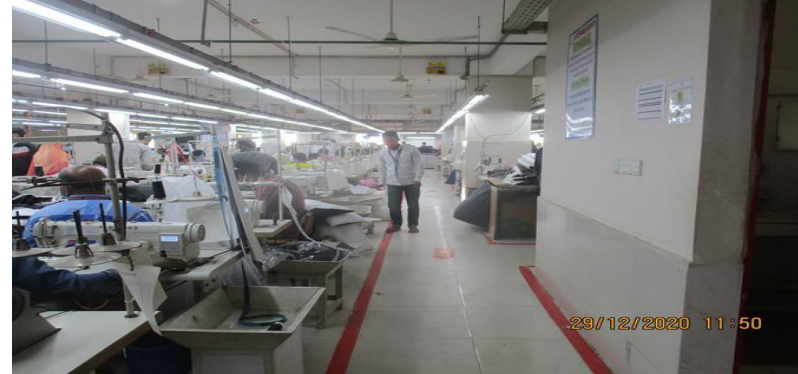
| F-4 | Egress | <p>The common path of egress travel was found 110 ft (33.5 m) on all floors except the ground floor which is a violation of Accord Standard.</p> <p>Location: Office Building</p> | <p>Reconfigure the egress arrangement to reduce the maximum common path of travel to not more than 23m.☐</p> | <p>Within 3 months</p> |

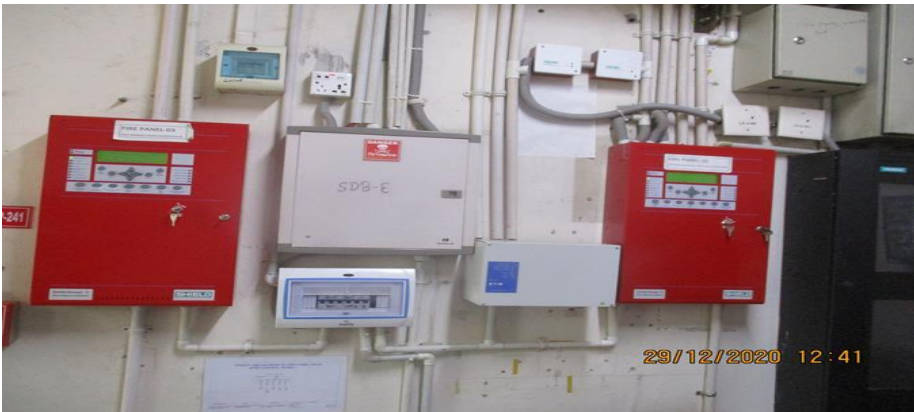
| F-7 | Fire Alarm & Detection System | The fire alarm system installation requires a detailed review to confirm compliance with NFPA 72 and ACCORD Standard. | Submit As-built drawings, testing records, equipment certification, and other relevant documentation to the RSC for review and approval/acceptance test | Design within 2 months, Install within 4 months (If modification required). |

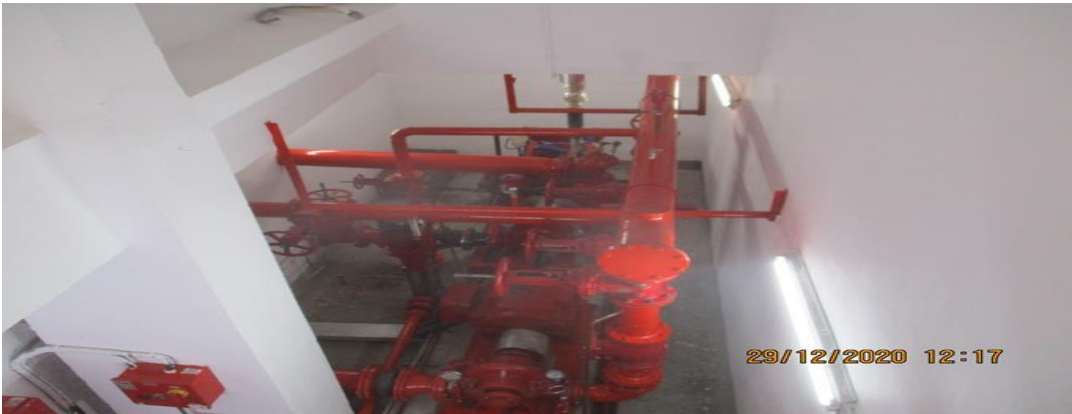
| F-9 | Fire Protection System(Standpipe) | The Standpipe system installation requires a detailed review to confirm compliance with NFPA 14 and ACCORD Standard. | Submit As-built drawings, testing records, equipment certification, and other relevant documentation to the RSC for review and approval/acceptance test | Design within 2 months, Install within 4 months (If modification required) |

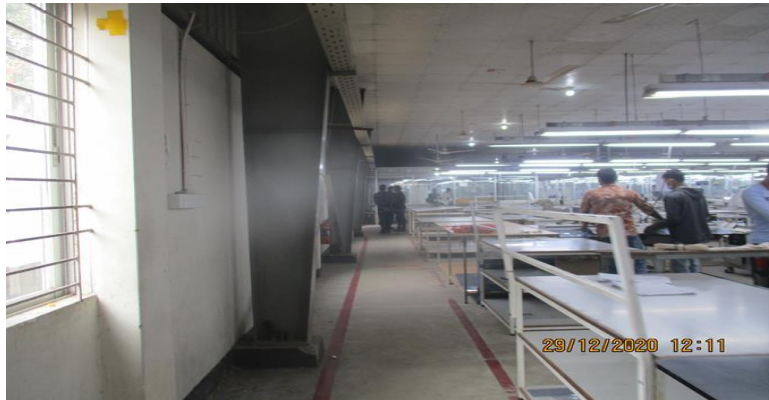
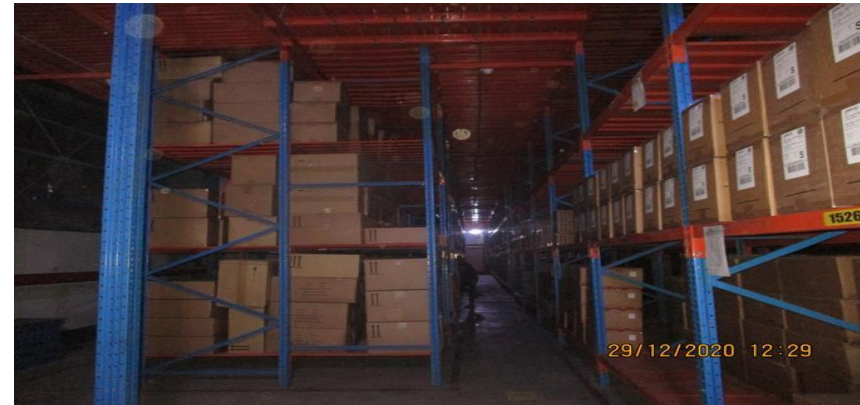
| F-13 | Egress lighting | Based on the number and location of emergency lights observed, adequate illumination levels are not anticipated along egress routes.<br>Location: Building 02 & Building 03 | Test the emergency lighting system on each floor and provide additional emergency fixtures to provide adequate illumination along with the means of egress. Provide a minimum illumination of 10 Lux at the floor level within exit stairs and exit discharge paths and a minimum of 2.5 Lux along exit access aisles. | Within 3months |

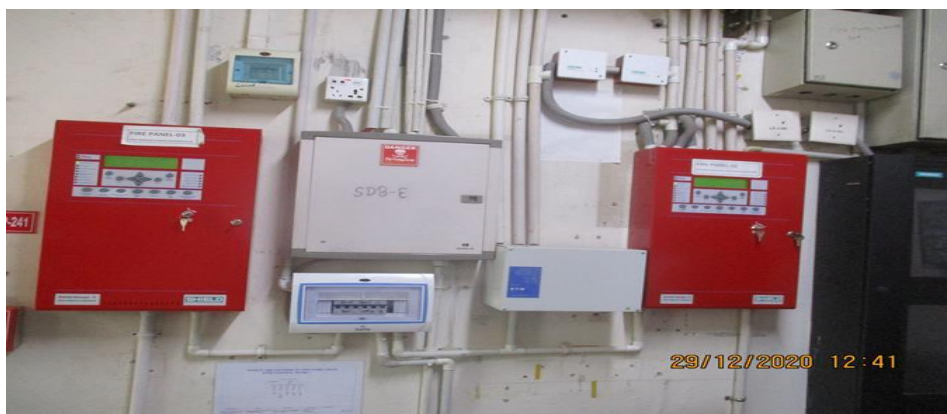
| F-15 | Fire Alarm & Detection System | The Required Fire Alarm system is not installed in accordance with the ACCORD standard and NFPA-72. Location: Building 02 & Building 03 | Design & Installation of Fire Alarm system should be in accordance with ACCORD standard and NFPA 72. | Design within 2 months, Install within 4 months (If modification required) |
