# INITIAL FIRE SAFETY INSPECTION REPORT

**Factory Name: Sterling Creations Ltd. (Extension)**

**Factory ID: 24091**

**Date: 28 December 2020**

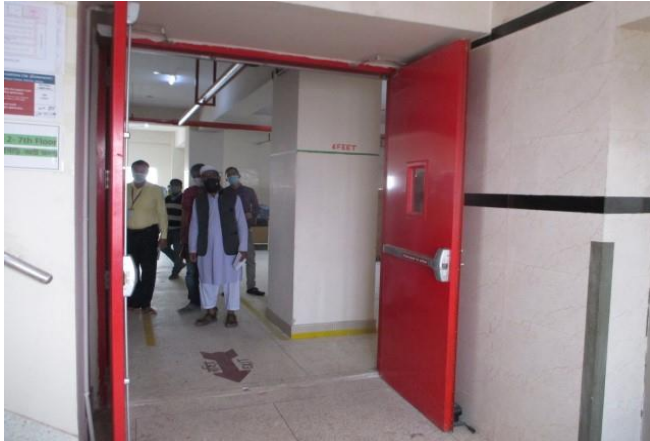
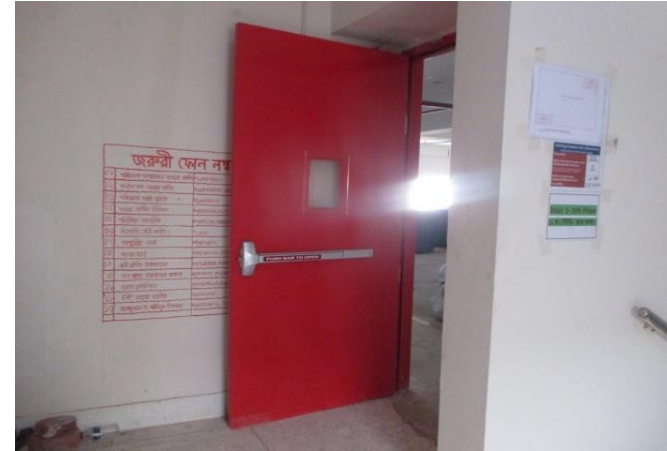
| SI No. | Category | Findings | Required Action | Remediation Time Frame |
|---|---|---|---|---|
| 1 | Fire Rated Construction | The exit stairs are not separated from other occupancy on each floor by fire rated construction. | Provide minimum 1.5-hr fire rated doors for buildings that are 4 or more stories. Seal all unprotected openings to separate the exit stairs from work areas and other building spaces on all floor levels. Ensure that the fire doors are self-closing and positive latching and that they are provided with fire exit (panic) hardware where serving production floors. If fire doors are required to be held open for functional reasons, provide automatic closing devices tied to the fire alarm system. Once fire doors are installed, every door in a stair enclosure serving more than 5 stories shall be provided with re-entry unless it meets accord standard 6.8.3.1. | Within 3 months |

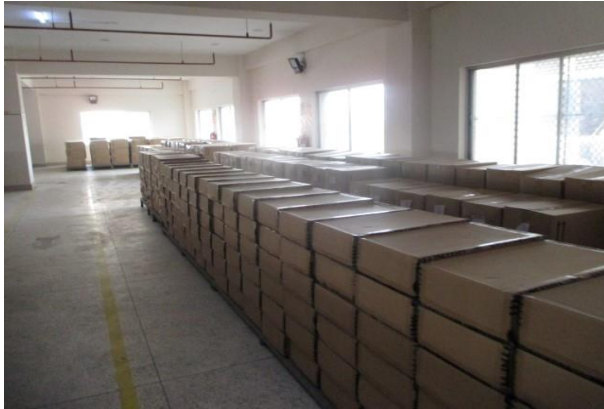
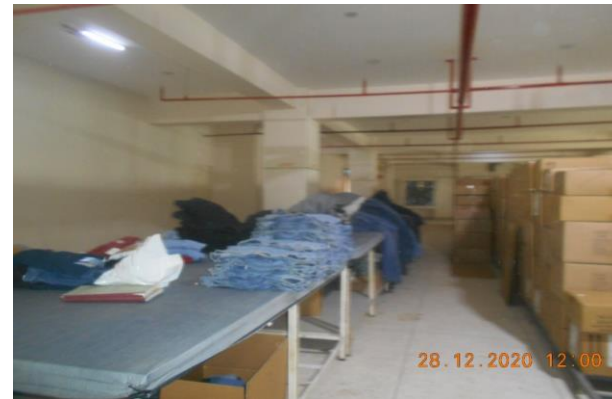
| 2 | Fire Rated Construction | Rooms used for storage of combustible materials are not separated from the surrounding occupancy/areas & floors.<br>Location: 7th Floor | Rooms used for storage of combustible materials shall be separated from the surrounding occupancy with a minimum 1 hour construction. | Within 3 months |

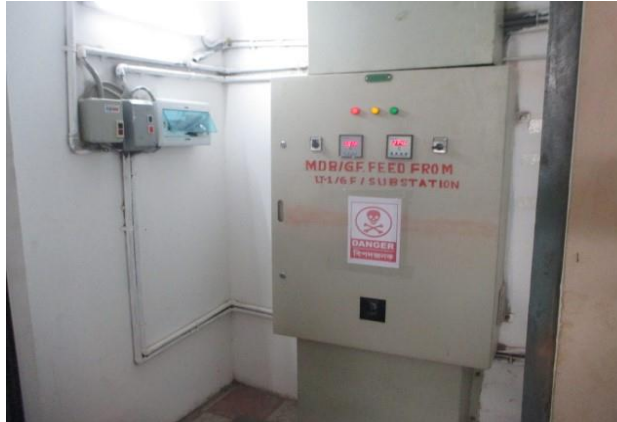
| 3 | Fire Rated Construction | Electrical Panel box was located in the exit stair discharge path on ground floor. | Remove or relocate all electrical panel box from exit stairs discharge path. | Within 3 months |

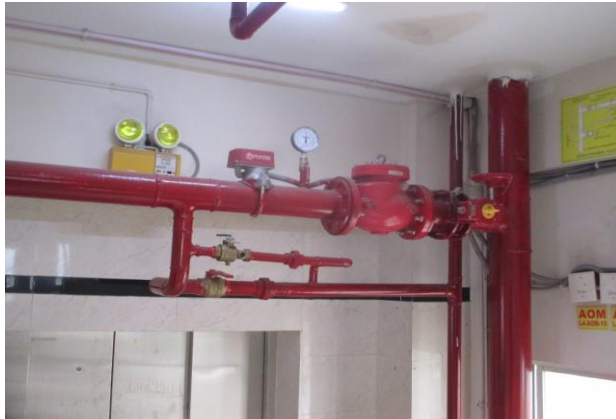
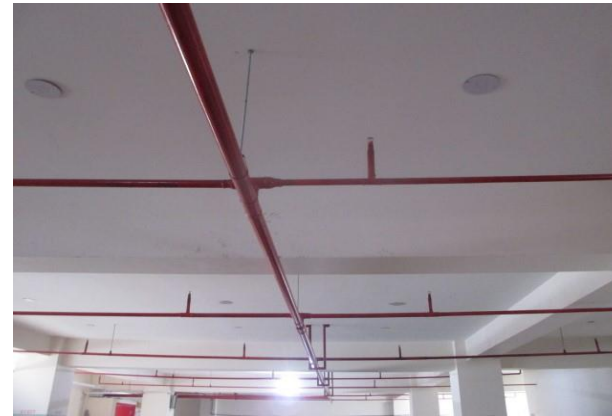
| 4 | Fire Protection | The high-rise building has an occupied floor greater than 23 meter (75 feet) and is not provided with automatic sprinkler protection. The large occupant loads, heavy fuel loading, and anticipated extended egress times warrant sprinkler protection. | Provide an automatic sprinkler protection throughout the building in accordance with NFPA 13. | Design within 6 months, install within 12 months |

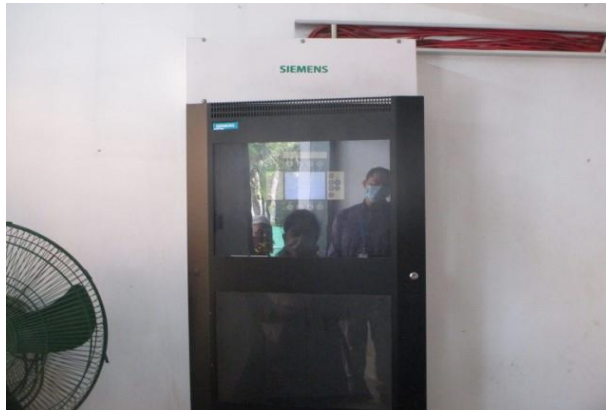
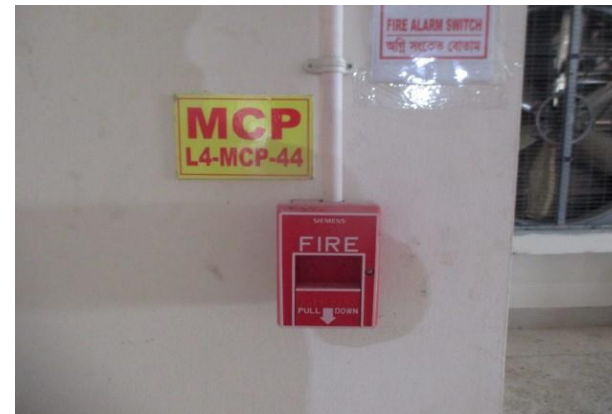
| 5 | Fire Alarm System | Fire alarm system installation requires detailed review to confirm compliance with NFPA 72 and ACCORD standards. | Submit as-built drawings, testing records, equipment certification and other relevant documentation to the ACCORD for review and approval. | Design within 2 months, install within 4 months |

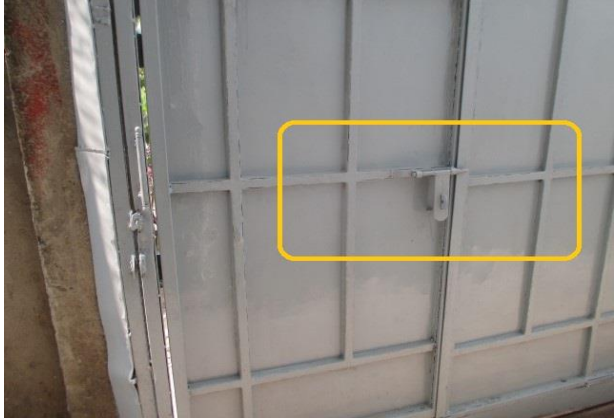
| 6 | Means of Egress | Egress doors/gates with locking features not complying with NFPA101 are provided at [ <i>building exits, exit stairs, along egress routes, exit discharge</i> ] | Remove locking features from all egress doors/gates. If locks are required for security reasons, utilize specialized door locking features complying with NFPA101. | Immediate |
