INITIAL FIRE SAFETY INSPECTION REPORT

Factory Name: Hamid Tex Fashion Ltd.

Date: 17-06-2021

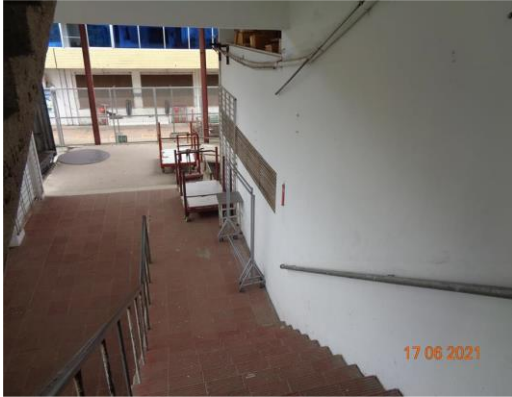
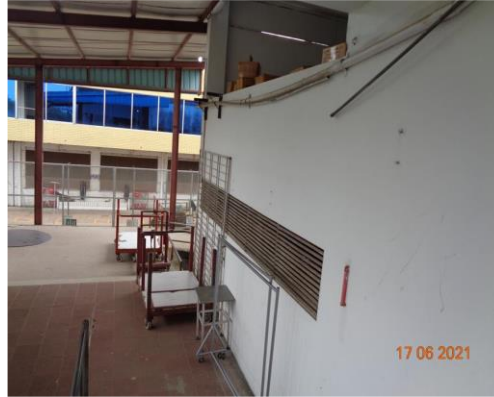
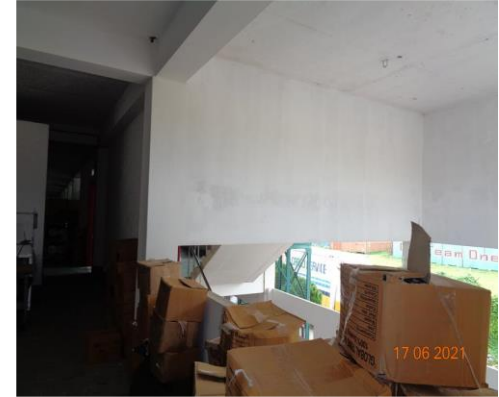
SI No.	Category	Findings	Required Action	Remediation Time Frame
1	Fire Rated Construction	The exit stair enclosures are not separated from work areas and other spaces on each floor by fire-rated construction.	<p>The exit stair enclosure shall be provided with a minimum 1-hr fire resistance rating for buildings with 3 or fewer stories and a minimum of 2-hr. fire resistance rating for buildings 4 or more stories. Provide 0.75 hr. fire rated door and seal all penetrations and openings by 1 hr. fire rated fire rated barrier construction for building with 3 or fewer stories. Provide 1.5 hr. fire rated door and seal all penetrations and openings by 2 hr. fire rated fire rated barrier construction for building with 4 or more stories.</p> <p>Provide a fire-resistive rated assembly between the exterior exit stairs and the building up to 10 ft. beyond the end of the stair to achieve the required separation. The rated assembly shall be approved and/or designed by a qualified fire protection engineer.</p> <p>Ensure that the fire doors are self-closing and positive latching and that they are provided with fire exit (panic) hardware where serving production floors. If fire doors are required to be held open for functional reasons, provide automatic closing devices tied to the fire alarm system.</p>	within 3 months

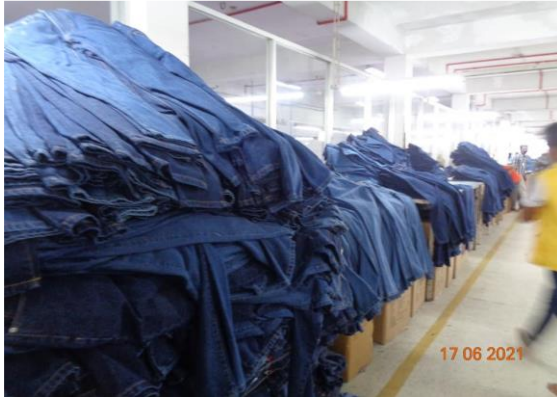
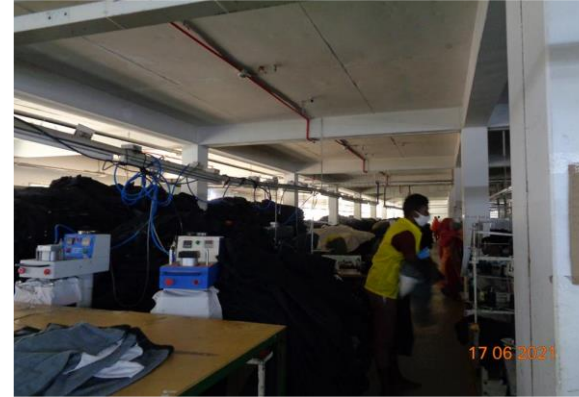
2	Fire Rated Construction	<p>Areas used for combustible storage are not separated by fire-rated construction. Locations: All floors.</p>	<p>Provide dedicated storage rooms separated by minimum 1-hr fire-rated construction.</p> <p>Where separate storage rooms are not feasible, provide defined storage areas and limit the storage arrangement as follows:</p> <ul style="list-style-type: none"> - Maximum height of 2.4m and maximum area of 23m² - If sprinkler protected: maximum height of 3.66m and maximum area of 93m² <p>Separate areas of unenclosed combustible storage by a minimum clear distance of 3m.</p>	Within 3 months
---	-------------------------	--	--	-----------------

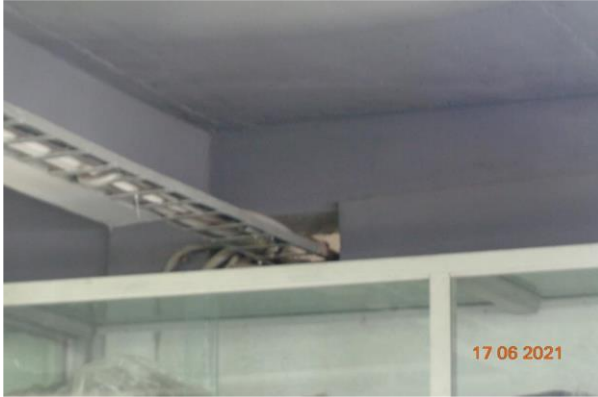
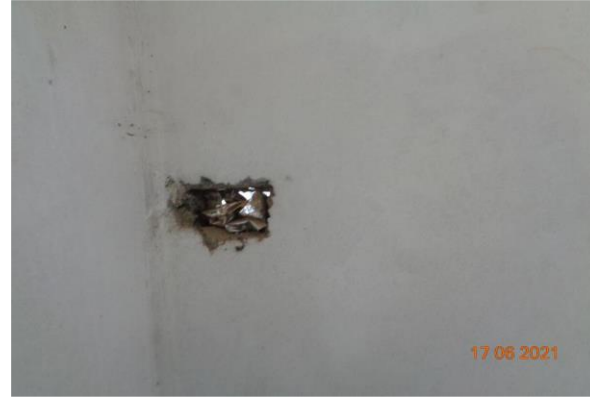
3	Fire Rated Construction	Unsealed penetrations and openings are located in the exit stair enclosures at several locations.	<p>Seal all penetrations and openings in the wall of exit enclosure walls (full thickness of the wall) by fire rated materials to maintain the fire resistance rating.</p> <p>Note: Penetrations into and through an exit enclosure shall be prohibited with the exception of required exit doors, sprinkler piping, standpipes, electrical raceway for fire alarm equipment, and electrical conduit serving the exit enclosure.</p>	Within 3 months
---	-------------------------	---	--	-----------------

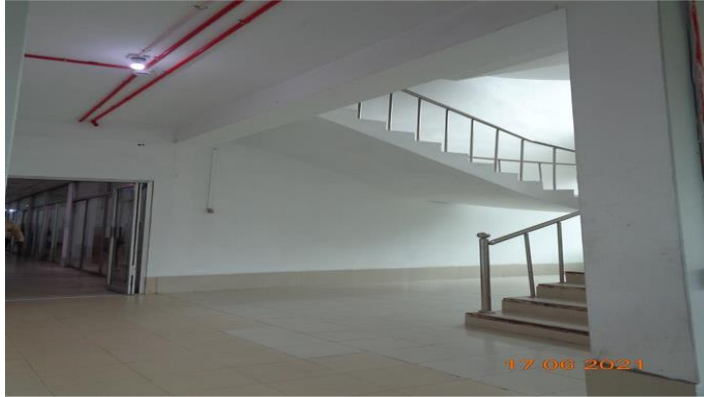
4	Fire Rated Construction	Exit stair-4 (north-west) is discharged the occupants inside the building at ground floor.	<p>1. Modify stair to discharge directly outside. Or</p> <p>2. Provide 2-hr fire-rated exit passageway leading directly outside (vestibules to separate any storage areas).</p> <p>Note: A maximum of 50 percent of the number and capacity of the exit enclosures can discharge through areas on the level of exit discharge whereall the conditions described in Accord building standard 6.17.3 are met.</p>	Within 3 months
---	-------------------------	--	---	-----------------

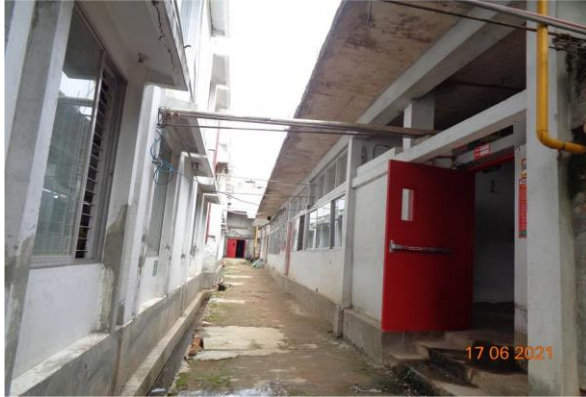
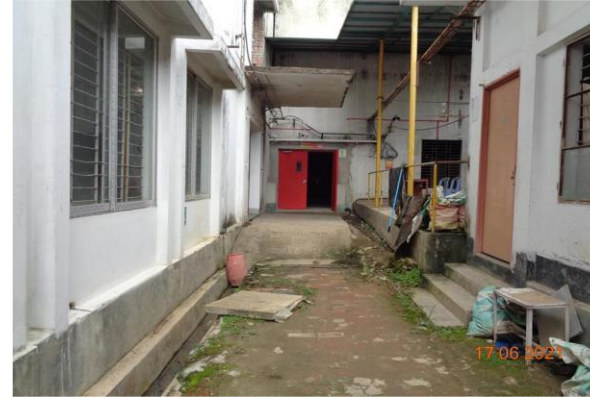
5	Fire Rated Construction	The exit discharge path is less than 10 ft wide and is not separated from the main production building interior of Shade-2 (Sample building).	Seal all penetrations and openings to the interior of the building along the discharge path, up to a height of 10 ft. to provide a minimum 1-hr fire separation.	within 3 months
---	-------------------------	---	--	-----------------

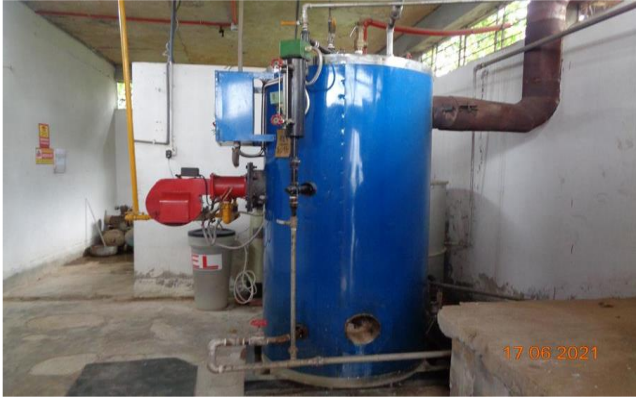
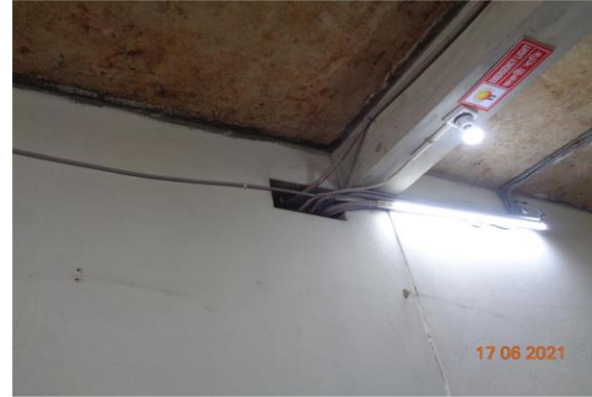
6	Fire Rated Construction	Boiler or furnace room is not properly separated by fire rated construction with sample section (shed-2).	Separate the boiler and compressor rooms by a minimum 1-hr fire-rated construction for non-high rise, and 2-hr fire rated construction for high rise. Seal and/or protect all openings to maintain the required fire separations. When located to the exterior of a building, 3m (10 ft.) separation is required. Provide proper ventilation and consult a qualified engineer.	Within 3 months
---	-------------------------	---	--	-----------------

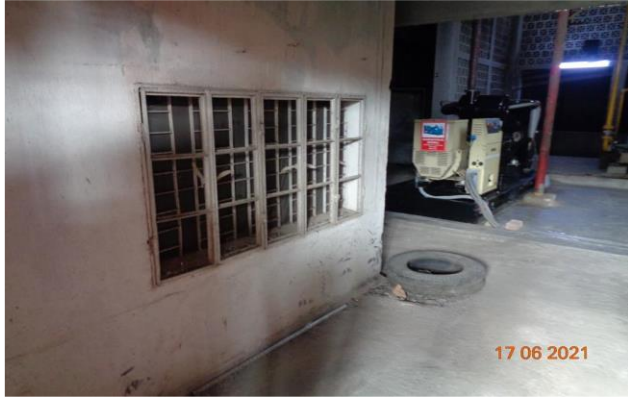
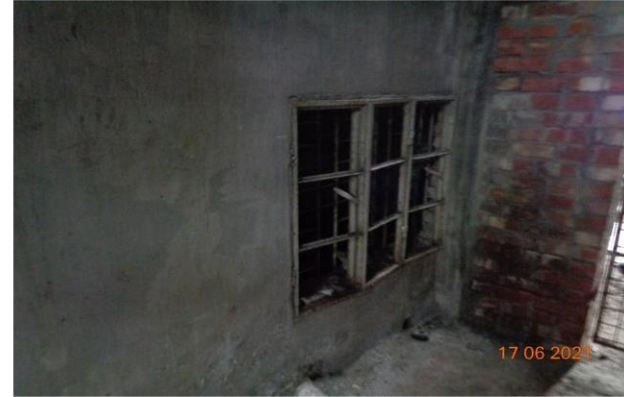
7	Fire Rated Construction	The generator room is not separated by fire rated construction (openings, penetrations) from main production building at ground floor.	Separate the generator room by a minimum 2-hr fire rated construction. Seal and/or protected all fire separations.	Within 3 months
---	-------------------------	--	--	-----------------

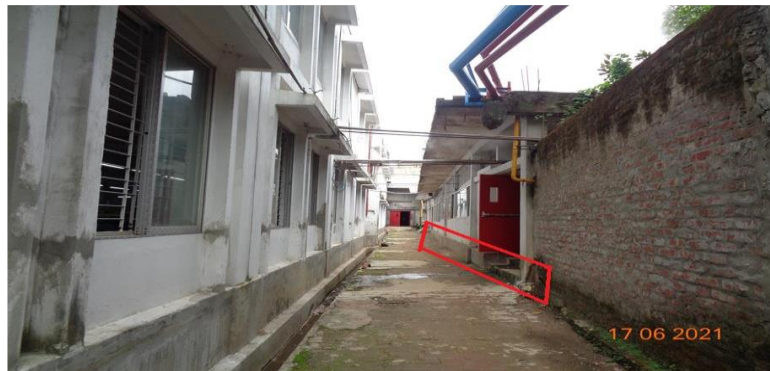
8	Means of egress	<p>The change in elevation of walking surface is greater than 1/2 inch between landing level and floor level of east exit of Shed# 1 & 2 and there is no slope.</p>	<p>Changes in level exceeding 535 mm (21 in.) in elevation shall meet the requirements for stairs in 6.9 or ramps in 6.10 of Accord Building Standard.</p>	<p>Within 1 month</p>
---	-----------------	---	--	-----------------------

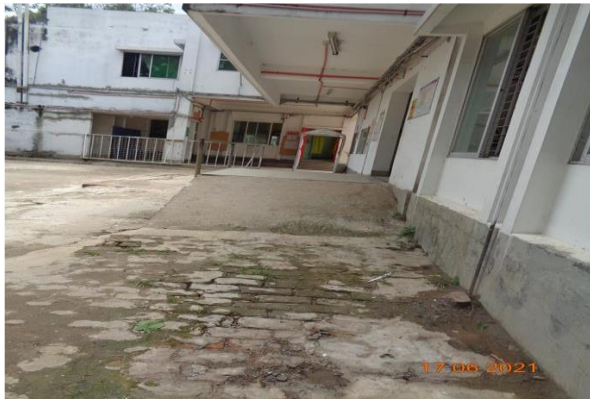
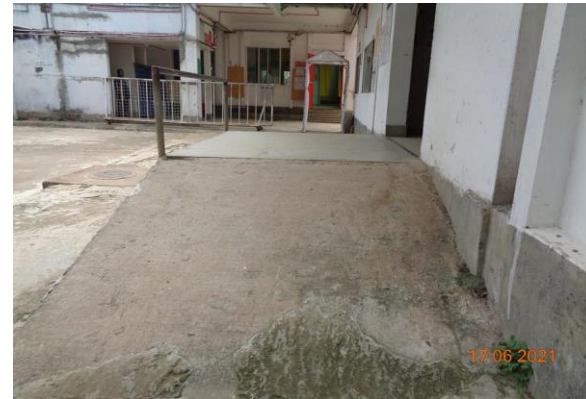
9	Means of egress	No hand rail is provided for exit discharge ramps on ground floor.	Provide handrails on both sides of the exit stair. Handrails shall have a minimum height of 865 mm (34 in.) and a maximum height of 965 mm (38 in.) as measured from the leading edge of the tread. Intermediate handrails shall be provided when the stair width exceeds 2.2 m (87 in.).	Within 3 months
---	-----------------	--	---	-----------------

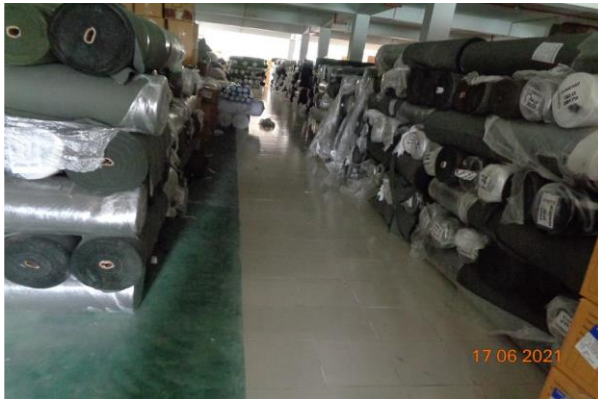
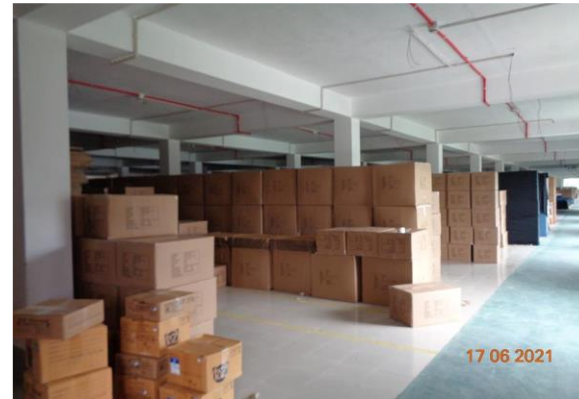
10	Means of egress	Aisles marks are not provided in some places. Location: 1st floor (Main building)	Aisles shall be provided with a minimum unobstructed clear width of 0.9 m (36 in.).	Within 1 month
----	-----------------	--	---	----------------

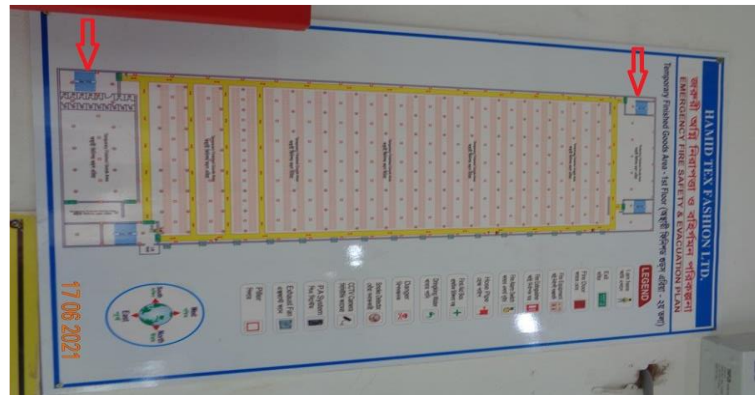
11	Means of egress	Travel distance exceeds 45 meter.	Reconfigure the egress arrangement or include additional stair to reduce the maximum travel distance to not more than 45 meter as per the Accord Standard Part 6 Section 6.13	Within 3 months
----	-----------------	-----------------------------------	---	-----------------

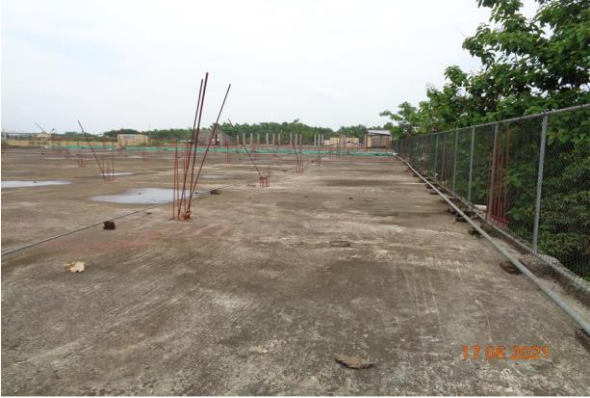
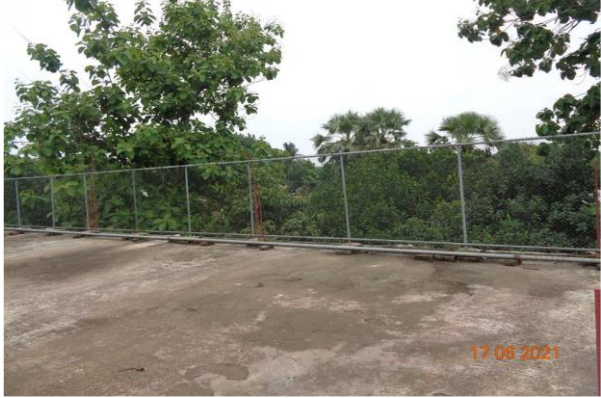
12	Means of egress	<p>Proper Parapets or guards are not provided in occupied/occupiable roof.</p> <p>Note: Temporary guards were provided on roof top.</p>	<p>Provide parapets or guards with a minimum height of 1067mm (42 inch.).</p>	<p>Within 3 months</p>
<div style="display: flex; justify-content: space-around;">

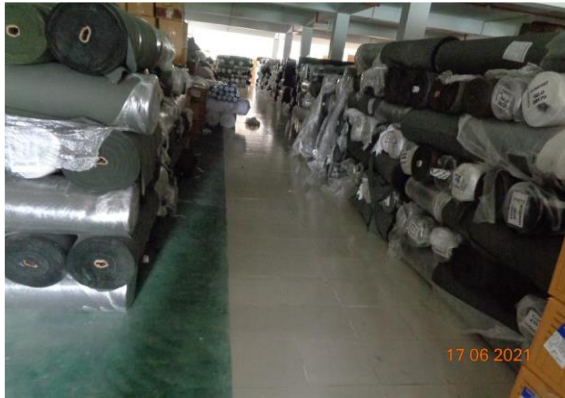
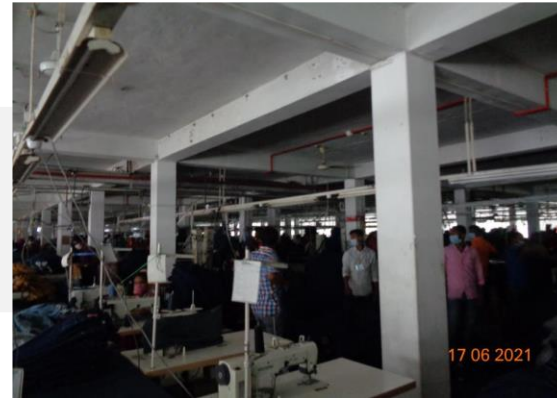
15	Fire Detection System(ITM of FADS)	Inspection, testing, and maintenance for the fire detection system is not in accordance with NFPA 72.	Inspect, test and maintain the fire detection system, and keep written records on-site, in accordance with NFPA 72.	Within 3 months (After installation)
16	Egress lighting	Based on the number and location of emergency lights observed, adequate illumination levels are not anticipated along egress routes.	Test the emergency lighting system on each floor and provide additional emergency fixtures to provide adequate illumination along the means of egress. Provide a minimum illumination of 10 lux at the floor level within exit stairs and exit discharge paths and minimum 2.5 lux along exit access aisles.	Within 3 months

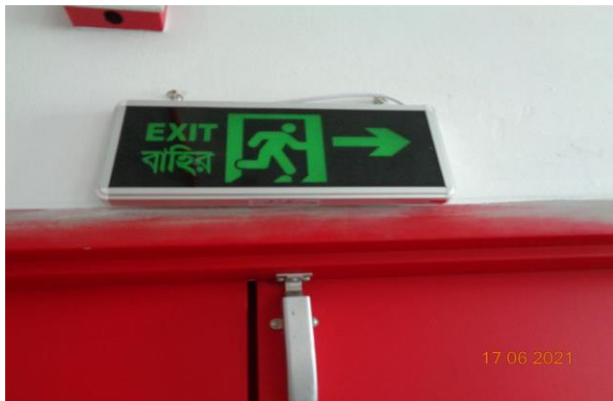
17	Egress lighting	Exit signage not illuminated (burned out, broken, etc.).	Regularly inspect all exit signage and replace/install lights as needed to illuminate signs	Within 1 month
----	-----------------	--	---	----------------

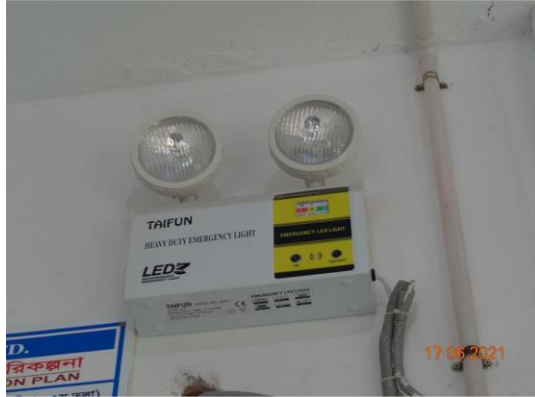
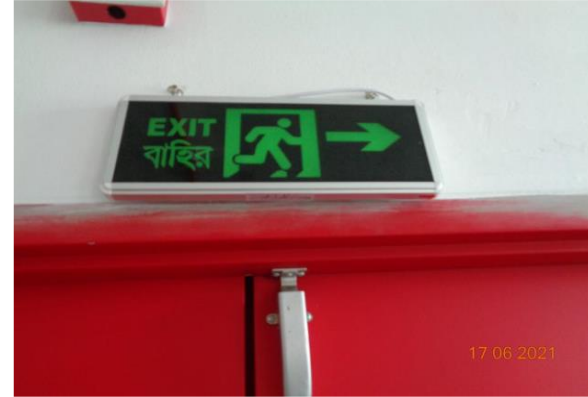
18	Egress lighting	Manual on-off switch is provided for [emergency lighting / exit signage] units.	Remove manual on/off switches from [emergency lighting /exit signage] units to prevent them from being switched off	Within 1 month
----	-----------------	---	---	----------------

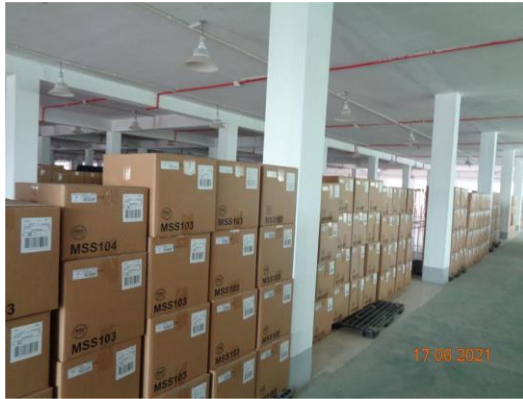
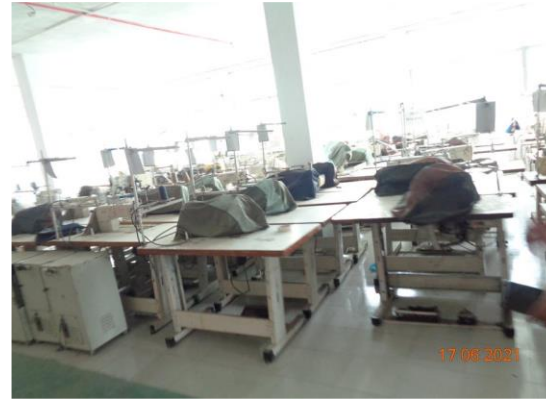
19	Egress lighting	Exit sign and Directional Sign are not provided at and towards exit at several floors.	Lighted exit signs shall be placed at entrance to an exit. Additional exit signs shall be placed throughout the facility anywhere the continuation of the egress is not obvious. Lighted exit signs shall be provided with either battery backup or uninterruptable power supply systems and shall be continuously illuminated.	Within 1 month
----	-----------------	--	---	----------------
