# INITIAL FIRE SAFETY INSPECTION REPORT

**Factory Name: Jinnat Knitwears Limited (Sreepur) (Extension)**

**RSC ID: 24543**

**Date: 8th Jan, 2023**

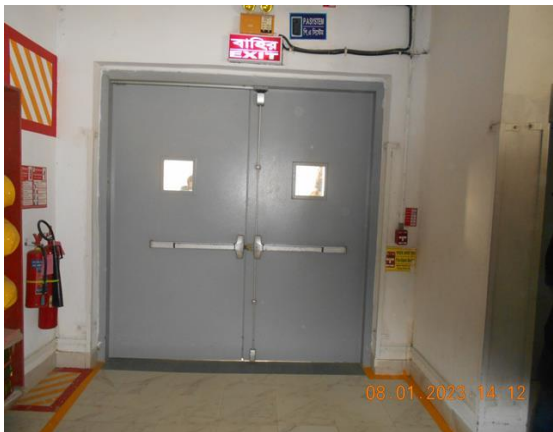
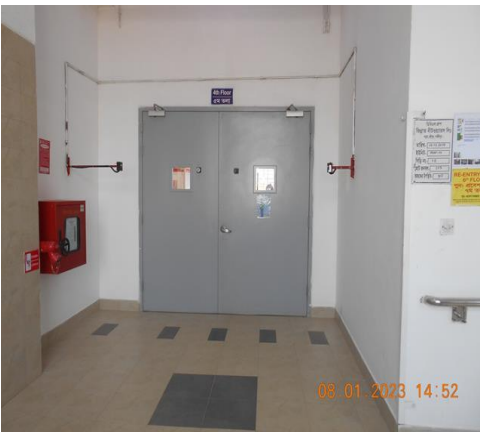
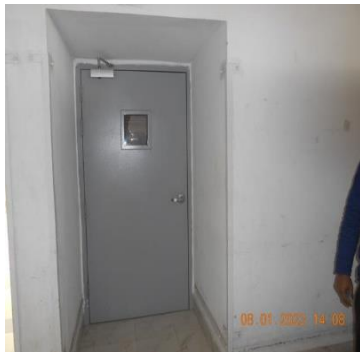
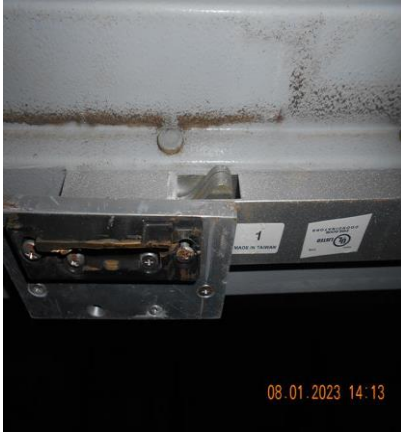
| SI No. | Category | Findings | Required Action | Remediation Time Frame |
|---|---|---|---|---|
| F-1 | Fire Rated Construction | <p><b>Building-04:</b></p> <p>Datasheets and certificates of the installed rated doors and it's accessories for all exit stairs, utility shafts, and sub-chemical storage rooms throughout the factory building are not found on-site for review. Also some double leaf doors are not closing properly.</p> | <p>Collect all datasheets and certificates for the installed fire rated doors and it's accessories and keep on-site for further review. Also ensures that all the doors are functioning properly.</p> <p>If not available, or certification is not approved, install new, properly certified fire rated doors/accessories in accordance with The RSC Technical Guideline (Standard).</p> <p>Once fire doors are installed, every door in a stair enclosure serving more than 5 stories shall be provided with re-entry unless it meets RSC Technical Guidelines (Standard) 6.8.3.1</p> | Within 3 months |

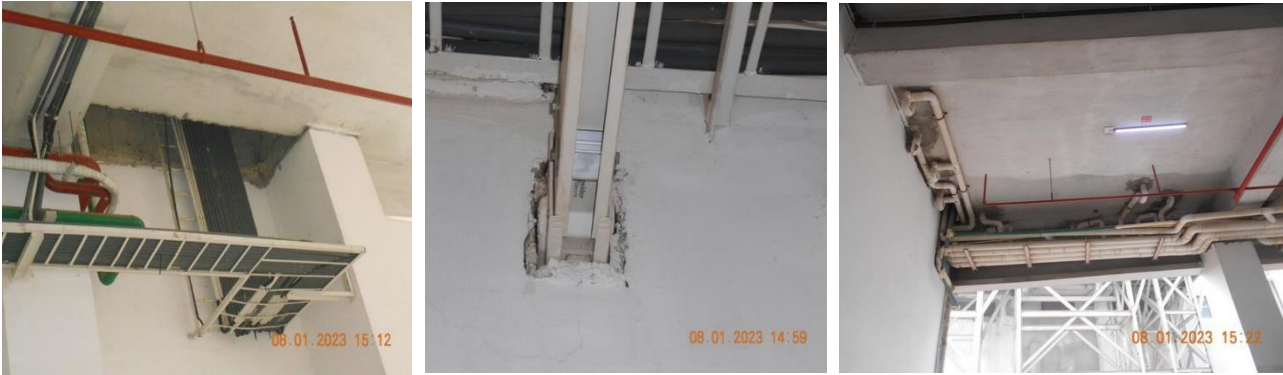
| F-2 | Fire Rated Construction | Unsealed penetrations and openings due to utility riser shaft (standpipe, water supply line, IT and CCTV line) are located in the exit stair enclosures. Location: Stair-1 and stair-2 on ground floor. | Seal all penetrations and openings in exit stair enclosure walls a minimum 2-hr fire rated separations. | Within 3 months | | | | | |

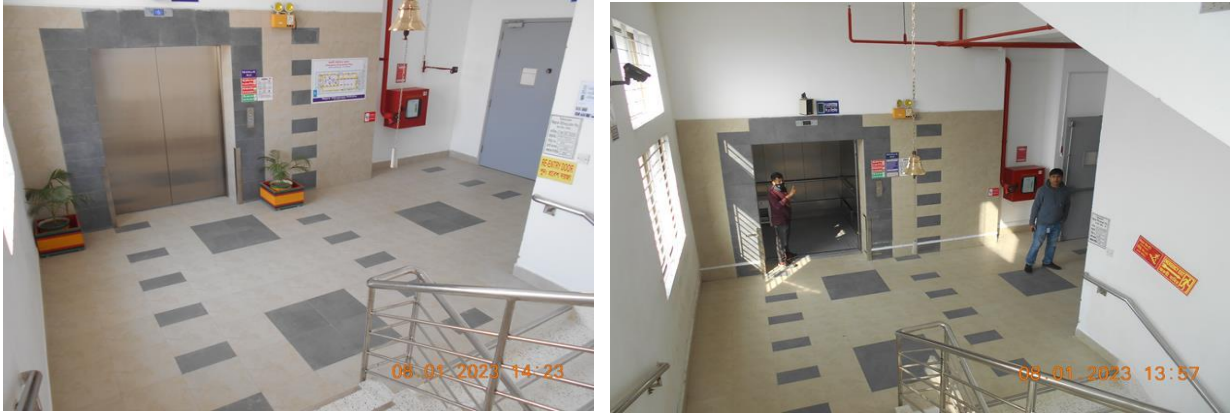
| F-3 | Fire Rated Construction | <p>Elevator shafts are directly open into the inside of exit enclosure.</p> <p>Located: Stair-1 and stair-2</p> | <p>Modify the elevator shaft as per The RSC Technical Guideline (Standard) V1-6.14.3. An exit stairway shall not be built around a lift shaft unless both of them are located in a smoke proof enclosure and made of a material with fire resistance rating required for the type of construction of smoke proof enclosure.</p> | Within 6 months |

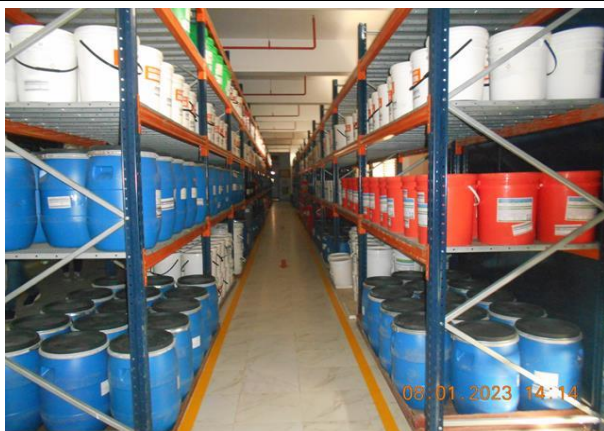
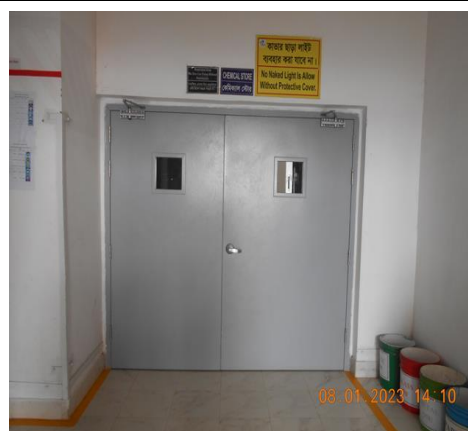
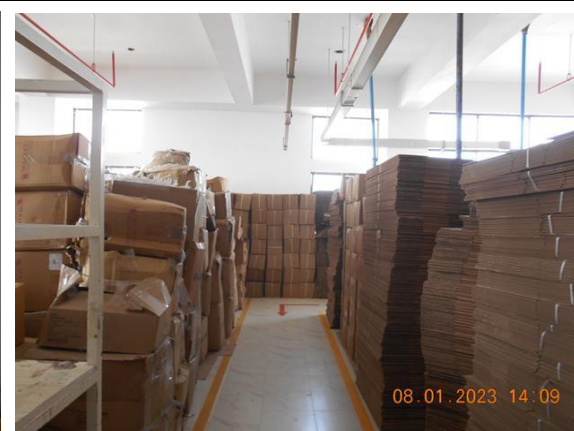
| F-4 | Fire Rated Construction | Chemical storage room is not properly separated by fire-rated construction from surrounding occupancy.<br>Location: On 7th floor of building-4. | Separate the chemical storage room by 4-hr fire rated construction. Seal all penetrations and protect the openings to maintain the required fire separations for 4-hrs. Opening is not permitted for 4-hrs fire rated separation. Keep 16-points SDS of all chemicals in the storage area. Note: Construction type shall be Type-1 and separation shall be as per Table 3.2.1 of BNBC-2006. | Within 6 months |

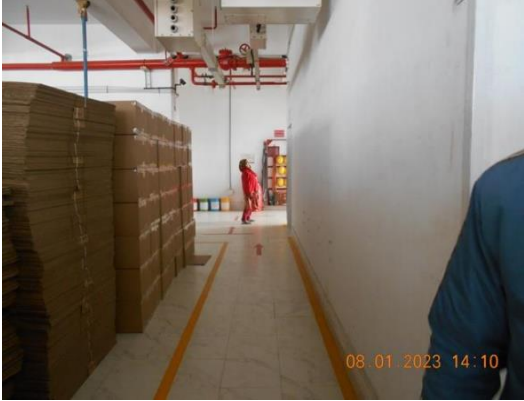
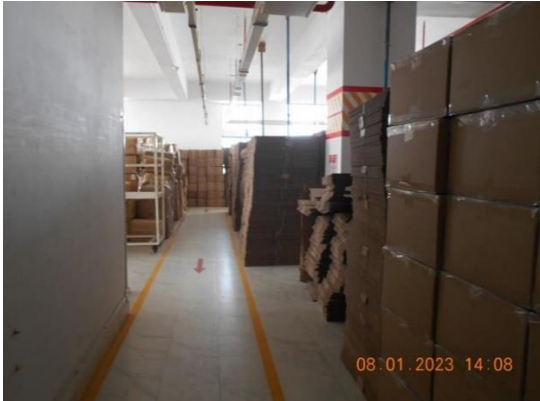
| F-5 | Fire Rated Construction | <p>Storage discharges directly into the exit stair discharge.</p> <p>Location: On 7th floor of stair-1, stairs-2 and stair-3.</p> | <p>Openings from exit enclosure to storage room, generator and transformer spaces shall be provided with a vestibule with fire rated construction and openings.</p> <p>Provide a 1.5 hr. fire rated door on the exit stair side and a 1-hr. fire rated door on the Store, generator, sub-station room side. Ensure that the fire rating of the vestibule construction matches that of the exit stair enclosure.</p> | Within 4 months |

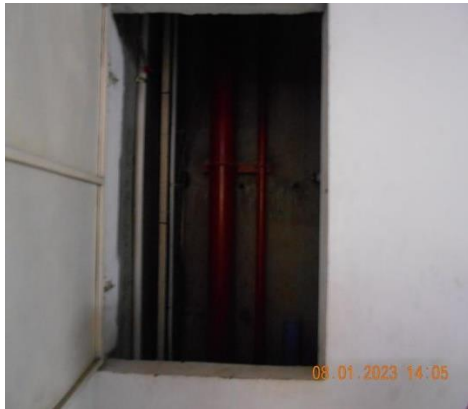
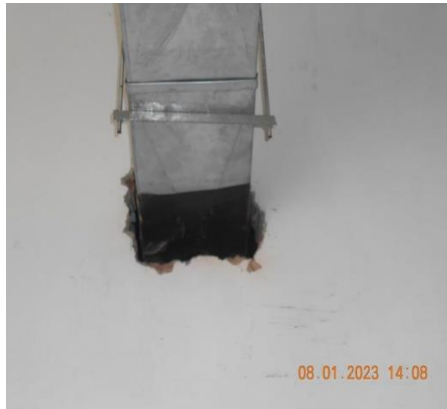
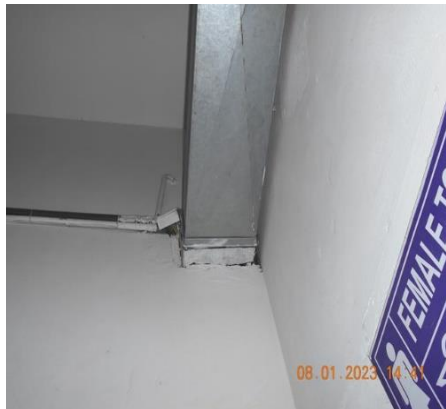
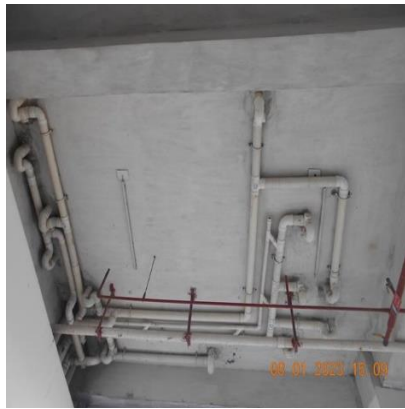
| F-6 | Fire Rated Construction | <p>Unsealed penetrations and openings are located in the fire rated floor/ceiling assemblies. Followings are the description of openings or penetrations indicating specific locations:</p> <ol style="list-style-type: none"> <li>1. Passing of BBT riser through rated walls from ground floor to 6th floor of production building (B-4).</li> <li>2. PVC pipes penetrate the floor slabs in toilet block of production building (B-4).</li> <li>3. Floor penetrations due to fire alarm/ IT/ electrical cable riser in production building (B-4).</li> <li>4. PVC pipes penetrate the floor slabs for supplying water on all floors of production building (B-4).</li> <li>5. Standpipe riser penetrate the floor slabs on all floors of production building (B-4)</li> </ol> | <p>Seal all penetrations and openings in floor/ceiling assemblies to maintain the fire separation at least by 3-hr. The used sealer shall be 3rd party certified and installation shall be as per manufacturer's datasheet.</p> <p>Or</p> <p>Provide a minimum 2-hr fire rated shaft to separate the utility risers from each floor if required. If fire doors are required to be held open for functional reasons, provide automatic closing devices tied to the fire alarm system.</p> | Within 3 months |

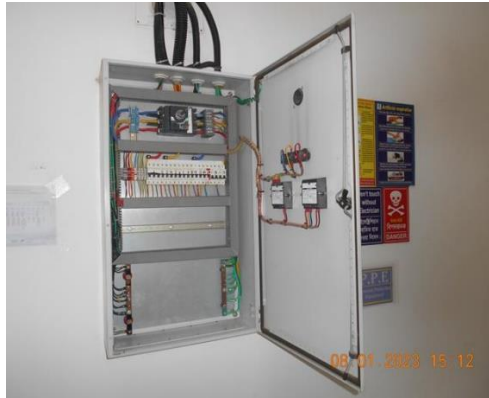
| F-7 | Means of egress | Electrical DB panel has been found in the exit stair-2 on ground floor of B-4. | Remove the electrical DB panel from exit stair to a safe location. Also remove storage items from the exit stairs and egress paths. | Within 1 month |

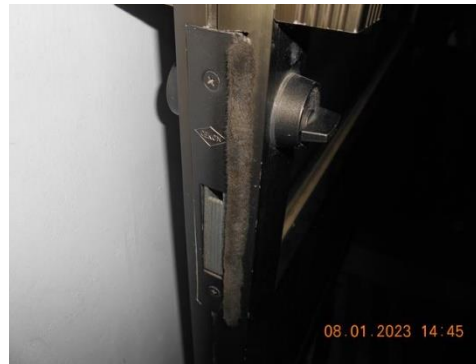
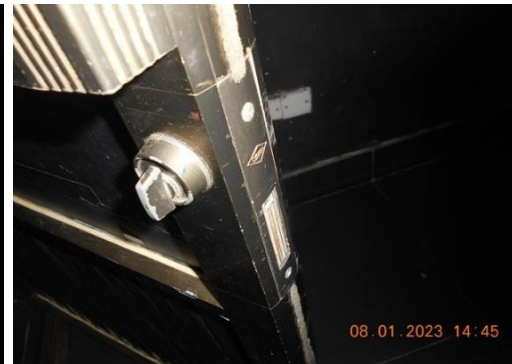
| F-8 | Means of egress | Egress gates with locking features are provided at 5th floor of expose rooms of building-4.<br>Location: On 5th floor of B-4. | Remove locking features from all egress doors and gates. If locks are required for security reasons, utilize special door locking features complying with NFPA 101 and The RSC Technical Guidelines (Standard) 6.8.2. | Within 1 week |

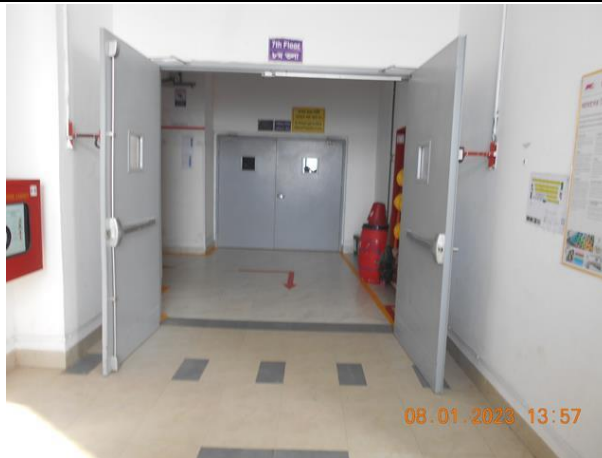
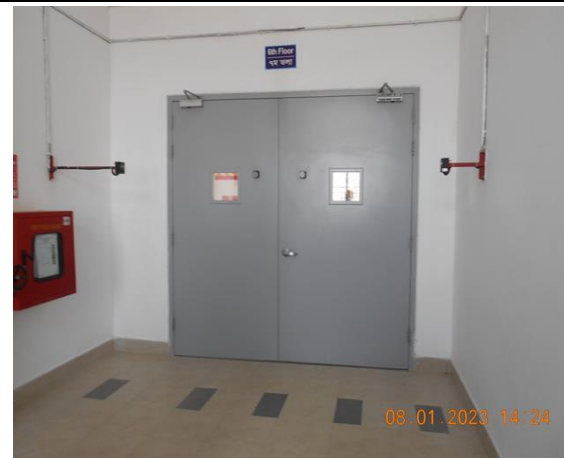
| F-9 | Means of Egress | <p>Building did not have stair designation signs &amp; occupant load signs at required locations.</p> <p>Location: 8-storied printing building (B-4)</p> | <p>Provide stair designation sign &amp; occupant load sign at each floor entrance from the stair to the floor in English and Bengali. Signs shall indicate the name of the stair and the floor level. Signs shall be posted adjacent to the door.</p> | Within 1 month |

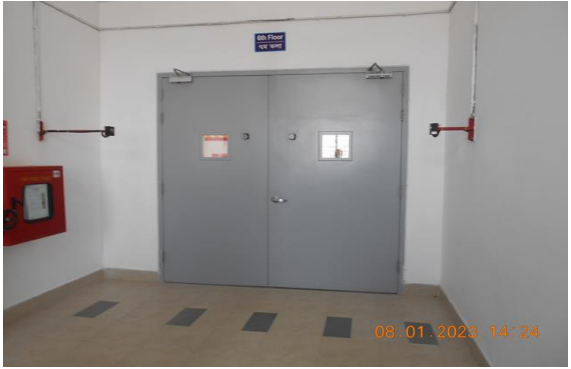
| F-10 | Means of Egress | Fire evacuation maps are not posted at the entrance to each exit stair. | Fire evacuation maps shall be posted at the entrance to each exit stair. | Within 1 month |

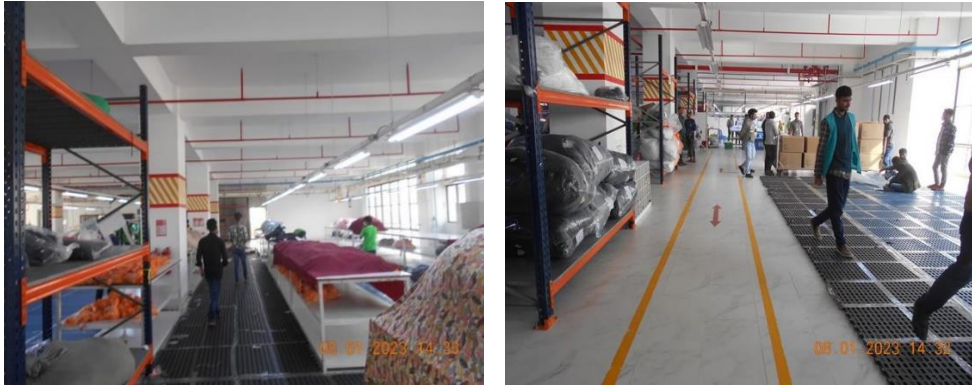
| F-11 | Egress Lighting | Based on the number and location of emergency lights observed, adequate illumination levels are not anticipated along egress routes.<br><br><b>Location:</b> On several floors of Building-4. | Test the emergency lighting system on each floor and provide additional emergency fixtures to provide adequate illumination along the means of egress. Provide a minimum illumination of 10 lux at the floor level within exit stairs and exit discharge paths and minimum 2.5 lux along exit access aisles. | Within 1 month |

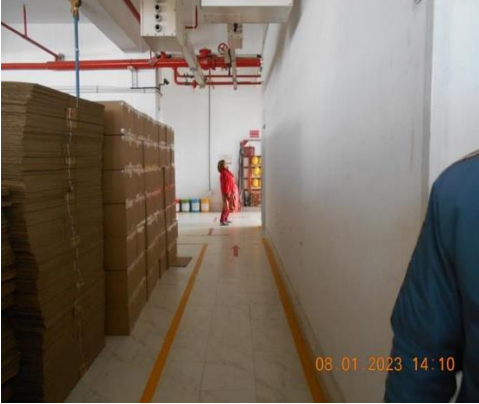
| F-12 | Egress Lighting | <p>The directional signs are not provided where there is a change in direction and where the continuation of the egress path is not obvious.<br/>Location: On several floors of production building (B-4).</p> | <p>Install illuminated directional signs shall be provided where there is a change in the direction for the path of travel and the direction to an exit is not obvious.</p> | Within 1 month |

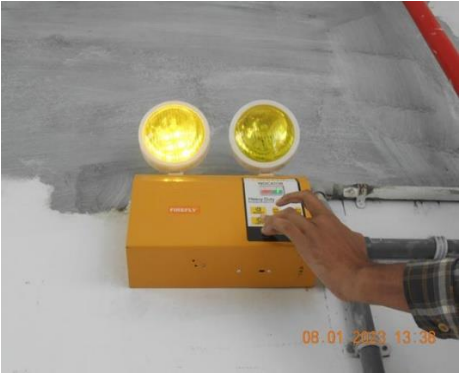
| F-13 | Egress Lighting | Manual on-off switch is provided for [emergency lighting / exit signage] units. | Remove manual on/off switches from [emergency lighting / exit signage] units to prevent them from being switched off. | Within 1 month |

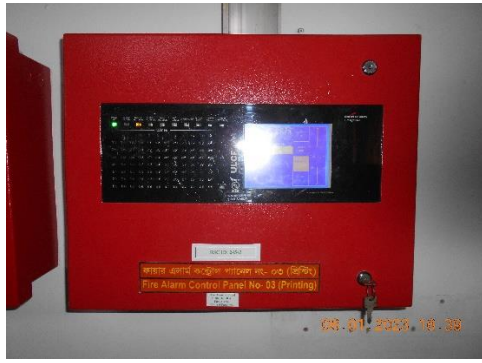
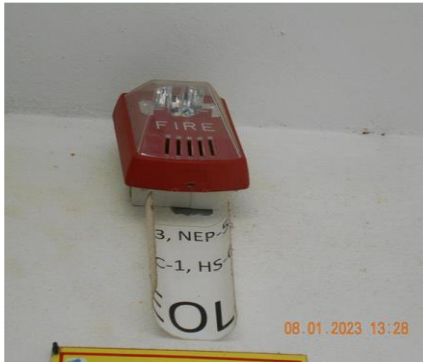
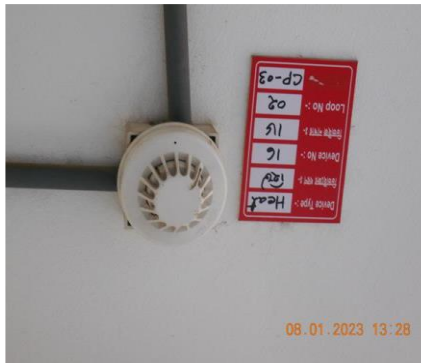
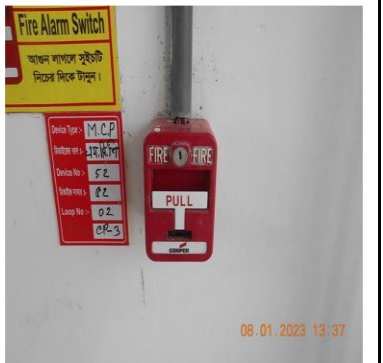
| F-15 | Fire Alarm & Detection system | Automatic fire alarm and detection system installation complete which requires detailed review to confirm compliance with NFPA 72 and The RSC Technical Guidelines (Standard). | <p>Submit the fire alarm system design to RSC for review. Once the design is reviewed, install and modify the fire detection and alarm system throughout the buildings in accordance with review comment, RSC Technical Guidelines (Standard) and NFPA 72.</p> <p>After installation the owner shall conduct internal testing and commissioning and then contact the RSC for witness of final acceptance testing. Also inspect, test and maintain the fire alarm system, and keep written records on-site, in accordance with Table-14.3.1 of NFPA 72.</p> | Design Review within 2 months and installation within 4 months |

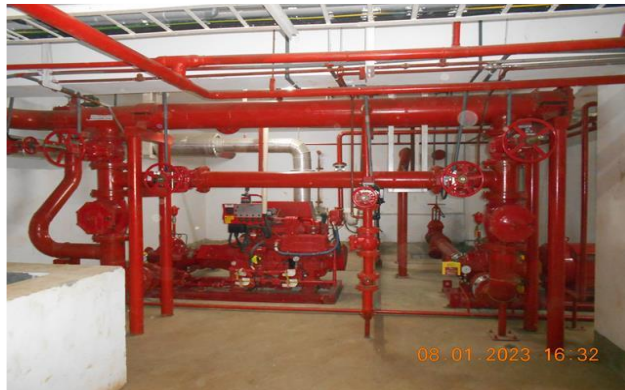
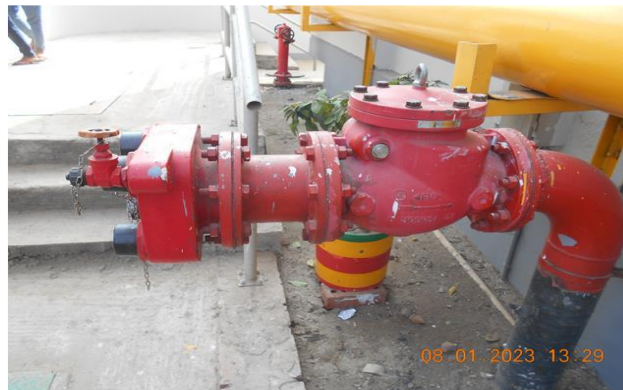
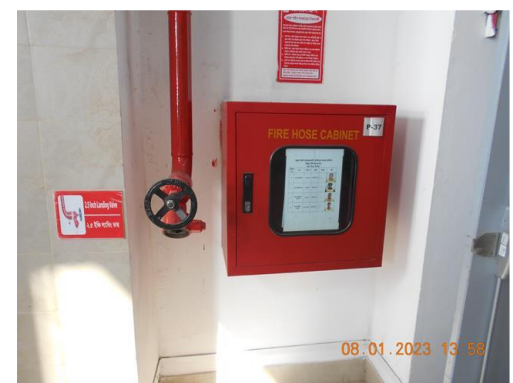
| F-17 | Fire Protection System (Fire Pump & Standpipe) | <p>Standpipe installation requires detailed review to confirm compliance with NFPA 14, 20 and RSC Technical Guideline (Standard).</p> <p>Location: Production building (B-4)</p> | <p>Submit the standpipe system drawing to RSC for review. Once reviewed, install or modify the standpipe system throughout the building in accordance with RSC Technical Guideline (Standard) and NFPA 14, 20,22 and 24. After installation the owner shall contact the RSC for witness of conducting the final acceptance testing of the standpipe system.</p> | <p>Design Review within 2 months and installation within 4 months.</p> |

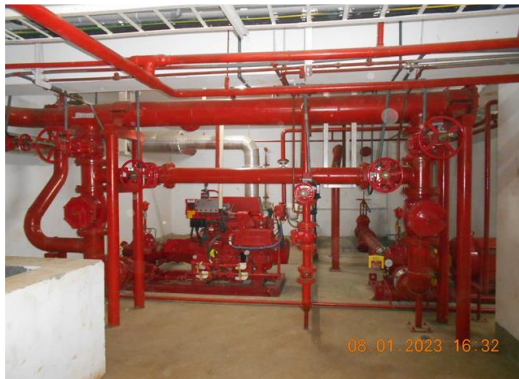
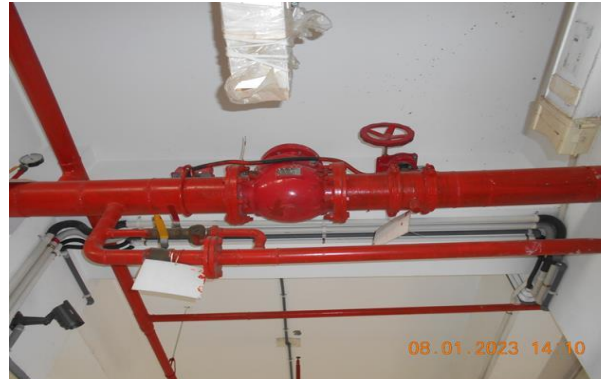
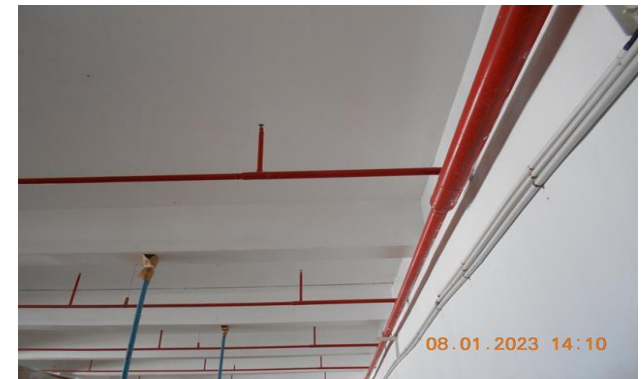
| F-18 | Fire Protection System (Sprinkler) | <p>Sprinkler system installation requires detailed review to confirm compliance with NFPA 13, 14, 20, 22 and RSC Technical Guideline (Standard).<br/>Location: Building-4.</p> | <p>Submit the fire pump, standpipe and sprinkler system drawing to RSC for review. Once reviewed, install or modify the standpipe system throughout the building in accordance with RSC Technical Guideline (Standard) and NFPA 13, 14, 20,22 and 24. After installation the owner shall contact the RSC for witness of conducting the final acceptance testing of the standpipe system.</p> | <p>Design Review within 2 months and installation within 4 months.</p> |
