# INITIAL FIRE SAFETY INSPECTION REPORT

**Flamingo Fashions Limited, Unit-2 (Extension)**

**RSC ID: 24559**

**ADDRESS: Mariali, Joydebpur, Gazipur.**

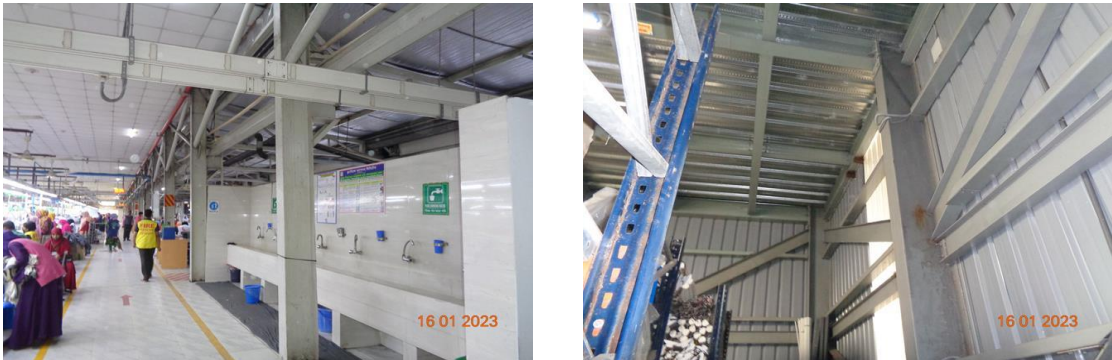
| SI No. | Category | Findings | Required Action | Remediation Time Frame |
|---|---|---|---|---|
| F-1 | Fire-Rated Construction | <p>The main structural element of the building is constructed by steel element which is non-rated and were found in exposed condition without any fire protection.</p> <p><b>(Single storied lingerie shed &amp; Three storied EGB steel structure Building)</b></p> | <p>Interim building shall be type-1 or type-2 construction. Provide required fire rating on the structural elements by following Section 4.4 and Table 4.4.1 of the RSC Standard or Table 3.3.1 and Table 4.1.1 from BNBC Part 4. Consult a qualified fire protection engineer to design the rated construction barriers in between two floors and in structural members.</p> | Within 6 months |

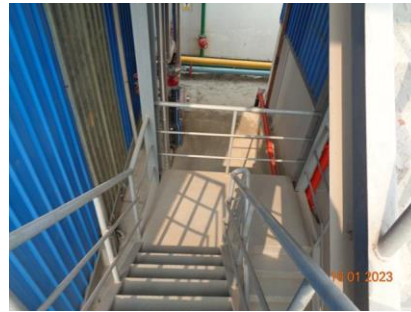
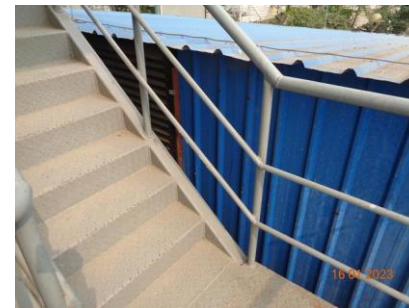
| F-2 | Fire-Rated Construction | <p>Exit Enclosures are not properly fire separated from other occupancy on each floor by fire rated construction.</p> <p><b>(Three storied EGB steel structure Building)</b></p> | <p>Provide minimum 2-hr fire rated separation in exit enclosures with minimum 1.5-hr fire rated doors and seal all unprotected openings and penetration to separate the exit stairs from work areas and other building spaces on all floor levels with similar rating of fire door.</p> <p>Ensure that the fire doors are self-closing and positive latching and that they are provided with fire exit (panic) hardware where serving production floors. If fire doors are required to be held open for functional reasons, provide automatic closing devices tied to the fire alarm system.</p> | Within 3 months |

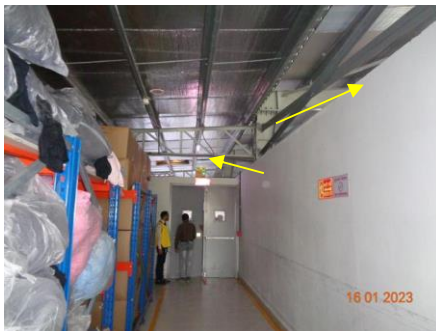
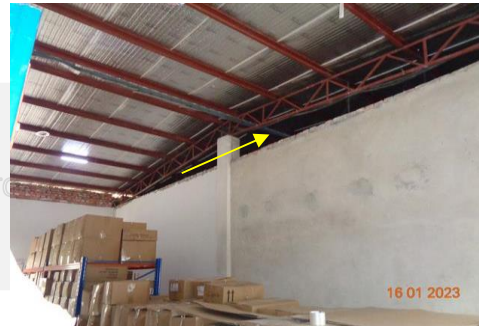
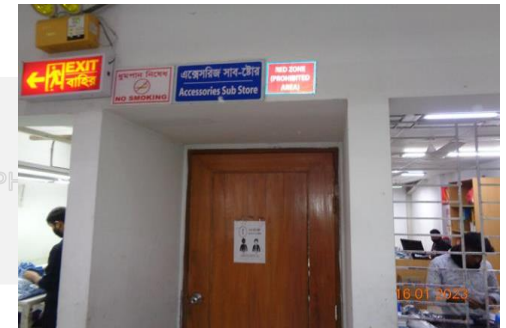
| F-3 | Fire-Rated Construction | <p>Rooms used for combustible storage are not separated by fire-rated construction.</p> <p>Locations: East side accessories sub-store &amp; North side fabric store at single storied lingerie shed; civil storage at single storied molding &amp; civil store shed.</p> | <p>Rooms used for storage of combustible materials shall be separated from the surrounding occupancy with a minimum 1 hour construction. Openings shall be protected with minimum ¾ hr. fire protective opening assemblies.</p> | Within 3 months |

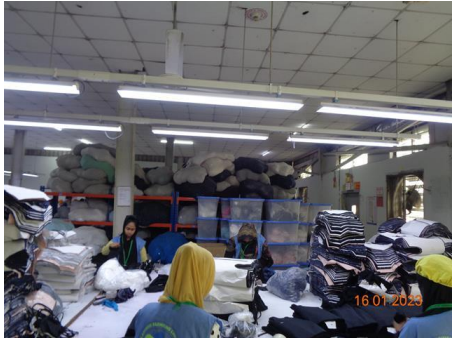
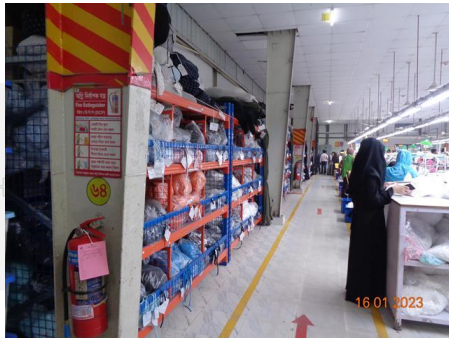
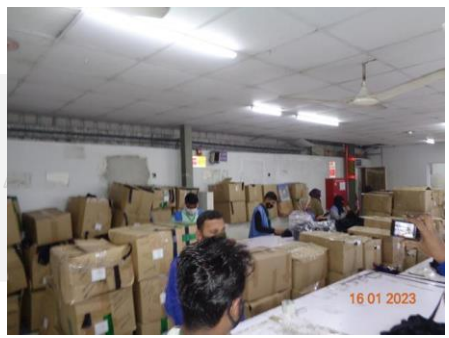
| F-4 | Fire-Rated Construction | <p>Areas used for in-process storage of combustible materials are open to the surrounding occupancy which are not separated by fire rated construction.</p> | <p>Provide dedicated storage rooms separated by minimum 1-hr fire-rated construction.</p> <p>Or, Where separate storage rooms are not feasible, Provide defined storage areas and limit the storage arrangement as follows:-</p> <ol style="list-style-type: none"> <li>1. General Condition: Maximum height of 2.4 m and maximum area of 23 m<sup>2</sup>. Separate areas of unenclosed combustible storage by a minimum clear distance of 3m.</li> <li>2. If sprinkler protected: maximum height of 3.66 m and maximum area of 93 m<sup>2</sup>. Separate areas of unenclosed combustible storage by a minimum clear distance of 3m.</li> </ol> | Within 3 months |

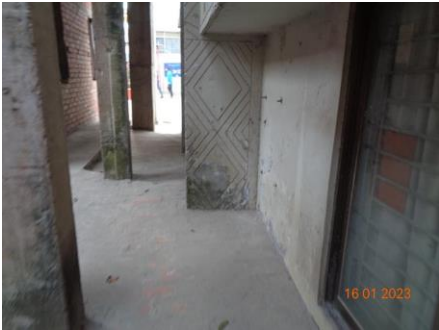
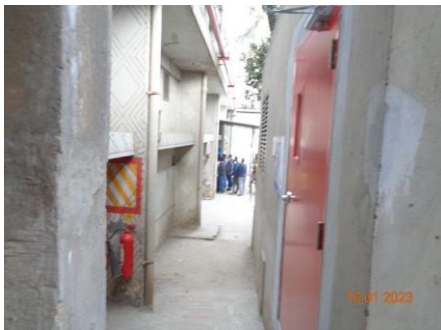
| F-5 | Fire-Rated Construction | The exit discharge path [serving the east side exits of single storied lingerie shed] is less than 10 ft wide and is not separated from the building interior. | <p>Seal all penetrations and openings to the interior of the building along the discharge path, up to a height of 10 ft. to provide a minimum 1-hr fire separation.</p> <p>Alternatively, provide a second remote discharge path to the public way.</p> | Within 3 months |

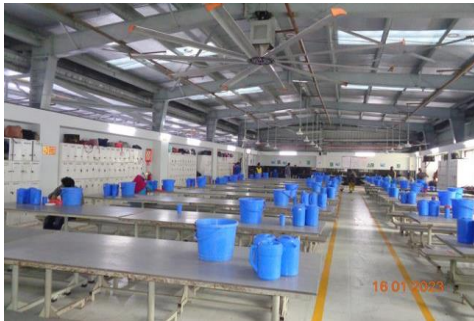
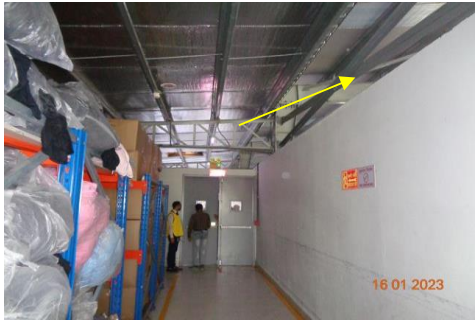
| F-6 | Fire-Rated Construction | <p>Dining area is not separated from storage and production area.</p> <p>Location: Dining area in the north-west side of single storied lingerie shed.</p> | <p>Re-locate the dining area or separate the dining area from storage areas with 3-hr fire rated construction.</p> <p>And,</p> <p>Separate the dining area by a minimum 2-hr fire-rated construction having a direct access to exit. Seal and/or protected all openings to maintain the required fire separations.</p> | Within 3 months |

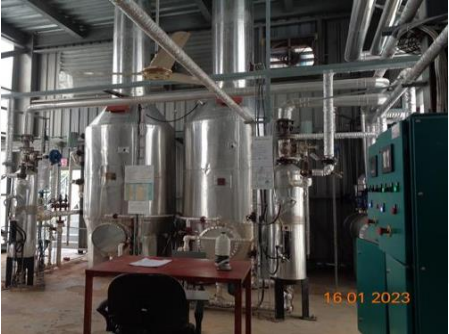
| F-7 | Fire-Rated Construction | <p>Boiler room is not properly separated by fire rated construction with other Occupancies/Areas.</p> <p>Location: Second floor- Three storied EGB steel structure Building.</p> | <p>Boilers or other heat producing equipment shall be separated from other occupancies by a minimum 1-hr (2-hr for highrise building) fire rated construction (wall, floor, slab etc). Seal all penetrations and openings (door, window etc.) should be protected by 0.75-hr (45 min) fire rated materials to maintain the fire separation if required. All exhaust systems shall discharge to the exterior of the building in a safe location.</p> <p>Or</p> <p>Relocate it to exterior of the building and maintain a minimum 3m (10 ft.) spatial separation distance from the building.</p> | Within 3 months |

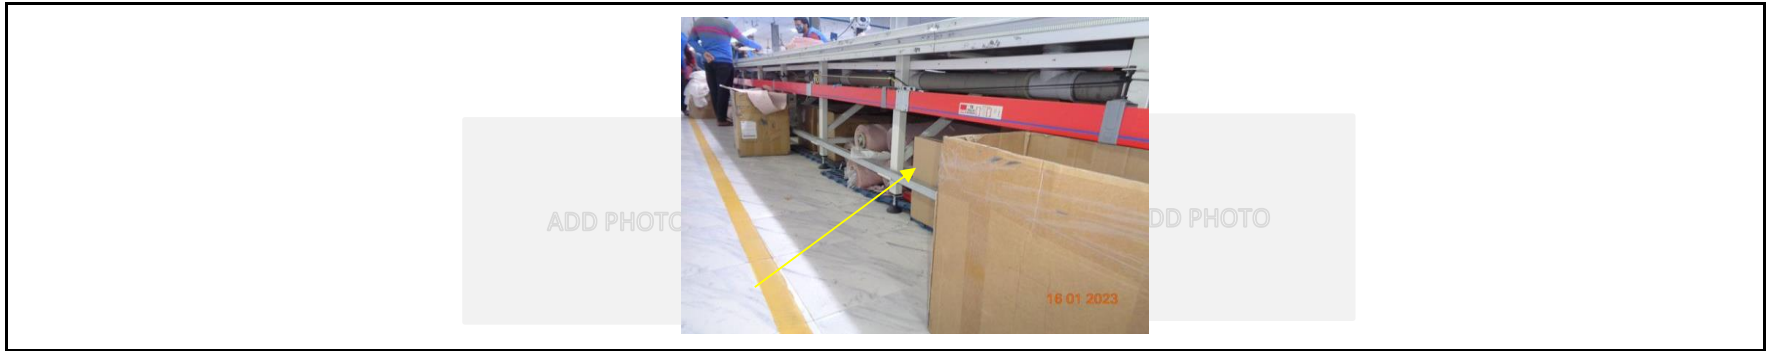
| F-8 | Fire-Rated Construction | <p>Storages were observed underneath the cutting table.</p> <p>Location: Cutting section at at single storied lingerie shed.</p> | <p>Storage underneath the cutting tables shall be kept clear of combustibles at all time, except as provided for miscellaneous storage in accordance with 3.4.2.1.6 or where automatic sprinkler protection is installed. Where an automatic sprinkler system is installed sprinklers are required to be installed beneath cutting tables greater than 4 ft in width that are used for storage of combustibles.</p> | Within 3 months |

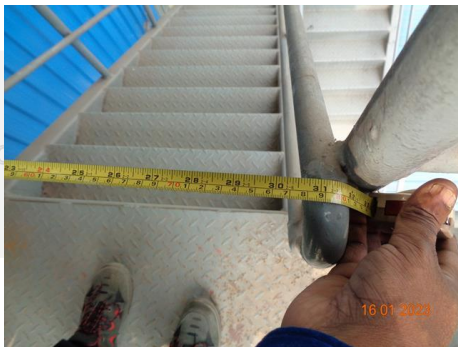
| F-10 | Means of Egress | Width of exit stair is less than 1m (60 inches).<br><b>(Three storied EGB steel structure Building)</b> | Modify the stair to have a minimum width of 1.5 m (60 inches). | Within 3 months |

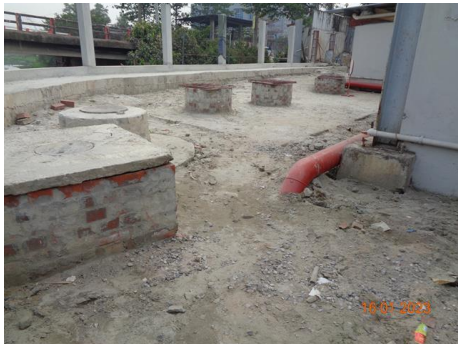
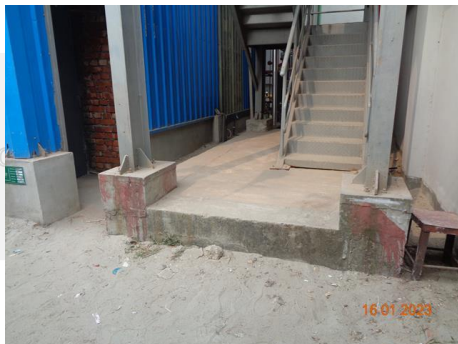
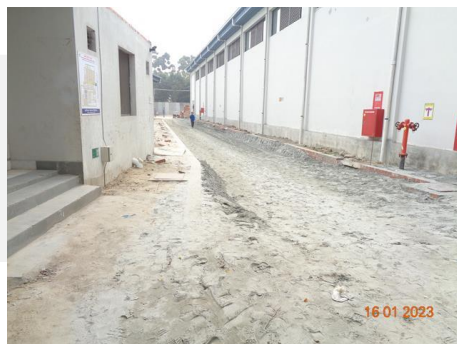
| F-11 | Means of Egress | <p>Uneven path of travel and obstructions observed in the exit discharge.</p> <p>(Locations: North, East &amp; West side Exits of the Single storied Lingerie shed and Exit Stair's discharge path on the ground floor of the Three storied EGB steel structure Building).</p> | Remove the obstructions and level the exit path to the public way. | Within 2 months |

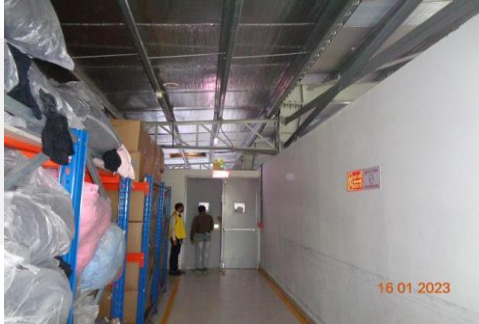
| F-13 | Means of Egress | <p>Common path of egress travel exceeds 23 meter.</p> <p>Location: Fabric Storage room on the north side- Single storied Lingerie shed.</p> | Reconfigure the egress arrangement to reduce the maximum common path of travel to not more than 23 meter. | Within 2 months |

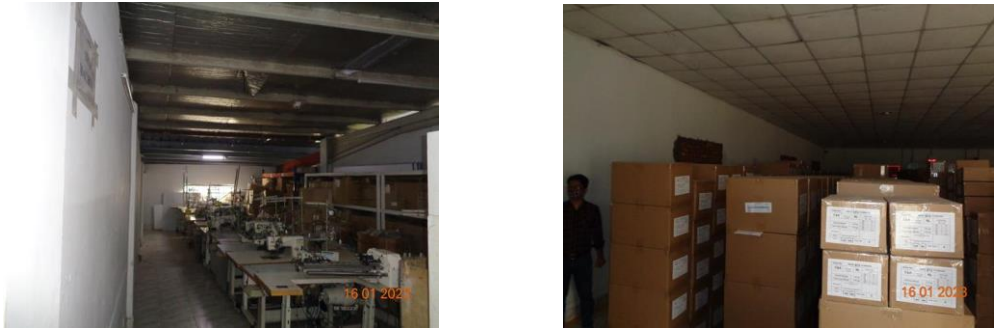
| F-14 | Egress lighting | Based on the number and location of emergency lights observed, adequate illumination levels are not anticipated along egress routes. | Test the emergency lighting system on each floor and provide additional emergency fixtures to provide adequate illumination along the means of egress. Provide a minimum illumination of 10 lux at the floor level within exit stairs and exit discharge paths and minimum 2.5 lux along exit access aisles. | Within 2 months |

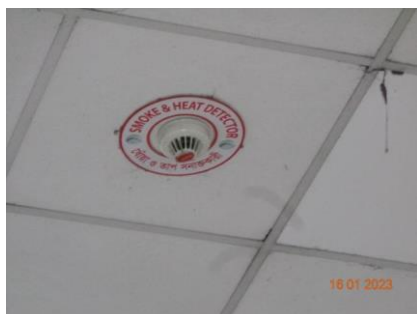
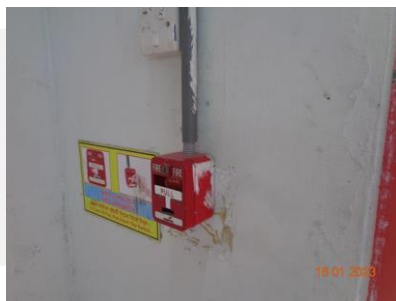
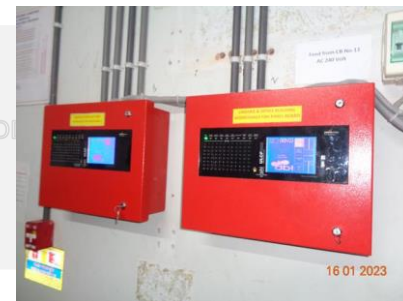
| F-16 | Fire Alarm System | Fire alarm and detection system installation complete which requires detailed review to confirm compliance with NFPA 72 and RSC Technical Guidelines (Standard). | Submit drawing, calculations, equipment certifications and other relevant documentation to the RSC for review and approval, modification (if required) shall have to be done as per the reviewed design, NFPA 72 & RSC standard. &<br>Upon approval & modification (if required) the factory shall verify the system by RSC for final acceptance. | Design within 2 months & Installation within 4 months |
