INITIAL FIRE SAFETY INSPECTION REPORT

Ayesha Fashion Limited

RSC ID: 24507

Fire Safety Inspection Report

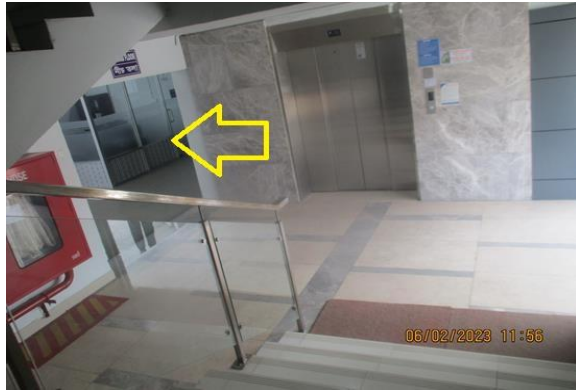
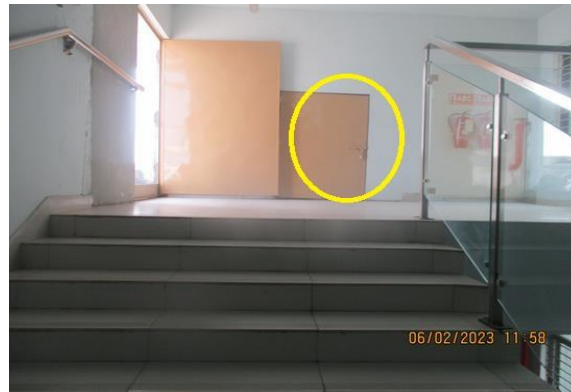
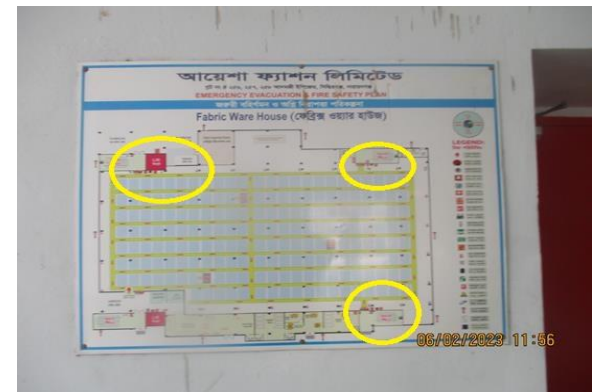
| SI No. | Category | Findings | Required Action | Remediation Time Frame |
|---|---|---|---|---|
| F-1 | Fire Rated Construction | <p>The exit stairs are not separated from [work areas, other spaces] on each floor by fire rated construction due to unprotected opening</p> <p>Location: 6 Storied main production building.</p> | <p>The exit stair enclosure shall be provided with a minimum of 2- hr. fire resistance rating with 90 minutes opening protection.</p> <p>The clearance under the bottom of a fire door shall be a maximum of 19mm.</p> <p>Ensure that the fire doors are self-closing and positive latching and that they are provided with fire exit (panic) hardware where serving production floors. If fire doors are required to be held open for functional reasons, provide automatic closing devices tied to the fire alarm system.</p> <p>Once fire doors are installed, every door in a stair enclosure serving more than 5 stories shall be provided with re-entry unless it meets RSC Technical Guideline (Standard) V1- 6.8.3.1.</p> <p>Openings from exit enclosures to storage areas shall be provided with vestibules as per RSC Technical Guideline (Standard) V1-6.14.3</p> | Within 3 months |

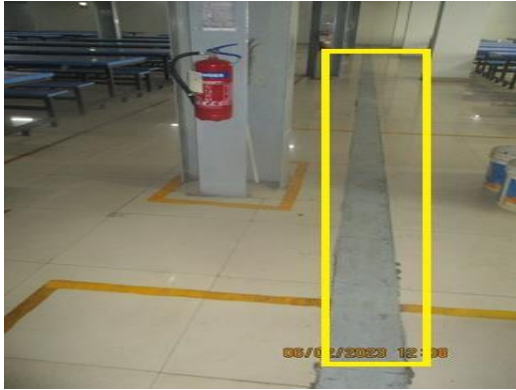
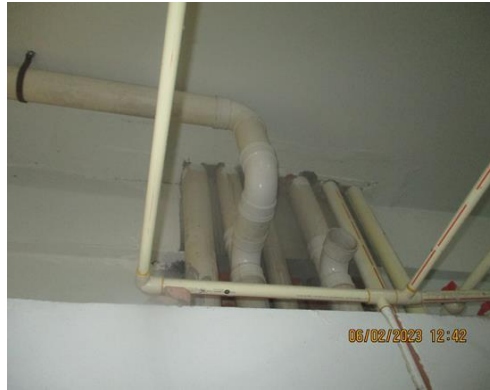
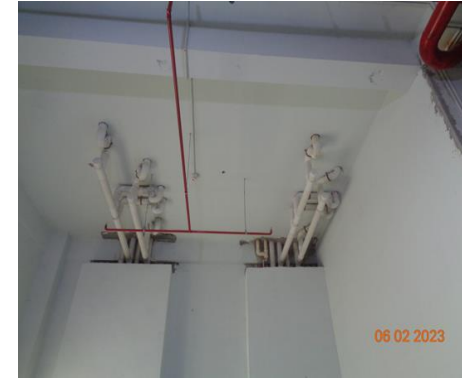
| F-2 | Fire rated construction | <p>Unsealed penetrations and openings are located in the fire-rated floor/ceiling assemblies.</p> <p>Location: Building construction joint , sewage line & Riser</p> | <p>Seal all penetrations and openings in floor/ceiling assemblies to maintain the fire separation at least by 3-hr. The used sealer shall be 3rd party certified and installation shall be as per manufacturer's datasheet.</p> <p>Or</p> <p>Provide a minimum 2-hr fire rated shaft to separate the utility risers from each floor if required.</p> | within 3 months |

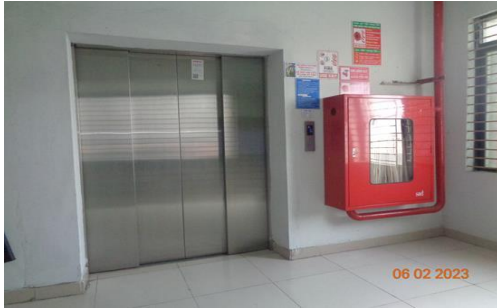
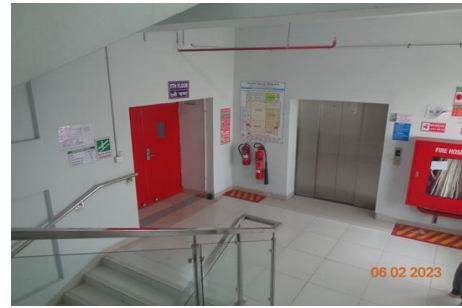
| F-3 | Fire Rated Construction | <p>Elevator shafts are directly open into the inside of exit enclosure.</p> <p>Location: Stair-1 & stair-4 of production building</p> | <p>Modify the elevator shaft as per RSC Technical Guideline (Standard) V1-6.14.3. An exit stairway shall not be built around a lift shaft unless both of them are located in a smoke proof enclosure and made of a material with fire resistance rating required for the type of construction of smoke proof enclosure. So, ensure the lift shaft is 2-hr fire rated including opening protection with similar rating.</p> | Within 3 months |

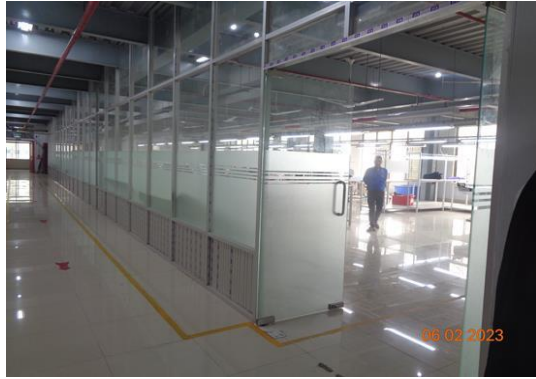
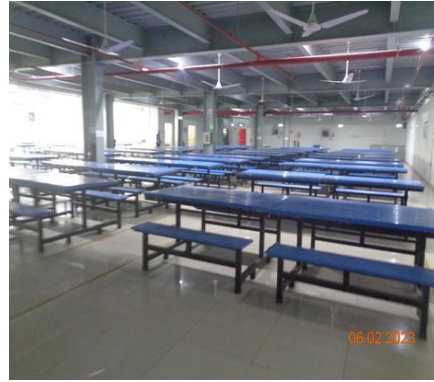
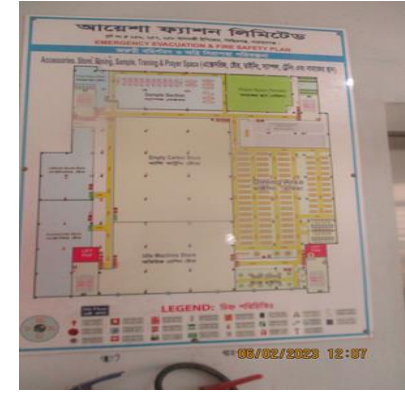
| F-4 | Fire Rated Construction | <p>The Dining area (E4) is not separated by fire rated construction with the adjacent production occupancies(present storage & Sample section) Location: 5th floor of main production building.</p> | <p>Separate the dining area from production & other occupancies(present temporary storage) by minimum 3-hr fire rated construction. Provide rated exit passageways leading directly to the exit stairs of the same resistance rating.</p> | Within 3 months |

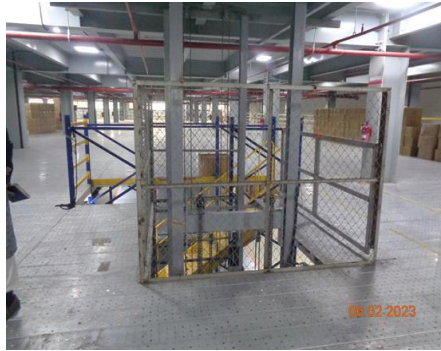
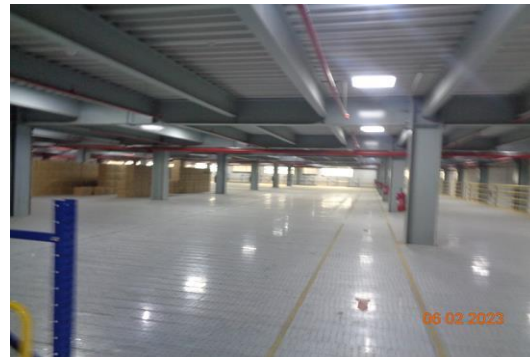
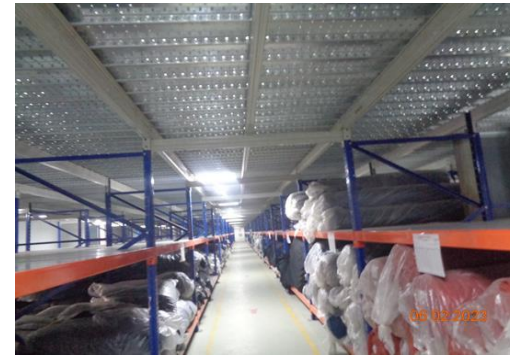
| F-5 | Fire Rated Construction | It has been observed that the ground floor to first floor (claimed mezzanine) are not separated from each other of main production building where claimed mezzanine floor is occupying more than 33.33% of the building plinth area(measure full plinth area). | <p>Mezzanine floor shall not exceed 33.33% of the building plinth area as per BNBC-2006, clause 1.12.6.1.</p> <p>Separate each floors by fire rated construction as per BNBC, Part-3, chapter-3 and Table 3.3.1.</p> <p>3-hr fire rated floor to floor separation is required from claimed mezzanine floor (actually first floor) to ground floor other surroundings as well as separation is needed at required number of exit stairs.</p> | Within 4 months |

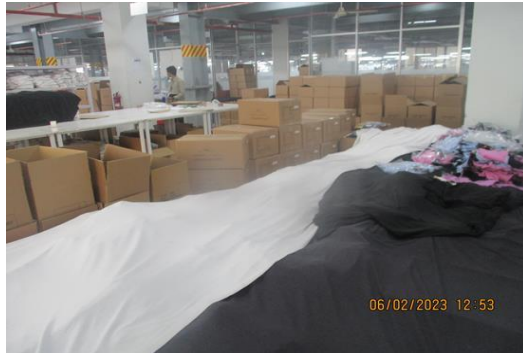
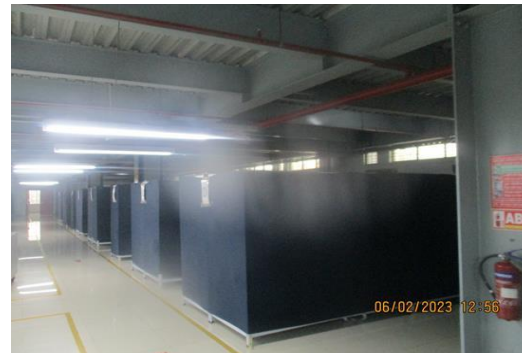
| F-6 | Fire Rated Construction. | <p>Areas used for in-process storage of combustible materials are open to the surrounding occupancy.</p> <p>Location: Several floor of main production building.</p> | <p>Provide defined storage areas and limit the storage arrangement as follows:</p> <p>Maximum height of 2.45 m and maximum area of 23 m² and is separated by a minimum 3.0 m (10ft) from other storage areas and they do not exceed 10 percent of the building area of the story in which they occur. If sprinkler protected, Maximum height 12 ft (3.66 m) and maximum area of 1000 ft² (93 m²) and separated by a at least 25 ft (7.62 m) from other storage areas and does not constitute more than 10 percent of the building area or 4000 ft² (372 m²) of the sprinklered area, whichever is greater.</p> <p>or,</p> <p>Enclose the storage area from the surrounding occupancy with a minimum 1 hour fire rated construction.</p> | Within 3 months |

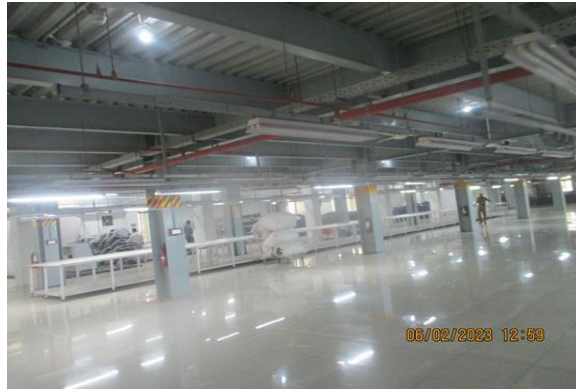
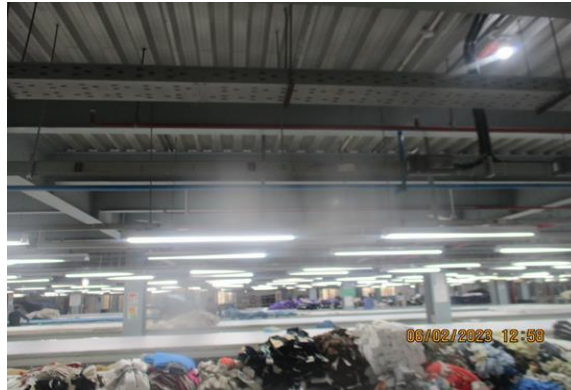
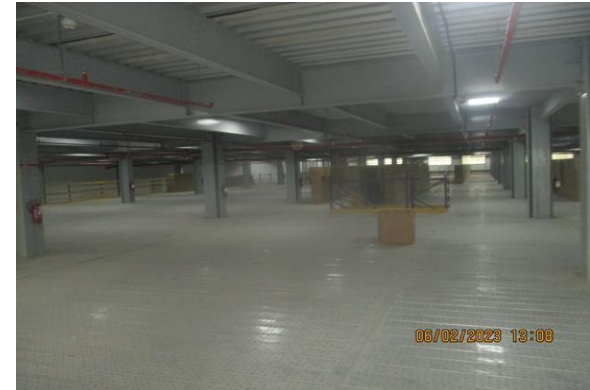
| F-7 | Fire Rated Construction | <p>The newly constructed main production building is steel construction which appears to be nonrated and were found in exposed condition.</p> <p>Location: 6 Storied main production building.</p> | <p>The building is a new steel structure which shall be type-I or II construction. So, provide require fire rating in the structural elements of the building. Consult with a qualified fire protection engineer. Follow BNBC 2006- Table 3.2.4, 3.1.9 and 3.3.1 as reference.</p> | Within 6 months |

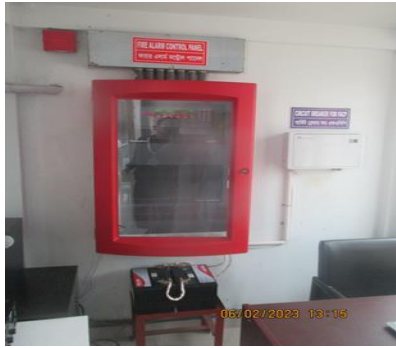
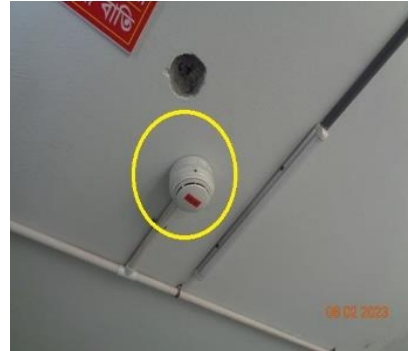
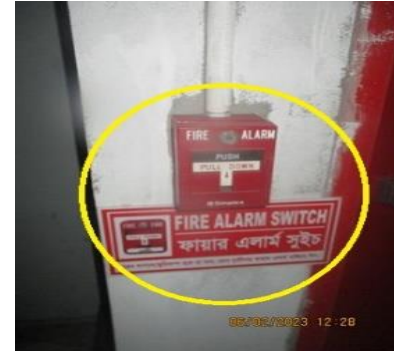
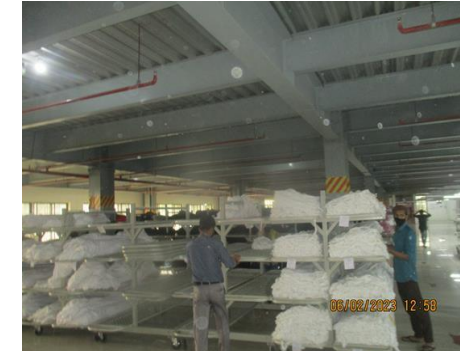
| F-11 | Fire Alarm & Detection System (FADS) | Addressable fire alarm & detection system installation requires detailed review to confirm compliance with NFPA 72 and RSC standard. | <p>Submit design, documents and calculations to RSC for review prior and based on the review modify the system if there is any.</p> <p>After installation the owner shall contact the RSC for witness of conducting the final acceptance testing of the fire detection & alarm system installation.</p> <p>Also inspect, test and maintain the fire alarm system, and keep written records on-site, in accordance with NFPA 72.</p> | Design Review within 1 month and modification within 3 months (If require). |

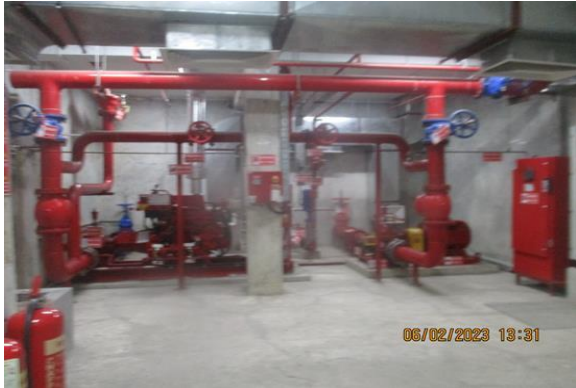
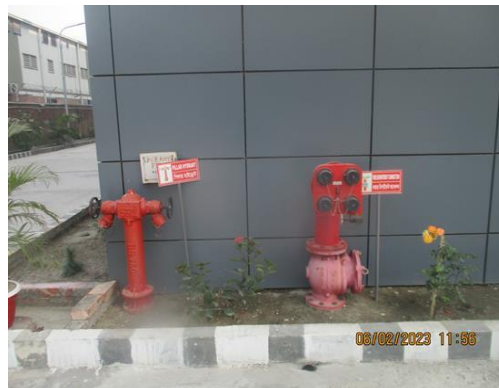
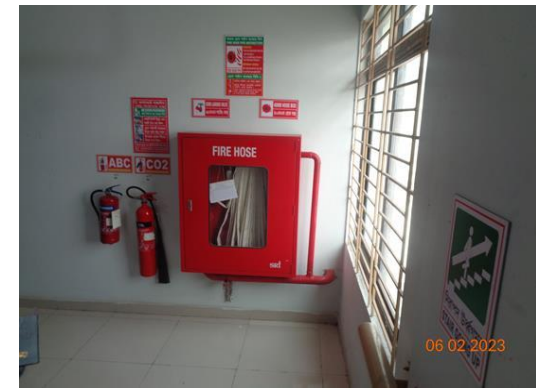
| F-13 | Fire Protection System(Standpipe) | Standpipe system installation requires detailed review to confirm compliance with NFPA 14 ,20 ,22 & 24 or as per RSC standard. | <p>Submit the standpipe system drawing to RSC for review. Once the design is reviewed, install and modify the standpipe system throughout the building in accordance with review comment, RSC Standard and NFPA 14,20,22 and 24.</p> <p>After installation the owner shall conduct internal testing and commissioning and then contact the RSC for witness of final acceptance testing.</p> | Design Review within 1 month and modification within 3 months (If require). |
