# INITIAL FIRE SAFETY INSPECTION REPORT

## BARAKA FASHIONS LIMITED (Extension)

**Date: 13th-March-2023**

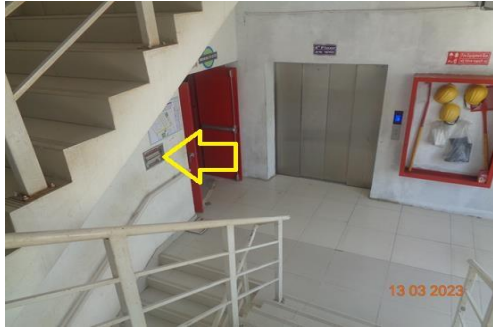
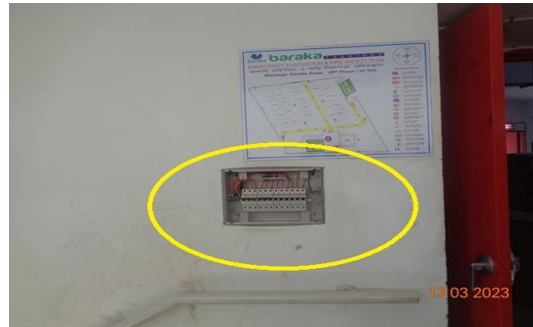
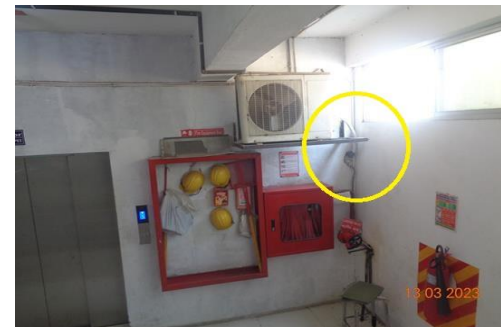
| SI No. | Category | Findings | Required Action | Remediation Time Frame |
|---|---|---|---|---|
| F-1 | Fire Rated Construction | The exit stairs are not separated from [work areas, other spaces] on each floor by fire rated construction due to unprotected opening to DB, penetration & fire door non-functionality. | <p>The exit stair enclosure shall be provided with a minimum of 2- hr. fire resistance rating with 90 minutes opening protection. Ensure that the fire doors are self-closing and positive latching and that they are provided with fire exit (panic) hardware where serving production floors. If fire doors are required to be held open for functional reasons, provide automatic closing devices tied to the fire alarm system.</p> <p>No other penetration into and through the exit enclosure except for fire alarm equipment electrical raceway, required exit doors, sprinkler piping, standpipes, and electrical conduit serving the exit enclosure is permitted.</p> | Within 3 months |

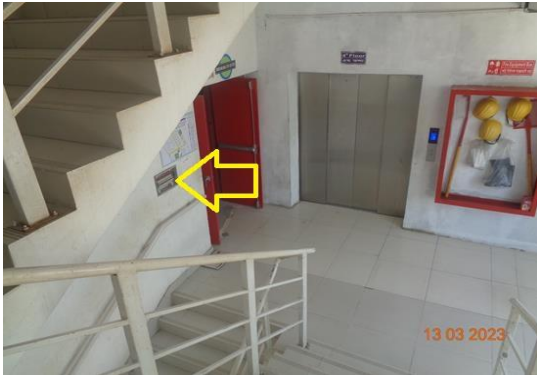
| F-2 | Fire Rated Construction | <p>Elevator shafts are directly open into the inside of exit enclosure.</p> <p>Location: Stair-1</p> | <p>Modify the elevator shaft as per RSC Technical Guideline (Standard) V1-6.14.3. An exit stairway shall not be built around a lift shaft unless both of them are located in a smoke proof enclosure and made of a material with fire resistance rating required for the type of construction of smoke proof enclosure. So, rearrange the facility to provide separate enclosure for lifts. If not possible anyway then provide a minimum 2-hr fire- rated elevator shaft with listed fire rated lift landing door to separate from each floor level.)</p> | Within 3 months |

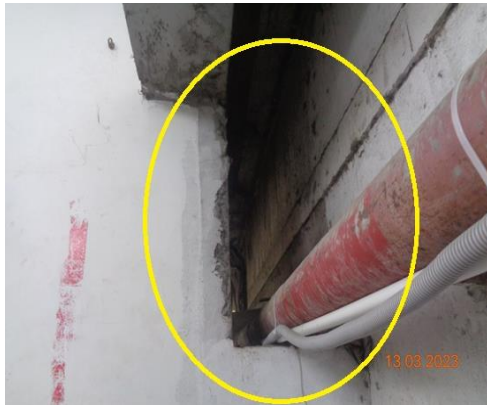
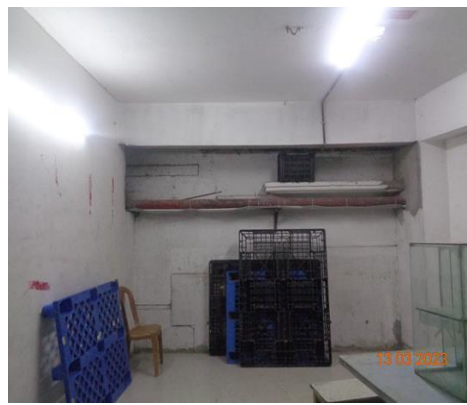
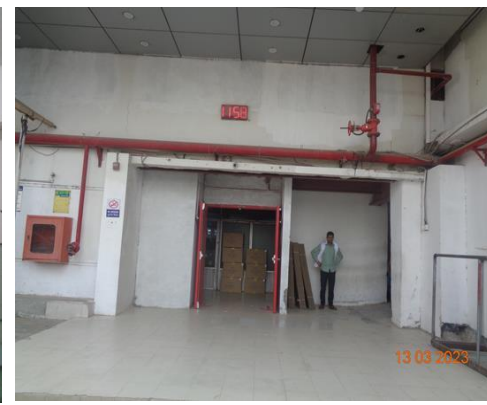
| F-3 | Fire Rated Construction | <p>The exit discharge path (Passageway) is not separated by fire-rated construction.</p> <p>Location: Exit Stair-1</p> | Provide minimum 2 hr. fire rated exit discharge path which will lead directly outside. | Within 3 months |

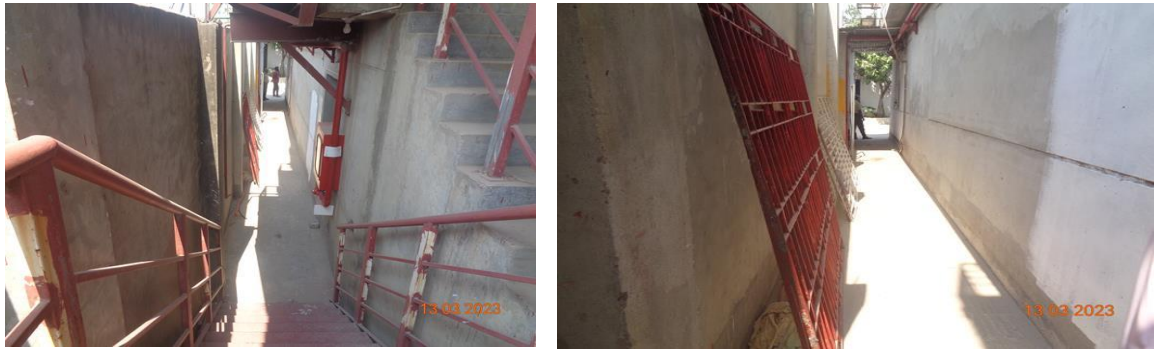
| F-4 | Fire Rated Construction | <p>The exit discharge path (Egress Court) was less than 10 ft wide and was not separated from the building interior. Some Storage/Obstacles in the exit discharge path.</p> <p>Location: Exit stair-2</p> | Seal all penetrations and openings to the interior of the building along the discharge path, up to a height of 10 ft. to provide a minimum 2-hr fire separation. Exit discharge path shall be free from all Storages/Obstacles. | Within 3 months |

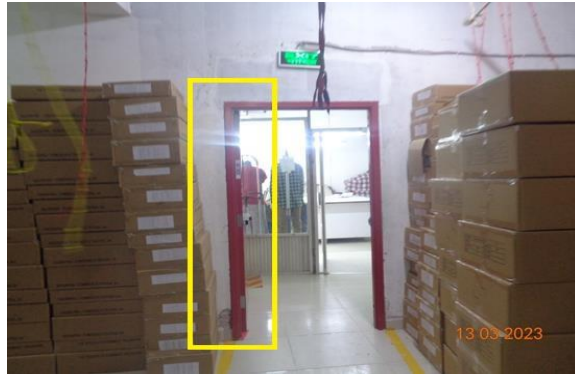
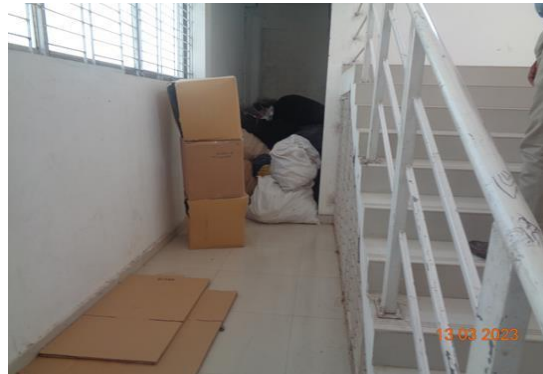
| F-5 | Fire Rated Construction | <p>Rooms used for combustible storage are not separated by fire rated construction.</p> <p>Location: 2nd floor &amp; Near to Exit stair-1 of several floor.</p> | Provide dedicated storage rooms separated by minimum 1 hr. fire rated construction. Seal all unprotected openings and penetration. If fire doors are required to be held open for functional reasons, provide automatic closing devices tied to the fire alarm system. | Within 3 months |

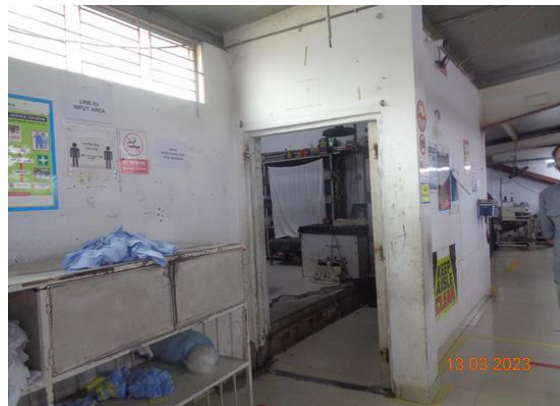
| F-6 | Fire Rated Construction | The workshop/idle machine room on the first floor of 6 storied store building is not separated from two storied main steel production shed by fire-rated construction. | Separate the store building and 2 storied steel building is fire separated by minimum 4-hr fire rated construction, where no opening is permitted. | Within 3 months |

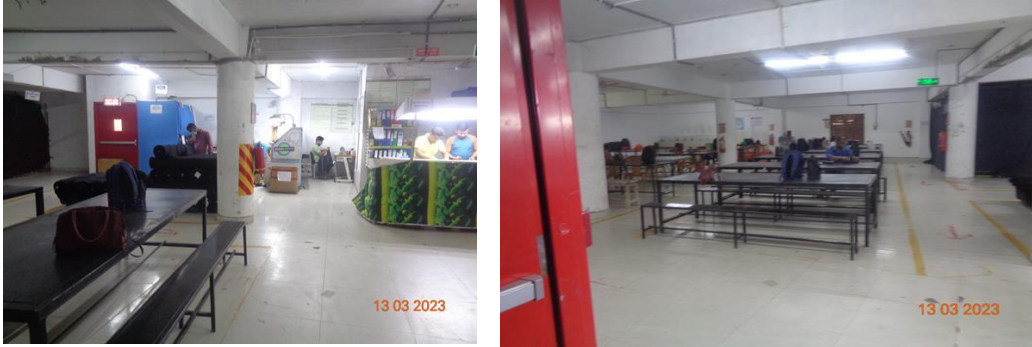
| F-7 | Fire Rated Construction | The Dining area(E4) is not separated by fire rated construction with the adjacent production area. | Separate the dining area(E4) from adjacent production occupancies by minimum 3-hr fire rated construction. Provide rated exit passageways leading directly to the outside of the building or rated stair enclosure. | Within 3 months |

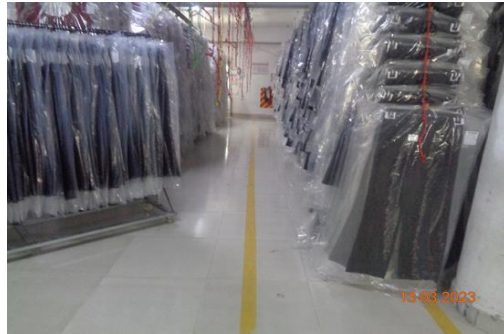
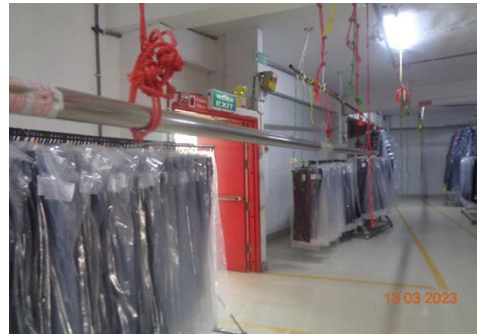
| F-8 | Means of Egress | The egress path along the means of egress has been interrupted by obstruction.<br>Location: 3rd & 4th floor. | Aisles shall be provided with a minimum unobstructed clear- with of 0.9m (36 in). Means of egress shall be maintained continuously free and clear of all obstructions/storage. | Immediately |

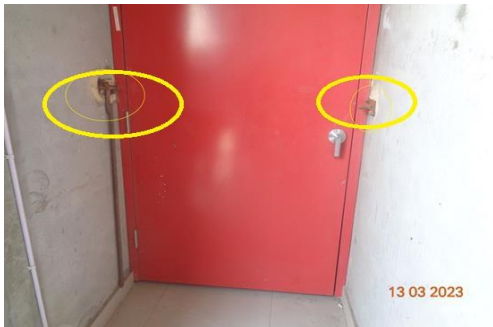
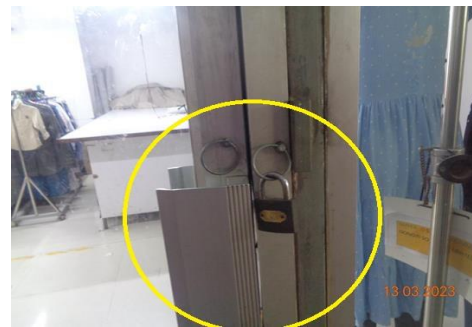
| F-09 | Means of Egress | Egress doors & gates on the 2nd & 5th floor with non-compliant locking features are provided at exits. | Remove non-compliant locking features from all egress door & gates.<br>If locks are required for security reasons, utilize special door locking features complying with NFPA 101 & RSC Technical Guidelines (Standard) V1- 6.8.2 | Immediately |

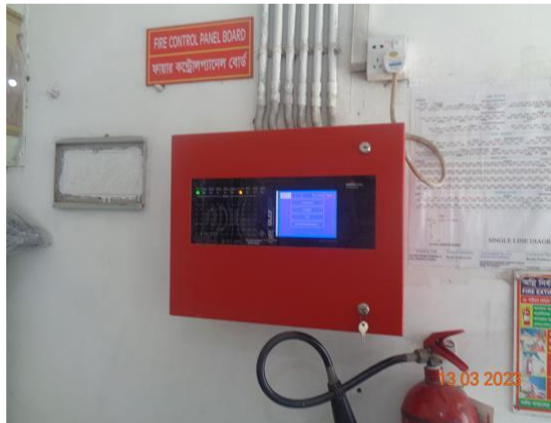
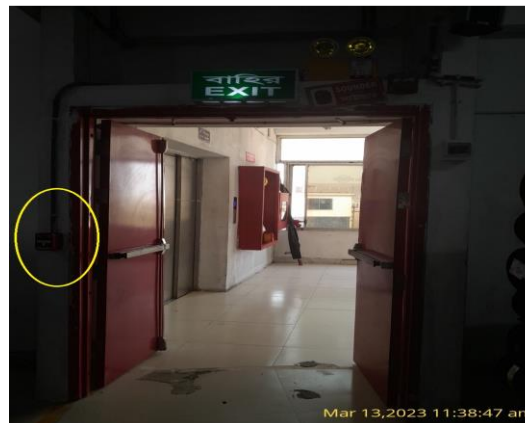
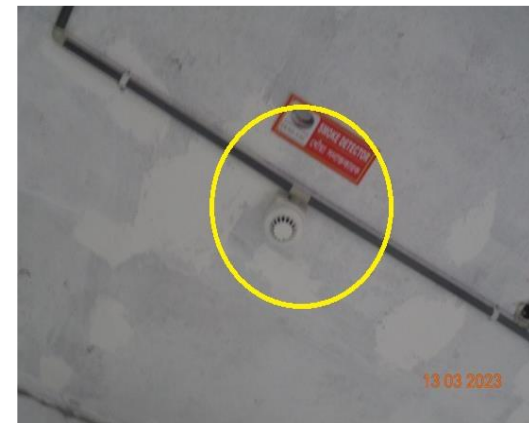
| F-10 | Fire Alarm & Detection System (FADS) | Addressable fire alarm & detection system installation requires detailed review to confirm compliance with NFPA 72 and RSC Technical Guidelines (Standard). | <p>Submit design, documents and calculations to RSC for review prior and based on the review modify the system if there is any.</p> <p>After modification/installation the owner shall contact the RSC for witness of conducting the final acceptance testing of the fire detection &amp; alarm system installation.</p> <p>Also inspect, test and maintain the fire alarm system, and keep written records on-site, in accordance with NFPA 72.</p> | Design Review within 1 month and modification (If require) within 3 months after review of design. |

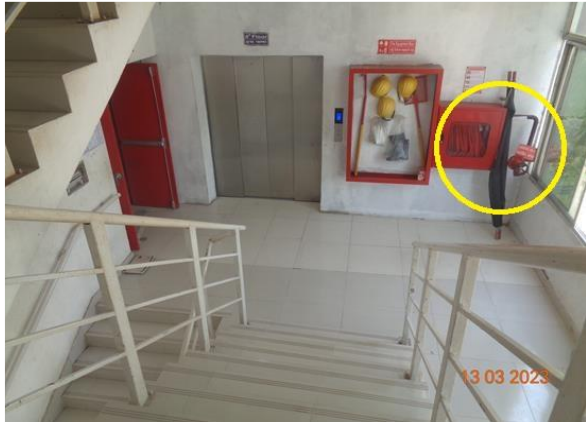
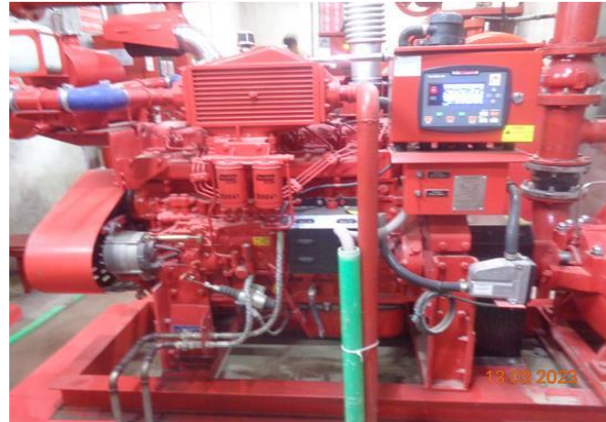
| F-12 | Fire Protection System(Standpipe) | Standpipe system installation requires detailed review to confirm compliance with NFPA 14 ,20 ,22 & 24 or as per RSC Technical guidelines (Standard). | <p>Submit the standpipe system drawing to RSC for review.</p> <p>Once the design is reviewed, install/ modify the standpipe system throughout the building in accordance with review comment, RSC Standard and NFPA 14,20,22 and 24.</p> <p>After installation the owner shall conduct internal testing and commissioning and then contact the RSC for witness of final acceptance testing.</p> | Design Review within 1 month and modification (If require) within 3 months after review of design. |
