INITIAL FIRE SAFETY INSPECTION REPORT

Textil Fashions Ltd.(Extension)

RSC ID: 24537

HOLDING# 6/1 (PLOT# 168) CHAYDANA, National University, Gazipur-1704

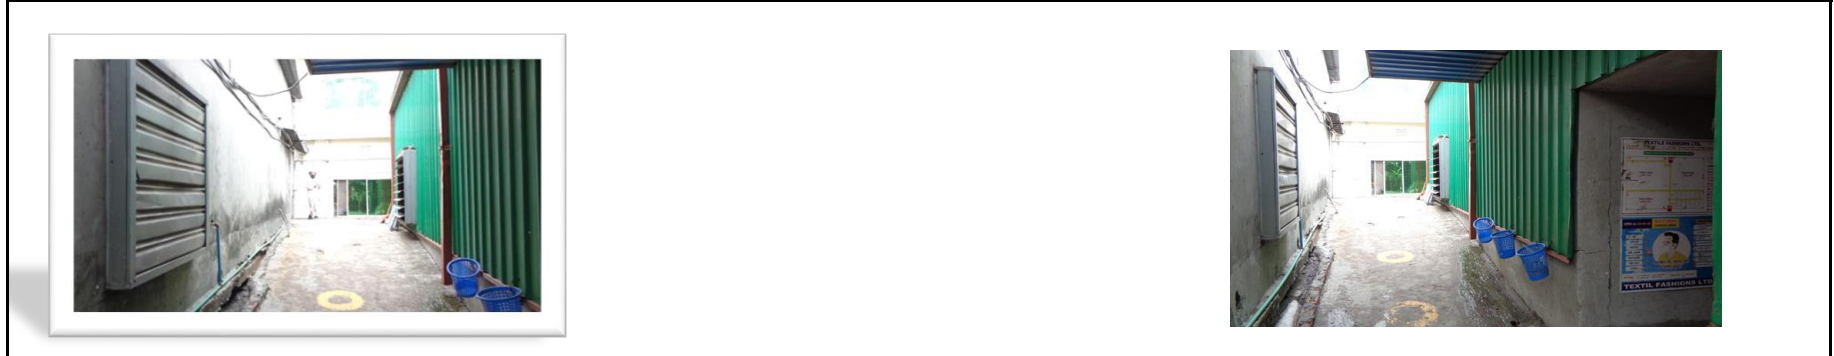
Table-1:				
SI No.	Category	Findings	Required Action	Remediation Time Frame
F-01	Fire-Rated Construction	The West exit discharge path is less than 10ft. wide and is not separated from the Utility Shed.	Seal all penetrations and openings to the interior of the building along the discharge path, up to a height of 10 ft, to provide a minimum 1-hr fire separation. Alternatively, provide a second remote discharge path to the public way (only include this if feasible).	Within 6 months

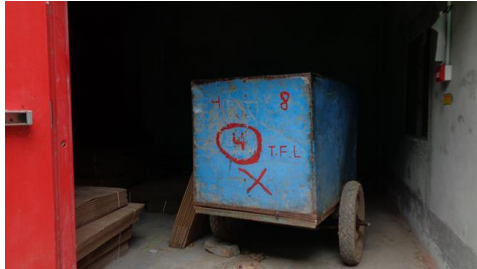
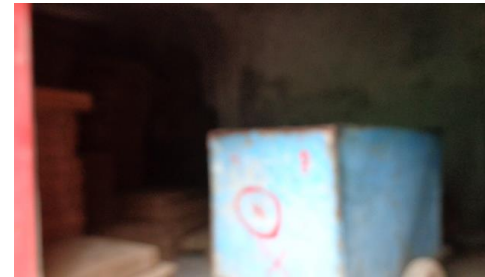
F-02	Fire Rated Construction	Liquefied or compressed gas cylinders were located in the factory premises along with storage materials. Location(s): CNG room.	<p>The RSC Technical Guidelines (Standard) Section 3.4.2.1.11 prohibits the storage or use of liquefied or compressed flammable gas (LPG/CNG) cylinders within the factory building.</p> <p>Alternatively:</p> <ol style="list-style-type: none"> 1. The storage building must be at least 3 meters away from any other buildings and boundaries. 2. The exterior walls of the building must have a fire resistance rating of 3 hours using noncombustible construction. 3. Doors and other openings in the exterior walls must be protected with suitable closing devices having a fire protection rating of 3 hours. 4. The building is to be used for no other purpose than the storage of LPG/CNG cylinders. 5. The building must be mechanically ventilated to control the accumulation of flammable vapors. 6. The installations must be approved and accepted by the requirements of the AHJ, Gas supply company regulations, manufacturers/supplier's instructions/guidance, Chief Inspector of Boiler (CIOB) and Chief Inspector of Explosives Bangladesh (CIEB). 	Within 3 months

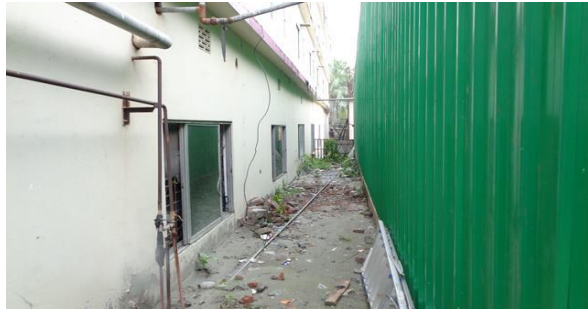
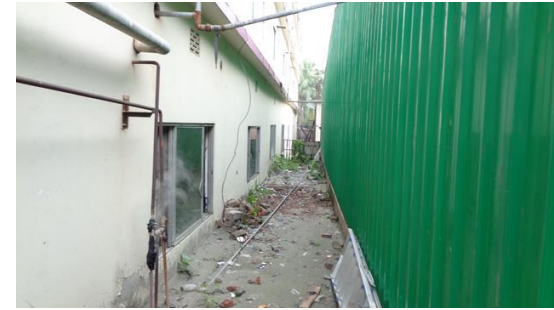
F-03	Fire Rated Construction	Warehouse Shed was not separated by fire rated construction from Main production building (Less than 10 feet from main production building).	Provide dedicated storage rooms separated by minimum 1-hr fire-rated construction. Where separate storage rooms are not feasible, provide defined storage areas and limit the storage arrangement as follows: - Maximum height of 2.4m and maximum area of 23 m ² - If sprinkler protected: maximum height of 3.66m and maximum area of 93 m ² Separate areas of unenclosed combustible storage by a minimum clear distance of 3m.	Within 3 months
------	-------------------------	---	--	-----------------

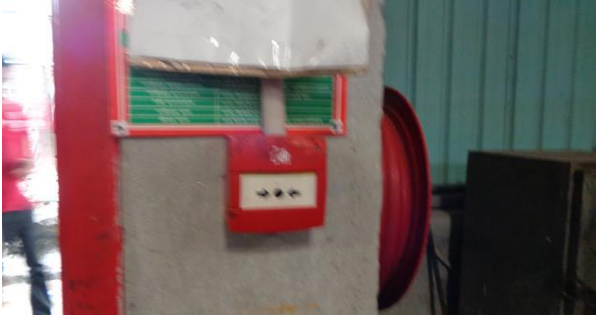
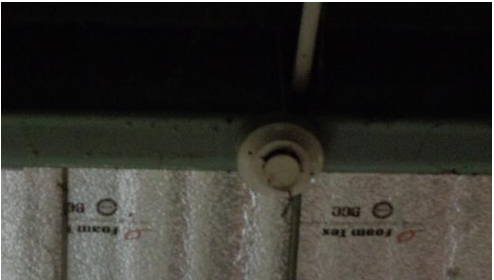
F-05	Fire Alarm & Detection system	The fire detection system is antiquated, not a listed system, and does not provide alarm and notification features consistent with acceptable standards. Fire detection system installation requires detailed review to confirm compliance with NFPA 72 and in accordance with The RSC Technical Guidelines (Standard).	Replace the fire detection system with a new, listed addressable fire detection system in accordance with NFPA 72.	Design within 3 months and installation with 6 months
<div style="display: flex; justify-content: space-around;">

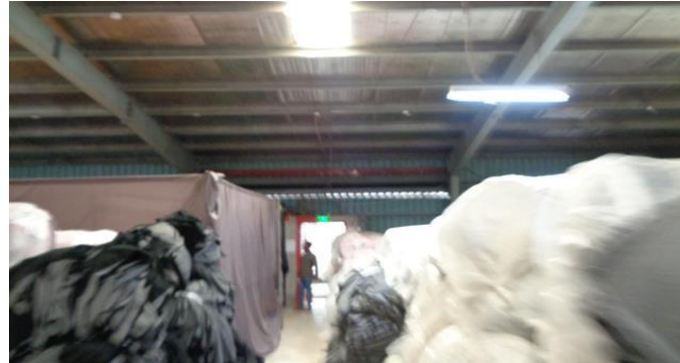
F-07	ITM of Fire Extinguishers	Inspection, testing and maintenance of portable fire extinguishers is not in accordance with NFPA 10.	Inspect, test and maintain the portable fire extinguishers and keep written records onsite, in accordance with NFPA 10 ,and in accordance with The RSC Technical Guidelines (Standard).	Within 3 month
F-08	Mean of Egress	Width of aisles is less than 0.9m (36-in.) or aisles mark is not properly provided in the warehouse Shed.	Aisles shall be provided with a minimum unobstructed clear-width of 0.9 m (36 in.).	Within 3 months

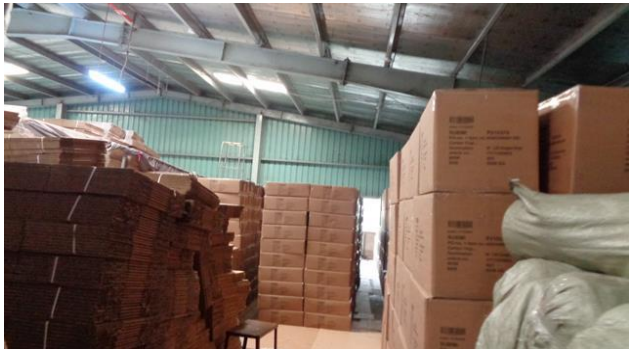
F-9	Emergency light and Exit Sign	Based on the number and location of emergency lights observed, adequate illumination levels are not anticipated along egress routes. Location- Warehouse Shed.	Test the emergency lighting system on each floor and provide additional emergency fixtures to provide adequate illumination along the means of egress. Provide a minimum illumination of 10 lux at the floor level within exit stairs and exit discharge paths and minimum 2.5 lux along exit access aisles.	Within 3 months
