# INITIAL FIRE SAFETY INSPECTION REPORT

## Green Textile Limited (Unit-3)\_Expansion

RSC ID: 24526

Date: 24 May-2023

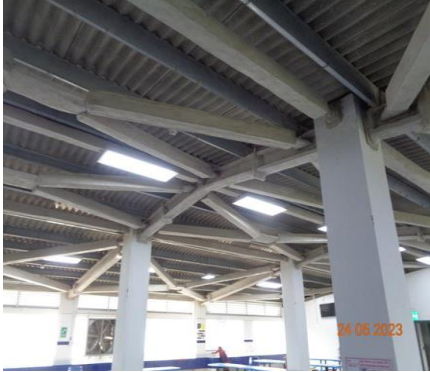
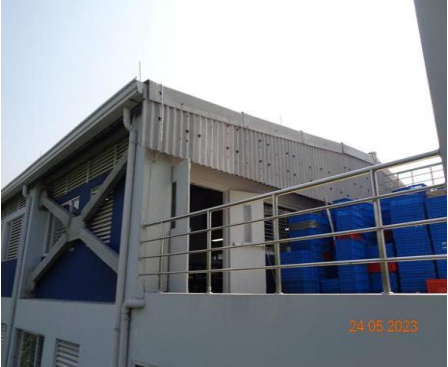
Sl No.	Category	Findings	Required Action	Remediation Time Frame
F-1	Fire Rated Construction	The main structural element on the canteen building's 3rd floor (roof) is constructed of steel and observed protected by spray-applied fire resistive materials.	Please submit the design philosophy, as-built design, dry-film thickness calculation, manufacturer's technical datasheet, independent 3rd party certification, primer's detail, and other relevant documents to the RSC for review. Based on the review, the application will be verified accordingly for final acceptance.	Within 3 months
<div style="display: flex; justify-content: space-around;">

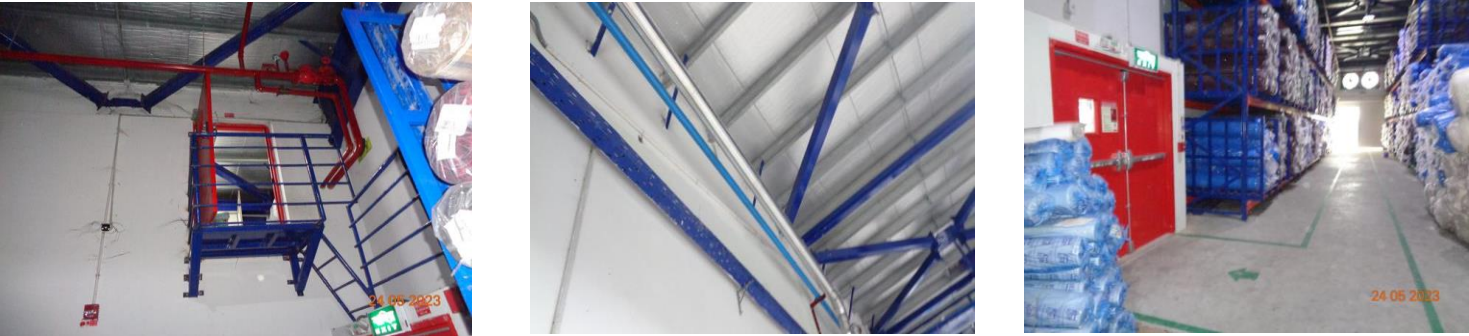
F-2	Fire Rated Construction	The factory has used gypsum board to separate storage for the main production shed-warehouse.	Submit materials certification and other relevant documentation to the RSC for review.	Within 1 month

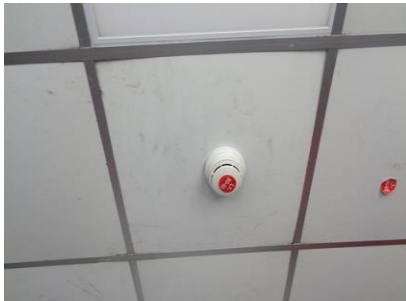
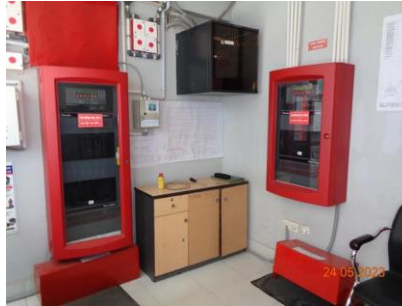
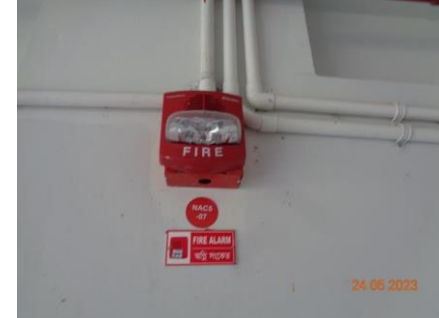
F-5	Egress lighting (ITM)	Inspection, testing, and maintenance for the exit sign and emergency lighting system was not in accordance with the RSC standard.	Inspect, test and maintain the exit sign and emergency lighting system in accordance with the RSC standard. Keep written records on-site.	Within 3 Months
F-6	Fire Alarm System	Fire alarm and detection system installation complete which requires detailed review to confirm compliance with NFPA 72 and RSC Technical Guidelines (Standard).	Submit as-built drawing, calculations, equipment certifications and other relevant documentation to the RSC for review and approval, modification (if required) shall have to be done as per the reviewed design, NFPA 72 & RSC standard & Upon approval & modification (if required) the factory shall verify the system by RSC for final acceptance.	Within 3 Months
