INITIAL FIRE SAFETY INSPECTION REPORT

SM Sourcing

RSC ID: 24719

Date: 23 July 2023

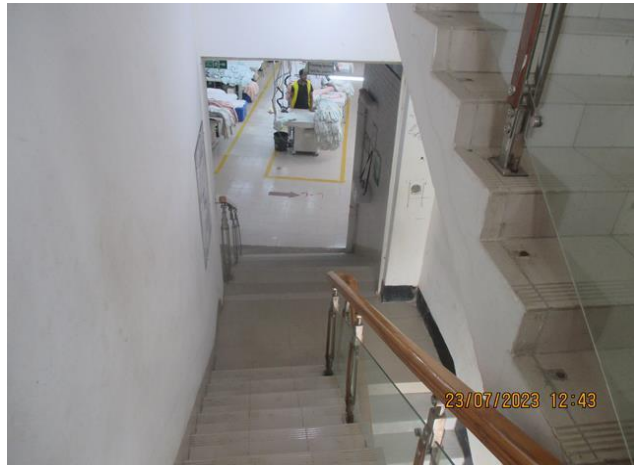
SI No.	Category	Findings	Required Action	Remediation Time Frame
F-1	Fire Rated Construction	The exit stair enclosures are not separated from work areas and other spaces on Ground floor of Building-1 by fire-rated construction .	<p>The exit stair enclosure shall be provided with a minimum 1-hr fire resistance rating for buildings with 3 or fewer stories and a minimum of 2- hr. fire resistance rating for buildings 4 or more stories. If required, provide 0.75 hr. fire rated door and seal all penetrations and openings by 1 hr. fire rated fire rated barrier construction for building with 3 or fewer stories. Provide 1.5 hr. fire rated door and seal all penetrations and openings by 2 hr. fire rated fire rated barrier construction for building with 4 or more stories.</p> <p>Ensure that the fire doors are self-closing and positive latching and that they are provided with fire exit (panic) hardware where serving production floors. If fire doors are required to be held open for functional reasons, provide automatic closing devices tied to the fire alarm system.</p>	Within 3 months

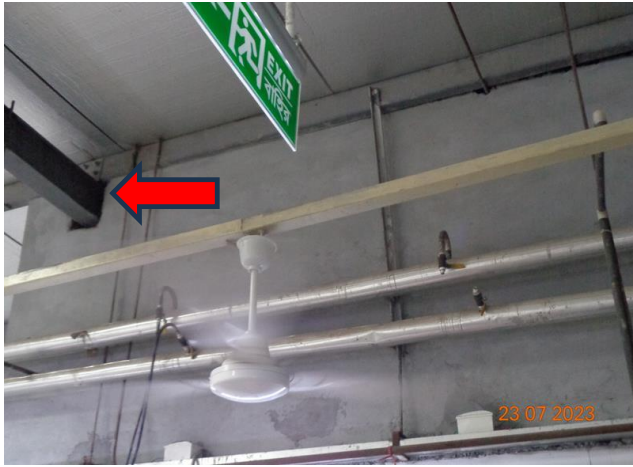
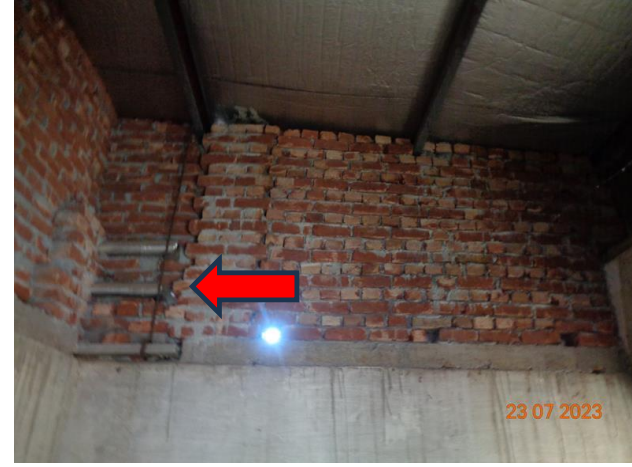
F-2	Fire Rated Construction	The Boiler, Gas meter room is not separated by fire rated construction (openings, penetrations) from Iron section of Shed-1.	Separate the Boiler & Gas room by a minimum 4-hr fire-rated construction. Seal and/or protected all openings to maintain the required fire separations. Provide proper ventilation for Gas room.	Within 3 Months
-----	-------------------------	--	---	-----------------

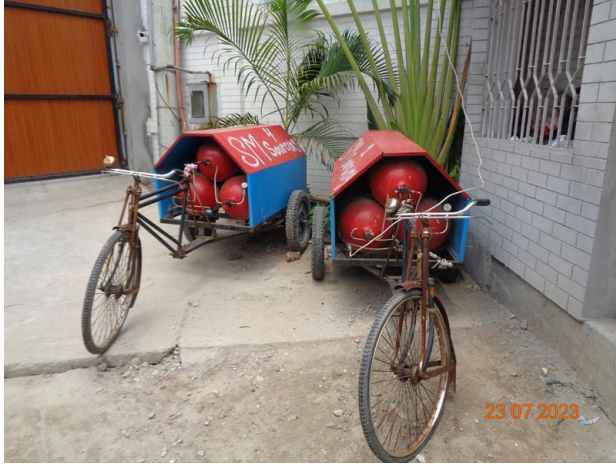
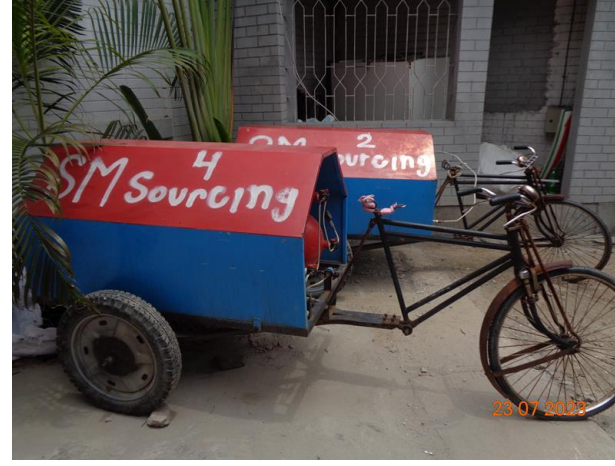
F-3	Fire Rated Construction	The factory is using/storing CNG cylinders for operating boiler. Location: Near Gate 2	<p>The RSC Technical Guideline (Standard) V1, section 3.4.2.1.11 prohibits the storage or use of liquefied or compressed flammable gas (LPG/CNG) cylinders within the factory building. However, if it is not feasible then conditionally those are permitted to be stored in a separate dedicated building on the factory premises within its boundaries if the building meets the following conditions.</p> <ol style="list-style-type: none"> 1. The storage building must be at least 3 meters away from any other building and boundaries. 2. The exterior walls of the building must have a fire resistance rating of 3 hours using noncombustible construction. 3. Doors and other openings in the exterior walls must be protected with suitable closing devices having a fire protection rating of 3 hours. 4. The building is to be used for no other purpose than the storage of LPG/CNG cylinders. 5. The building must be mechanically ventilated to control the accumulation of flammable vapors. 6. The installations must be approved and accepted by the requirements of the AHJ, Gas supply company regulations, manufacturers/supplier's instructions/guidance, Chief Inspector of Boiler (CIOB) and Chief Inspector of Explosives Bangladesh (CIEB). 	Within 1 Months

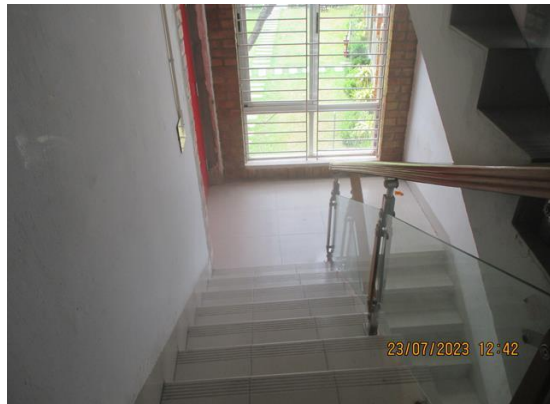
F-5	Means of Egress	A single means of exit has been provided. Location: Building-1, 2nd floor.	Provide an additional exit.	Within 1 Month
F-6	Means of Egress	Minimum 36-in. egress aisles is not provided in Shed 1,Packing section.	Provide minimum aisle width of 36-in.	Within 1 Month
F-7	Means of Egress	Handrails are not provided on the both side of exit stair.	Handrails shall be provided on both sides of each stairway.	Within 1 Month

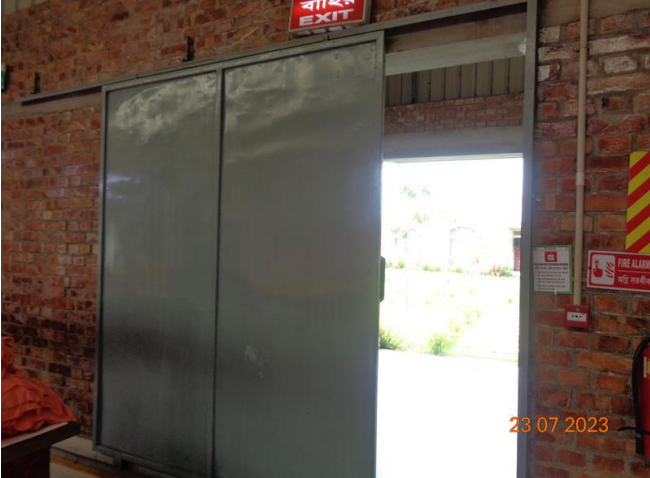
F-8	Means of Egress	Sliding Gate is provided in exit door. Location: Shed-3	Replace all gates / sliding doors along the means of egress with side-hinged, swinging egress doors in accordance with RSC standard 6.8.1. If locks are required for security reasons, utilize special door locking features complying with NFPA 101	Within 1 Month

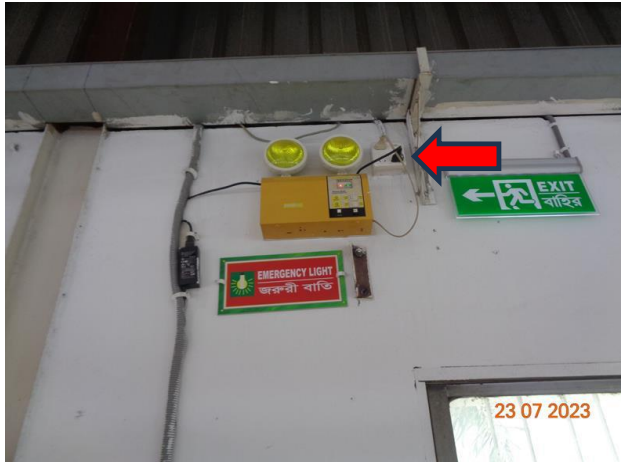
F-14	Egress Lighting	Manual on-off switch is provided for [emergency lighting / exit signage] units.	Remove manual on/off switches from emergency lighting / exit signage units to prevent them from being switched off.	Within 1 Month
