# INITIAL FIRE SAFETY INSPECTION REPORT

**Nafa Apparels Ltd. (Extension)**

**RSC ID: 24746**

**Date: 20th August 2023**

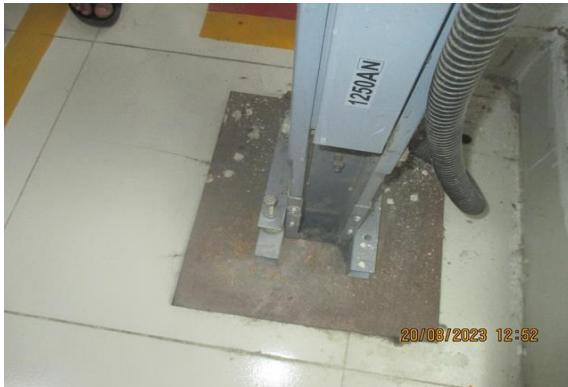
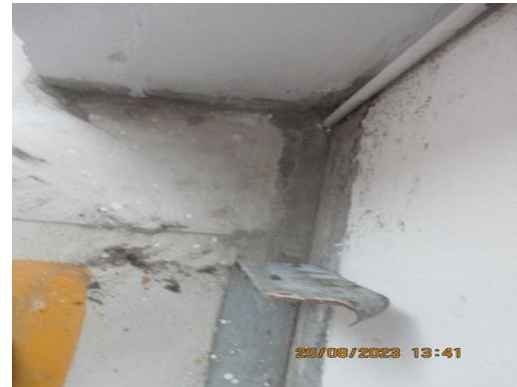
| SI No. | Category | Findings | Required Action | Remediation Time Frame |
|---|---|---|---|---|
| F-1 | Fire Rated Construction. | Building expansion joint & BBT riser are sealed by fire rated sealant/material. The factory has claimed that Building expansion joint & BBT riser are sealed by fire rated materials, which requires to be verified.<br><br>Location: Busbar penetration & Expansion joints. | Seal all penetrations and openings in floor/ceiling assemblies to maintain the fire separation at least by 3-hr. The used sealer shall be 3rd party certified and installation shall be as per manufacturer's datasheet.(Type 1 Construction).<br>Or<br>Provide a minimum 2-hr fire rated shaft to separate the utility risers from each floor if required. (Type 1 Construction). | Within 3months |

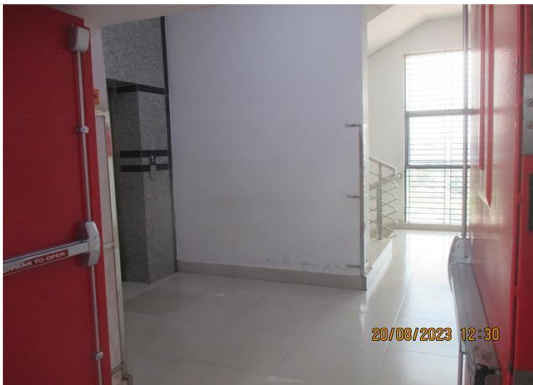
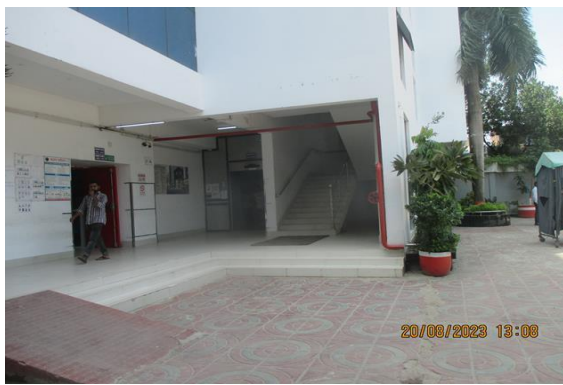
| F-2 | Fire Rated Construction | <p>Elevator shafts are directly open into the inside of exit enclosure.</p> <p>Location: East side of stair-1 of the new 6 storied RCC building.</p> | <p>Modify the elevator shaft as per RSC Technical Guideline (Standard) V1-6.14.3. An exit stairway shall not be built around a lift shaft unless both of them are located in a smoke proof enclosure and made of a material with fire resistance rating required for the type of construction of smoke proof enclosure. So, ensure the lift shaft is 2-hr fire rated including opening protection with similar rating.</p> | Within 3 months |

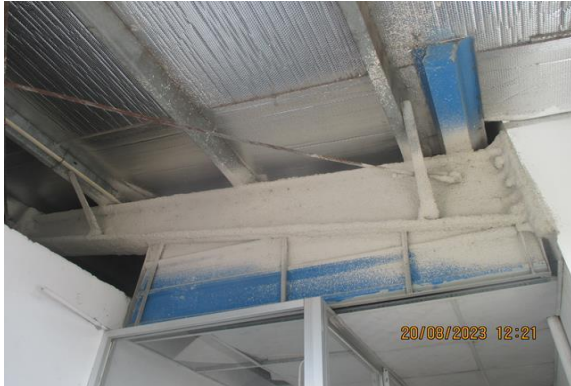
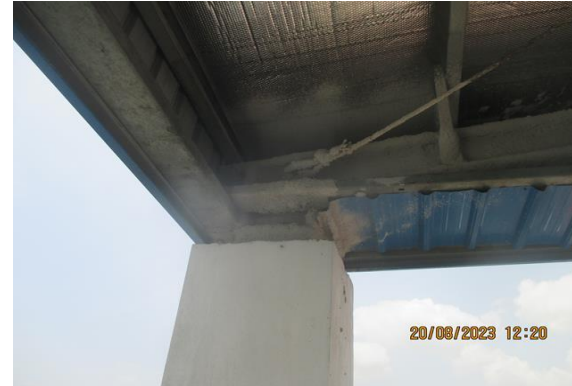
| F-3 | Fire Rated Construction. | <p>It was observed that one steel shed on the roof level which column is RCC, but rafter is steel structure. The factory has claimed that steel rafter is protected by fire rated materials, which requires to be verified.</p> <p>Location: Roof level of new 6 storied RCC building.</p> | <p>The building is a steel structure which shall be type-I construction. Prepare as built design drawing for the passive fire protection and submit RSC for review. Based on reviewed design the issue will be verified physically. Follow BNBC 2006-Table 3.2.4, 3.1.9 and 3.3.1 as reference.</p> | <p>Design within 1 month and application/modification within 4 months after review.</p> |

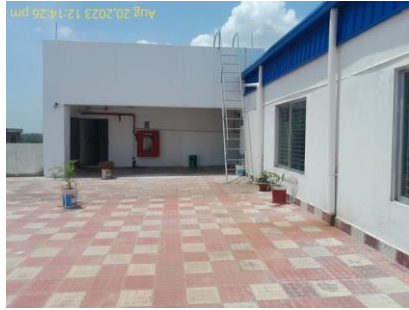
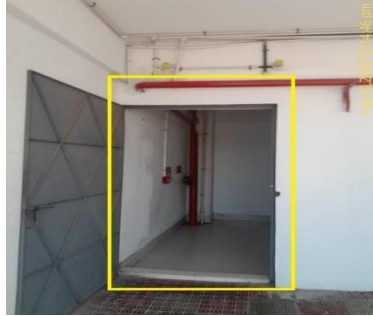
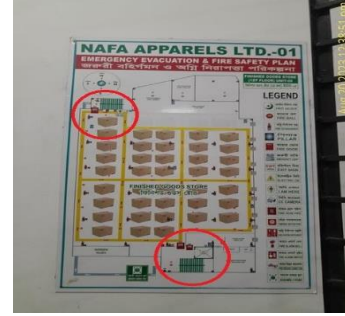
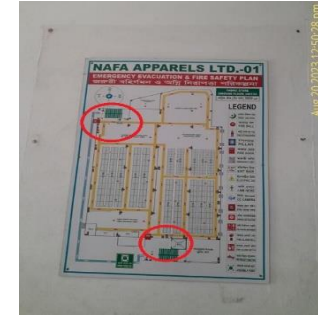
| F-4 | Mean of Egress | <p>The exit stairs are not separated from work areas, other spaces on each floor by fire rated construction due to unprotected opening.<br/>Location: New 6 storied RCC building.</p> | <p>The exit stair enclosure shall be provided with a minimum of 2- hr. fire resistance rating with 90 minutes opening protection.<br/>The clearance under the bottom of a fire door shall be a maximum of 19mm.<br/>Ensure that the fire doors are self-closing and positive latching and that they are provided with fire exit (panic) hardware where serving production floors. If fire doors are required to be held open for functional reasons, provide automatic closing devices tied to the fire alarm system.<br/><b>Openings from exit enclosure to storage spaces shall be provided with a vestibule with fire rated construction as per RSC Technical Guideline (Standard) V1-6.14.3 .</b></p> | Within 3 months |

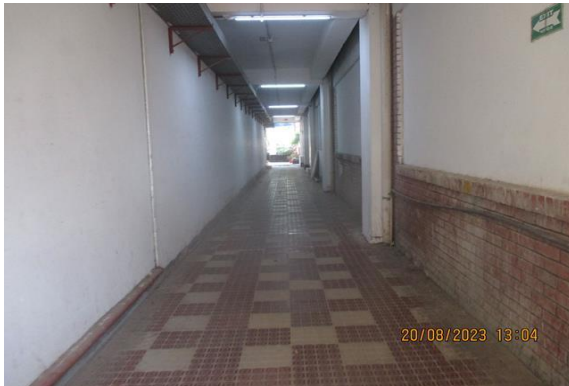
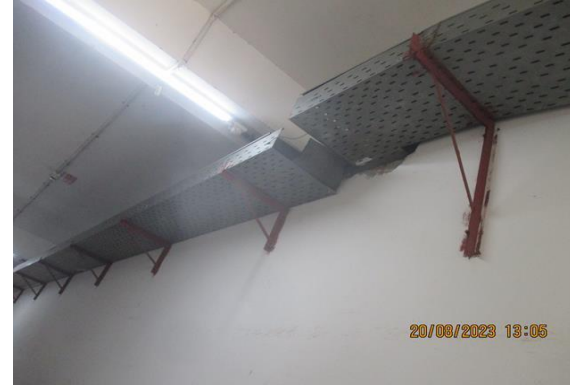
| F-5 | Mean of Egress | <p>The exit discharge path (passageway) is not properly separated due to power cable in the discharge passageway.</p> <p>Location: South side in-between 6 storied building &amp; 3 storied old building.</p> | <p>Relocate the electrical power cables / BBT from the passageway or seal them by masonry construction at least by 2 hour fire construction.</p> | Within 3months |

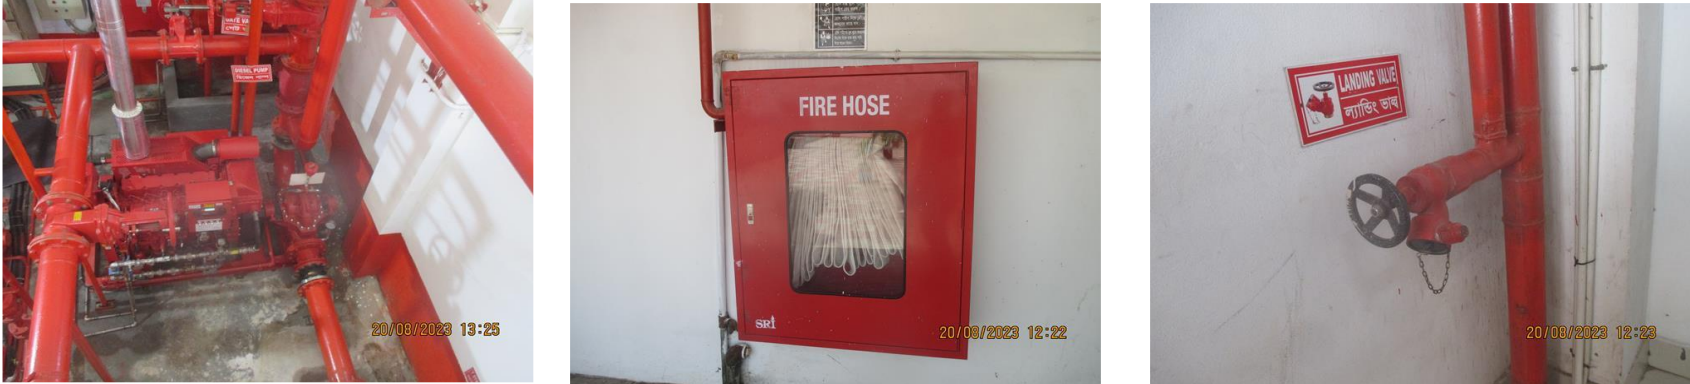
| F-6 | Fire Protection System(Standpipe) | Standpipe system installation requires detailed review to confirm compliance with NFPA 14 ,20 ,22 & 24 or as per RSC standard. | <p>Submit the standpipe system drawing to RSC for review.</p> <p>Once the design is reviewed, install and modify the standpipe system throughout the building in accordance with review comment, RSC Standard and NFPA 14,20,22 and 24.</p> <p>After installation the owner shall conduct internal testing and commissioning and then contact the RSC for witness of final acceptance testing.</p> | Design Review within 1 month and modification within 3 months (If require). |

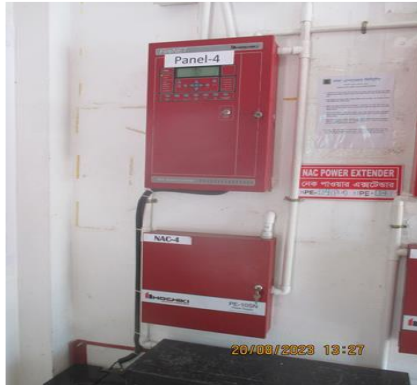
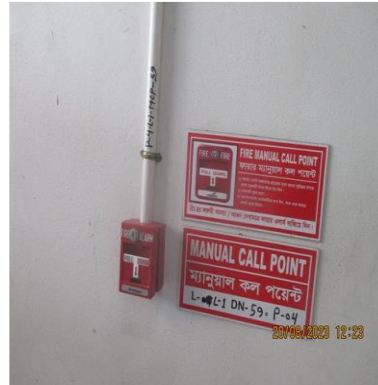
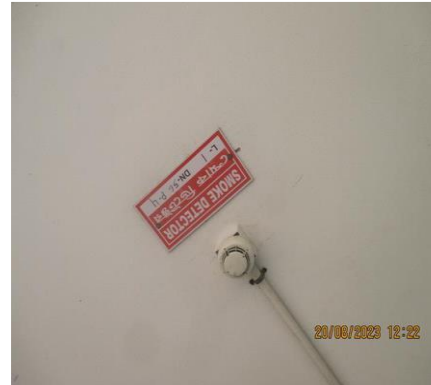
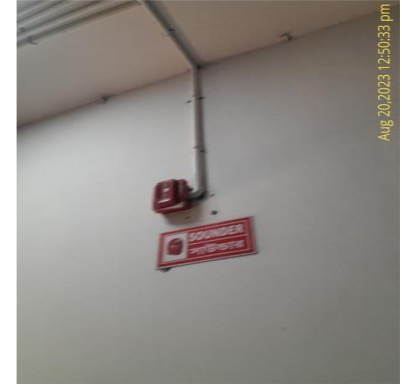
| F-9 | Fire Alarm & Detection System (FADS) | Addressable fire alarm & detection system installation requires detailed review to confirm compliance with NFPA 72 and RSC standard. | <p>Submit design, documents and calculations to RSC for review prior and based on the review modify the system if there is any.</p> <p>After installation the owner shall contact the RSC for witness of conducting the final acceptance testing of the fire detection &amp; alarm system installation.</p> <p>Also inspect, test and maintain the fire alarm system, and keep written records on-site, in accordance with NFPA 72.</p> | Design Review within 1 month and modification within 3 months (If require). |
