INITIAL FIRE SAFETY INSPECTION REPORT

Mega Denim Ltd (Extension)

RSC ID: 24763

Factory Name: Mega Denim Ltd (Extension)
RSC ID: 24763

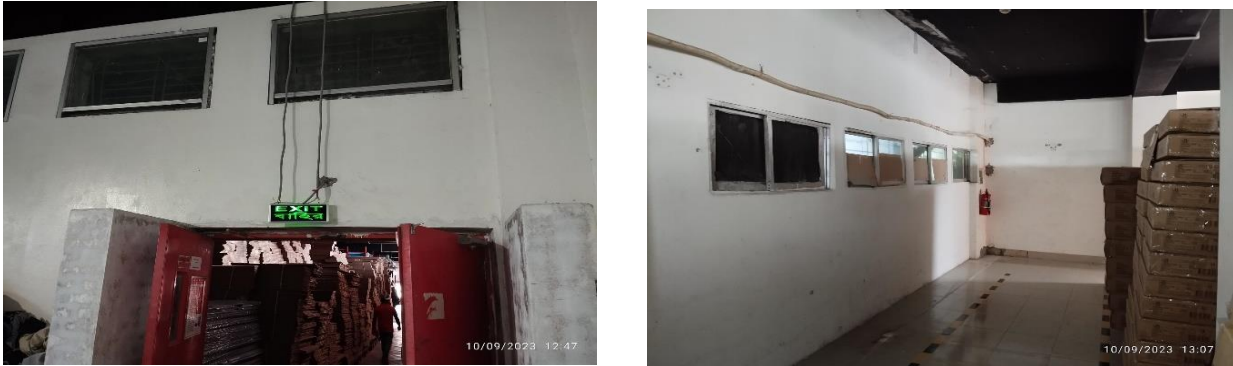
| SI No. | Category | Findings | Required Action | Remediation Time Frame |
|---|---|---|---|---|
| 1 | Fire Rated construction | BUILDING-2 Rooms used for storage of combustible materials are not separated from the surrounding occupancy/areas. Location: Building-2 (Ground Floor & 2nd Floor) | Rooms used for storage of combustible materials shall be separated from the surrounding occupancy with a minimum 1 hour construction. | Within 3 months |

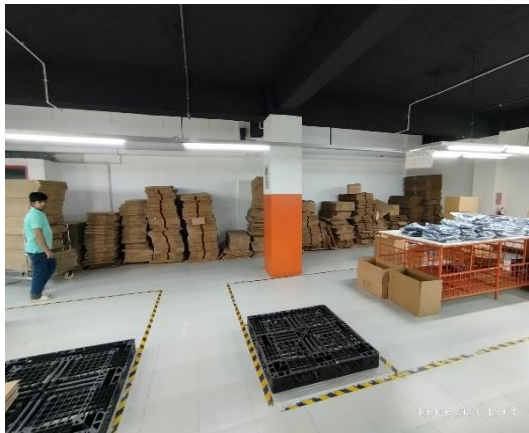
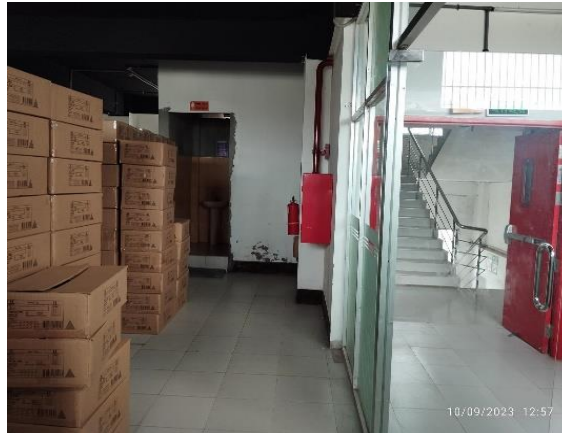
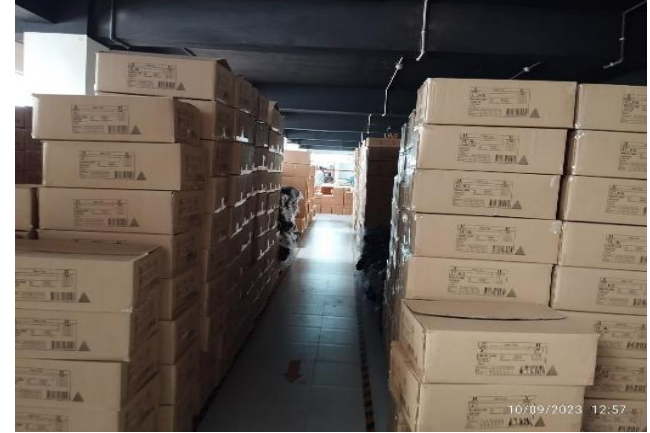
| 2 | Fire Rated construction | Areas used for in-process storage of combustible materials are open to the surrounding occupancy. Location:Building-2 (1st Floor) | <p>Provide defined storage areas and limit the storage arrangement as follows:-</p> <ol style="list-style-type: none"> 1. General Condition: Maximum height of 2.4 m and maximum area of 23m². Separate areas of unenclosed combustible storage by a minimum clear distance of 3m. 2. If sprinkler protected: maximum height of 3.66m and maximum area of 93m². Separate areas of unenclosed combustible storage by a minimum clear distance of 3m. or 3. Enclose the storage area from the surrounding occupancy with a minimum 1 hour construction. | Within 3 months |

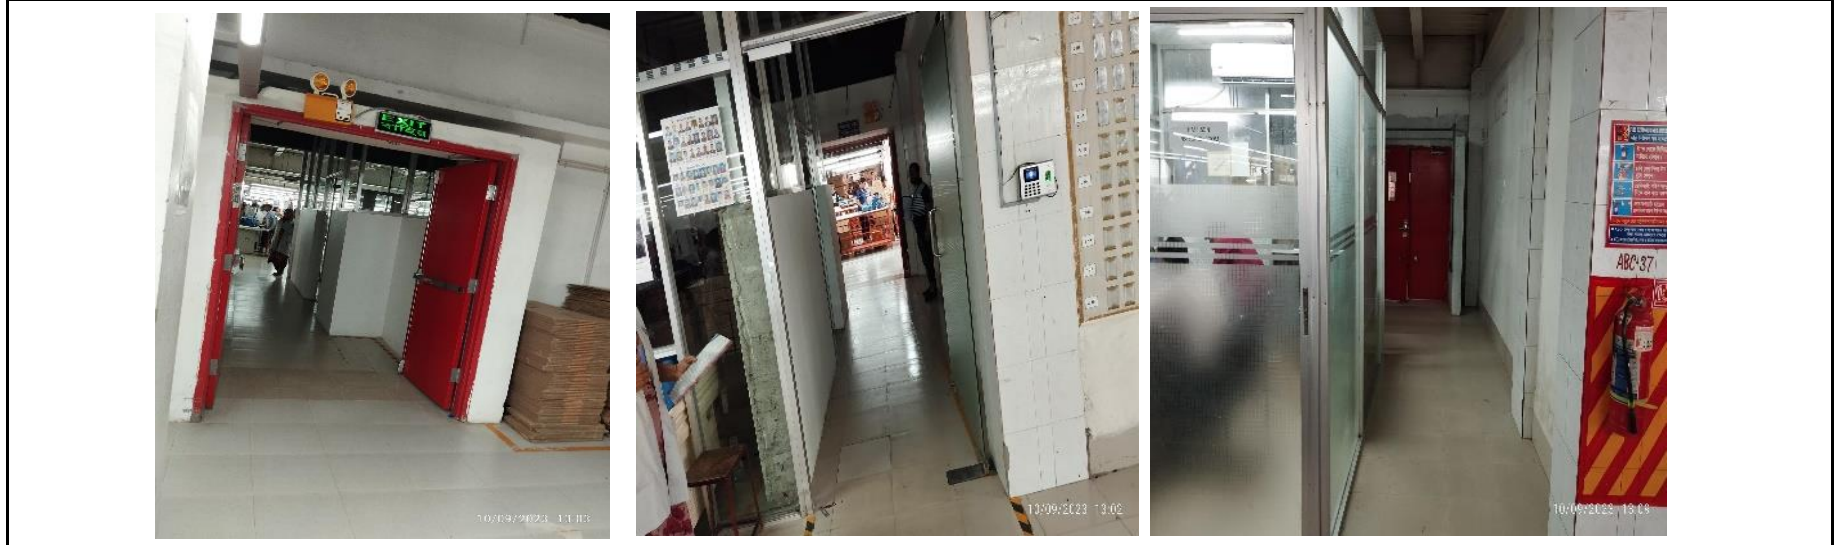
| 3 | Fire Rated construction | Corridor(s) serving more than 30 occupants is not separated by fire rated construction. Location: Building-2 (Several floor). | <ol style="list-style-type: none"> 1. Separate the corridor by a minimum 1-hr fire rated construction. Or 2. Provide automatic sprinkler system throughout the story as per NFPA 13 | Within 3 months |

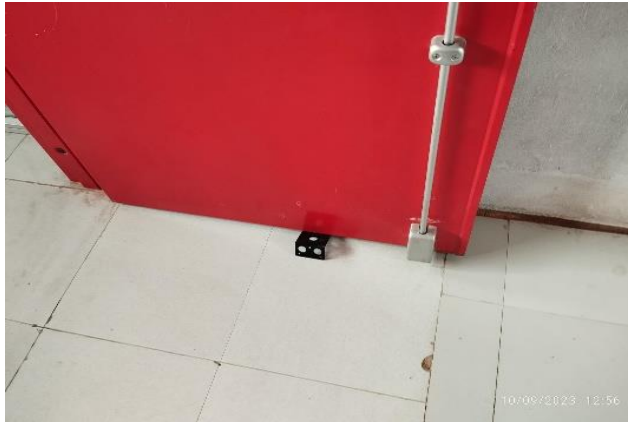
| 4 | Means of Egress | The fire doors were found tied by unauthorized means (door wedges, door stopper) and also interfacing with the fire alarm system & door closers were not properly functional during the inspection. Location: Building-2 | Ensure that the fire doors are self-closing and positive latching. If fire doors are required to be held open for functional reasons, provide automatic closing devices tied to the fire alarm system. | Immediately |

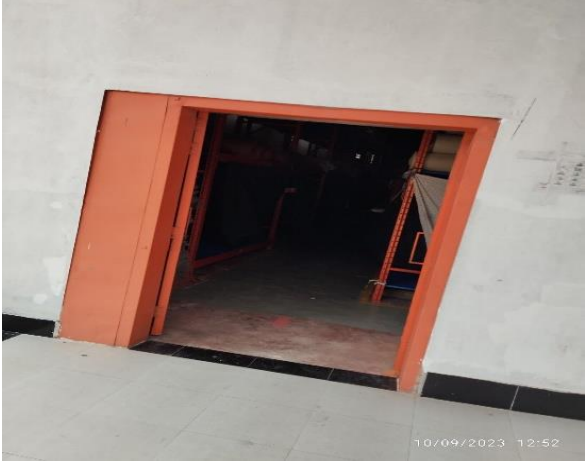
| 5 | Fire Rated construction | Storage/ storage rooms from ground floor discharges directly into the exit enclosures. Location: Building-2 (Ground Floor) | <p>Openings from exit enclosure to storage room, generator, basements, transformer boiler and similar normally unoccupied spaces shall be provided with a vestibule with fire rated construction and openings as per RSC Technical Guidelines (Standard) 6.14.3.</p> <p>Provide a 1.5 hr. fire rated door on the exit stair side and a 1-hr. fire rated door on the storeroom/storage side. Ensure that the fire rating of the vestibule construction matches that of the exit stair enclosure.</p> | Within 3 months |

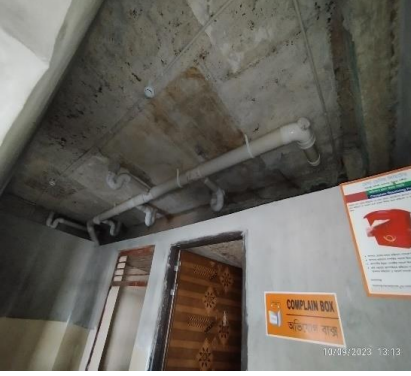
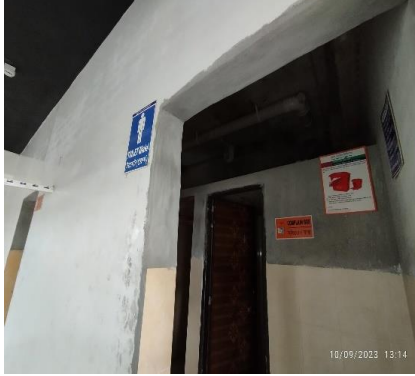
| 6 | Fire Rated construction | <p>Penetrations through floor/ceiling assemblies are found unsealed. Location: Building-2 (4th Floor)</p> | <p>Seal all penetrations and openings in floor/ceiling (full thickness of the floor/ceiling) assemblies by third-party certified fire rated materials to maintain the fire resistance rating. Provide a minimum 2-hr fire rated shaft to separate the utility risers from each floor if required.</p> | Within 3 months |

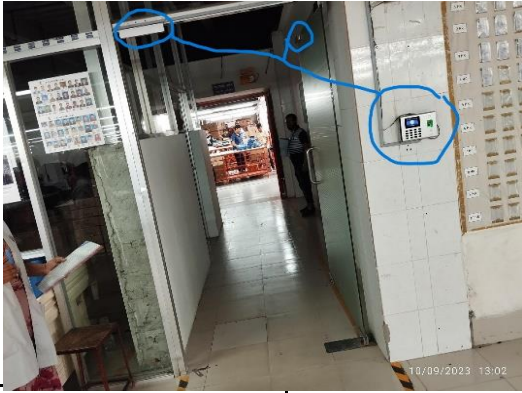
| 7 | Means of Egress | Doors along means of egress are provided with non compliant locking system. Location: Building-2; Access control devices has been used on the glass door at the end of exit access corridors. | <ol style="list-style-type: none"> 1. Remove all non compliant locking features from egress doors. 2. If locks are required for security reasons, utilize special door locking features complying with NFPA 101. 3. Doors may be locked where the latch and lock are disengaged with one motion where the occupant load does not exceed 49 persons. 4. Doors may be provided with locking hardware from the ingress side provided that a panic bar is installed on any door with an occupant load exceeding 49 persons. | Immediately |

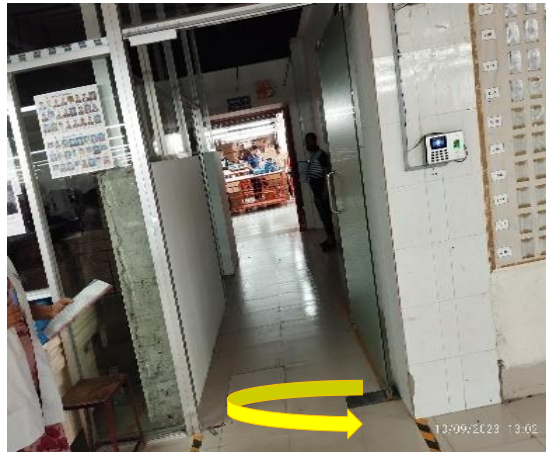
| 8 | Fire Rated construction | Egress door serving 50 or more occupants but does not swing in the direction of egress travel. Locations: Glass door at the end of exit access corridors. | Modify swing direction of egress doors to the direction of egress travel. Doors serving an occupant load of more than 50 shall swing in the direction (out-ward) of egress travel . | Within 3 months |

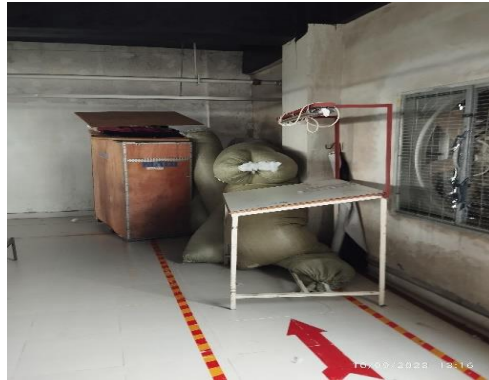
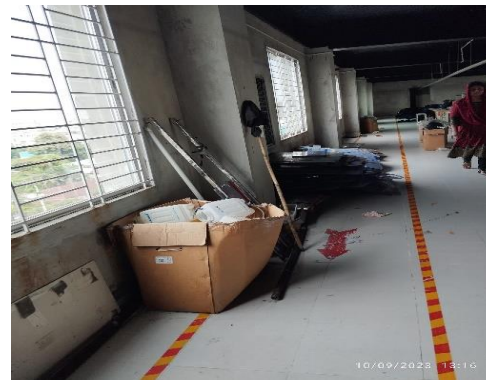
| 10 | Means of Egress | The egress path along means of egress has interrupted by obstruction/storage. Location: Building-2 (5th Floor) | Means of egress shall be maintained continuously free and clear of all obstructions/storage. Or Keep egress paths and stairs clear of storage. | Immediately |

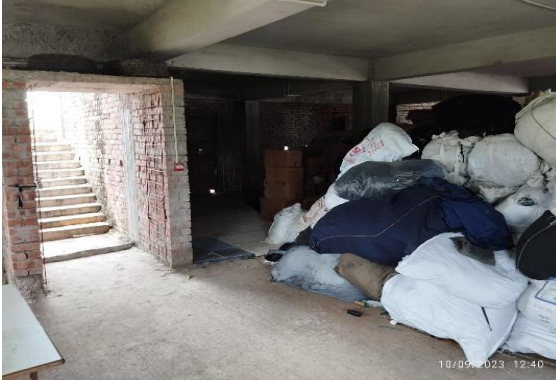
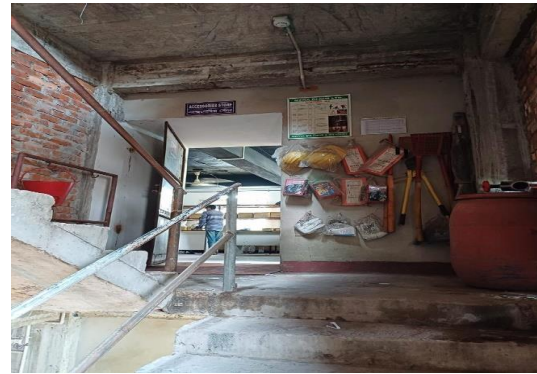
| 11 | Fire Rated construction | <p style="text-align: center;">BUILDING-3</p> <p>The exit stairs are not separated from store areas on each floor by fire-rated construction.</p> | <p>Provide minimum 2-hr fire rated construction for buildings 4 storied or more and 1-hr for up to 3 storied. Seal all unprotected openings to separate the exit stairs from work areas and other spaces on all floor levels by 90 minutes for 2 hr. construction and 60 minutes for 1-hr construction. Ensure that the fire rated doors are self-closing and positive latching and that they are provided with fire exit (panic) hardware where serving production floors and provide vestibules to avoid direct discharge from storage to exit stair enclosure. If fire rated doors are required to be held open for functional reasons, provide automatic closing devices tied to the fire alarm system. Once fire doors are installed, every door in a stair enclosure serving more than 5 stories shall be provided with re-entry unless it meets The RSC Technical Guidelines (Standard) 6.8.3.1</p> | Within 3 Months |

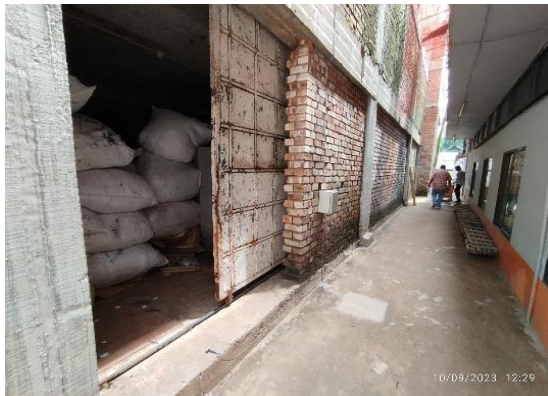
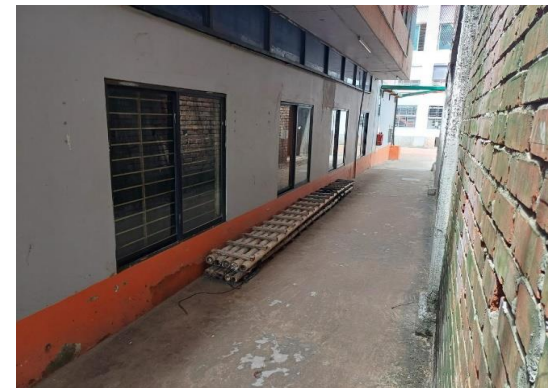
| 12 | Means of Egress | <p>The egress court for westside were less than 10 ft. wide but not separated from the building interior. Location: Building-3 (West side)</p> | <p>Provide a 1.5 hr. fire rated door on the store side and Seal all penetrations and openings to the interior of the building along the discharge path up to a height of 10 ft. to provide a minimum 2-hr fire separation.</p> | Within 3 Months |

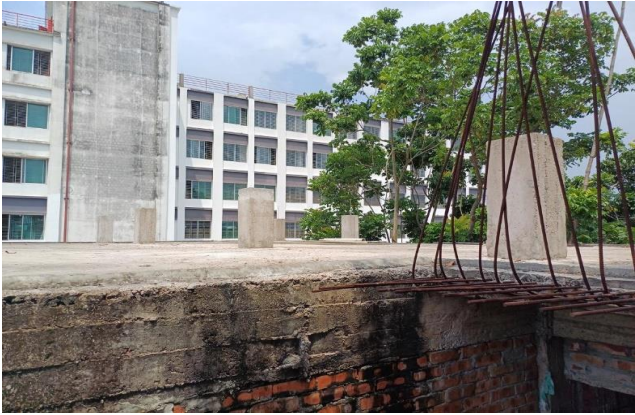
| 13 | Means of Egress | Parapets or guards are not provide in occupiable roof. Location: Building-3 | All occupiable roofs shall be provided with parapets or guards with a minimum height of 1067 mm (42 in.) | Within 3 Months |

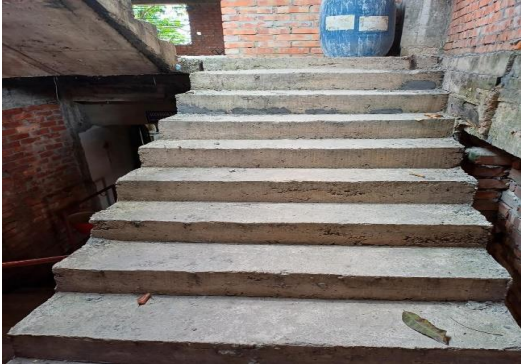
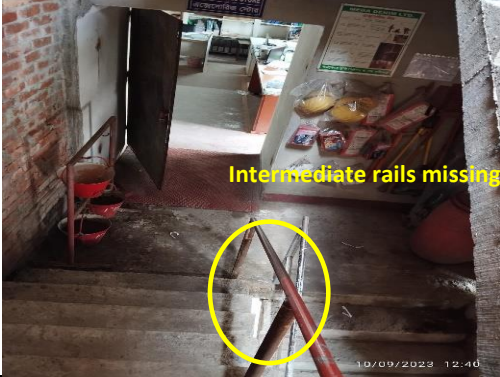
| 15 | Means of Egress | <p>Handrails are not provided throughout the exit stair. Additionally at many location intermediate rails are not provided.</p> <p>Location: Building-3</p> | <p>Provide handrails on both sides of the exit stair. Intermediate handrails shall be provided when the stair width exceeds 2.2 m (87 in.). New handrails shall have a minimum height of 865 mm (34 in.) and a maximum height of 965 mm (38 in.) as measured from the leading edge of the tread.</p> <p>Handrails shall have intermediate rails or pattern such that a sphere 200 mm (8 in.) in diameter cannot pass through any opening up to a height of 865 mm (34 in.).</p> | Within 1 month |

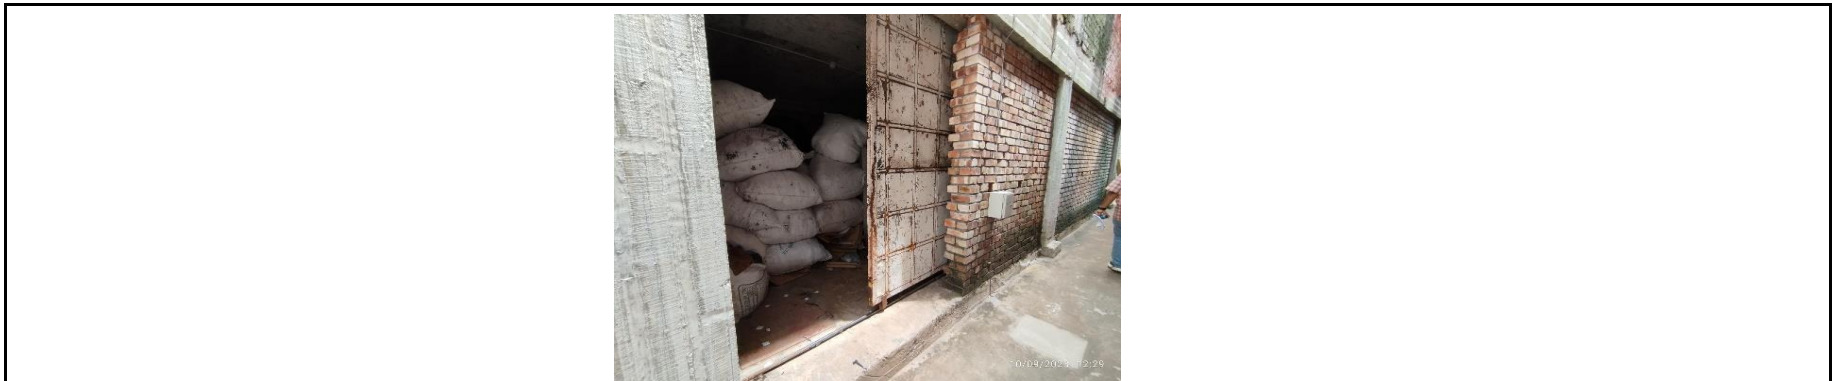
| 16 | Means of Egress | <p>Sliding type doors have provided along means of egress [Storage, building exits, exit discharge].</p> <p>Location: Building-3 (Ground floor, Wastage Godown)</p> | <p>Replace all collapsible/sliding/shutter type doors & gates by the side-hinged swinging type doors.</p> <p>If locks are required for security reasons, utilize special door locking features complying with NFPA 101.</p> | Within 1 Month |

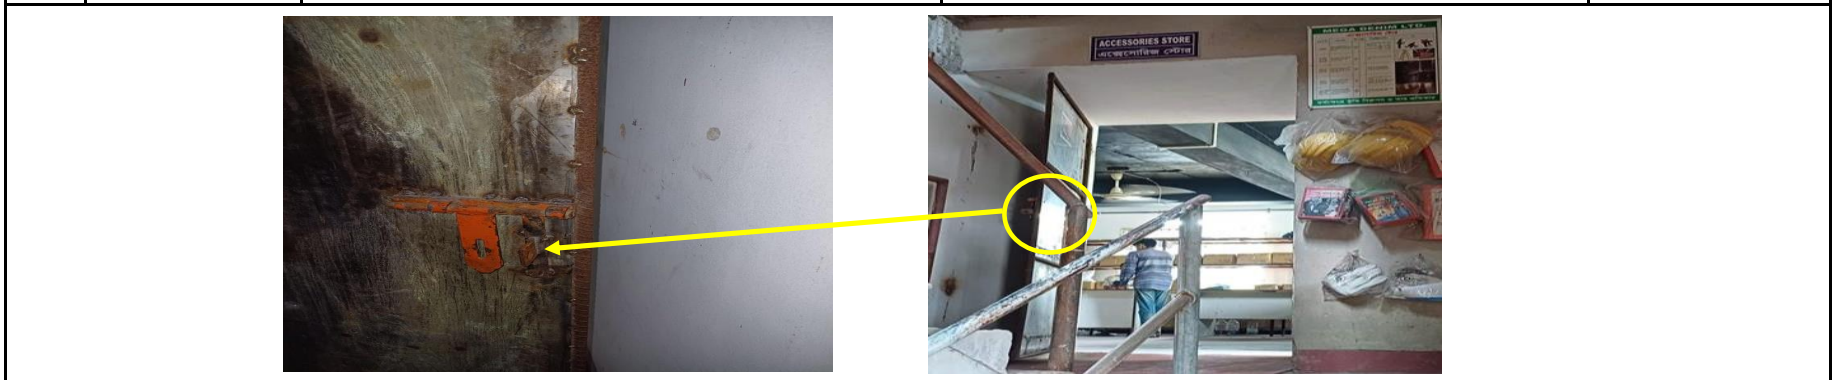
| 17 | Means of Egress | <p>Doors along means of egress are provided with non compliant locking system. Location: Exit doors of Building-3</p> | <ol style="list-style-type: none"> 1. Remove all non compliant locking features from egress doors. 2. If locks are required for security reasons, utilize special door locking features complying with NFPA 101. 3. Doors may be locked where the latch and lock are disengaged with one motion where the occupant load does not exceed 49 persons. 4. Doors may be provided with locking hardware from the ingress side provided that a panic bar is installed on any door with an occupant load exceeding 49 persons. | Immediately |

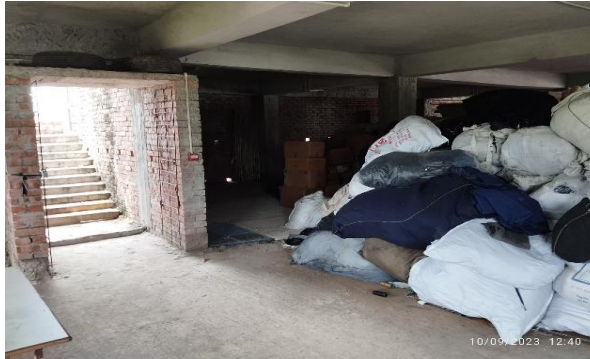
| 21 | Egress Lighting | Exit sign not provided at exit. Location: Building-2&3 | Lighted exit signs shall be placed at entrance to an exit. Additional exit signs shall be placed throughout the facility anywhere the continuation of the egress is not obvious. Lighted exit signs shall be provided with either battery backup or uninterruptable power supply systems and shall be continuously illuminated. | Within 1 Month |

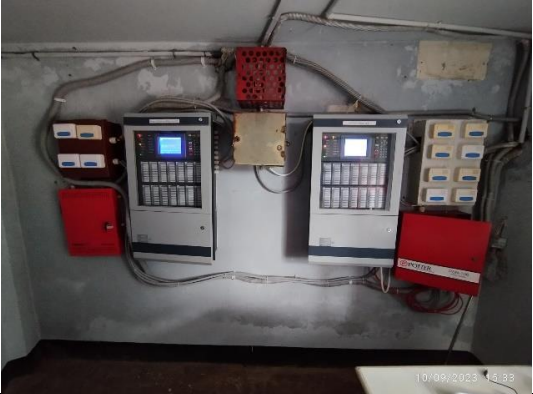
| 23 | Fire Alarm & Detection System (FADS) | The fire detection system installation requires detail review to confirm compliance with NFPA-72 and other applicable standard. Location: For all buildings | Submit as-built drawings, testing records, equipment certification and other relevant documentation to the RSC for review and then approval/acceptance test. | Drawing review within 2 months and Install/modification within 6 months. |

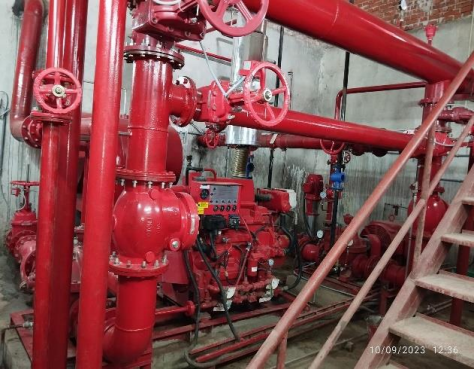
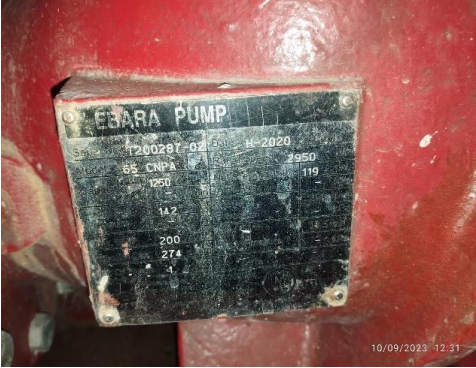
| 24 | Fire Suppression System (SUPS) | <p>Standpipe system and fire pump installation requires to detailed review to confirm compliance with NFPA 14, 20, 22, 24 and RSC standard.</p> <p>Location: For all buildings</p> | <p>Submit the standpipe system drawing to RSC for review. Once reviewed, install or modify the standpipe system throughout the building in accordance with RSC standard, NFPA 14 and 20. The factory management shall contact RSC to conduct the final acceptance testing after the installation, testing & commissioning</p> | <p>Review within 2 months and Install within 6 months</p> |
