# INITIAL FIRE SAFETY INSPECTION REPORT

## Teen Age Modern Fashion - Extension

**RSC ID: 24666**

**Purbohati, Hemayetpur, Savar, Dhaka-1340**

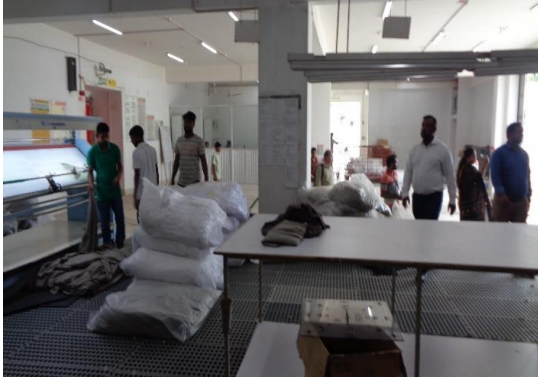
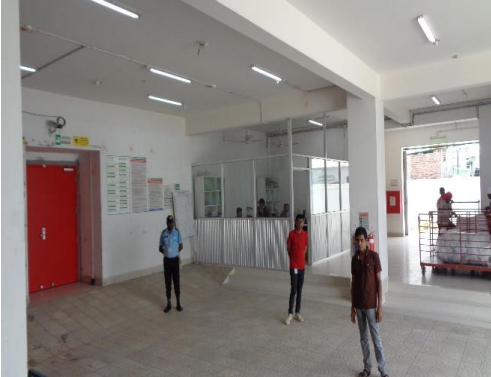
| SI No. | Category | Findings | Required Action | Remediation Time Frame |
|---|---|---|---|---|
| F-1 | Fire Rated Construction | Exit-1 from stair-1 was not discharge directly to the exterior of the building on ground floor. | Exits shall discharge directly to the exterior of the building. The exit discharge shall be at grade or provide direct access to grade. Exit discharge shall not reenter a building in accordance with RSC Technical Guideline (Standard)-6.17. | Within 3 months |

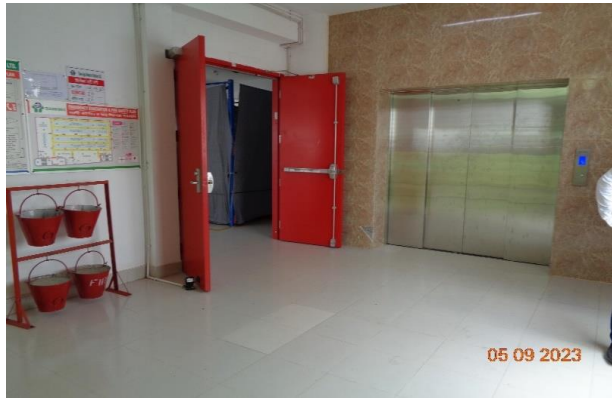
| SI No. | Category | Findings | Required Action | Remediation Time Frame |
|---|---|---|---|---|
| F-2 | Fire Rated Construction | Elevator shafts are directly open into the inside of Stair-1. | For new construction, elevators shall not open into an exit enclosure as per RSC-6.14.3. So, separate the stair enclosure from elevator shaft throughout the building. | Within 3 month |

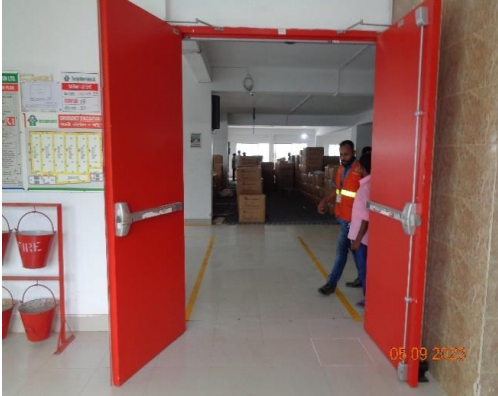
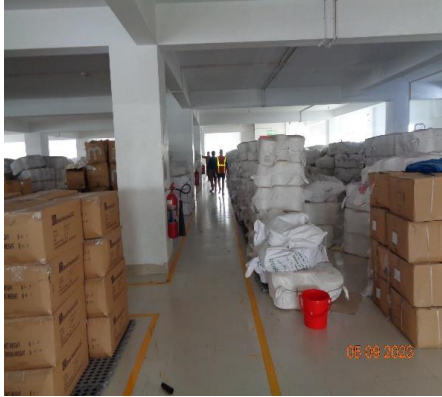
| F-3 | Fire-Rated Construction | Openings from exit enclosures to storage areas was not provided with vestibules on ground, 1st and 2nd floor. | Openings from exit enclosures to storage areas, basements, transformer rooms, generator rooms, boiler rooms, and similar normally unoccupied spaces shall be provided with vestibules in accordance with RSC Technical Guideline (Standard)-6.14.3. | Within 3 months |

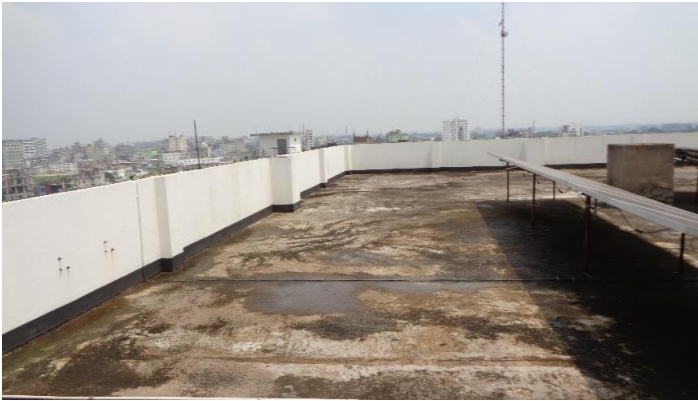
| F-4 | Means of Egress | Parapets or guards are provided in occupied roof which is less than 1067mm (42 inch.). | Provide parapets or guards with a minimum height of 1067mm (42 inch.). | Within 3 months |

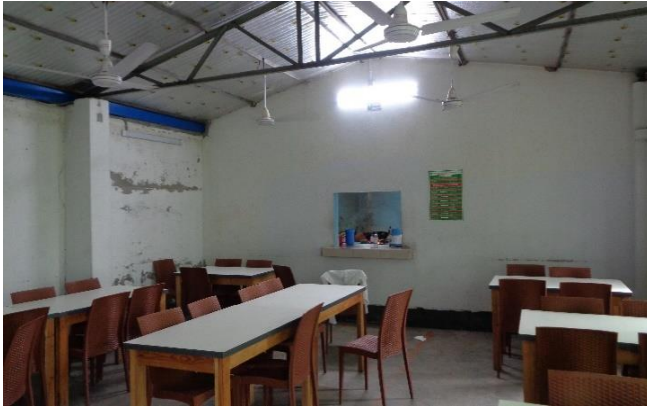
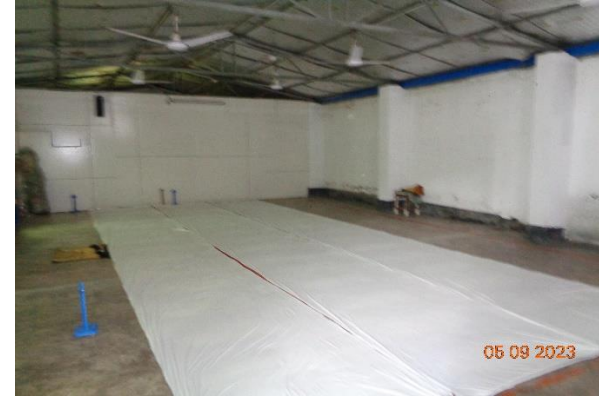
| F-5 | Fire Rated Construction | Kitchen and Mosque were not fire-rated separated on ground floor Shed-3. | Each portion of a building or structure shall be classified individually according to Section 3.3. When a building contains more than one occupancy, the building or portion shall comply with the applicable requirements in accordance with RSC Technical Guideline (Standard) of 3.4.2, 3.4.2.1.10, or 3.4.4. | Within 3 months |

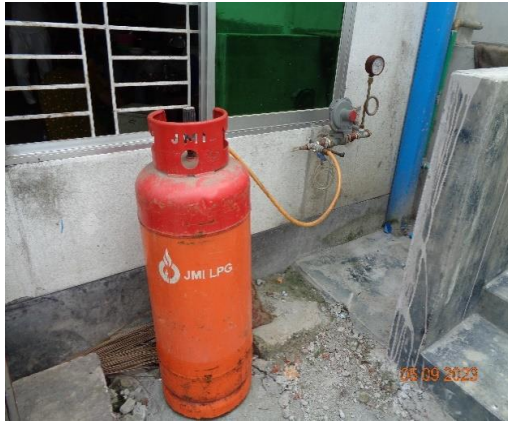
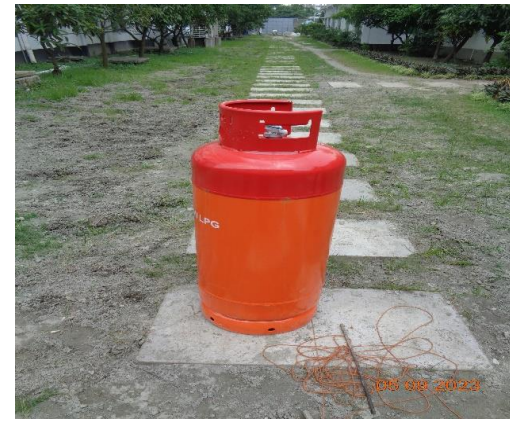
| F-6 | Fire Rated Construction | <p>Liquefied or compressed gas cylinders were located within the factory. Location: Kitchen Shed-3.</p> | <p>LPG/CNG cylinders are permitted to be stored in a separate dedicated building on the factory premises within its boundaries if the building meets the following conditions.</p> <ol style="list-style-type: none"> <li>1. The storage building must be at least 3 meters away from any other building and boundaries.</li> <li>2. The exterior walls of the building must have a fire resistance rating of 3 hours using noncombustible construction.</li> <li>3. Doors and other openings in the exterior walls must be protected with suitable closing devices having a fire protection rating of 3 hours.</li> <li>4. The building is to be used for no other purpose than the storage of LPG/CNG cylinders.</li> <li>5. The building must be mechanically ventilated to control the accumulation of flammable vapors.</li> <li>6. The installations must be approved and accepted by the requirements of the AHJ, Gas supply company regulations, manufacturers/supplier's instructions/guidance, CIOB and all other applicable agencies, codes and standards.</li> </ol> | Within 1 month |

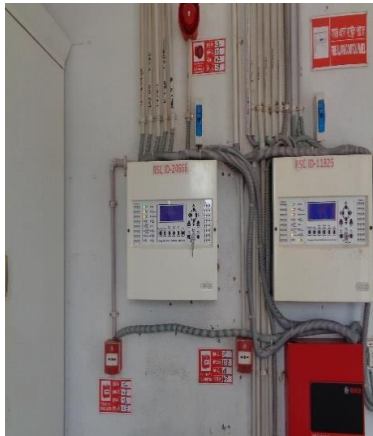
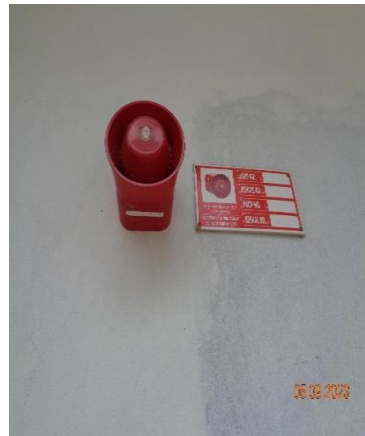
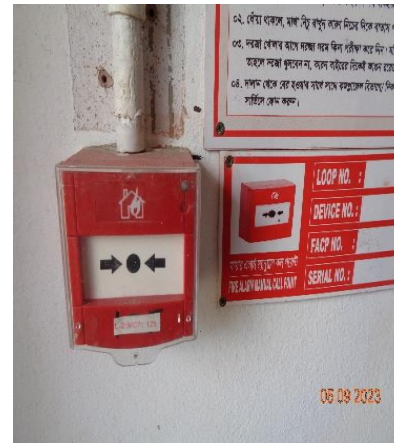
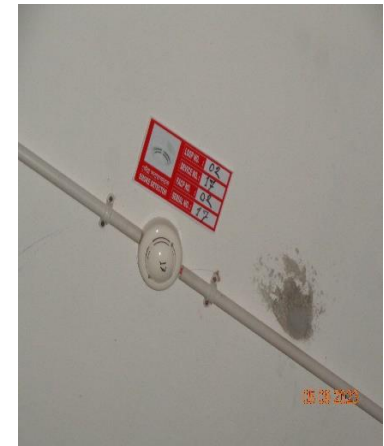
| F-9 | Fire Alarm & Detection System (FADS) | Automatic fire alarm & detection system installation requires detailed review to confirm compliance with NFPA 72 and RSC standards. | <p>Design &amp; Installation of Fire Alarm &amp; Detection system shall be in accordance with RSC standard and NFPA 72. Submit as-built design, documents and calculations to RSC for review prior installation/modification.</p> <p>After installation, the owner shall contact the RSC for witness of conducting the final acceptance testing of the fire detection &amp; alarm system installation.</p> <p>Also inspect, test and maintain the fire alarm system, and keep written records on-site, in accordance with NFPA 72.</p> | Design-1 Month, Modification if required-3 Months |

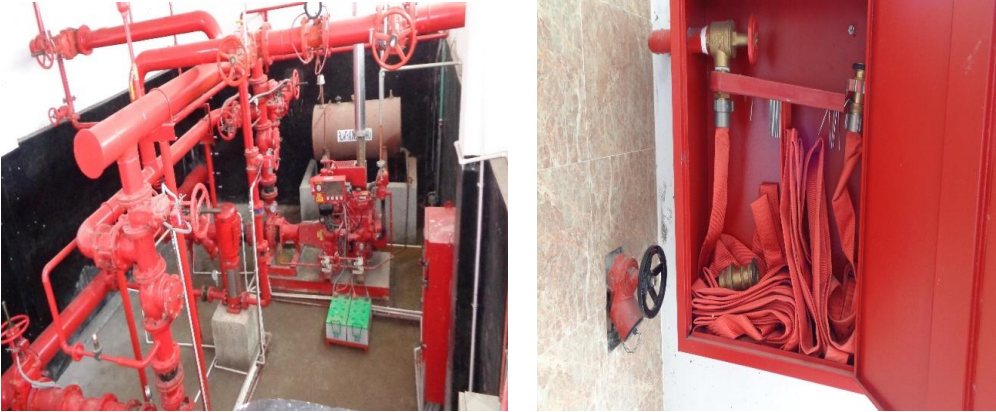
| F-11 | Fire Protection System(Standpipe) | Standpipe system installation requires detailed review to confirm compliance with NFPA 14 and RSC standards. | Submit as-built drawings, testing records, equipment certification and other relevant documentation to the RSC for review and approval. | Design-1 Month, Modification if required-3 Months |
