# FIRE SAFETY INSPECTION REPORT

## Best Wool Sweaters Ltd. (New Building)

Jarun, Konabari, Gazipur

Date: 26 September 2023

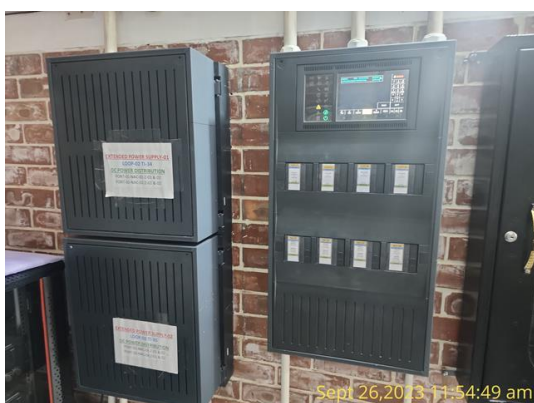
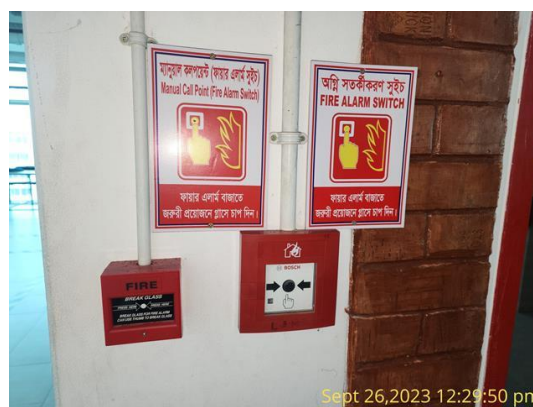
| No. | Category | Finding | Recommendation | Remediation Timeframe |
|---|---|---|---|---|
| F-1 | Fire Protection | The fire alarm and detection system installation requires detailed review to confirm compliance with NFPA 72 and RSC Technical Guidelines (Standard). | Submit as-built drawings, testing records, equipment certification and other relevant documentation to the RSC for review and then approval/acceptance test. | Drawing Within 2 months<br>Install Within 3 months |

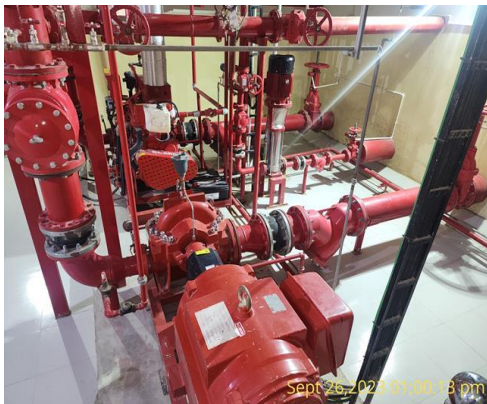
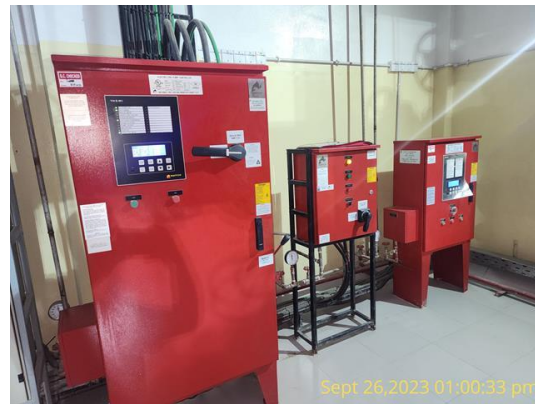
| F-2 | Fire Protection | The fire pump set installation requires detailed review to confirm compliance with NFPA 20 and RSC Technical Guidelines (Standard). | Submit as-built drawings, testing records, equipment certification and other relevant documentation to the RSC for review and then approval/acceptance test. | Within 2 months |

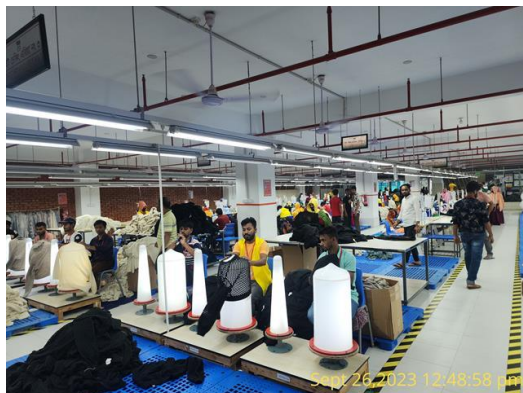
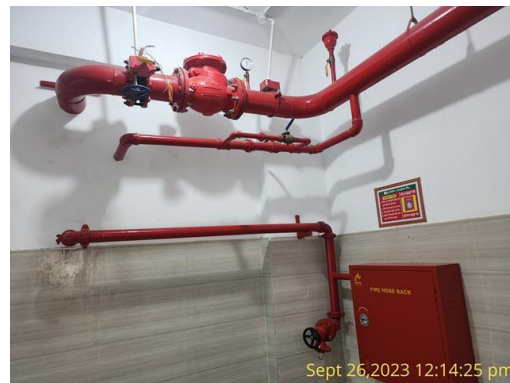
| F-3 | Fire Protection | The firefighting system (sprinkler & standpipe) installation requires detailed review to conform compliance with NFPA 13, NFPA 14. | Submit as built drawing, testing records, equipment certification and all relevant documents to the RSC for review, approval and acceptance test. | Drawing Within 2 months<br>Install Within 3 months |

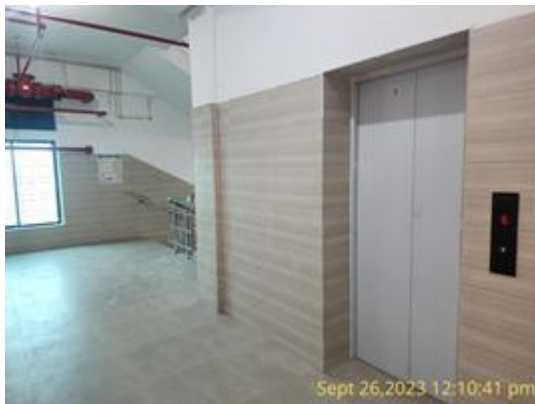
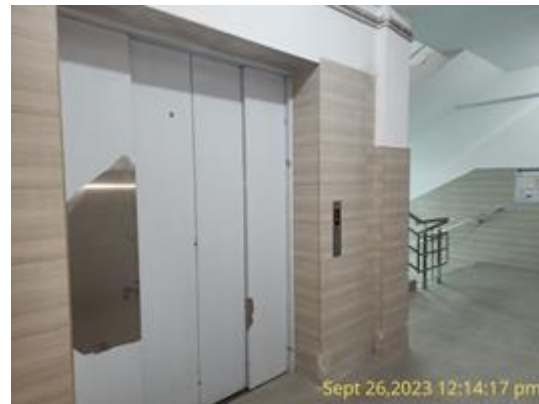
| F-7 | Egress | Elevator shaft is provided in the exit stair enclosures and directly open to exit stair enclosure. | Modify the elevator and stair enclosure arrangement in a way to satisfy RSC standard 6.14.3.<br>Or<br>Separate the elevator by 1.5-hr fire rated opening protection from factory floors and exit stairs.<br>There is a variety of opening protective types i.e., fire rated lift landing doors, fire doors with vestibules, fire rated curtain combination for both heat & smoke control with integration with fire alarm control panel. | Within 3 months |

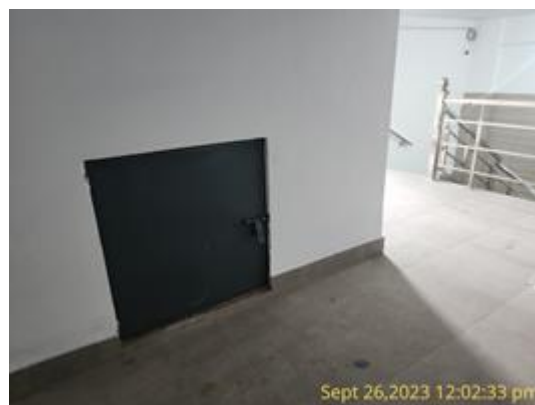
| F-10 | Fire Rated | Lift machine rooms not separated from exit stair enclosures. | Separate lift machine rooms by minimum 2-hr fire rated construction. | Within 3 months |

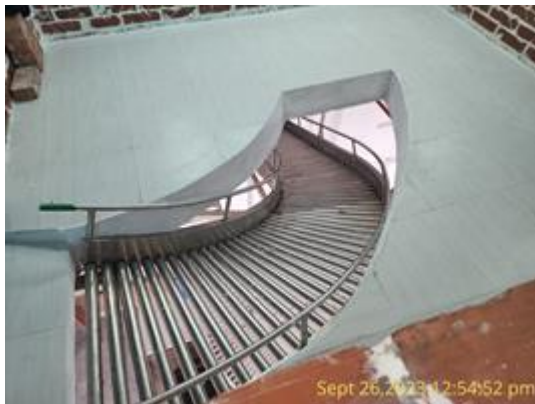
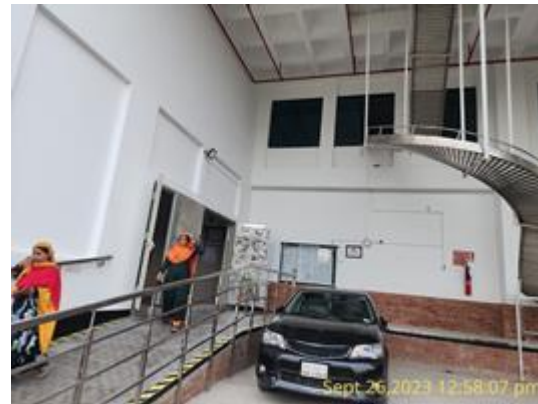
| F-13 | Fire Rated Construction | Unsealed opening is located in the fire-rated floor/ceiling assemblies. | Provide a minimum 2-hr fire-rated shaft to separate the opening from each floor level and seal all penetrations in floor/ceiling assemblies to maintain the fire separation. | Within 3 months |
