INITIAL FIRE SAFETY INSPECTION REPORT

Factory Name: Reaz Knitwear Ltd

**ADDRESS: Holding#163, Block-B, Hatimara, Kashempur, Gazipur
23.989069, 90.2908881**

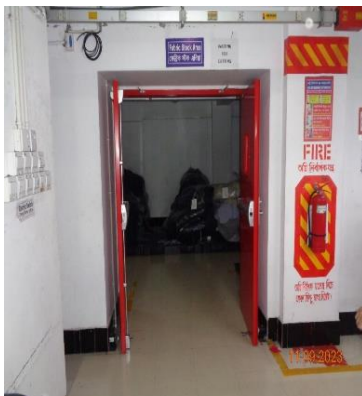
SI No.	Category	Findings	Required Action	Remediation Time Frame
F-01	Fire Rated Construction	Rooms used for combustible storage are not separated by fire rated construction on the ground floor. Location: 5th floor of factory building.	Provide dedicated storage rooms separated by minimum 1-hr fire-rated construction.	Within 3 months

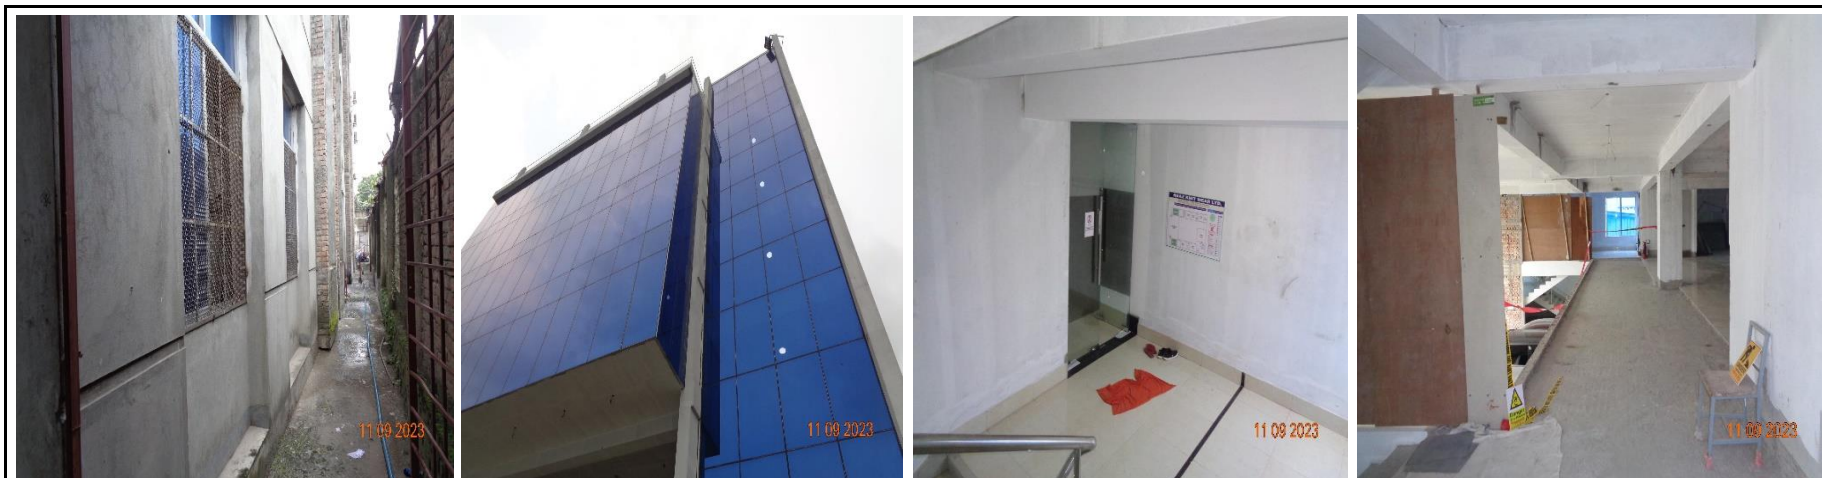
F-02	Fire Rated Construction	The exit stairs are not separated from work areas, other spaces on each floor by fire-rated construction. Location: Factory building and office building.	<p>Provide minimum 2-hr fire rated doors and seal all unprotected openings to separate the exit stairs from work areas and other building spaces on all floor levels. Ensure that the fire rated doors are self-closing and positive latching and that they are provided with fire exit (panic) hardware where serving production floors.</p> <p>If fire rated doors are required to be held open for functional reasons, provide automatic closing devices tied to the fire alarm system. Once fire doors are installed, every door in a stair enclosure serving more than 5 stories shall be provided with re-entry unless it meets RSC TECHNICAL GUIDELINES (STANDARD) 6.8.3.1</p> <p>If fire doors are required to be held open for functional reasons, provide automatic-closing devices tied to the fire alarm system.</p>	Within 3 months

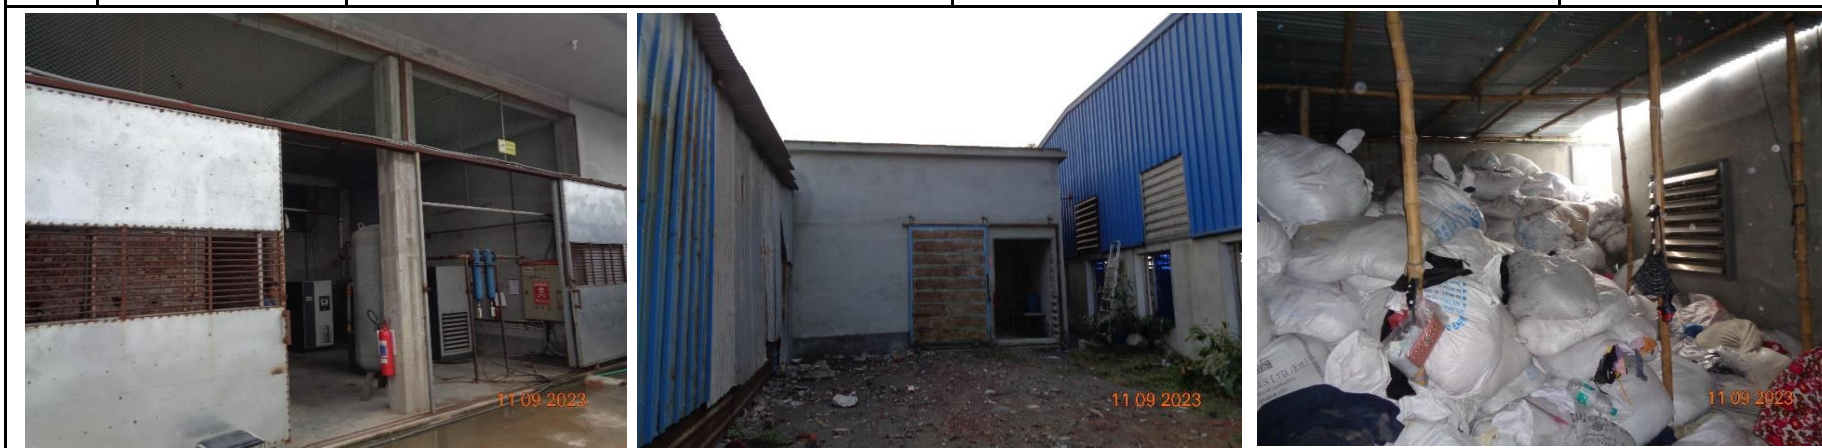
F-03	Fire Rated Construction	The boiler and air compressor room is not separated by fire rated construction (openings, non-rated doors, penetrations)	Separate the boiler room by a minimum 2-hr fire rated construction (for high rise building)/ 1-hr fire rated construction (for low rise building). Seal and/or protected all openings to maintain fire separations.	Within 3 months
------	-------------------------	--	---	-----------------

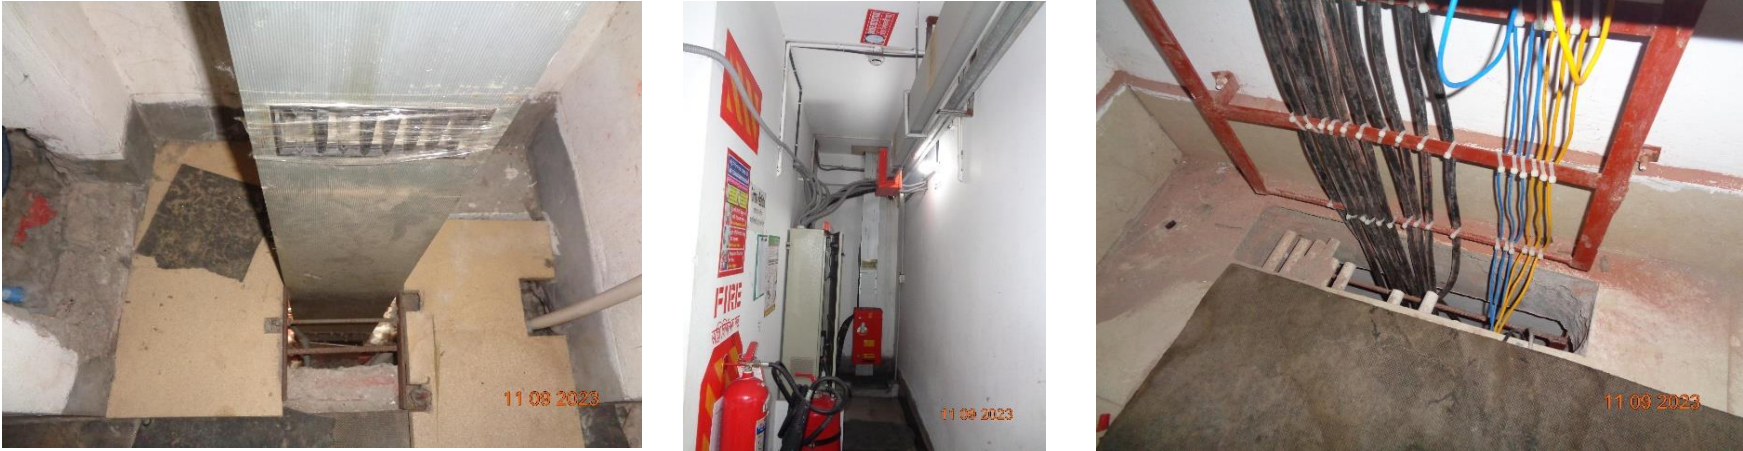
F-04	Fire Rated Construction	Penetrations through floor/ceiling assemblies are not properly sealed. Location: Electrical BBT and cable riser in factory building and office building.	Seal all penetrations and openings in floor/ceiling (full/required thickness of the floor/ceiling) assemblies by listed fire rated materials to maintain the fire resistance rating of 3-hr.	Within 3 months

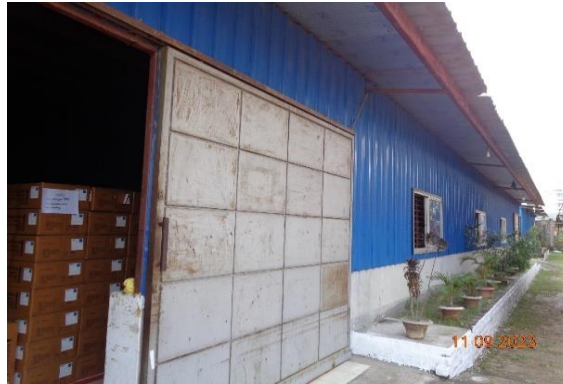
F-05	Egress	Sliding doors are provided at building exits, exit stairs, along egress routes, exit discharge at bonded warehouse and finished goods store.	Replace all collapsible gates/ sliding doors/ rolling shutter doors along the means of egress with side-hinged, swinging egress doors. If locks are required for security reasons, utilize specialized door locking features complying with NFPA 101.	Within 1 month

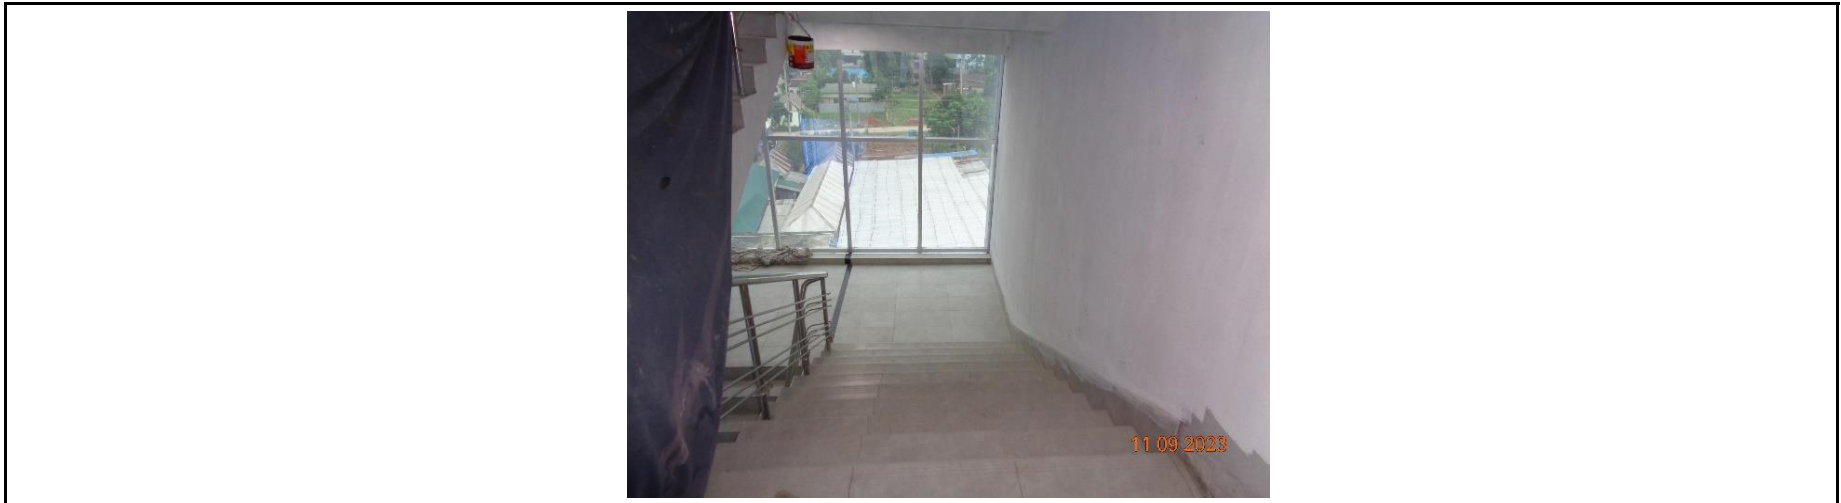
F-06	Egress	Building did not have stair designation signs and occupant load signs at required locations. Office building.	Install signage adjacent to each stair door indicating the stair name and the floor level at the noted locations in both English and Bengali language. Post the occupant load for every assembly and production floor in a facility in a conspicuous space near the main exit or exit access doorway for the space.	1 month
F-07	Egress	Handrails are not provided on both sides of each exit stairs on all floors. Location: Office building.	Handrails shall be provided on both sides of each stairway. Intermediate handrails shall be provided when the stair width exceeds 2.2m (87 in.).	Within 3 months

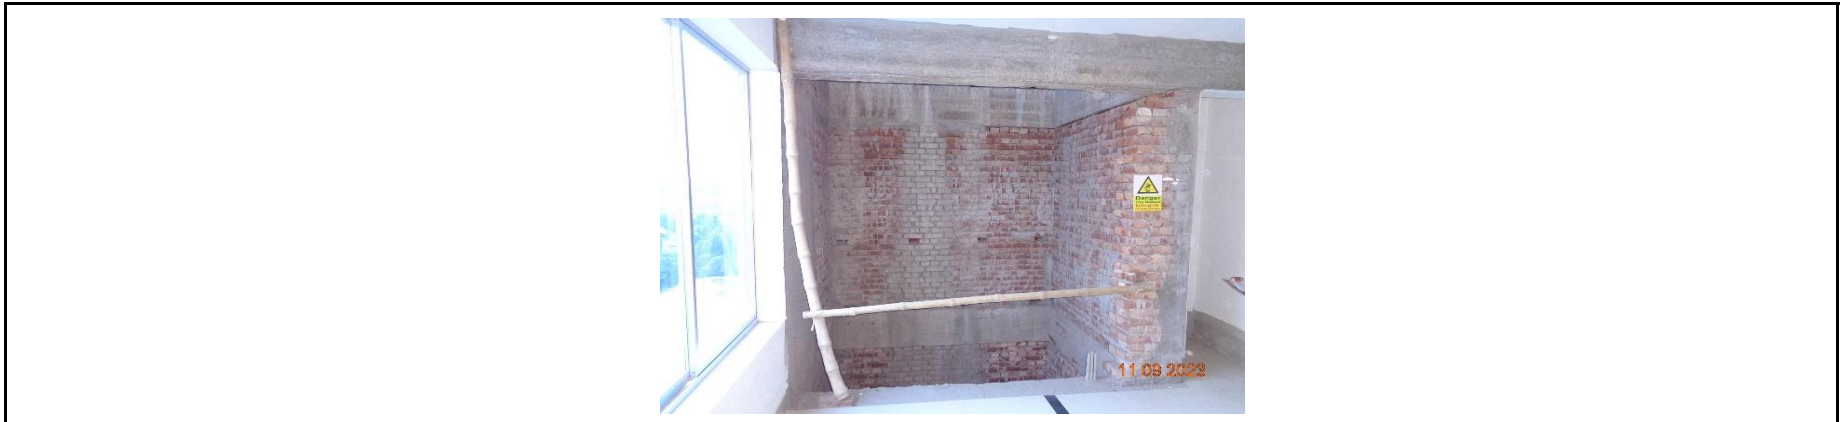
F-11	Egress	Unprotected shaft opening has been found within the exit stair enclosure.	Protect the shaft opening by 2 hour rated construction.	Within 2 months

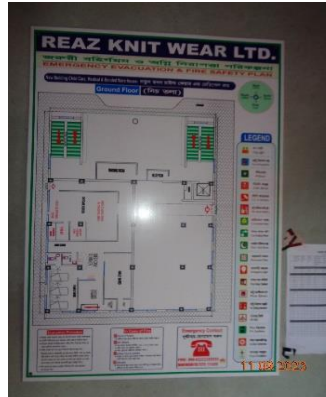
F-12	Egress	Exits are not remotely located from each other such that a single fire event could compromise both exits. Location: Office Building	<p>Specify appropriate upgrade based on conditions:</p> <ul style="list-style-type: none"> - Modify exit arrangement to meet RSC standard 6.6.6. - Provide additional exit(s) to meet RSC standard 6.6.6. - Provide sprinkler protection in accordance with NFPA 13 to meet RSC standard 6.6.6 	Within 3 months
------	--------	---	---	-----------------

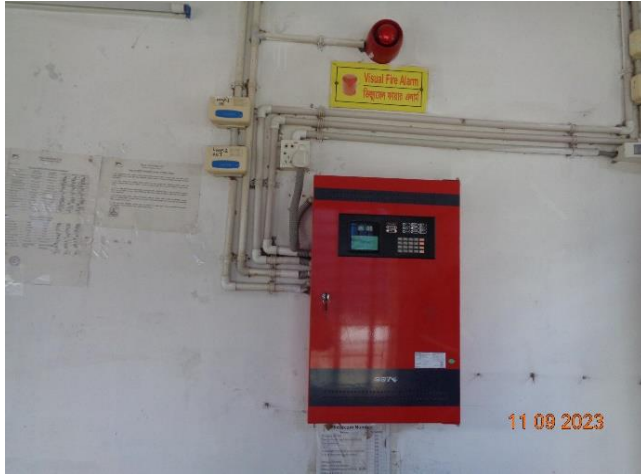
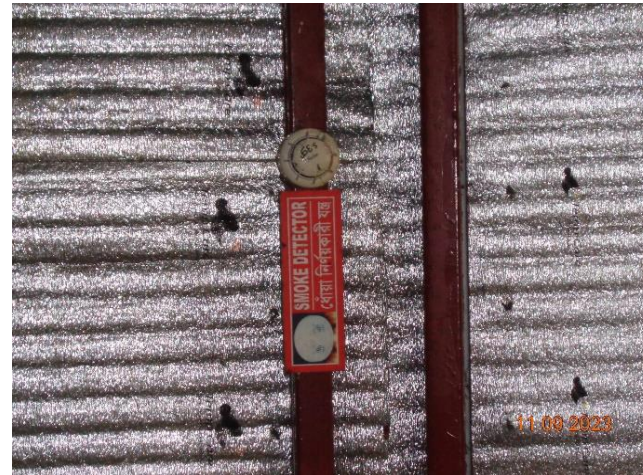
F-13	Fire Detection & Alarm System	Fire detection system installation requires detailed review to confirm compliance with NFPA 72 and RSC Technical Guidance standards.	Submit as-built drawings, testing records, equipment certification and other relevant documentation to the RSC for review and approval. Modification work shall be as per NFPA 72 .	Design within 2 month, installation/ modification within 4 months after drawing review
------	-------------------------------	--	---	--

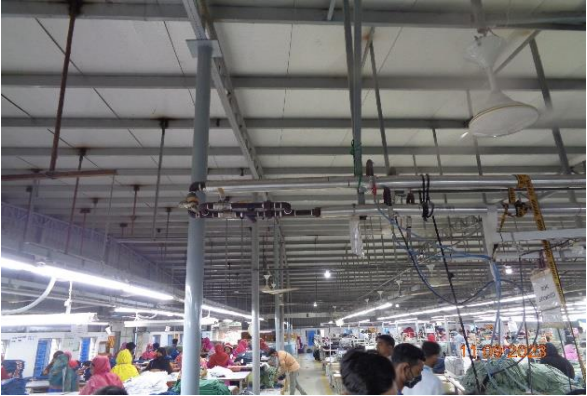
F-16	Inspection, testing, and maintenance of the standpipe system	Inspection, testing, and maintenance of the standpipe system is not in accordance with NFPA 25 or as per RSC standard.	Inspect, test and maintain the standpipe system, and keep written records on-site, in accordance with NFPA 25 or as per RSC standard.	Within 3 months
F-17	Non rated structure	The main structural element of the Block-G, single storied store shed is constructed by steel which is non-rated and were found in exposed condition without any fire protection. Location: Shed 1: Yarn store, Shed 2: Accessories store, Shed 3: Production, Shed 4: Bonded warehouse, Shed 5: Finished goods store,	The building shall be type-I or II construction. So, provide require rating in the structural elements of the building. Consult with a qualified fire protection engineer. Follow BNBC 2006 Part 3, Table 3.3.1	Within 6 months
