# INITIAL FIRE SAFETY INSPECTION REPORT

**Factory Name: Ananta Huaxiang Ltd. (Extension)**

**RSC ID: 24616**

**Date: 13-September-2023**

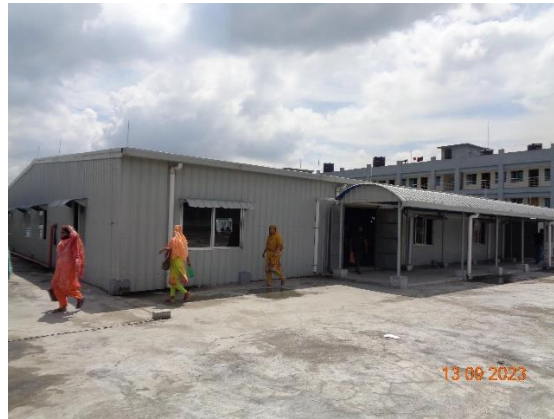
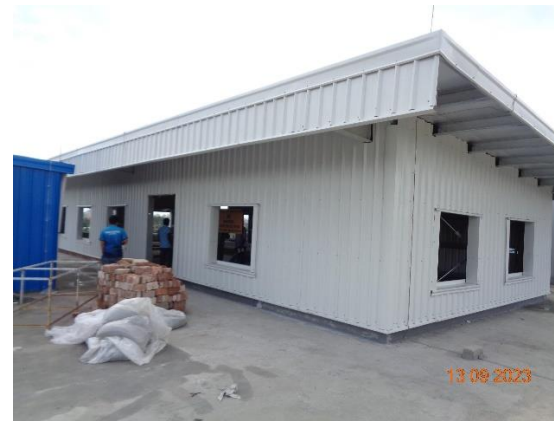
| SI No. | Category | Findings | Required Action | Remediation Time Frame |
|---|---|---|---|---|
| F-1 | Fire Rated Construction | Dinning & Prayer room (Assembly Occupancy) is provided on the roof of Building-C (Industrial Occupancy) which is not permitted according to BNBC 2020, Part III Chapter 2 Table 3.2.1 | <p>In new construction Assembly occupancy (I) is not allowed with industrial occupancy (G2).</p> <p>Relocate the dining to or from this building to meet the requirement as per BNBC 2020, part III chapter 2 table 3.2.1.</p> | Within 3 Months |

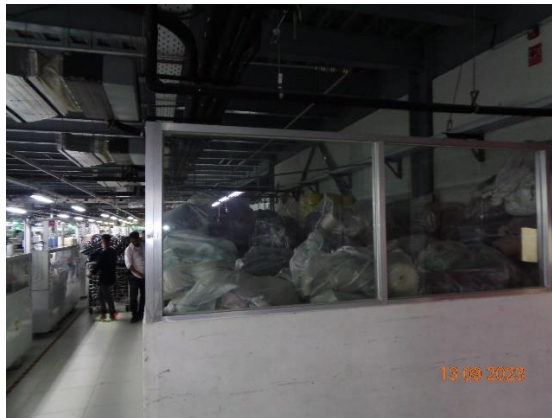
| F-3 | Fire Rated Construction | <p>Rooms/areas on Basement used for combustible storage are not separated by a minimum 1-hr fire-rated construction where storage area exceeding 10% of the floor area.</p> <p>Location: <b>Building-C, Ground floor.</b></p> | Provide dedicated storage rooms separated by minimum 1-hr fire-rated construction | Within 3 months |

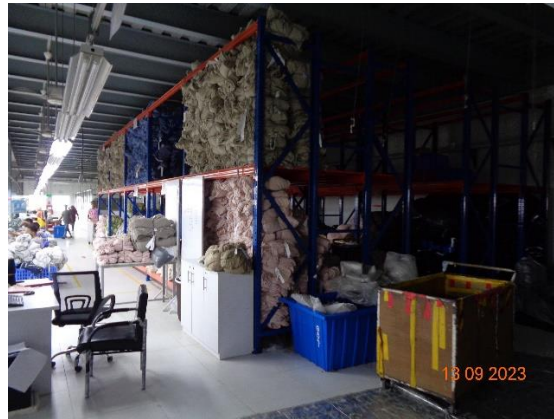
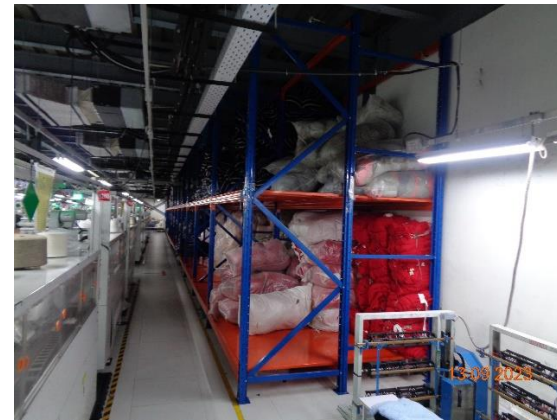
| F-4 | Fire-Rated Construction | <p>Areas used for combustible storage open to the factory are not properly defined and/or not within limits.</p> <p>Location: <b>Building-C, Ground floor &amp; First floor.</b></p> | <p>Provide defined storage areas and limit the storage arrangement as follows:<br/>Maximum height of 2.45m (8 ft) and maximum area of 23 m2 (250 ft2).</p> <p>If sprinkler protected:<br/>maximum height of 3.66m (12 ft) and maximum area of 93m2 (1000 ft2).</p> <p>Separate the areas of unenclosed combustible storage by a minimum clear distance of 3 m (10ft).</p> <p>Areas shall limit within 10% of entire floor area.</p> | Within 3 Months |

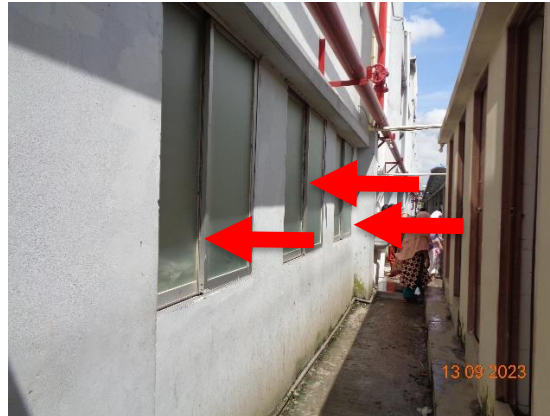
| F-5 | Fire-Rated Construction | <p>The exit discharge path [serving S-W exit discharge] is less than 10 ft wide and is not separated from the building interior.</p> <p>Location: <b>Building-C</b></p> | <p>Seal all penetrations and openings to the interior of the building along the discharge path, up to a height of 10 ft, to provide a minimum 1-hr fire separation. Alternatively, provide a second remote discharge path to the public way (only include this if feasible).</p> | Within 3 Months |

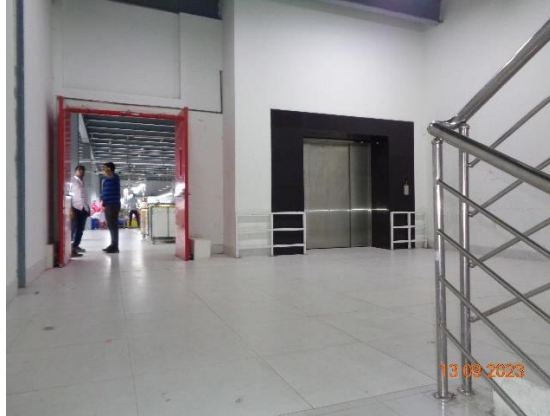
| F-6 | Fire Rated Construction | <p>Elevator shafts are directly open into the exit stair for stair-4.</p> <p>Location: <b>Building-C</b></p> | <p>In new and interim construction, an exit stairway shall not be built around a lift shaft unless both of them are located in a smoke proof enclosure and made of a material with fire resistance rating required for the type of construction of smoke proof enclosure as per RSC-6.14.3. So, separate the stair enclosure from elevator shaft throughout the building.</p> <p>There is a variety of opening protective types i.e., fire rated lift landing doors, fire doors, fire rated curtain combination for both heat &amp; smoke control with integration with fire alarm control panel.</p> | Within 3 Months |

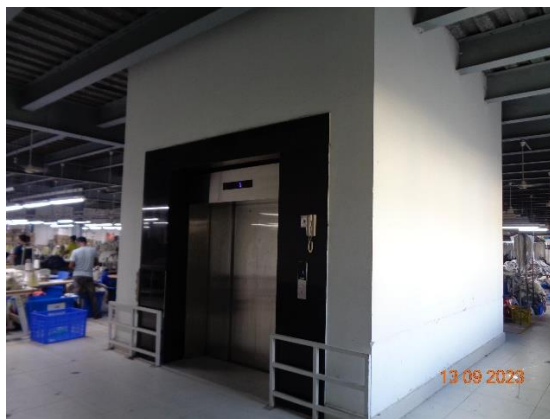
| F-7 | Fire Rated Construction | <p>The elevator discharges inside the production floor. [Unsealed penetrations &amp; openings]</p> <p>Location: <b>Building-C (Ground floor)</b></p> | <p>Provide a minimum 2-hr fire rated construction to separate the elevator shaft from each floor level.</p> <p>Seal all penetrations and openings in floors/ceiling assemblies to maintain the fire separation.</p> <p>There is a variety of opening protective types i.e., fire rated lift landing doors, fire doors, fire rated curtain combination for both heat &amp; smoke control with integration with fire alarm control panel.</p> | Within 3 Month |

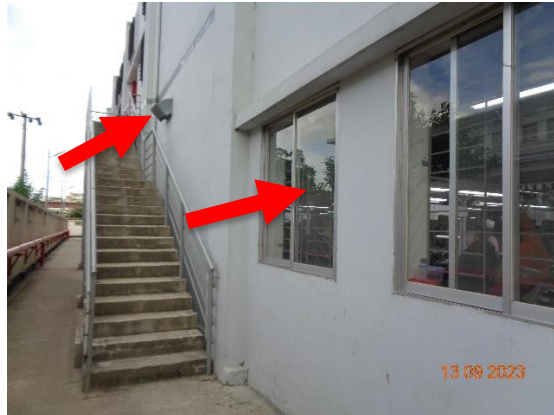
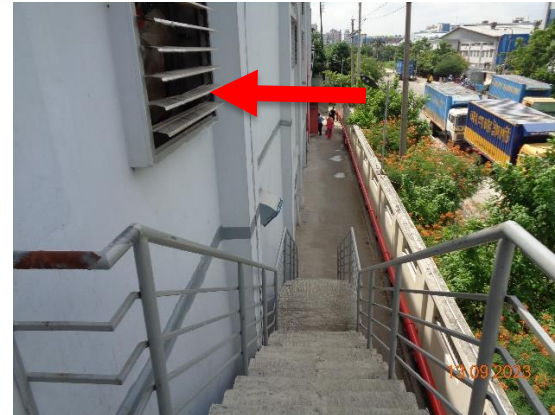
| F-8 | Fire Rated Construction | <p>Exterior exit stairs are not properly separated from the building and stair exit discharge.</p> <p>Location: <b>Building-C</b></p> | <p>Exterior exit stairs shall be separated by minimum 1-hr fire-rated construction and The rating of the exterior wall shall extend 3.05 m (10 ft.) beyond the ends of the stair structure. Provide minimum 0.75-hr fire rated doors to separate the exit stairs from work areas and other building spaces on all floor levels. Ensure that the fire doors are self-closing, positive latching and that they are provided with fire exit (panic) hardware where serving production floors.</p> <p>If fire doors are required to be held open for functional reasons, provide automatic-closing devices tied to the fire alarm system.</p> | Within 3 Month |

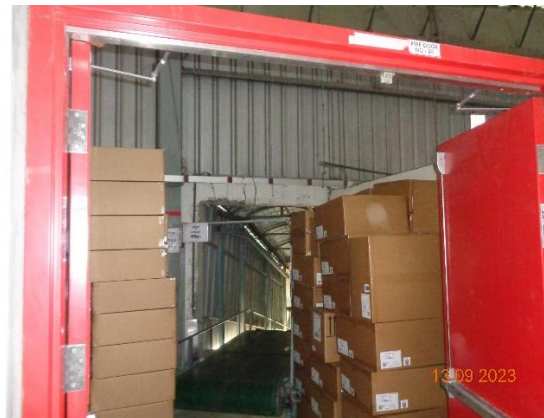
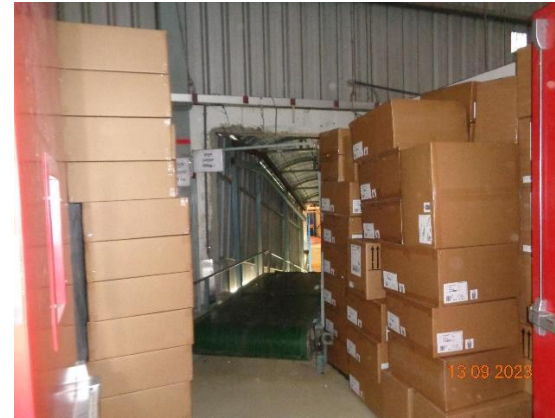
| F-9 | Fire Rated Construction | The raised walkways between Building B and H1-Shed are not separated by fire-rated construction. | Provide 2-hr fire rated construction or provide 1.5-hr fire rated door. | Within 1 Month |

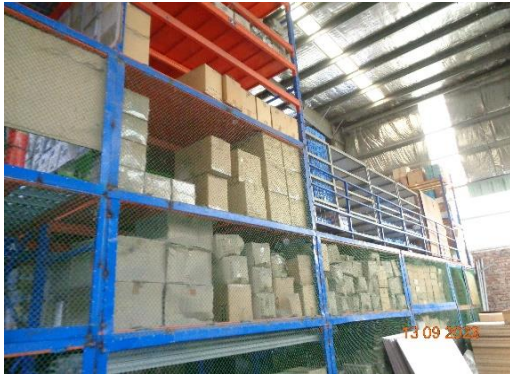
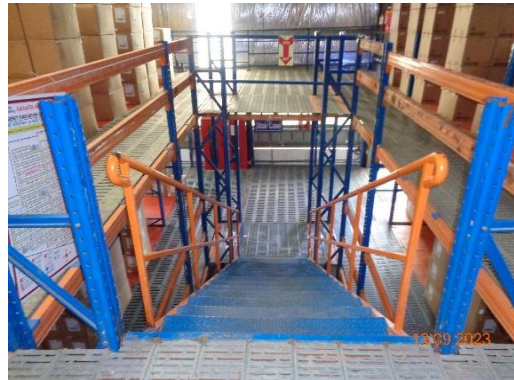
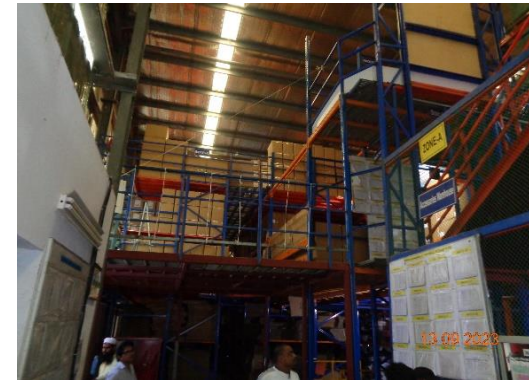
| F-10 | Fire Rated Construction | <p>The multi-storied racking system storage floor in the H1- Shed is prefabricated steel- type and all the steel panels are resting on the steel columns and girders which is in exposed condition without any fire protection. Also the mezzanine floor area exceeds the allowable limit and it shall count as a floor and floor to floor separation is required.</p> <p>It has been also observed that the ground floor to first and second floor (claimed mezzanine) are not separated from each other. Ground floor exit is from ground level and 1st and 2nd floor exit is also through ground floor level. Factory Claimed Mezzanine floor which is occupying more than 33.33% of the building plinth area (measure full plinth area) are not properly separated from the ground floor thus the 1st floor finished goods area appears more vulnerable regarding fire safety as well as property/material safety</p> | <p>Mezzanine floor shall not exceed 33.33% of the building plinth area as per BNBC-2006, clause 1.12.6.1. Separate each floors by fire rated construction as per BNBC, Part-3, chapter-3 and Table 3.3.1. 2-hr fire rated separation is required from claimed mezzanine floor (actually first floor and second floor) to ground floor other surroundings as well as separation is needed at required number of exit stairs.</p> <p>Provide required fire rating on the structural elements by following Section 4.4 and Table 4.4.1 of the RSC Standard or Table 3.3.1 and Table 4.1.1 from BNBC Part 4. Consult a qualified fire protection engineer to design the rated construction barriers in between the floors and in structural members.</p> <p>Or, reduce the 1st and 2nd floor area (claimed mezzanine) below 33.33% of the building plinth area.</p> | Within 3 Month |

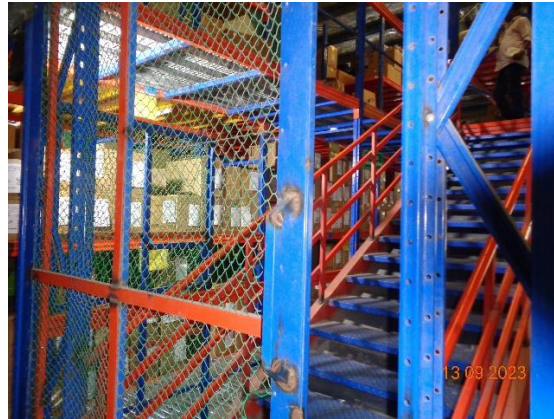
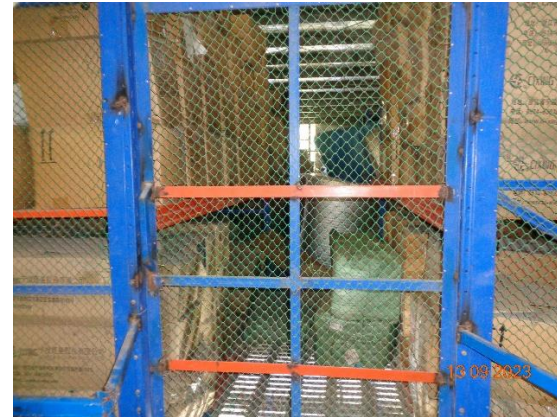
| F-11 | Means of Egress | <p>Sliding doors are provided at means of egress.</p> <p>Location: <b>H-1 Shed</b></p> | <p>Sliding doors along the means of egress with side-hinged, swinging egress doors.</p> <p>If locks are required for security reasons, utilize specialized door locking features complying with NFPA101.</p> | Within 1 Month |

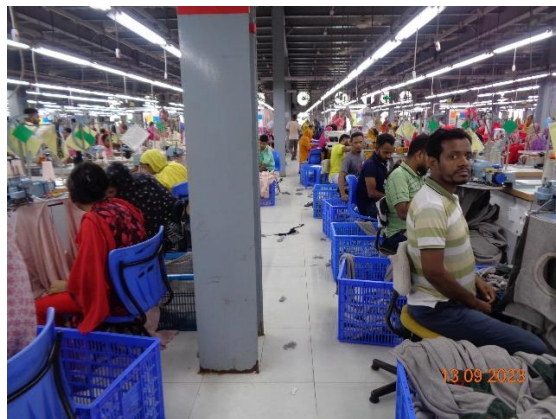
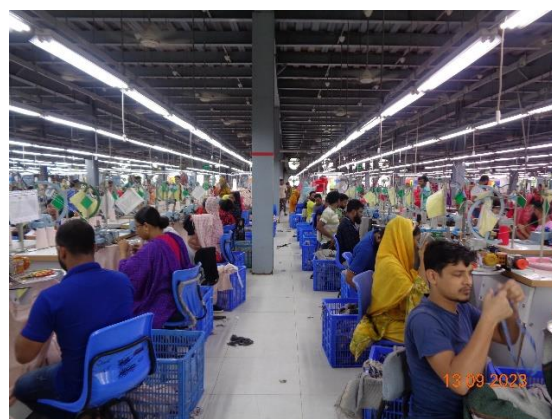
| F-12 | Means of Egress | <p>Width of aisle is less than 0.9m (36-in.) or not marked properly at 1st floor (Linking section).</p> <p>Location: <b>Building-C, Between Line 6 &amp; 7</b></p> | <p>Aisles shall be provided with a minimum unobstructed clear- with of 0.9m (36 in).</p> <p>Rearrange the floor layout if required.</p> | Within 1 Month |

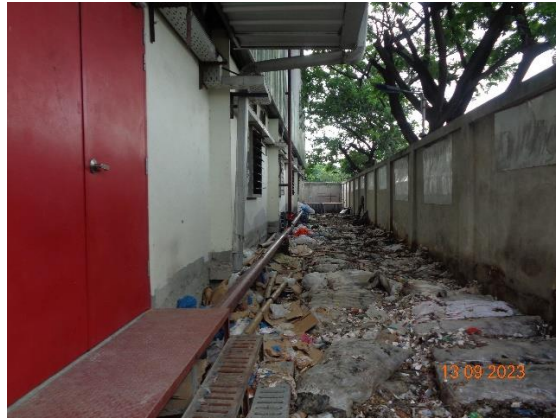
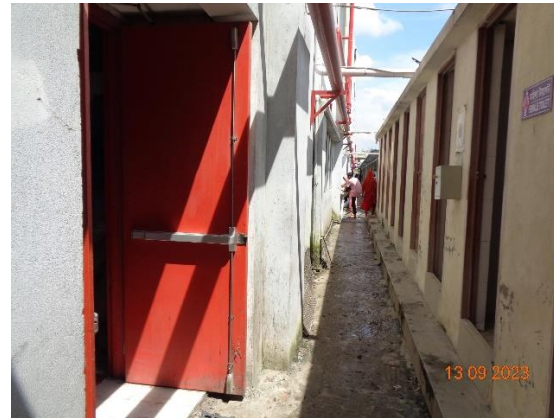
| F-13 | Means of Egress | <p>Uneven path of travel and blockage in exit access.</p> <p>Locations: <b>S-W Exit discharge of Building-C</b><br/> <b>North Exit discharge of H-1 Shed</b></p> | Remove unnecessary items and level exit path to the public way. | Within 1 Month |

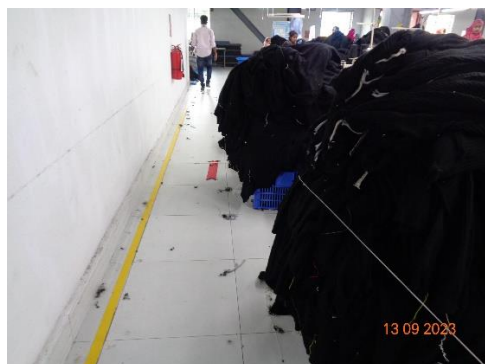
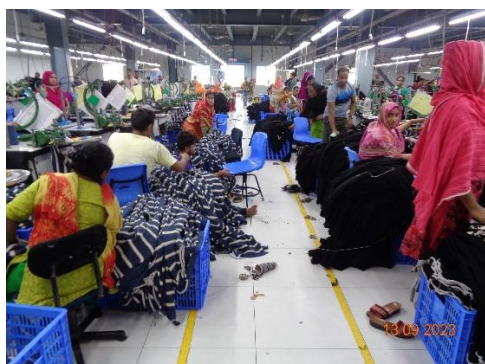
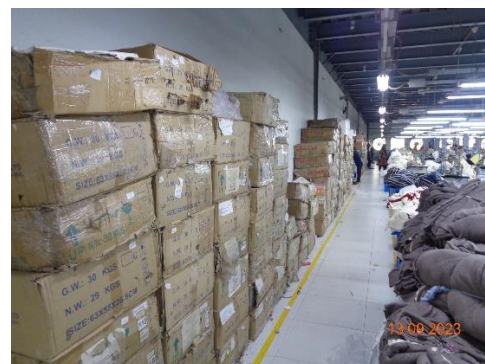
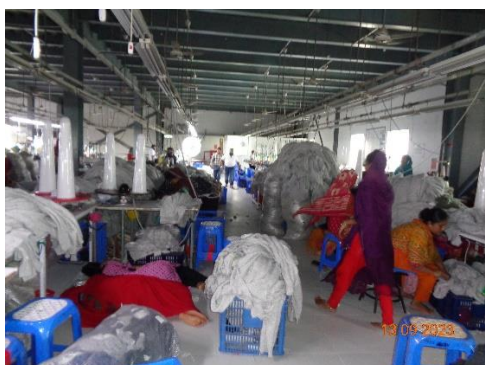
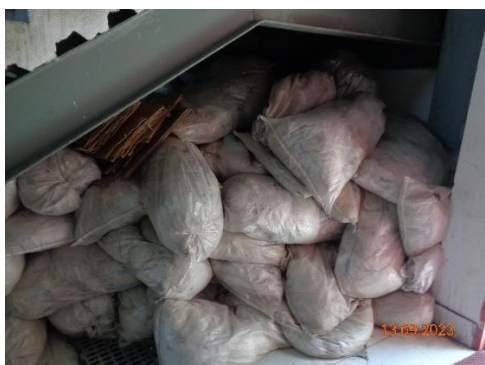
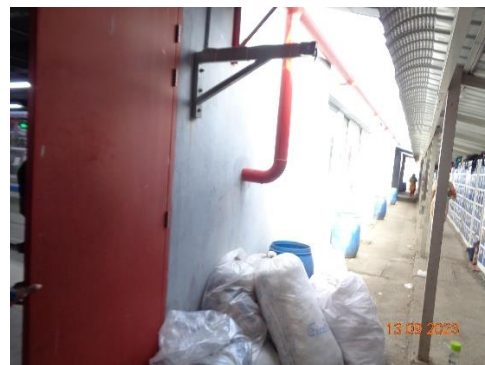
| F-14 | Means of Egress | <p>Storage was located in the exit stairs and aisles.</p> <p>Location: <b>Building-C</b></p> | <p>Remove all storage from the exit stairs and aisles.</p> <p>Keep egress paths and stairs clear of storage</p> | Immediate |

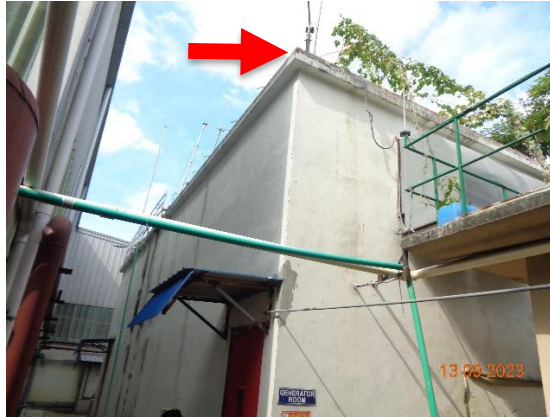
| F-15 | Means of Egress | Parapets or guards are not provided in occupiable roof.<br><br>Location: <b>GAS generator building.</b> | Provide parapets or guards with a minimum height of 1067mm (42 inch.). | Within 1 Month |

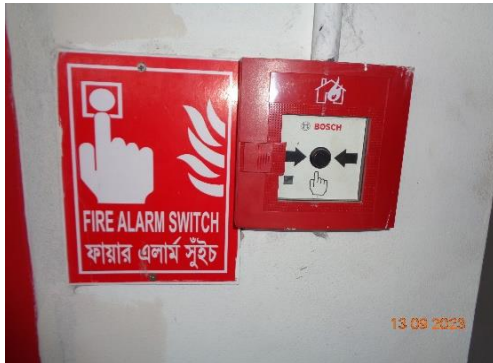
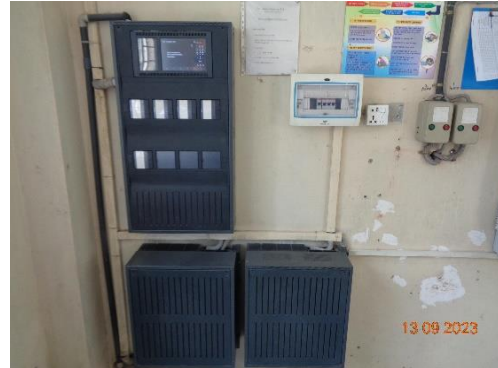
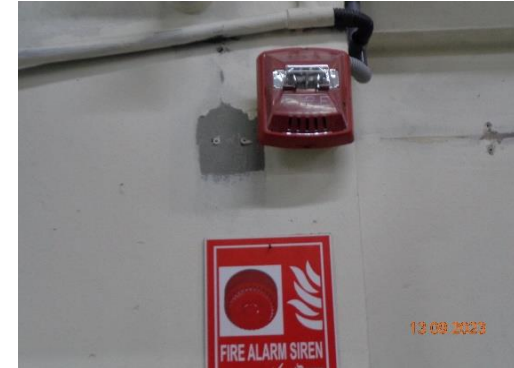
| F-21 | Fire Alarm & Detection System (FADS) | The fire alarm and detection system installation requires detailed review to confirm compliance with NFPA 72 and RSC standard.<br><br>Location: <b>Building-C</b> | Submit as-built drawings, testing records, equipment certification and other relevant documentation to the RSC for review and approval/acceptance test. | Design Review within 2 months and installation within 4 months. |

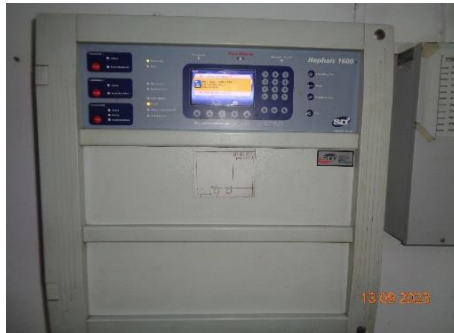
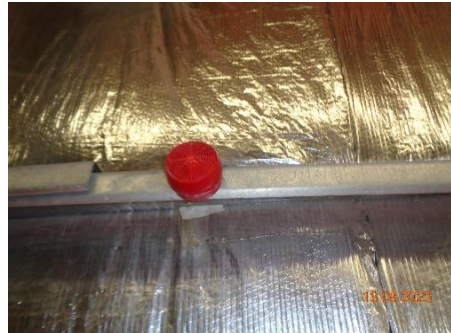
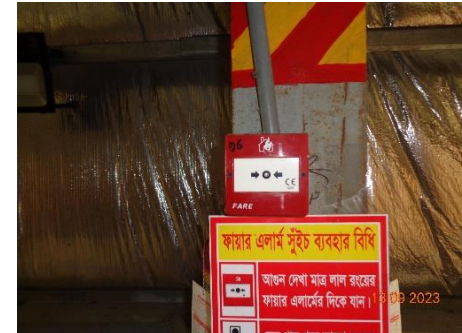
| F-22 | Fire Alarm & Detection System (FADS) | <p>The fire alarm and detection system installation requires detailed review to confirm compliance with NFPA 72 and RSC standard.</p> <p><b>Location: H1- Shed</b></p> | Submit as-built drawings, testing records, equipment certification and other relevant documentation to the RSC for review and approval/acceptance test. | Design Review within 2 months and installation within 4 months. |
