INITIAL FIRE SAFETY INSPECTION REPORT

Factory Name: Carlos Leather Fashion Ltd. (Extension)

RSC ID: 24615

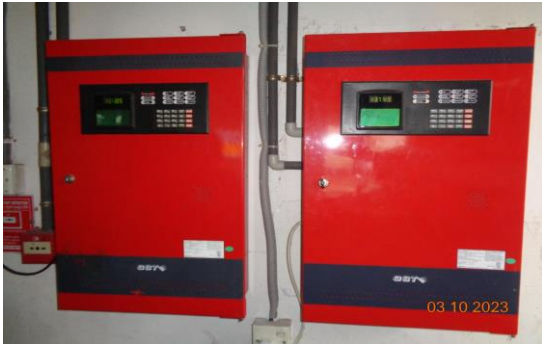
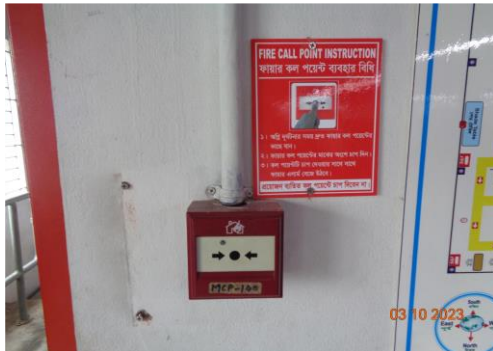
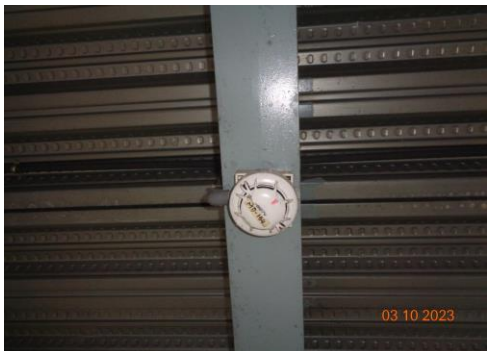
Sl No.	Category	Findings	Required Action	Remediation Time Frame
1	Fire Alarm & Detection System (FADS)	The fire alarm and detection system installation requires detailed review to confirm compliance with NFPA 72 and RSC standard.	Submit as-built drawings, testing records, equipment certification and other relevant documentation to the RSC for review and approval/acceptance test.	Review within 2 months and installation within 4 months

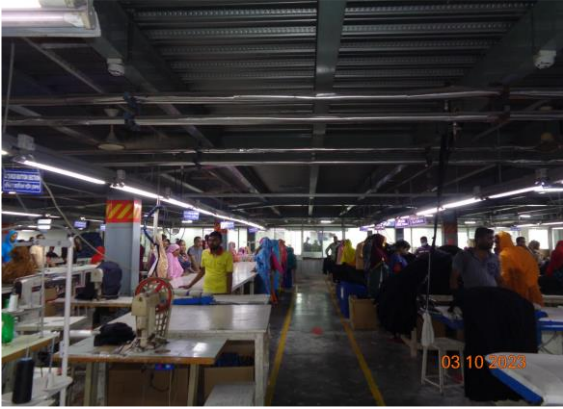
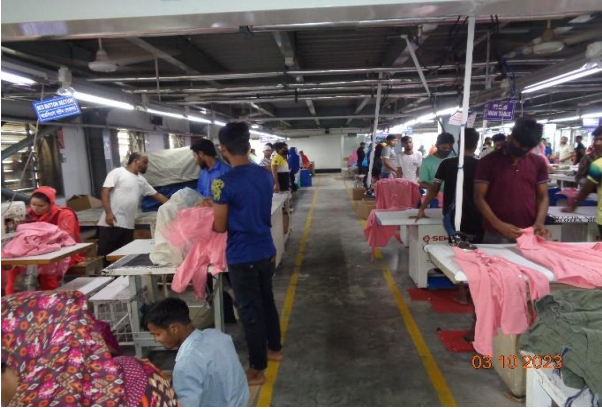
2	Fire Alarm & Detection System (FADS)	Inspection, testing and maintenance for the fire detection and alarm system was not in accordance with standard.	Inspect, test and maintain the fire alarm system and keep written records on-site, in accordance with NFPA 72.	Within 1 month after installation
3	Egress Lighting	Based on the number and location of emergency lights observed, adequate illumination levels are not anticipated along egress routes.	Test the emergency lighting system on each floor and provide additional emergency fixtures to provide adequate illumination along the means of egress. Provide a minimum illumination of 10 lux at the floor level within exit stairs and exit discharge paths and minimum 2.5 lux along exit access aisles.	Within 3 months
<div style="display: flex; justify-content: space-around;">

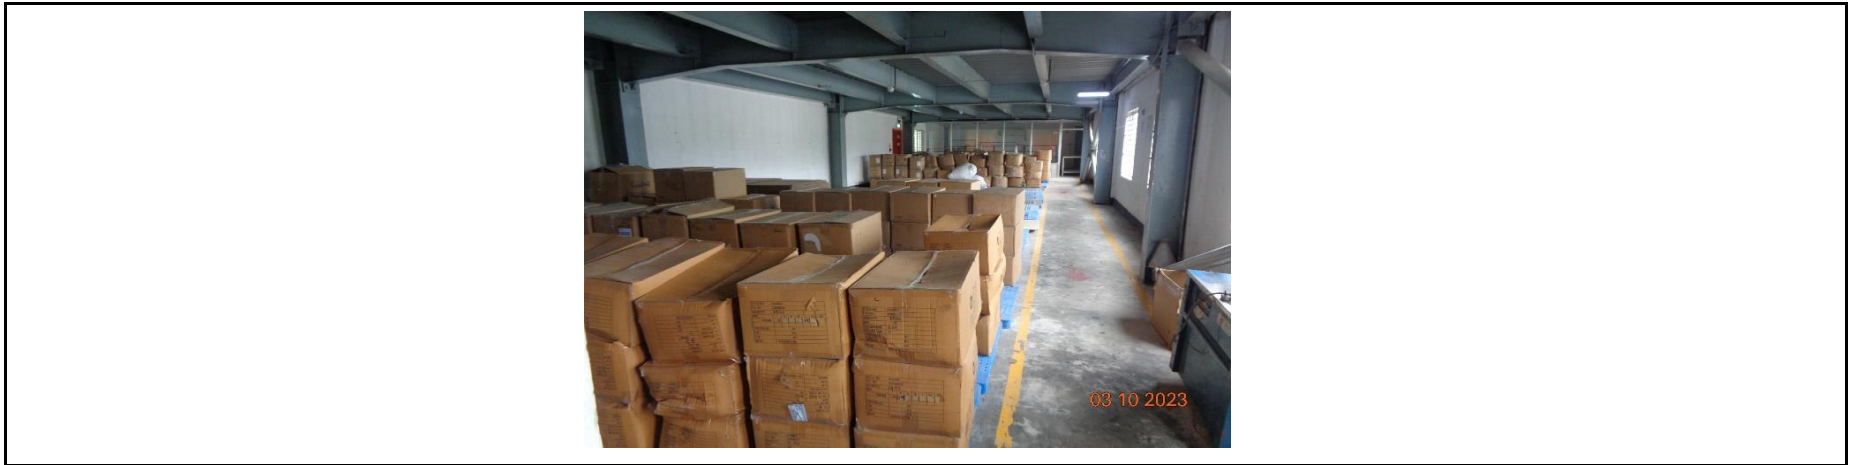
8	Fire Rated Construction	Room used for combustible storage are not separated by fire rated construction.	Separate the storage room by a minimum 1- hr fire-rated construction. Seal and/or protected all openings to maintain the required fire separations.	3 months
