# INITIAL FIRE SAFETY INSPECTION REPORT

## AMAN FASHIONS & DESIGNS LTD (EXTENSION)

**RSC ID: 24858**

**Date: 02- November- 2023**

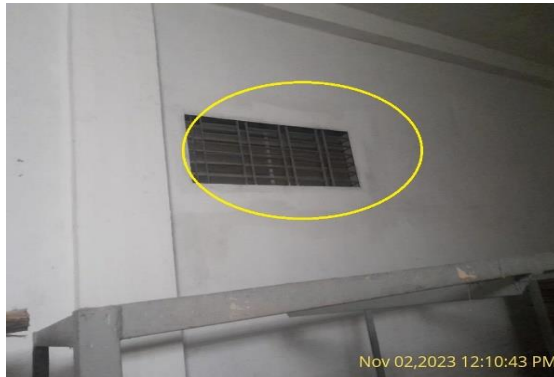
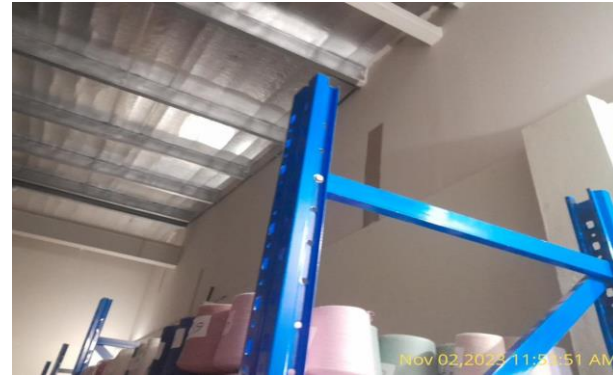
| SI No. | Category | Findings | Required Action | Remediation Time Frame |
|---|---|---|---|---|
| F-1 | Fire rated construction | Store room is not separated by fire rated construction due to unprotected opening & penetrations. Reportedly, store room are protected by fire rated materials which required adequate technical documents for further verification. | Enclose the storage area from the surrounding occupancy with a minimum 1 hour fire rated construction. | Within 3months |

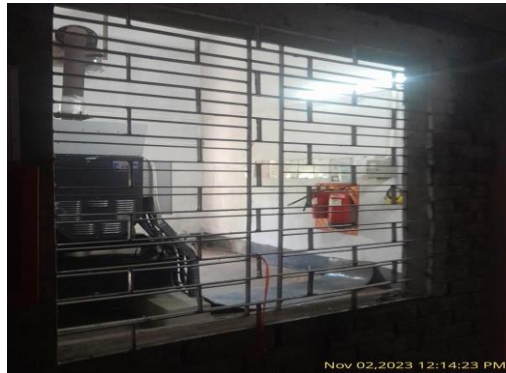
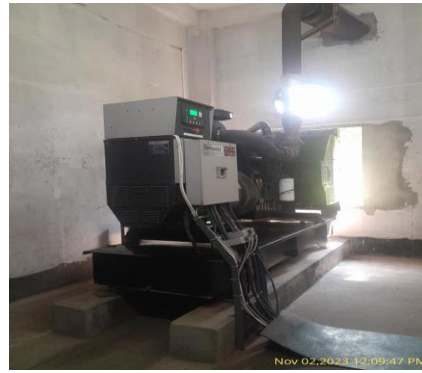
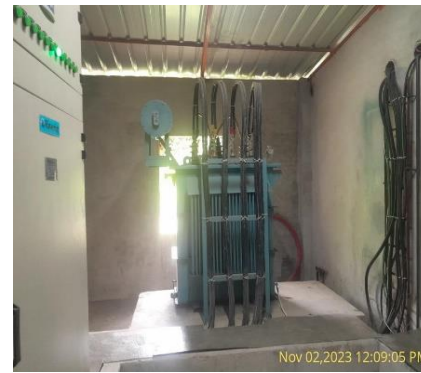
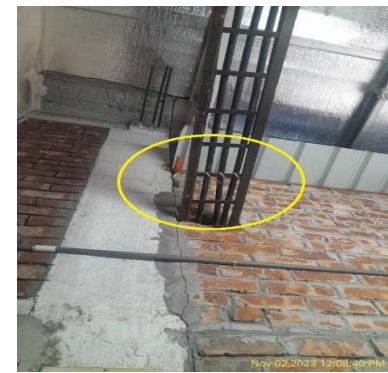
| F-2 | Fire rated construction | Generator & transformer are not separated due to unprotected opening & penetrations | Separate the generator & transformer from each other by a minimum 2-hr fire rated construction (wall, floor, slab etc.). Seal all penetrations and openings (door, window etc. | Within 3 months |

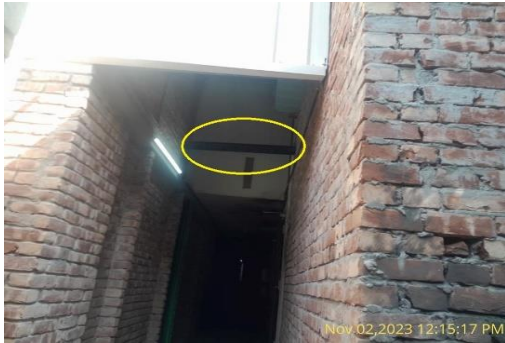
| F-3 | Mean of Egress | <p>The exit discharge path (passageway) is not properly protected due to power cable in the discharge passageway.</p> <p>Location: Near generator &amp; substation</p> | <p>Relocate the electrical power cables from the passageway or protect the passageway from power cable by 1 hour fire rated construction.</p> | <p>Within 2 month</p> |

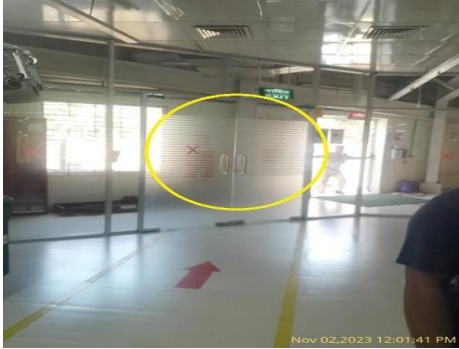
| F-4 | Mean of Egress | Doors are swing out over the aisles or egress paths | Modify the egress doors and ensure unobstructed aisles or egress paths. | Within 1month |

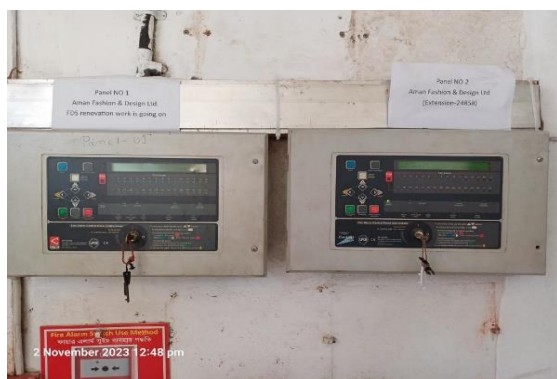
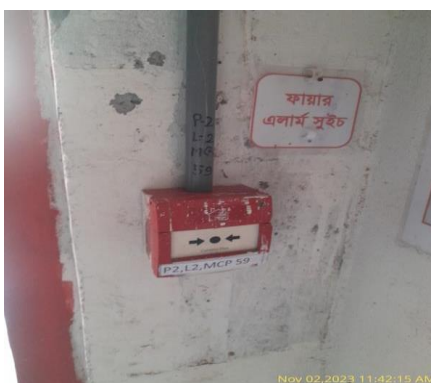
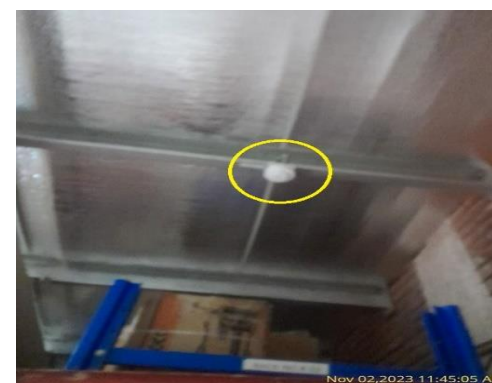
| F-6 | Fire Alarm & Detection System (FADS) | Addressable fire alarm & detection system installation requires detailed review to confirm compliance with NFPA 72 and RSC standard. | <p>Submit design, documents and calculations to RSC for review prior and based on the review modify the system if there is any.</p> <p>After installation the owner shall contact the RSC for witness of conducting the final acceptance testing of the fire detection &amp; alarm system installation.</p> <p>Also inspect, test and maintain the fire alarm system, and keep written records on-site, in accordance with NFPA 72.</p> | Design Review within 1 month and modification within 3 months (If require). |
