INITIAL FIRE SAFETY INSPECTION REPORT

Factory Name: Ishayat Apparels Ltd

RSC ID: 24795

**ADDRESS: Sharmin Group, Narashingapur, Ashulia, Savar, Dhaka – 1341, Bangladesh.
23.93192, 90.30640**

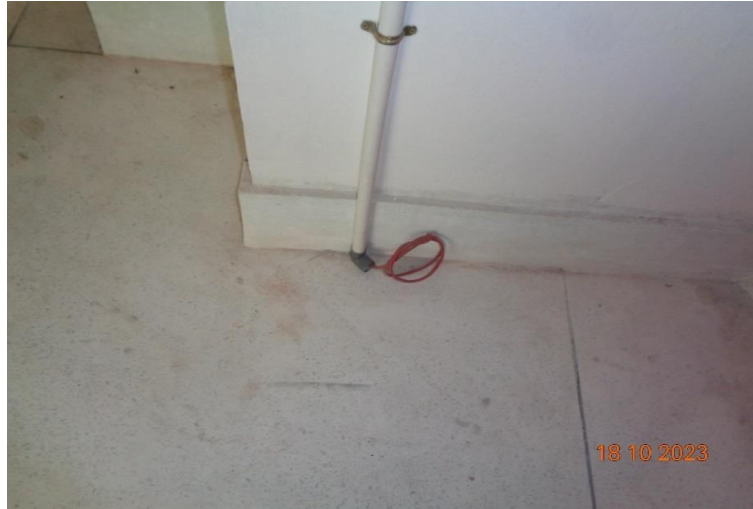
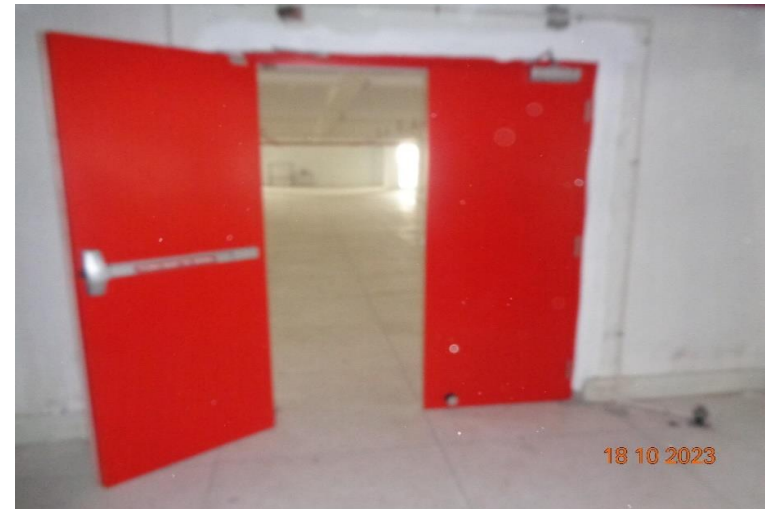
F-1	Fire Rated Construction	<p>The exit stair enclosures are not separated from work areas and other spaces on each floor by fire-rated construction. Location: Ishayat Apparels Building</p>	<p>The exit stair enclosure shall be provided with a minimum 1-hr fire resistance rating for buildings with 3 or fewer stories and a minimum of 2-hr. fire resistance rating for buildings 4 or more stories. Provide 0.75 hr. fire rated door and seal all penetrations and openings by 1 hr. fire rated fire rated barrier construction for building with 3 or fewer stories. Provide 1.5 hr. fire rated door and seal all penetrations and openings by 2 hr. fire rated fire rated barrier construction for building with 4 or more stories.</p> <p>Provide a fire-resistive rated assembly between the exterior exit stairs and the building up to 10 ft. beyond the end of the stair to achieve the required separation. The rated assembly shall be approved and/or designed by a qualified fire protection engineer.</p> <p>Ensure that the fire doors are self-closing and positive latching and that they are provided with fire exit (panic) hardware where serving production floors. If fire doors are required to be held open for functional reasons, provide automatic closing devices tied to the fire alarm system.</p>	Within 3 months

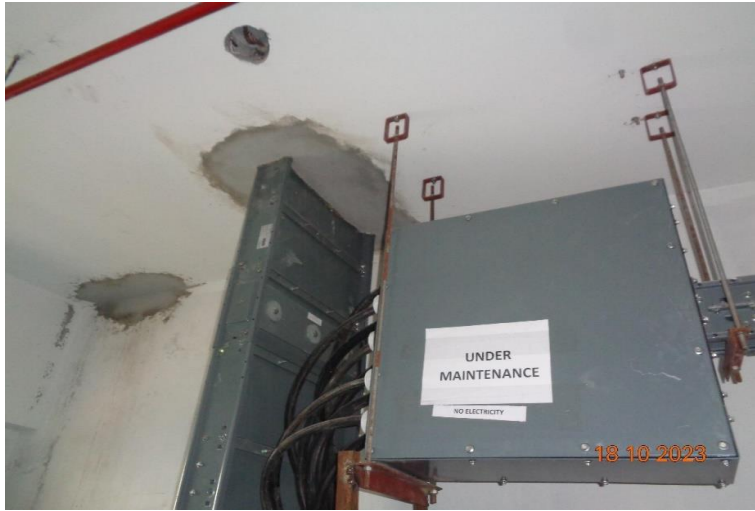
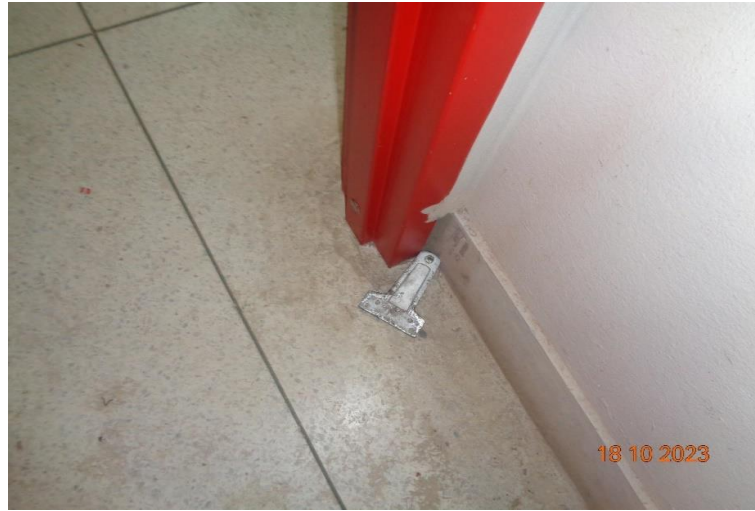
F-2	Fire Rated Construction	Unsealed penetrations and openings are located in the fire rated floor/ceiling assemblies. Location: Ishayat Apparels Building	Provide a minimum 2-hr fire rated shaft to separate the utility risers from each floor level or seal all penetrations and openings in floors/ceiling assemblies by 3-hr fire rated listed/certified materials. The installation of such fire rated materials shall be following certified design.	Within 3 months
-----	-------------------------	--	---	-----------------

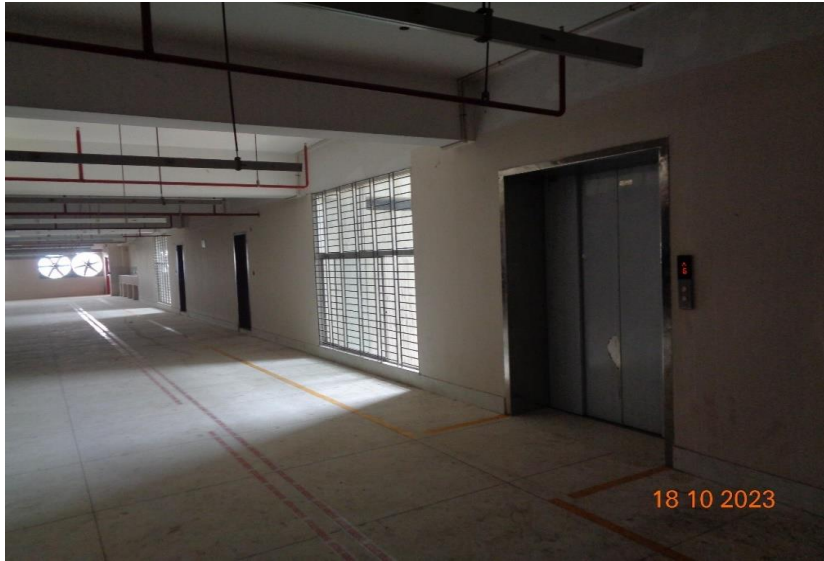
F-3	Fire Rated Construction	Elevator shafts are directly open inside the floor through installed fire door. Location: Ishayat Apparels Building	Ensure minimum 1.5-hr fire rating for the doors of elevator shafts otherwise close the shafts area with 2-hr fire rated construction barrier and 1.5-hr fire rated doors.	Within 3 months
-----	-------------------------	---	---	-----------------

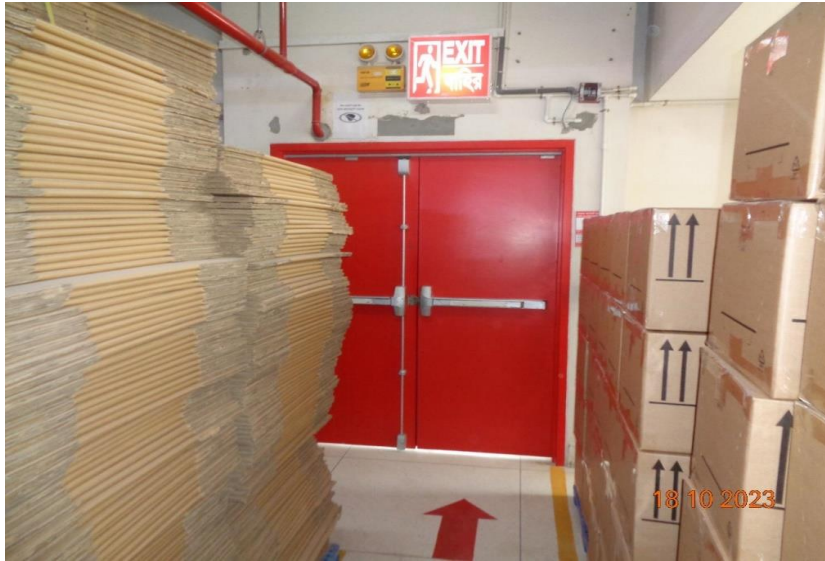
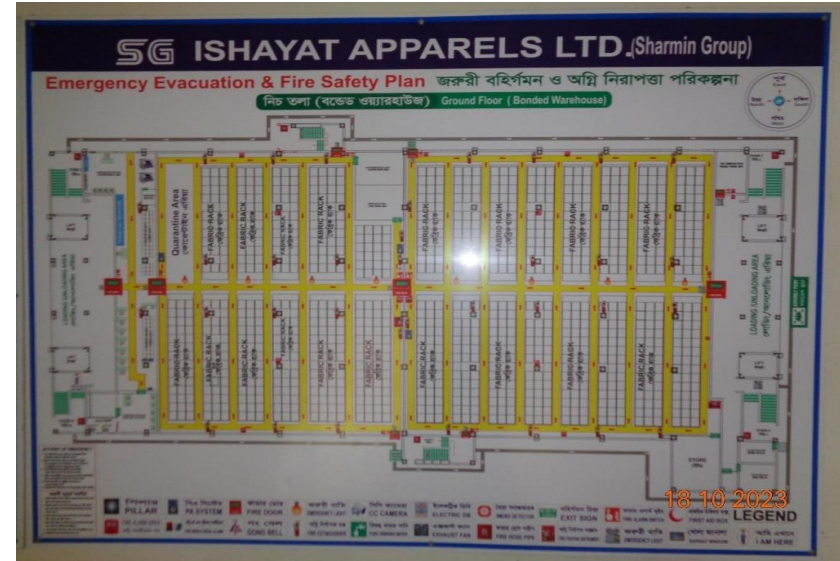
F-4	Fire Rated Construction	Storage discharges directly into the exit stair discharge. Location: Ishayat Apparels Building: 1st floor and ground floor.	Openings from exit enclosure to storage room, generator and transformer spaces shall be provided with a vestibule with fire rated construction and openings. Provide a 1.5 hr. fire rated door on the exit stair side and a 1-hr. fire rated door on the Store, generator, sub-station room side. Ensure that the fire rating of the vestibule construction matches that of the exit stair enclosure.	Within 3 months
-----	-------------------------	---	---	-----------------

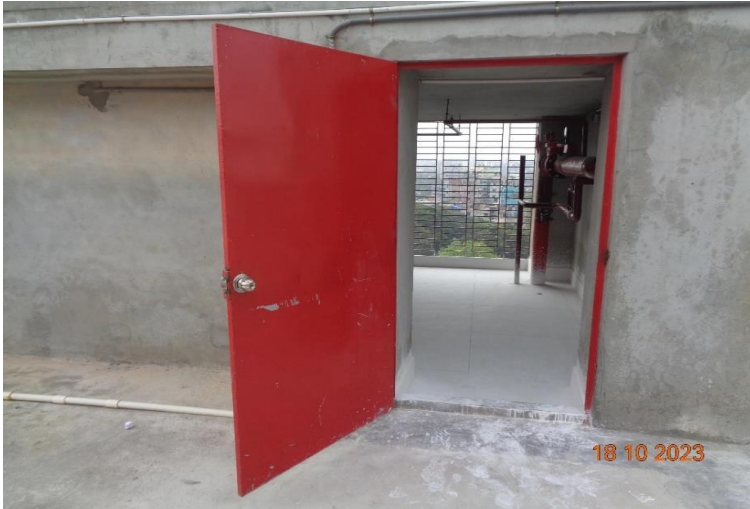
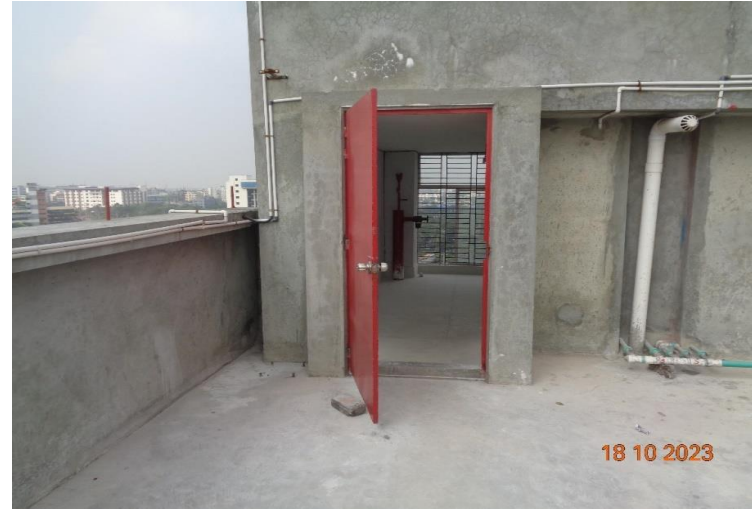
F-5	Means of egress	Egress door serving 50 or more occupants but does not swing in the direction of egress travel.	Modify swing direction of egress doors to the direction of egress travel.	Within 3 months
-----	-----------------	--	---	-----------------

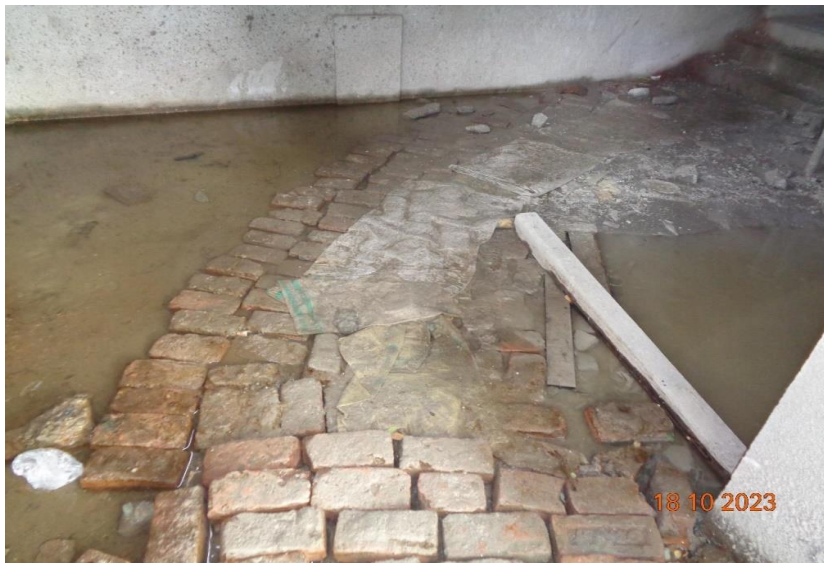
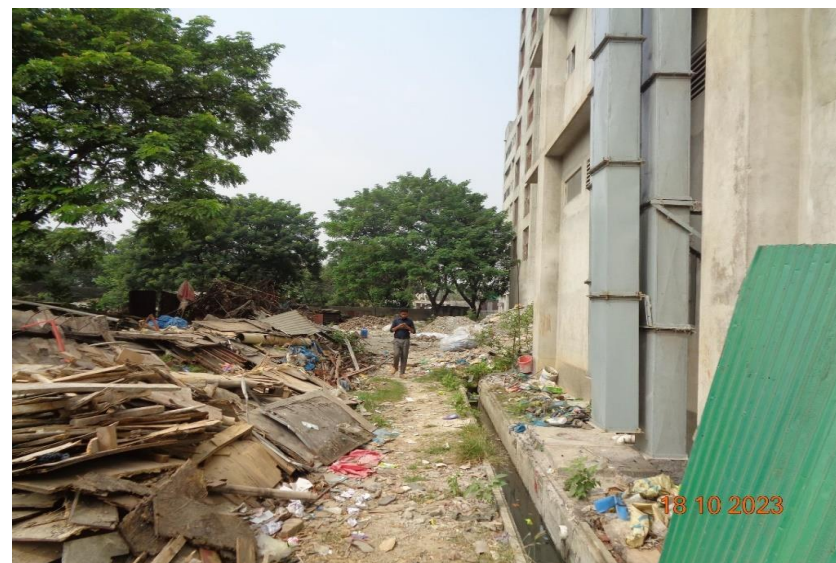
F-6	Means of egress	The width of the exit stair is less than 1.5 m (60 in.). Location: Stair no 5 and stair no 6	In new and interim construction and constructed stairs post 24 November 2013, stairs shall have a minimum width of 1.5 m (60 in.) for all industrial occupancies and 2.0 m(79 in.) for all assembly occupancies. For assembly use areas provided for prayer halls, dining halls and like areas that are for integral use by the factory workers, the minimum width for the primary occupancy use of the building shall be permitted to be used.	Within 3 months
F-7	Means of egress	Uneven path of travel and obstructions observed in the exit discharge. Location: West stair	Remove the obstructions and level the exit path to the public way.	Within 3 months

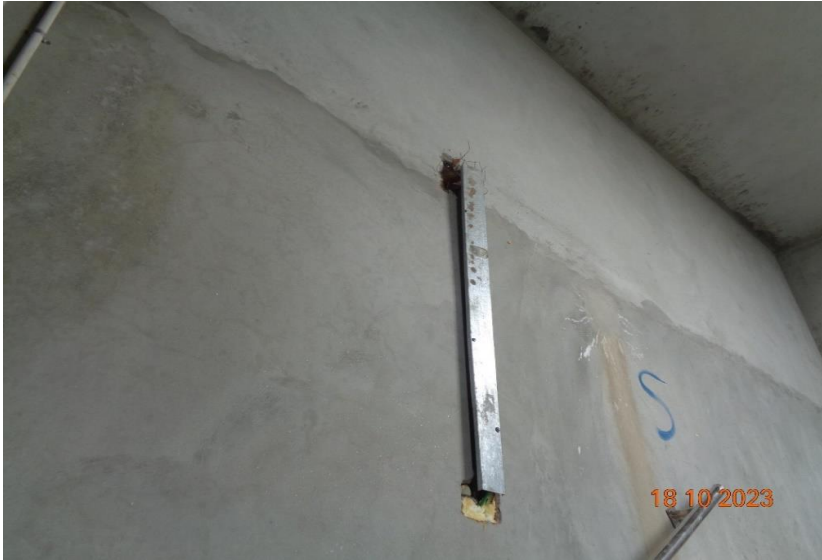
F-8	Means of egress	Penetrations within exit stair enclosures have been observed for various applications.	Penetrations into or through an exit stair enclosures are permitted only for the applications as recommended by RSC Technical Guidelines (Standard) Section 6.14.4 for required exit doors, sprinkler piping, standpipes, electrical raceway for fire alarm equipment, and electrical conduit serving the exit enclosure	Within 3 months
-----	-----------------	--	--	-----------------

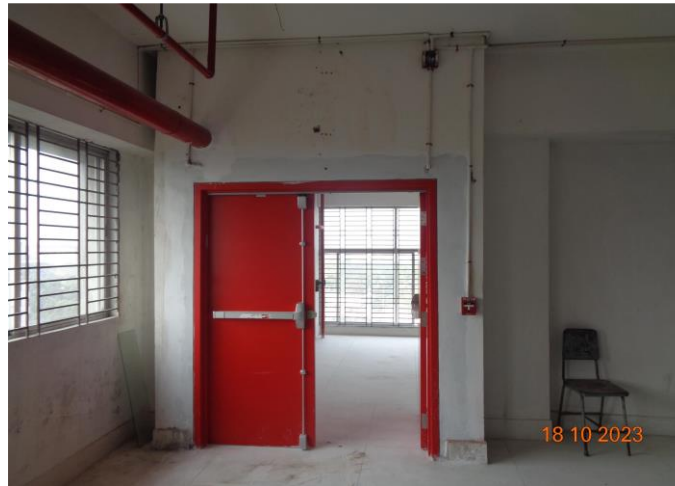
F-11	Egress Lighting	Directional signs are not provided where direction of the path of travel to an exit has changed.	Illuminated directional signs shall be provided where there is a change in the direction for the path of travel and the direction to an exit is not obvious.	Within 1 month
F-12	Means of egress	Exit sign not provided at exit.	Lighted exit signs shall be placed at entrance to an exit. Additional exit signs shall be placed throughout the facility anywhere the continuation of the egress is not obvious. Lighted exit signs shall be provided with either battery backup or uninterruptable power supply systems and shall be continuously illuminated.	Within 1 month

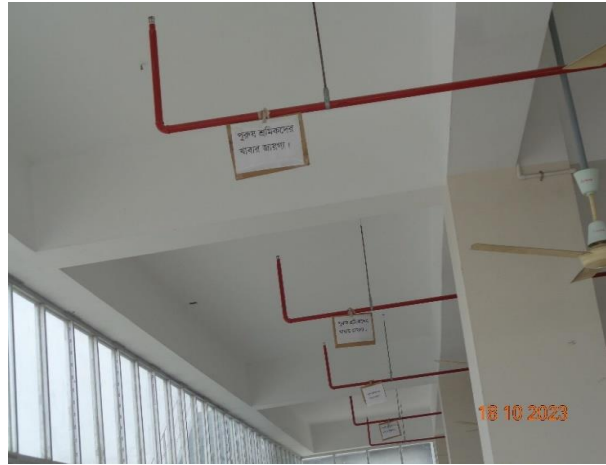
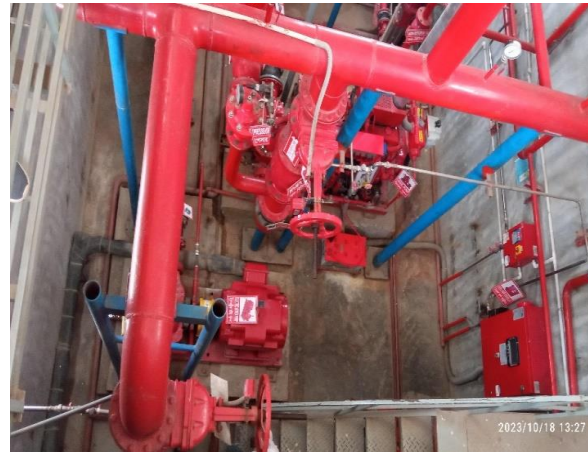
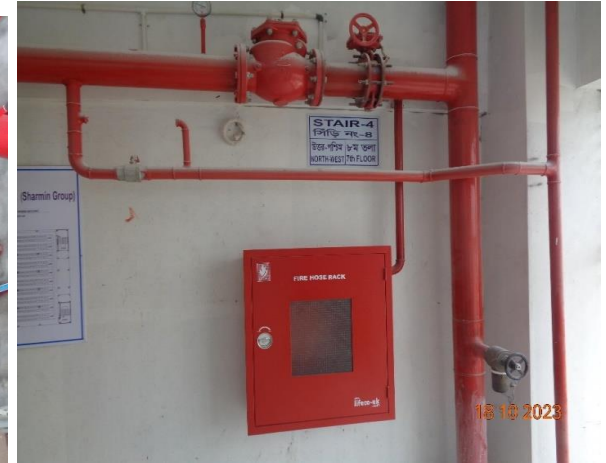
F-15	Fire Protection System (Sprinkler)	Sprinkler system installation requires detailed review to confirm compliance with NFPA 13, 14, 20, 22 and RSC Technical Guideline (Standard). Location: Ishayat Apparels Building.	Submit the fire pump, standpipe and sprinkler system drawing to RSC for review. Once reviewed, install or modify the standpipe system throughout the building in accordance with RSC Technical Guideline (Standard) and NFPA 13, 14, 20, 22 and 24. After installation the owner shall contact the RSC for witness of conducting the final acceptance testing of the standpipe system.	Design Review within 2 months and installation within 4 months.
