# INITIAL FIRE SAFETY INSPECTION REPORT

**Olympic Fashion Ltd**

**RSC ID: 24883**

**BK Bari, Mirzapur Bazar, Gazipur Sadar, Gazipur, Bangladesh**

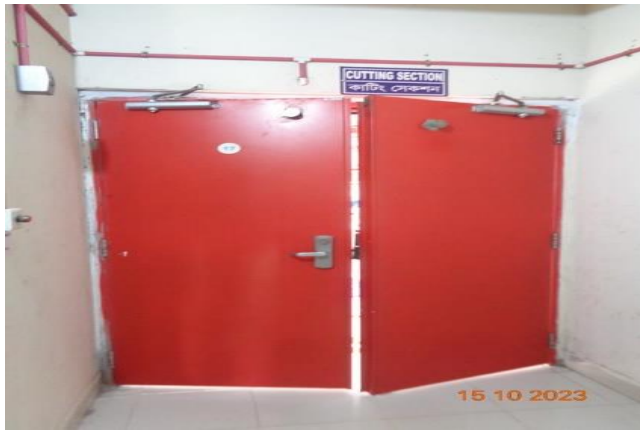
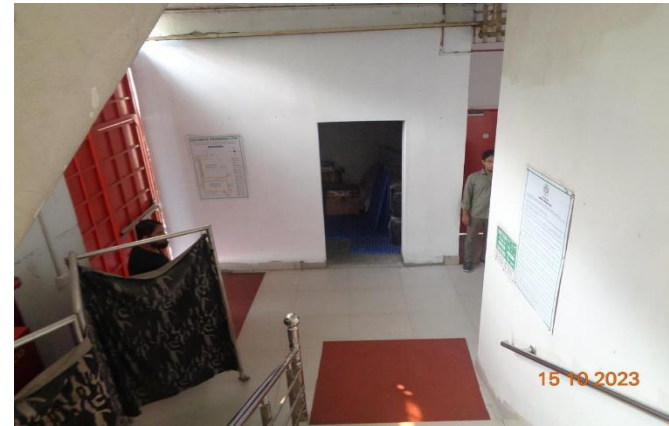
| SI No. | Category | Findings | Required Action | Remediation Time Frame |
|---|---|---|---|---|
| F-1 | Fire Rated Construction | The exit stairs are not separated from work areas , storage, other spaces and due to non functional fire door, smoke seal on each floor by fire rated construction. | Provide minimum 2-hr rated fire wall and 1.5-hr fire rated doors for buildings that are 4 or more stories. Seal all unprotected openings to separate the exit stairs from work areas and other building spaces on all floor levels. Ensure that the fire doors are self-closing and positive latching and that they are provided with fire exit hardware where serving production floors. If fire doors are required to be held open for functional reasons, provide automatic closing devices tied to the fire alarm system. Once fire doors are installed, every door in a stair enclosure serving more than 5 stories shall be provided with re-entry. | Within 3 Months |

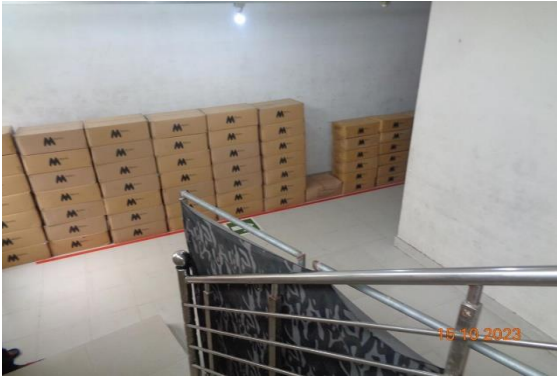
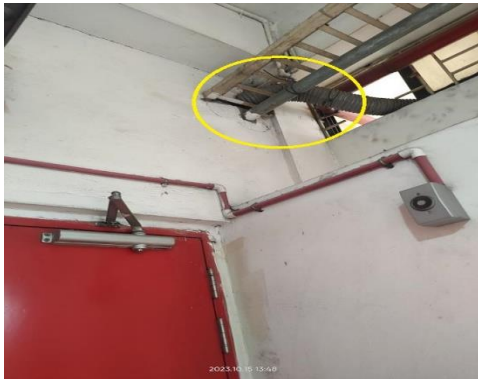
| F-3 | Fire Rated Construction | Exit discharge from exit stair-03 is not directed to outside of the building and exit passageway are not separated from store & other occupancy due to non protected penetration & Openings. | Provide minimum 2-hr rated fire wall and 1.5-hr fire rated doors/openings protective materials for exit passageways & shall terminate on exit discharge. | Within 3 months |

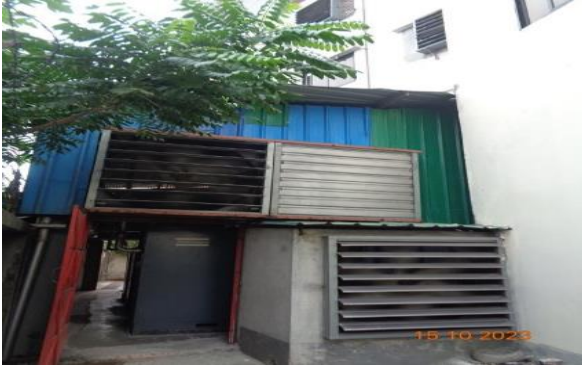
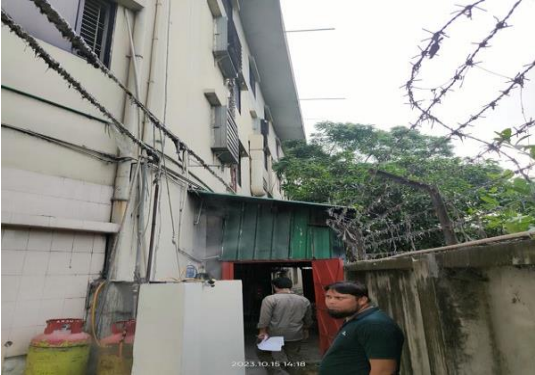
| F-4 | Fire Rated Construction | <p>The Boiler, Compressor room is located just adjacent to main building at exterior location &amp; not separated by fire rated construction (openings, non-rated structure, penetrations) from Main Building.</p> | <p>Separate the Boiler &amp; Compressor room by a minimum 1-hr fire-rated construction from main building including the adequate protection from main building. Seal and/or protected all openings to maintain the required fire separations.</p> <p>Or,</p> <p>Minimum spatial separation of 3 m (10 ft) shall provide where located exterior to the building. Ensure proper ventilation for the boiler &amp; compressor room.</p> | Within 3 Months |

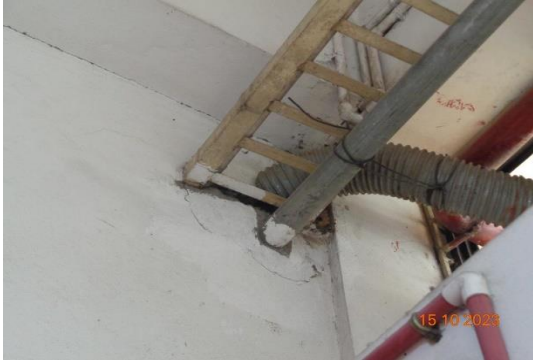
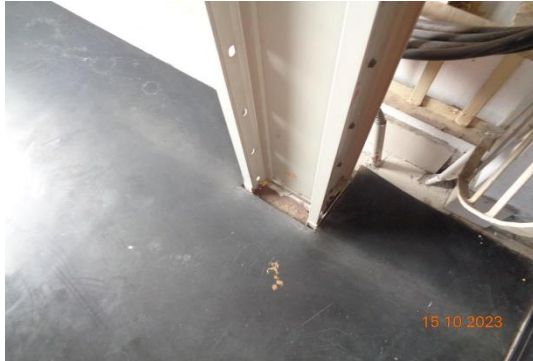
| F-5 | Fire Rated Construction | Unsealed penetrations and openings are located in the fire rated floor/ceiling assemblies due to BBT cable riser. | Seal all penetrations and openings in floor/ceiling (full thickness of the floor/ceiling) assemblies by fire rated materials to maintain the fire resistance rating.<br>or,<br>Provide a minimum 2-hr fire rated shaft to separate the BBT shaft & toilet area from each floor. | Within 3 Months |

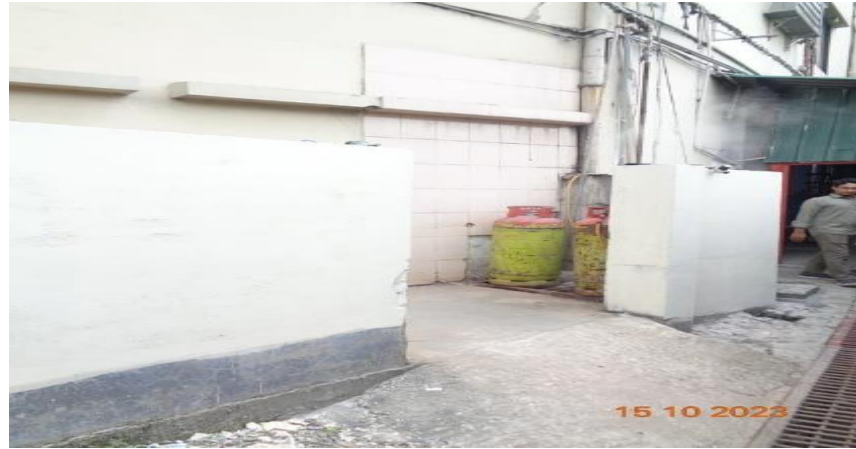
| F-6 | Fire Rated Construction | The factory is using/storing liquefied gas cylinder (LPG) without separation. | <p>The RSC Technical Guideline (Standard) V1, section 3.4.2.1.11 prohibits the storage or use of liquefied or compressed flammable gas (LPG/CNG) cylinders within the factory building.</p> <p>However, if it is not feasible then conditionally those are permitted to be stored in a separate dedicated building on the factory premises within its boundaries if the building meets the following conditions.</p> <ol style="list-style-type: none"> <li>1. The storage building must be at least 3 meters away from any other building and boundaries.</li> <li>2. The exterior walls of the building must have a fire resistance rating of 3 hours using noncombustible construction.</li> <li>3. Doors and other openings in the exterior walls must be protected with suitable closing devices having a fire protection rating of 3 hours.</li> <li>4. The building is to be used for no other purpose than the storage of LPG/CNG cylinders.</li> <li>5. The building must be mechanically ventilated to control the accumulation of flammable vapors.</li> <li>6. The installations must be approved and accepted by the requirements of the AHJ, Gas supply company regulations, manufacturers/supplier's instructions/guidance, Chief Inspector of Boiler (CIOB) and Chief Inspector of Explosives Bangladesh (CIEB).</li> </ol> <p>Follow RSC Published "SUPPLEMENTARY PAPER ON TECHNICAL GUIDANCE NOTE FOR USE OF LIQUIFIED OR COMPRESSED FLAMMABLE GAS IN FACTORY PREMISES"</p> | Within 3 Months |

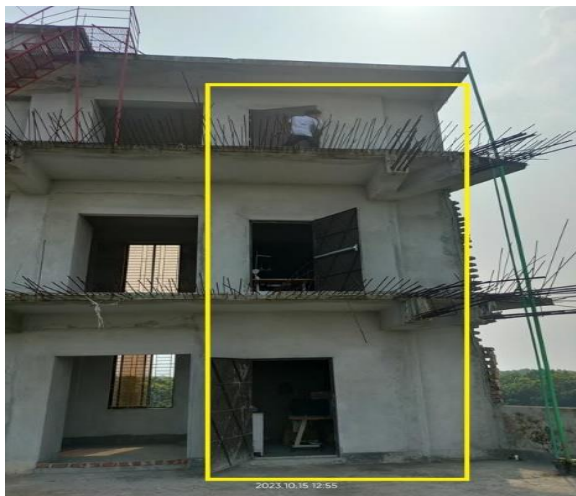
| F-7 | Means of Egress | A single means of exit has been provided room at 4th, 5th floor & Roof of Main Building. | <p>Provide additional exit according to RSC Technical Guidelines (StandardV 1.0) 6.6.1.</p> <p>Or,</p> <p>Seal the room by masonry wall to restrict access &amp; usages of the rooms.</p> | Within 3 months |

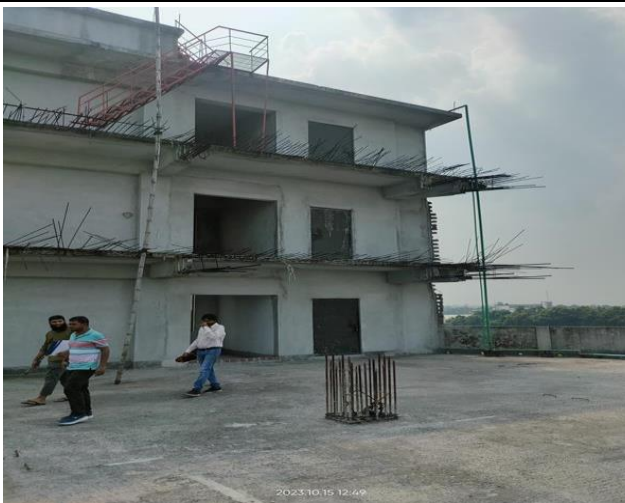
| F-11 | Mean of Egress | Safe guards are not provided at outside of 4th, 5th floor & Occupied roof areas. | Guards shall provide as per RSC Technical Guidelines (StandardV1.0.) Section 6.12.2 where elevation exceeds 30 in. | Within 1 Month |

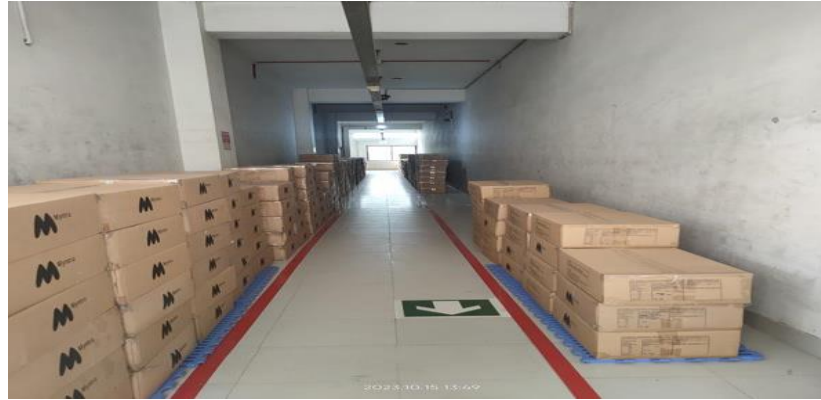
| F-12 | Mean of Egress | Storage was located in the Stair-3 egress path. | Keep egress path and stair clear of storage | Immediate |

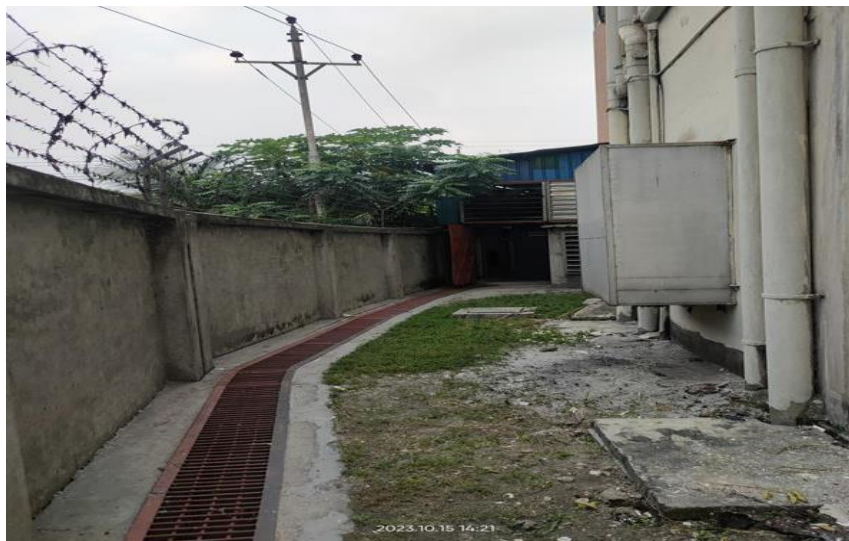
| F-13 | Mean of Egress | Boiler & Compressor room both are located exterior location of the main building with a Approx distance 20m. Boiler operator have to discharge through compressor room. | Provide an egress court having a 1-hr fire resistance rated construction through compressor room from boiler room<br>Or,<br>Provide alternative safe exit from boiler are per RSC Technical Guidelines. | Within 3 Month |

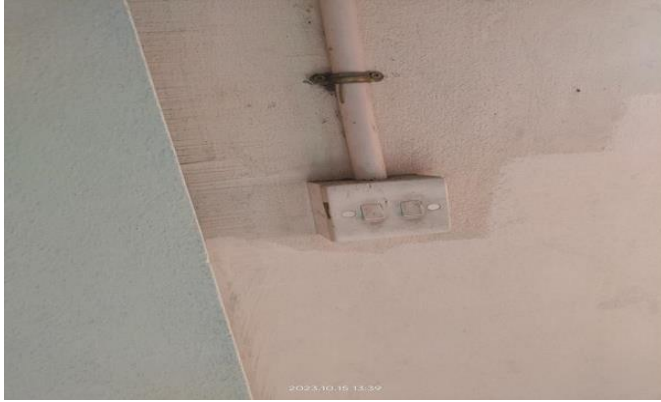
| F-16 | Egress Lighting | <p>Manual On/Off Switch is provided at emergency lighting.</p> | <p>Remove manual on/off switches from emergency lighting / exit signage units to prevent them from being switched off.</p> | Within 1 Month |

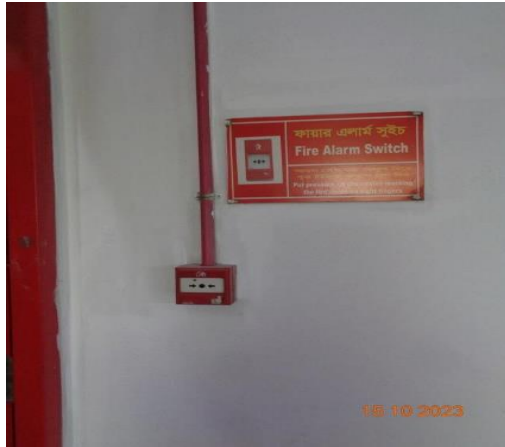
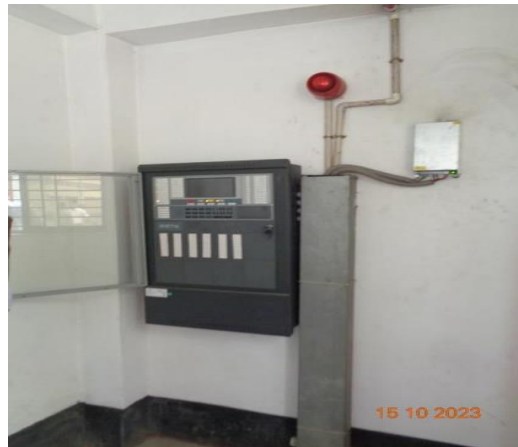
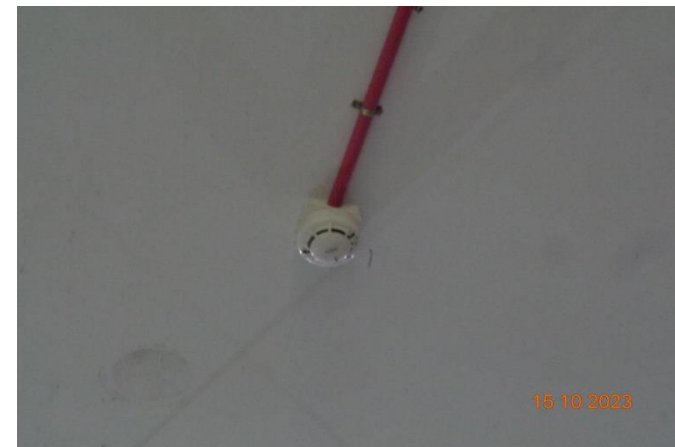
| F-19 | Fire Alarm & Detection System (FADS) | Automatic fire alarm & detection system installation requires detailed review to confirm compliance with NFPA 72 and RSC standards. | <p>Design &amp; Installation of Fire Alarm &amp; Detection system shall be in accordance with RSC standard and NFPA 72. Submit as-built design, documents and calculations to RSC for review prior installation/modification.</p> <p>After installation, the owner shall contact the RSC for witness of conducting the final acceptance testing of the fire detection &amp; alarm system installation.</p> <p>Also inspect, test and maintain the fire alarm system, and keep written records on-site, in accordance with NFPA 72.</p> | Design Review within 2 months and installation within 4 months. |

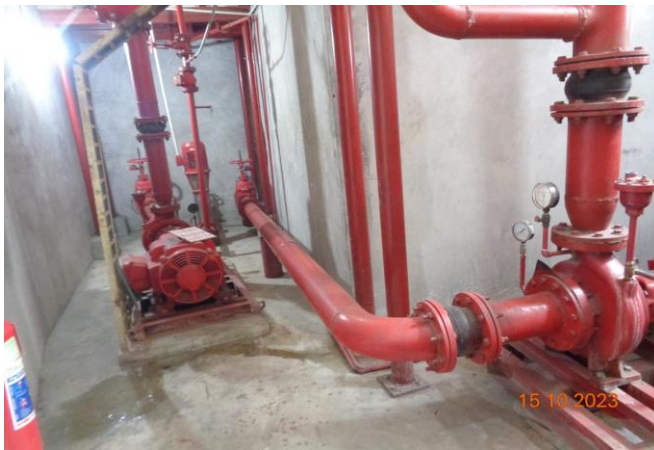
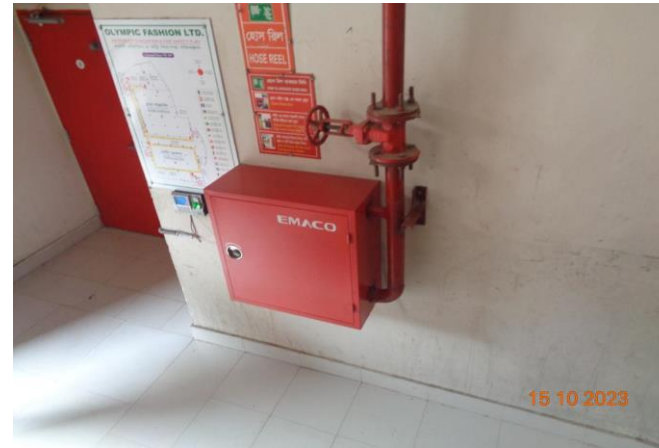
| F-21 | Fire Protection System(Standpipe) | Standpipe system installation requires detailed review to confirm compliance with NFPA 14 and RSC standards. | Submit as-built drawings, testing records, equipment certification and other relevant documentation to the RSC for review and approval. | Design Review within 2 months and installation within 4 months. |
