# INITIAL FIRE SAFETY INSPECTION REPORT

**Sisal Composite Limited (Relocated)**

**RSC ID: 24887**

**Date: 08-Nov-2023**

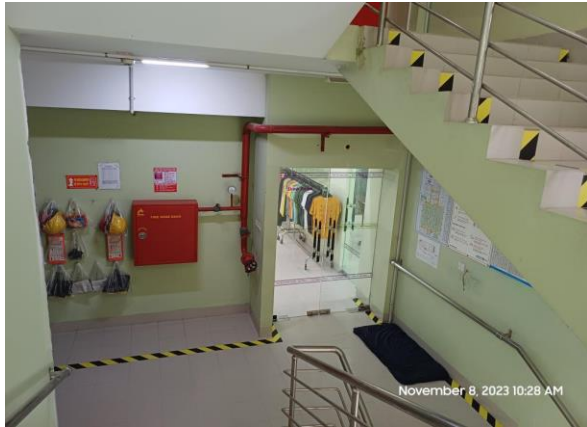
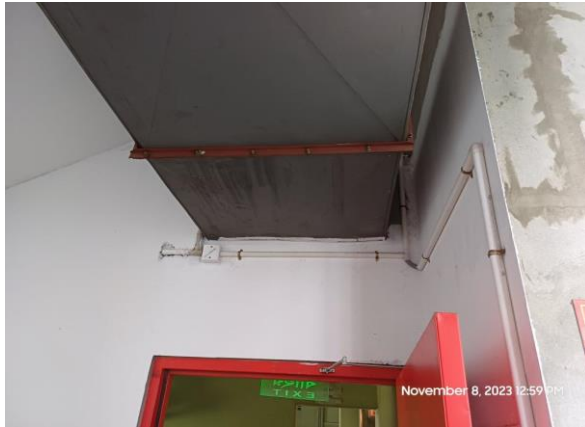
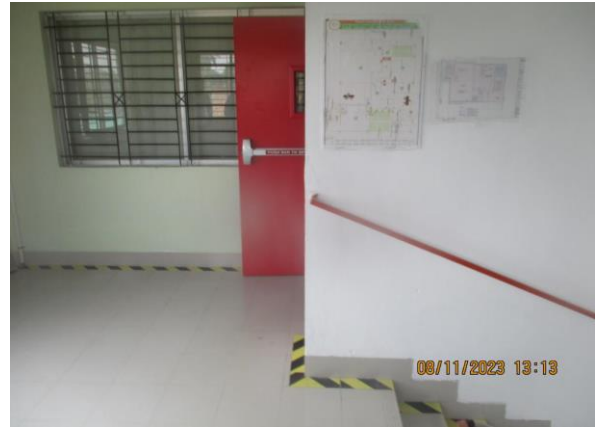
SI No.	Category	Findings	Required Action	Remediation Time Frame
F-01	Fire Rated Construction	<p>The exit stairs are not separated from work areas, other spaces on each floor by fire-rated construction.</p> <p><b>Location:</b>                      i) Main Building.                      ii) Utility Building.</p>	<p>Provide minimum 2-hr fire rated construction for buildings 4 storied or more and 1-hr for up to 3 storied. Seal all unprotected openings to separate the exit stairs from work areas and other spaces on all floor levels by 90 minutes for 2 hr. construction and 60 minutes for 1-hr construction. Ensure that the fire rated doors are self-closing and positive latching and that they are provided with fire exit (panic) hardware where serving production floors. If fire rated doors are required to be held open for functional reasons, provide automatic closing devices tied to the fire alarm system.</p>	Within 3 months

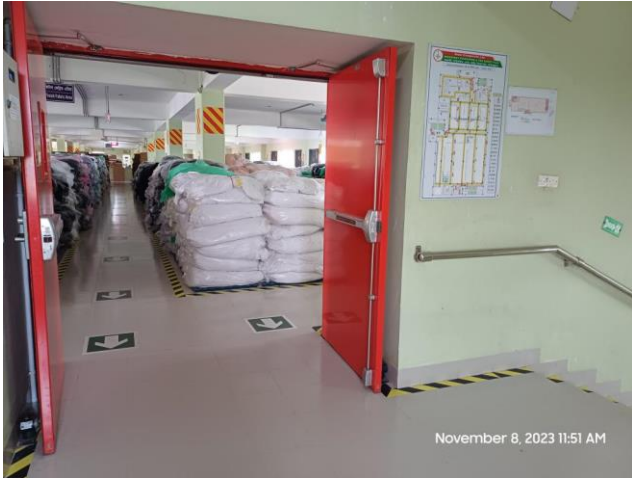
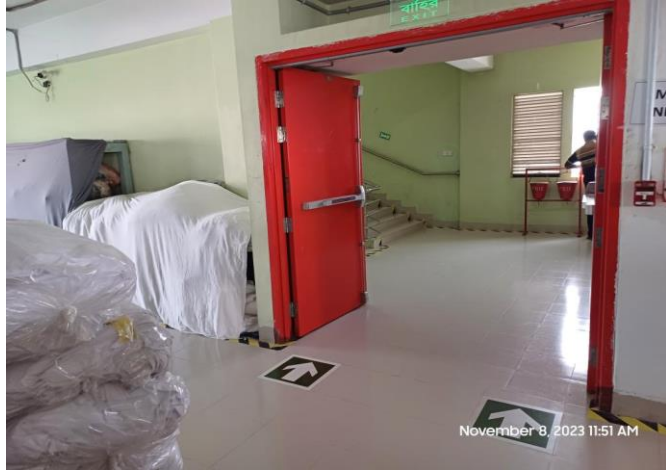
F-02	Fire Rated Construction	<p>Storage room discharges directly into exit stair enclosure.</p> <p><b>Location:</b> 3rd Floor, Stair-02(South) &amp; Stair-03(N-E)</p>	<p>Openings from exit enclosure to storage room, shall be provided with a vestibule with fire rated construction and openings.</p> <p>Provide a 1.5 hr. fire rated door on the exit stair side and a 1-hr. fire rated door on the store side. Ensure that the fire rating of the vestibule construction matches that of the exit stair enclosure.</p>	Within 4 months
------	-------------------------	---	---	-----------------

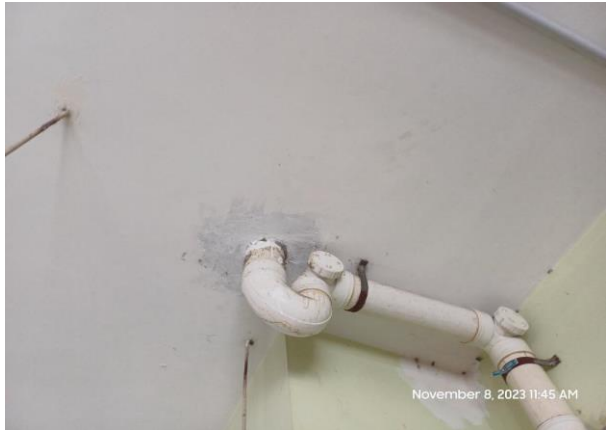
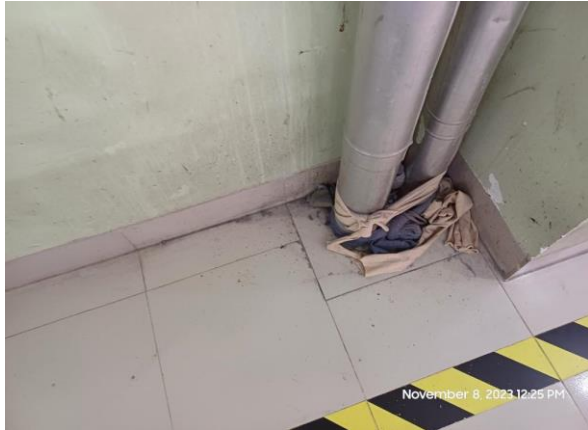
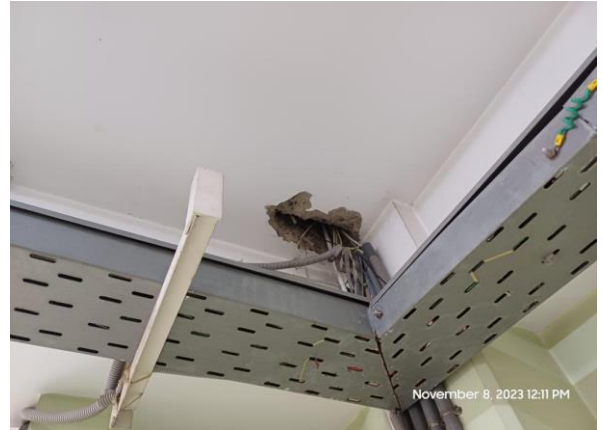
F-03	Fire Rated Construction	<p>Penetrations through floor/ceiling assemblies are found unsealed.</p> <p><b>Location(s):</b> Plumbing pipes, Electrical Cable and Steam Line at several locations of <b>Main Building</b></p>	<p>Seal all penetrations and openings in floor/ceiling (full thickness of the floor/ceiling) assemblies by fire rated materials to maintain the fire resistance rating. Provide a minimum 3-hr fire rated shaft to separate the utility risers from each floor if required.</p>	Within 3 months
------	-------------------------	--	---	-----------------

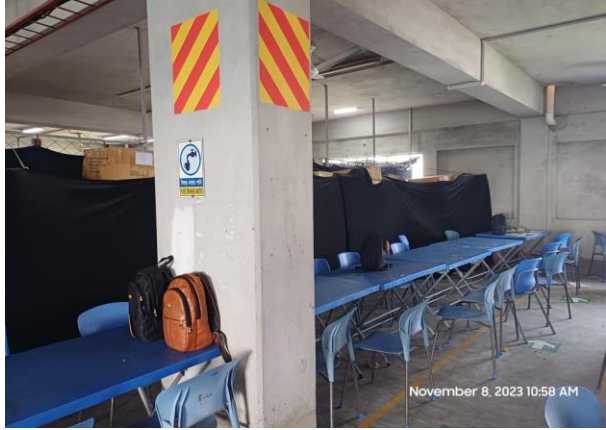
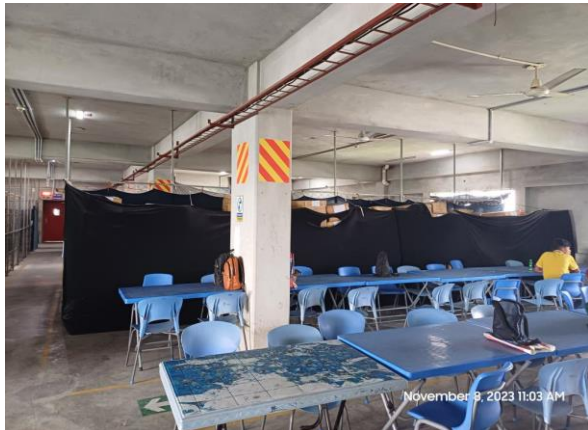
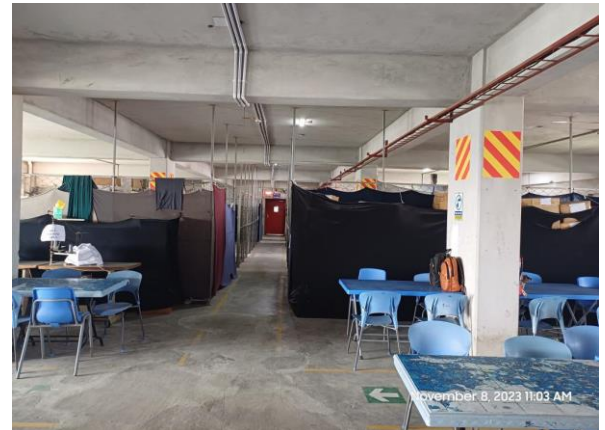
F-04	Fire Rated Construction	<p>Dining and Prayer room was not separated from other occupancies (Storage Area)</p> <p><b>Location:</b> 5th Floor of Main Production Building</p>	<p>Re-locate the dining area or          Provide 3 Hr. fire separation of Assembly occupancy (E3) from Storage (H2) to meet the requirement as per BNBC 2006, part III chapter 2 table 3.2.1. Seal all penetration and opening to maintain the separation.</p>	Within 3 Months
------	-------------------------	---	--	-----------------

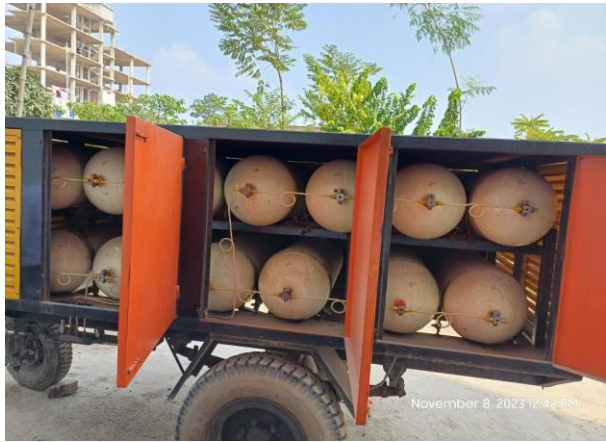
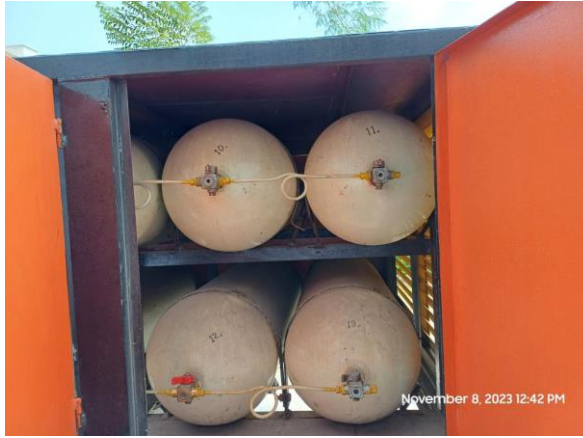
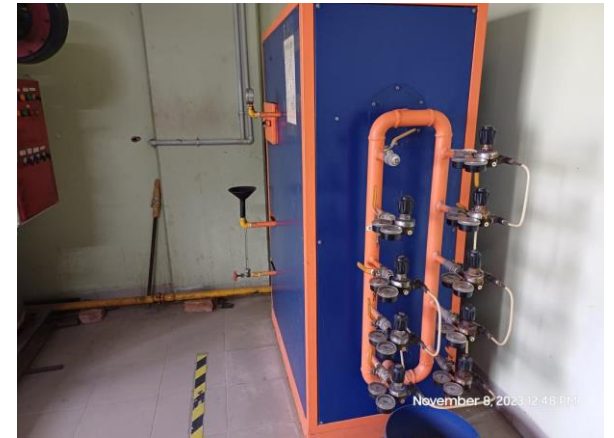
F-05	Fire Rated Construction	Liquefied or compressed gas cylinders/CNG appliances (high pressure CNG pipeline and pressure reducing unit) used in a fuel of boiler were located within the factory (CNG Cylinder found in <b>front of the utility building and CNG high pressure line &amp; pressure reducing control unit located inside the boiler room</b> ).	<p>The RSC Technical Guideline (Standard) V1, section 3.4.2.1.11 prohibits the storage or use of liquefied or compressed flammable gas (LPG/CNG) cylinders within the factory building.</p> <p>However, if it is not feasible then conditionally those are permitted to be stored in a separate dedicated building on the factory premises within its boundaries if the building meets the following conditions.</p> <ol style="list-style-type: none"> <li>1. The storage building must be at least 3 meters away from any other building and boundaries.</li> <li>2. The exterior walls of the building must have a fire resistance rating of 3 hours using noncombustible construction.</li> <li>3. Doors and other openings in the exterior walls must be protected with suitable closing devices having a fire protection rating of 3 hours.</li> <li>4. The building is to be used for no other purpose than the storage of LPG/CNG cylinders.</li> <li>5. The building must be mechanically ventilated to control the accumulation of flammable vapors.</li> <li>6. The installations must be approved and accepted by the requirements of the AHJ, Gas supply company regulations, manufacturers/supplier's instructions/guidance, CIOB and all other applicable agencies, codes and standards.</li> </ol>	Within 3 months

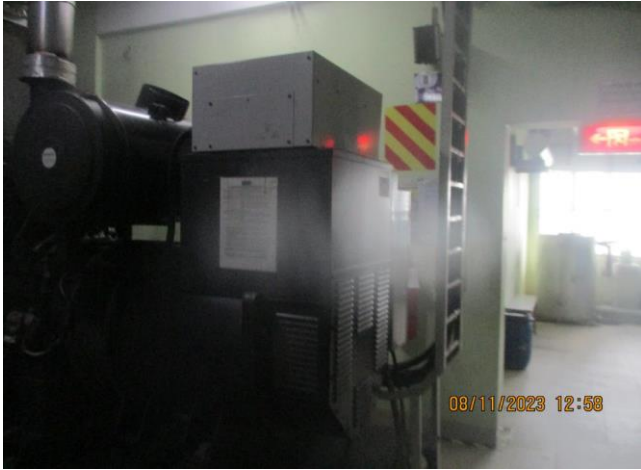
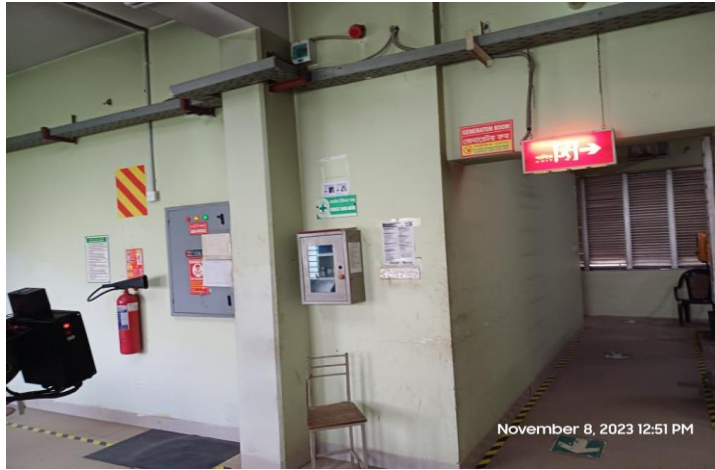
F-06	Fire Rated Construction	<p>The boiler, generator, compressor and substation rooms are not fire separated with fire rated construction barrier or assemblies.</p> <p><b>Location:</b> Ground floor of utility building.</p>	<p>Separate the boiler and compressor rooms by a minimum 1-hr fire-rated construction with 0.75-hr fire rated opening protective assemblies like fire rated door.</p> <p>Similarly separate generator and substation room by a minimum 2-hr fire rated construction with 1.5-hr fire rated opening protective assemblies like fire rated door. Provide proper ventilation and consult a qualified engineer for overall solution.</p> <p>When located to the exterior of a building by at least 3m (10 ft.) distance from surroundings then fire rated construction barrier is not mandatory.</p>	Within 3 months
------	-------------------------	--	--	-----------------

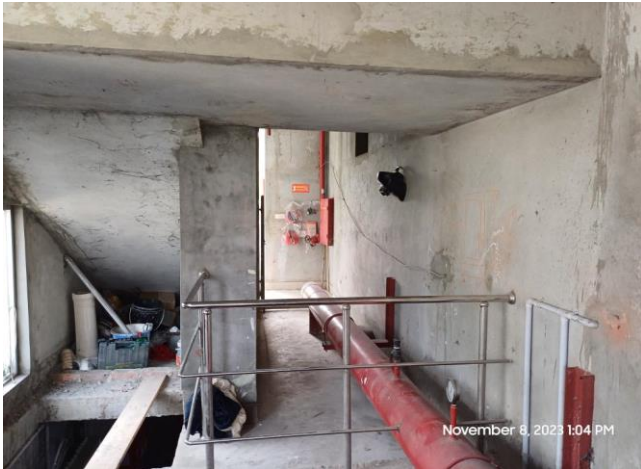
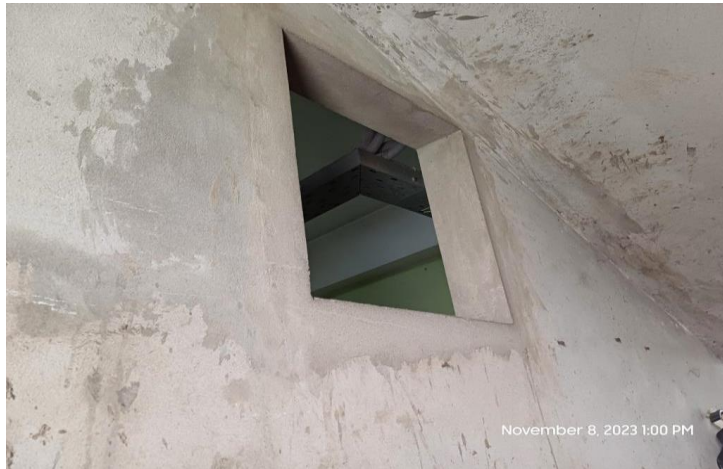
F-07	Fire Rated Construction	The fire pump room was not provided with adequate fire rated separation with the boiler room.	Provide fire pump room with 2 hr rated fire separation when not sprinklered and 1 hr rated fire separation when provided with automatic sprinklers, in accordance with NFPA 20. In the case exterior it shall be 50 ft away from another occupancy.	Within 3 months
------	-------------------------	---	---	-----------------

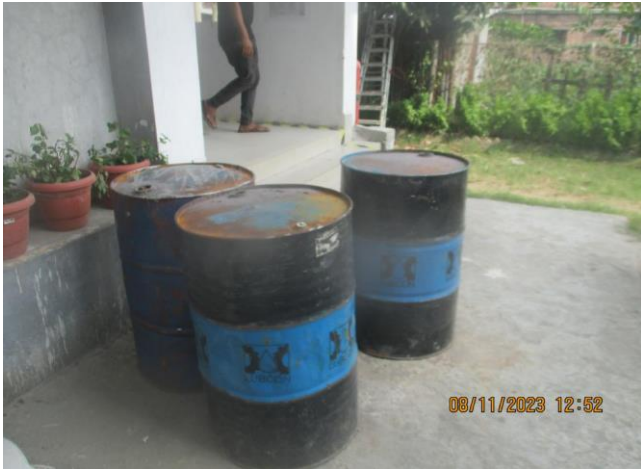
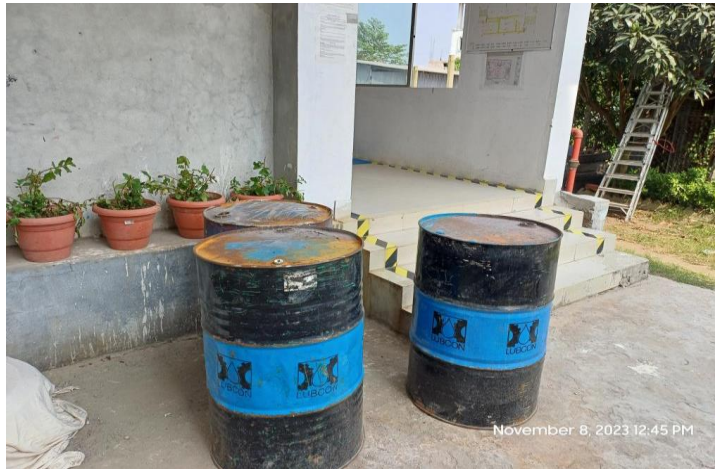
F-08	Fire Rated Construction	<p>Storage of hazardous materials/flammable liquids (diesel) was located at near of the egress path that were not separated by fire-rated construction.</p> <p><b>Location:</b> In front of the utility building</p>	<p>Remove all diesel fuel storage from the egress paths and relocate to the exterior such that the diesel fuel storage is at least 10 ft from required egress paths. If located along egress paths separate the diesel fuel storage with 2- hr. fire rated construction.</p>	Within 3 months
------	-------------------------	--	--	-----------------

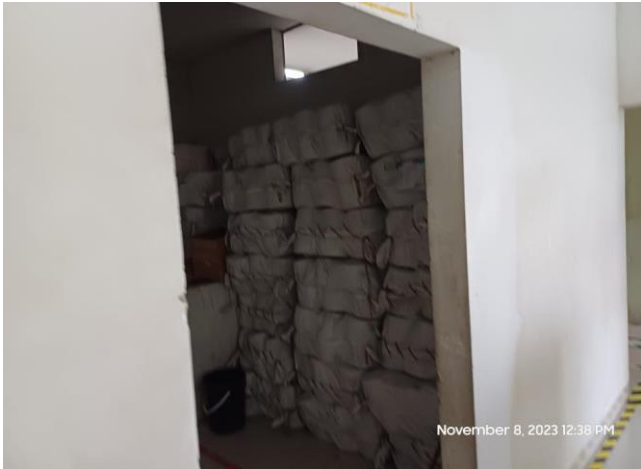
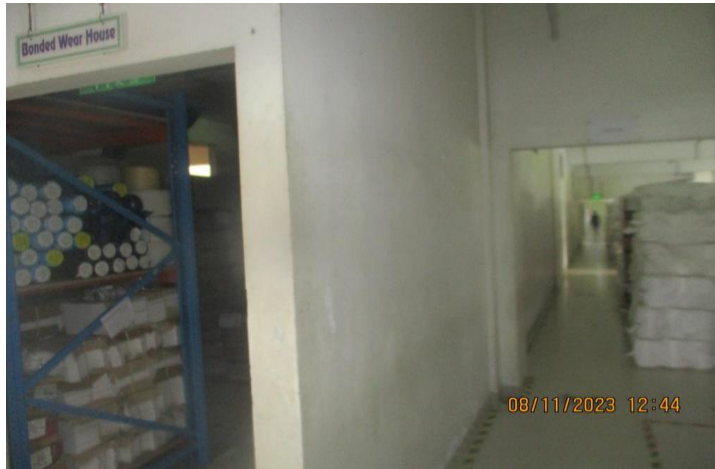
F-9	Fire Rated Construction	<p>Rooms used for storage of combustible materials located at several floors are not separated from the surrounding occupancy/areas.</p> <p><b>Locations:</b> Main Building.</p>	<p>Rooms used for storage of combustible materials shall be separated from the surrounding occupancy with a minimum 1 hour construction.</p>	Within 3 months
-----	-------------------------	--	--	-----------------

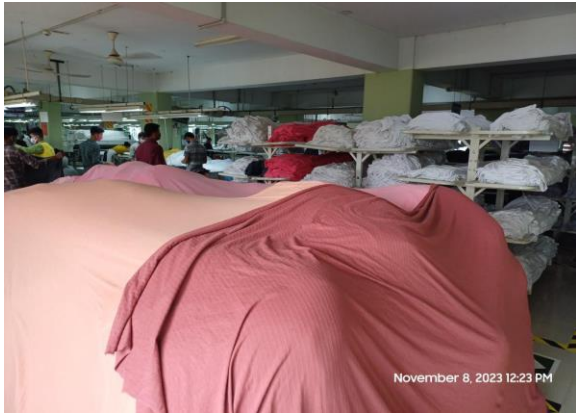
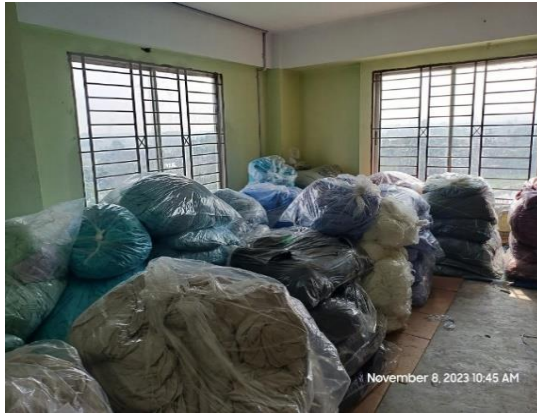
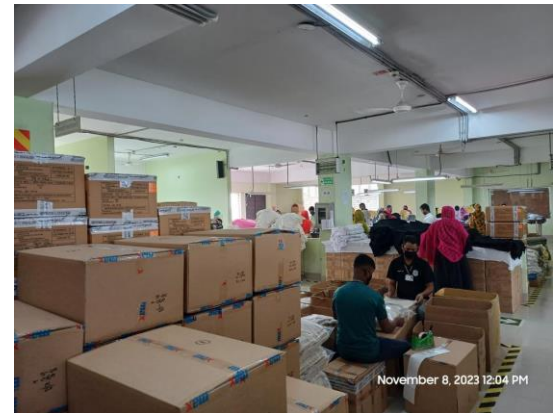
F-10	Fire Rated Construction	<p>Areas used for in-process storage of combustible materials are open to the surrounding occupancy.</p> <p>Combustible materials has kept under cutting table which is non compliant.</p> <p><b>Location:</b> Main Building at several locations.</p>	<p>Provide defined storage areas and limit the storage arrangement as follows: -</p> <ol style="list-style-type: none"> <li>1. General Condition: Maximum height of 2.4m and maximum area of 23m<sup>2</sup>. Separate areas of unenclosed combustible storage by a minimum clear distance of 3m.</li> <li>2. If sprinkler protected: maximum height of 3.66m and maximum area of 93m<sup>2</sup>. Separate areas of unenclosed combustible storage by a minimum clear distance of 3m.</li> <li>or</li> <li>3. Enclose the storage area from the surrounding occupancy with a minimum 1-hour construction.</li> </ol>	Within 3 months
------	-------------------------	--	---	-----------------

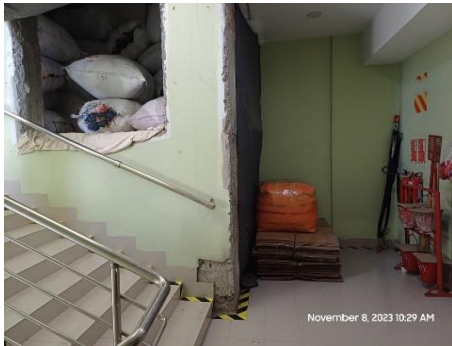
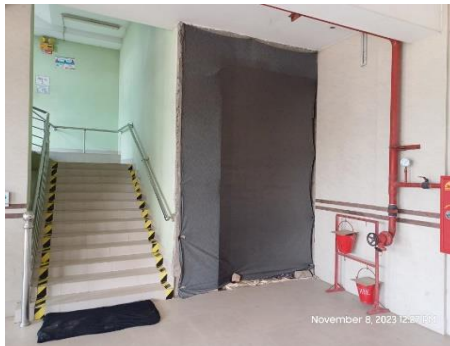
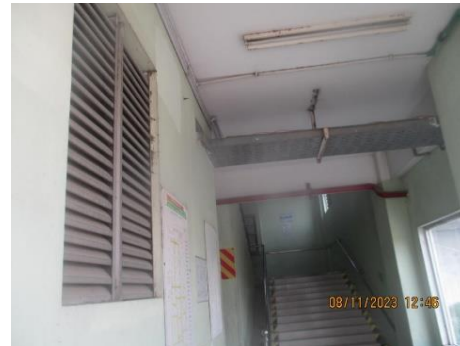
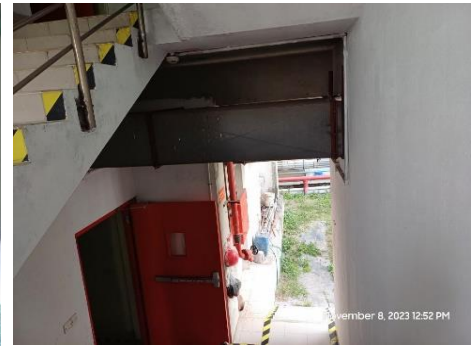
F-11	Means of Egress	<p>Exit stair enclosures are not free from unsealed penetrations and openings (Elevator/Lift core, Electrical cable tray and duct)</p> <p><b>Locations:</b> Main building &amp; Utility building.</p>	<p>Penetrations into and through an exit enclosure shall be prohibited with the exception of required exit doors, sprinkler piping, standpipes, electrical raceway for fire alarm equipment, and electrical conduit serving the exit enclosure. Remove Steam Pipe/ cable raceway/busbar riser/ plumbing pipes and electrical pipes from the exit stair enclosures. Seal all penetrations and openings in the wall of exit enclosure (lift/elevator core penetrations) by fire rated materials to maintain the fire resistance rating.</p>	Within 1 month
------	-----------------	---	---	----------------

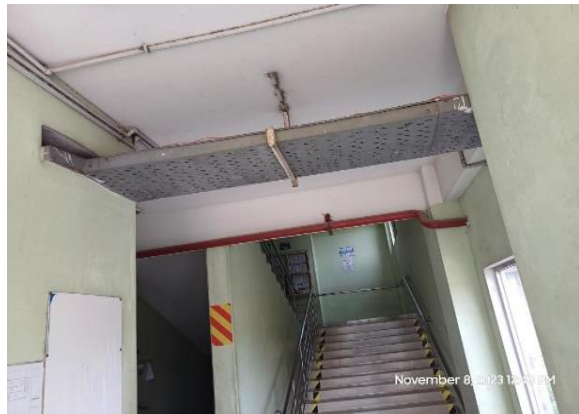
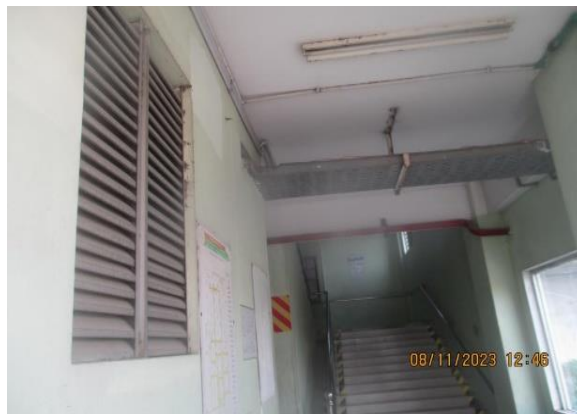
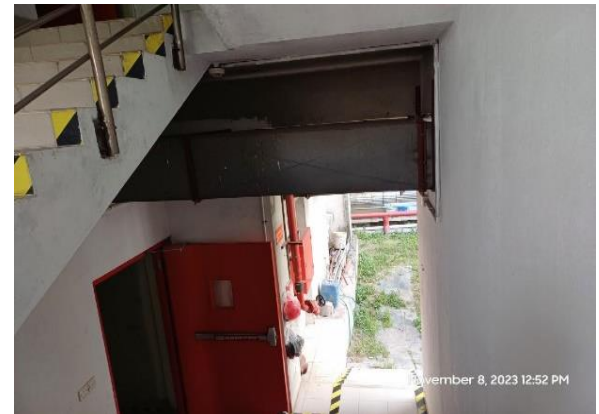
F-12	Means of Egress	<p>Outward swinging type doors were not provided at the building exits, exit stairs, along egress routes and exit discharge.</p> <p><b>Location:</b> All stairs to the roof top of the main building.</p>	<p>Replace all gates, sliding doors and rolling shutters along the means of egress with side-hinged, swinging egress doors, swinging in the direction of egress travel. If locks are required for security reasons, utilize special door locking features complying with NFPA 101</p>	Within 1 month
------	-----------------	---	---	----------------

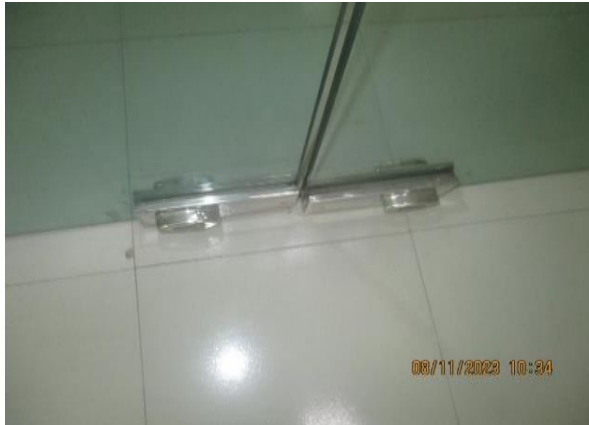
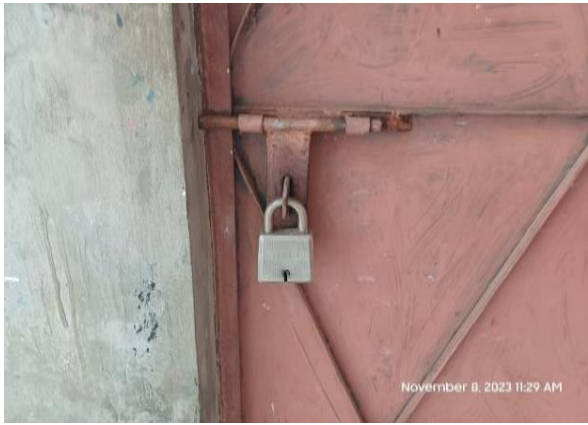
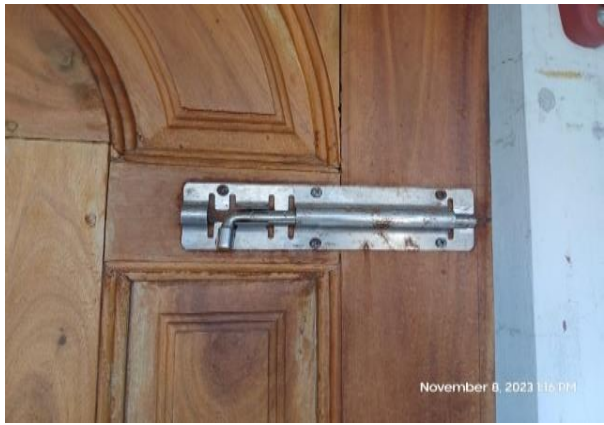
F-14	Means of Egress	Non compliant locking system were observed at several floors of means of egress path.	<ol style="list-style-type: none"> <li>1. Remove all non compliant locking features from egress doors.</li> <li>2. If locks are required for security reasons, utilize special door locking features complying with NFPA 101.</li> <li>3. Doors may be locked where the latch and lock are disengaged with one motion where the occupant load does not exceed 49 persons.</li> <li>4. Doors may be provided with locking hardware from the ingress side provided that a panic bar is installed on any door with an occupant load exceeding 49 persons.</li> </ol>	Immediately
------	-----------------	---	---	-------------

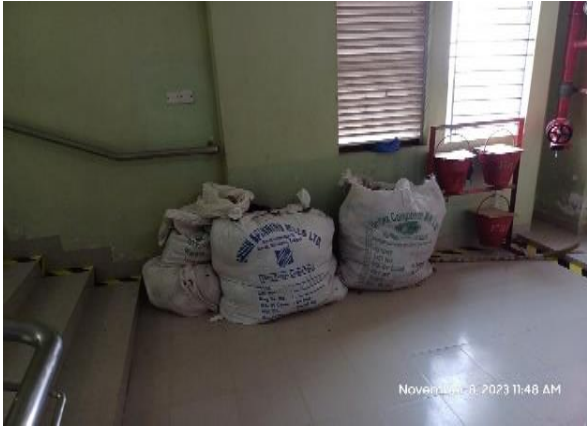
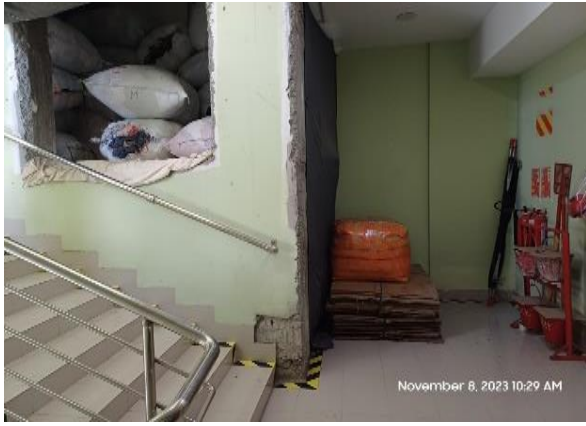
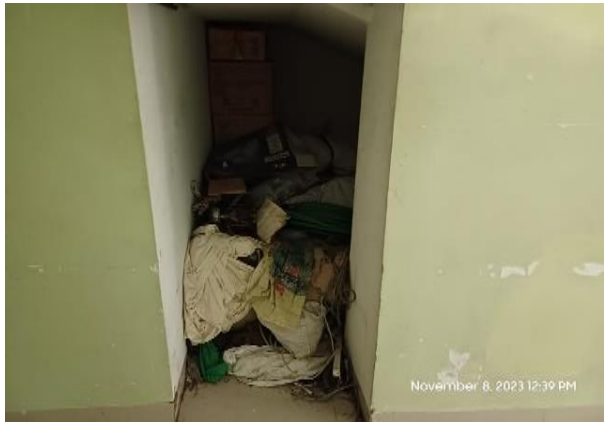
F-15	Means of Egress	Storage was located in exit stair	Remove storage from the exit stairs and egress path	Immediately
------	-----------------	-----------------------------------	---	-------------

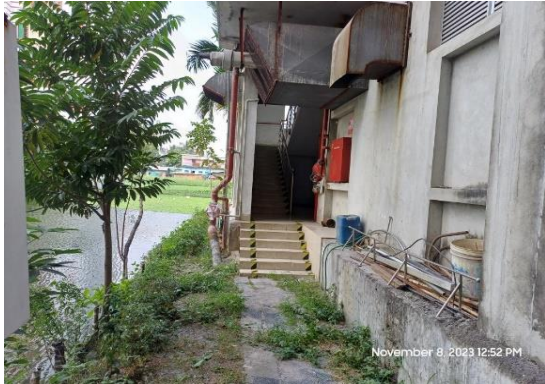
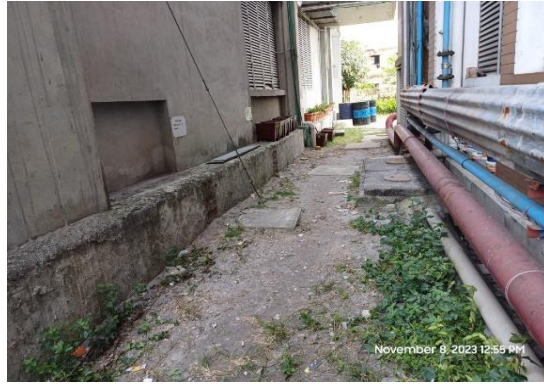
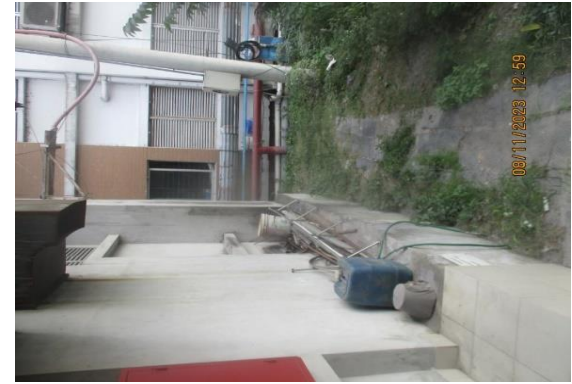
F-17	Means of Egress	<p>Uneven path of travel and blockage in exit access.</p> <p><b>Locations:</b> Utility Building, Exit-02(N-W)</p>	<p>Remove unnecessary items and level exit path to the public way.</p>	<p>Within 1 month</p>
------	-----------------	---	--	-----------------------

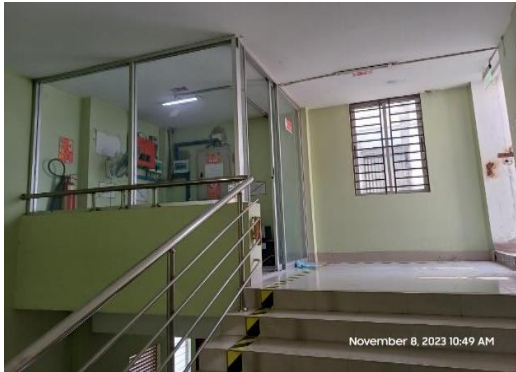
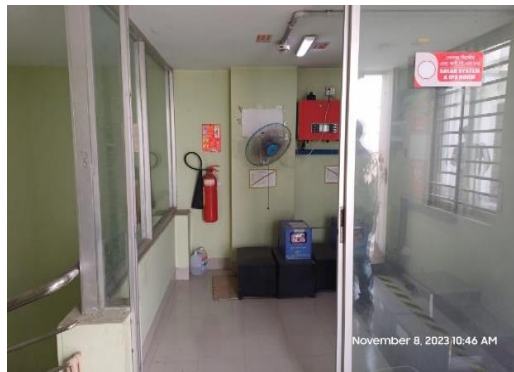
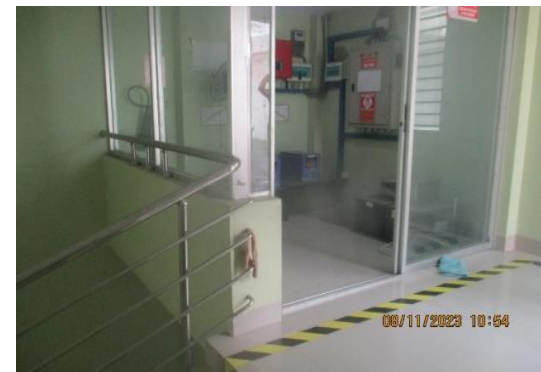
F-18	Means of Egress	<p>Electrical panels were located in the exit stair enclosures.</p> <p><b>Location:</b> Roof Top, Stair-3(N-E), of Main Building.</p>	<p>Remove and re-locate all electrical panels from exit stair enclosures.</p>	<p>Within 1 month</p>
------	-----------------	---	---	-----------------------

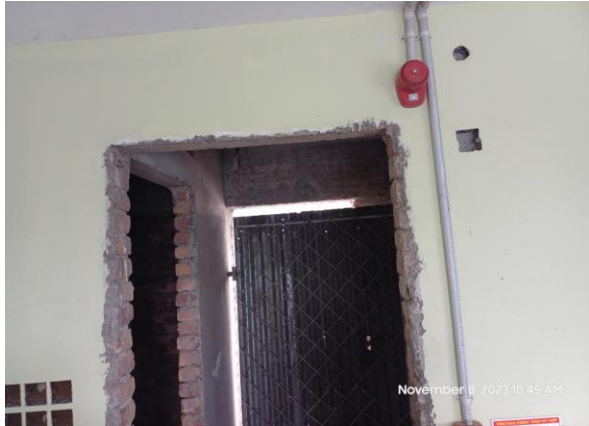
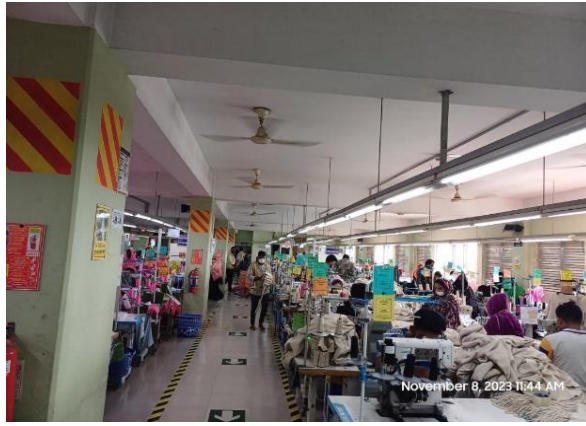
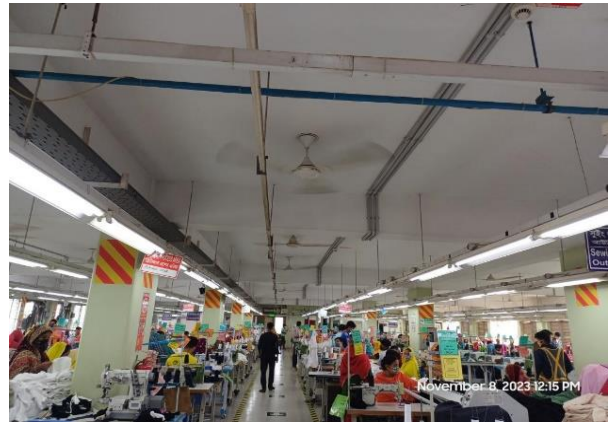
F-19	Egress Lighting	Exit sign and Directional Sign are not provided at and towards exit at several floors.	Lighted exit signs shall be placed at entrance to an exit. Additional exit signs shall be placed throughout the facility anywhere the continuation of the egress is not obvious. Lighted exit signs shall be provided with either battery backup or uninterruptable power supply systems and shall be continuously illuminated.	Within 1 month
------	-----------------	--	---	----------------

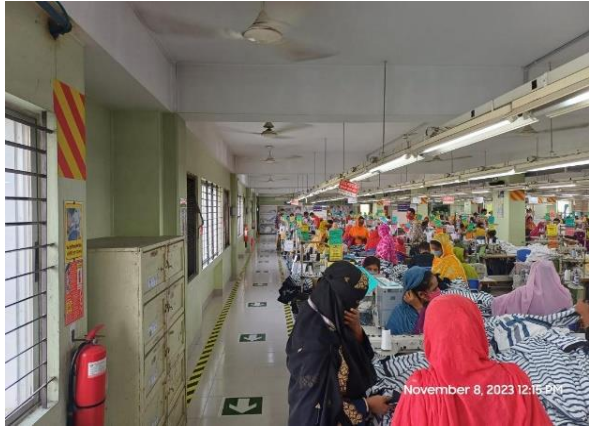
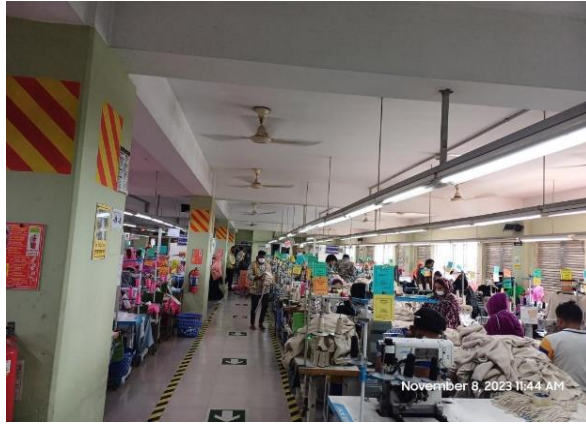
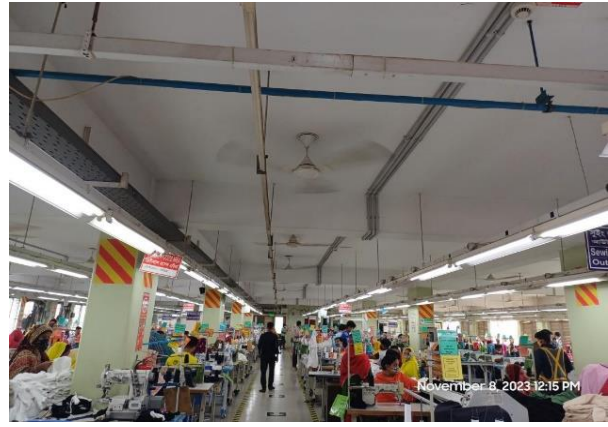
F-20	Egress Lighting	Based on the number and location of emergency lights observed, adequate illumination levels are not anticipated along egress routes at several floors..	Test the emergency lighting system on each floor and provide additional emergency fixtures to provide adequate illumination along the means of egress. Provide a minimum illumination of 10 lux at the floor level within exit stairs and exit discharge paths and minimum 2.5 lux along exit access aisles.	Within 3 months
------	-----------------	---	--	-----------------

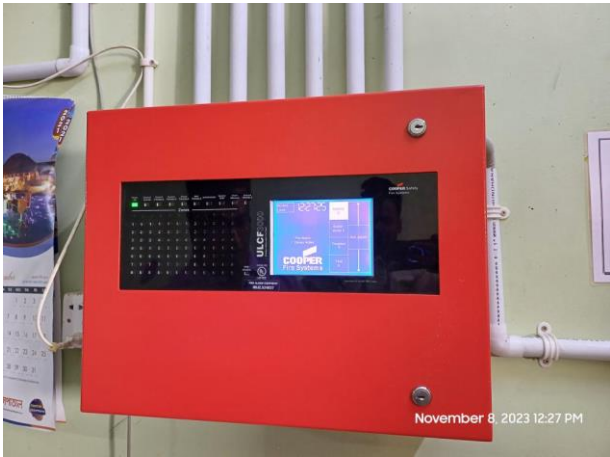
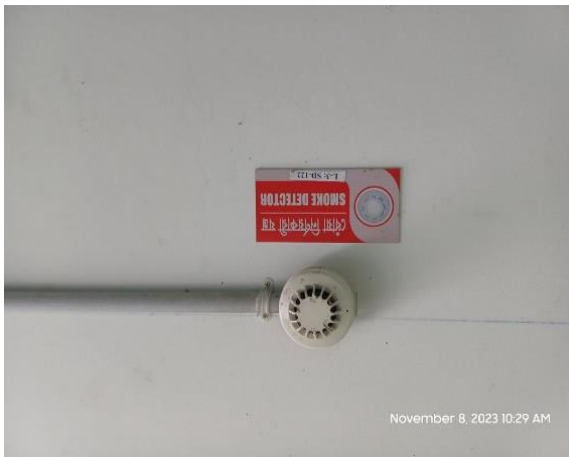
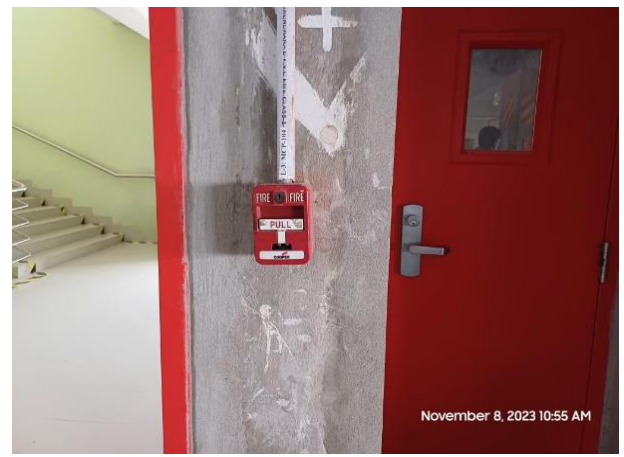
F-21	Fire Alarm & Detection system	Automatic fire alarm and detection system installation has been found complete which requires detailed review to confirm compliance with NFPA 72 and The RSC Technical Guidelines (Standard).	Submit the fire alarm system design to RSC for review. Once the design is reviewed, install and modify the fire detection and alarm system throughout the buildings in accordance with review comment, Accord/ RSC Technical Guidelines (Standard) and NFPA 72. After installation the owner shall conduct internal testing and commissioning and then contact the RSC for witness of final acceptance testing. Also inspect, test and maintain the fire alarm system, and keep written records on-site, in accordance with Table-14.3.1 of NFPA 72.	Design Review within 2 months and installation/modification within 4 months
------	-------------------------------	---	--	---

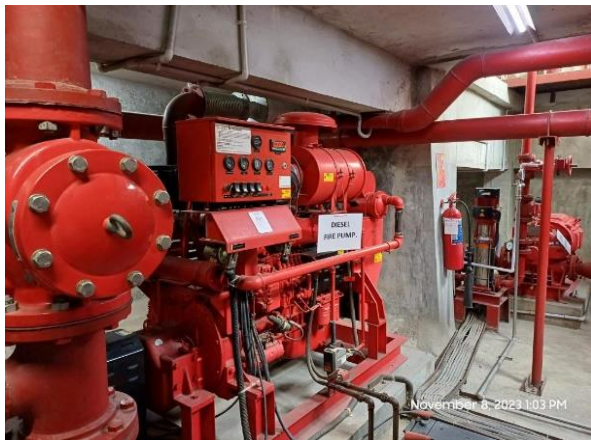
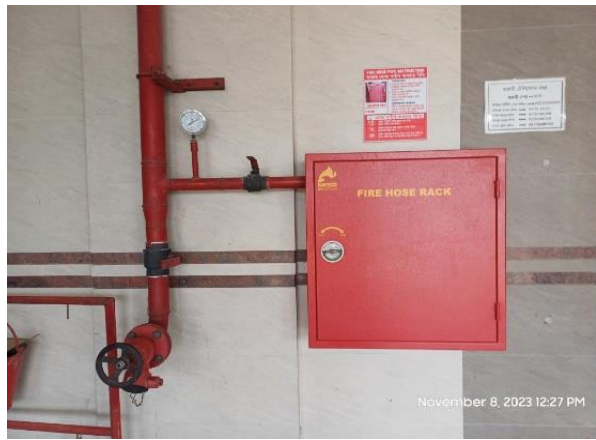
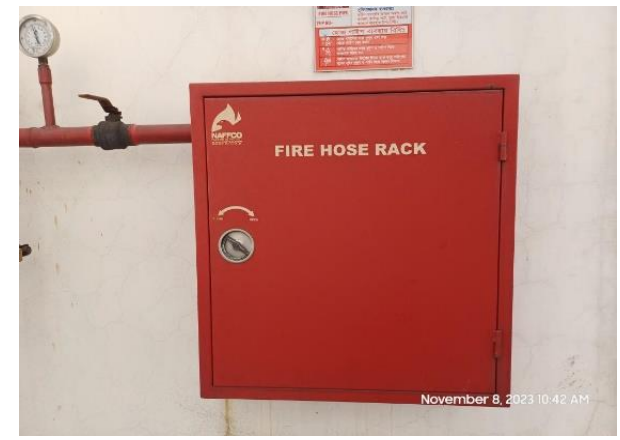
F-22	Fire Alarm & Detection system (ITM of FADS)	Inspection, testing and maintenance for the fire alarm system is not in accordance with NFPA 72 and and The RSC Technical Guidelines (Standard).	Inspect, test and maintain the fire alarm system and keep written records on-site, in accordance with NFPA 72 and The RSC Technical Guidelines (Standard) and keep written records on-site	Within 1 month (after installation)
F-23	Fire Protection System (Standpipe)	Fire pump, water supply & standpipe system installation requires detailed review to confirm compliance with NFPA 14, 20, 22, 25 and RSC Technical Guideline (Standard).	Submit as built drawings, testing records, listing information and other relevant documentation to the RSC for review and approval, modification shall have to done as per the reviewed design (if required). Upon approval & modification (if required) the factory shall inform RSC to conduct final testing and commissioning verification of the system for final acceptance.	Design within 2 months, installation/modification on within 4 months
