# INITIAL FIRE SAFETY INSPECTION REPORT

**Ratool Apparels Ltd. (Extension 2)**

**RSC ID: 24733**

**Date: 09th-November- 2023**

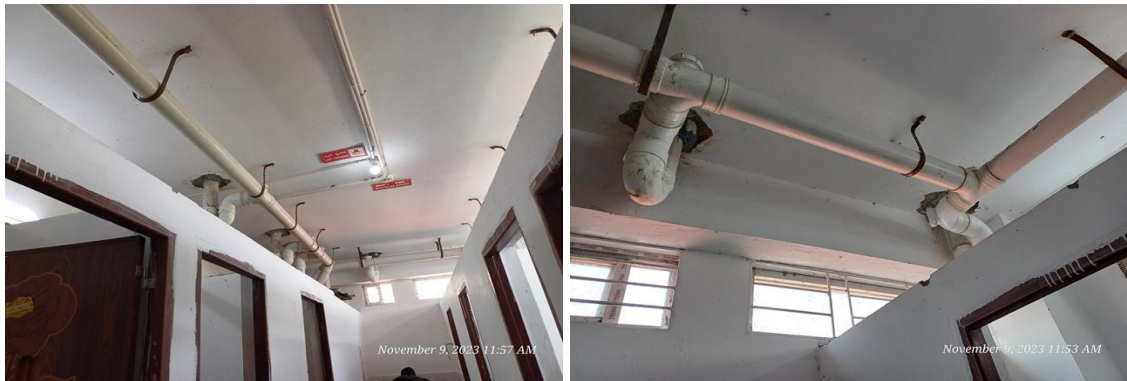
SI No.	Category	Findings	Required Action	Remediation Time Frame
F-1	Fire rated Construction	<p>Unsealed penetrations and openings are located in the fire-rated floor/ceiling assemblies.</p> <p><b>Location:</b> Toilet area, 1st and ground floor of main production building</p>	<p>Seal all penetrations and openings in floor/ceiling assemblies to maintain the fire separation at least by 2-hr. The used sealer shall be 3rd party certified and installation shall be as per manufacturer's datasheet.</p> <p>Or</p> <p>Provide a minimum 2-hr fire rated shaft to separate the utility risers from each floor if required.</p>	Within 3months

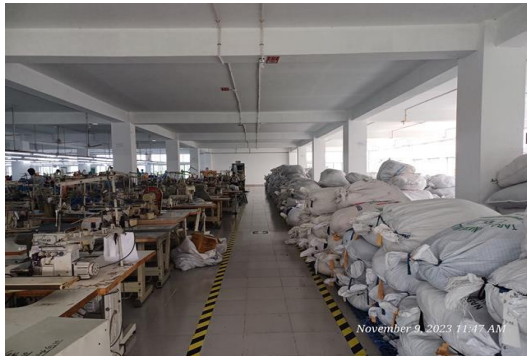
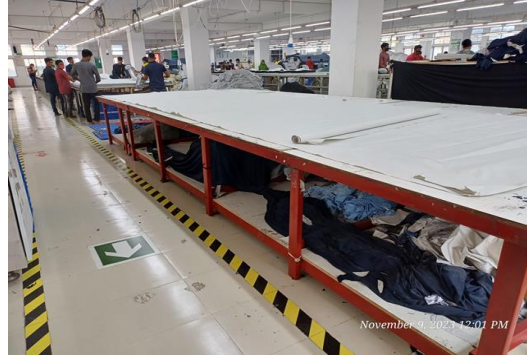
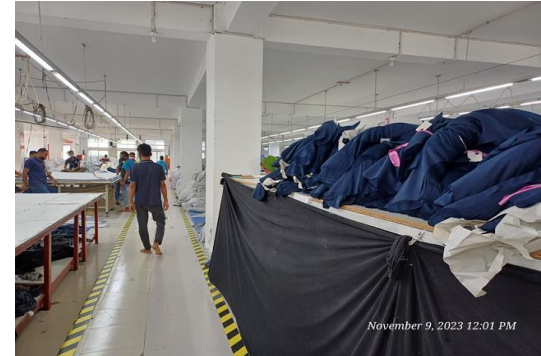
F-2	Fire Rated Construction	<p>Areas used for in-process storage of combustible materials are open to the surrounding occupancy.</p> <p><b>Location:</b> 2nd, 1st and ground floor of main production building.</p>	<p>Provide defined storage areas and limit the storage arrangement as follows: Maximum height of 2.45 m and maximum area of 23 m<sup>2</sup> and is separated by a minimum 3.0 m (10ft) from other storage areas and they do not exceed 10 percent of the building area of the story in which they occur. If sprinkler protected, Maximum height 12 ft (3.66 m) and maximum area of 1000 ft<sup>2</sup> (93 m<sup>2</sup>) and separated by a at least 25 ft (7.62 m) from other storage areas and does not constitute more than 10 percent of the building area or 4000 ft<sup>2</sup> (372 m<sup>2</sup>) of the sprinklered area, whichever is greater.</p> <p>or,</p> <p>Enclose the storage area from the surrounding occupancy with a minimum 1 hour construction</p>	Within 3 months

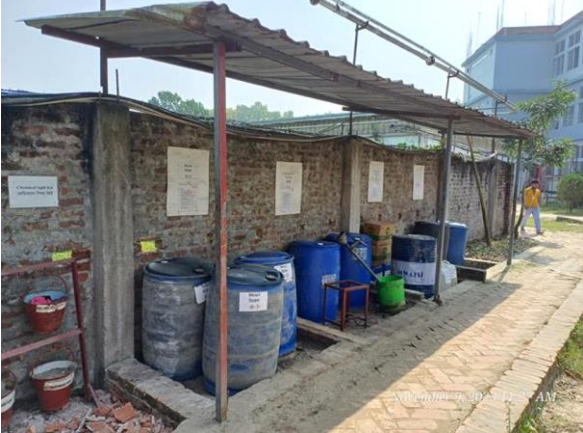
F-3	Fire Rated Construction	Chemical store room is not properly separated due to unprotected opening & penetrations. Location: Near to compressor shed.	<p>Separate the chemical storage room by 4-hr fire rated construction. Seal all penetrations and protect the openings to maintain the required fire separations. Keep 16-points MSDS of all chemicals in the storage area.</p> <p>** As per BNBC, chemical storage room will be Type 1 construction. Follow section-2.13 and Table 3.2.1 of BNBC-2006 for the guideline.</p>	Within 3 months
-----	-------------------------	--	--	-----------------

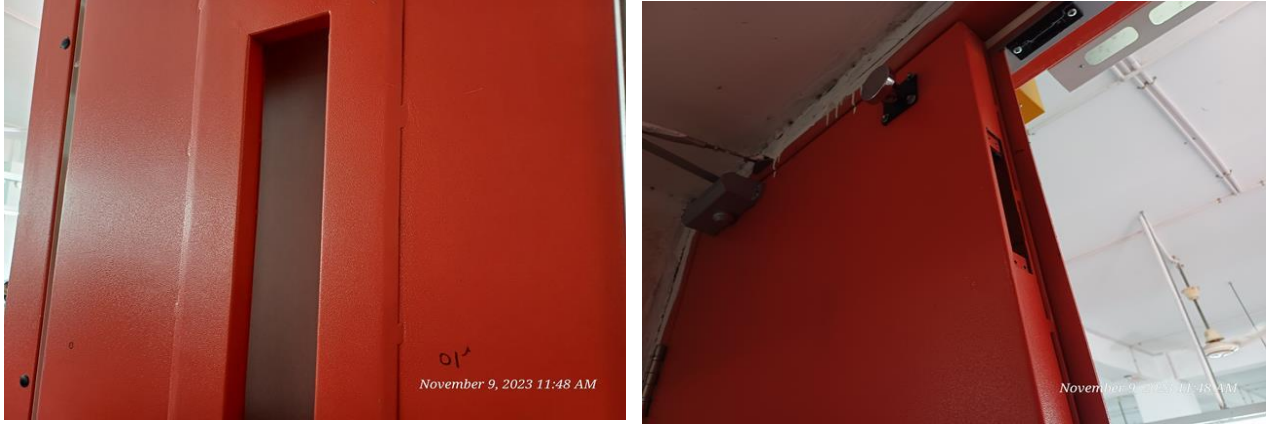
F-4	Mean of Egress	<p>The exit stairs are not separated from [work areas, other spaces] on each floor by fire rated construction as the installed fire doors are partially assembled or non-functional.</p> <p><b>Location:</b> 3 storied main production building</p>	<p>The exit stair enclosure shall be provided with a minimum of 1- hr. fire resistance rating with 60 minutes opening protection.</p> <p>The clearance under the bottom of a fire door shall be a maximum of 19mm.</p> <p>Ensure that the fire doors are self-closing and positive latching and that they are provided with fire exit (panic) hardware where serving production floors. If fire doors are required to be held open for functional reasons, provide automatic closing devices tied to the fire alarm system.</p>	Within 3 months

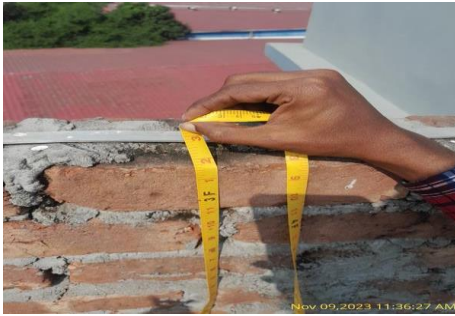
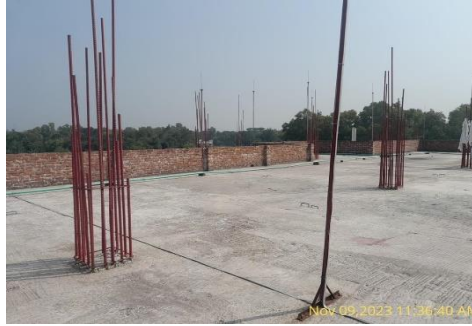
F-5	Means of Egress	<p>Parapets or guards are provided in occupied roof which is less than 1067mm (42 inch).</p> <p>Location: Roof floor of main production building</p>	Provide parapets or guards with a minimum height of 1067mm (42 inch.).	Within 3 months

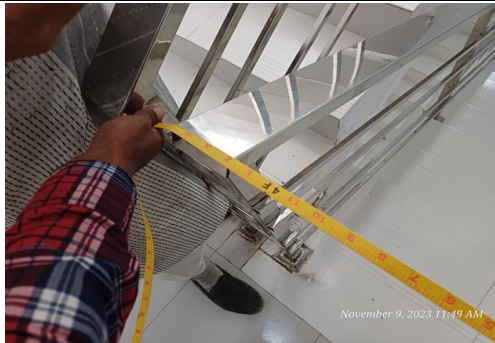
F-6	Means of Egress	Stair width was found less than 60 inches. Location: Stair-1 of main production building.	Provide exit stair minimum clear and unobstructed width of 1.5 m (60 in.) in accordance with as per RSC Technical guideline standard V1 6.5.6.2.1.	Within 3 months
-----	-----------------	--	--	-----------------

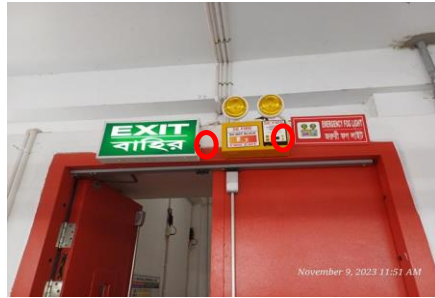
F-7	Means of Egress	Building did not have stair designation signs & exit designation signs at required locations.	Provide stair designation sign & exit designation sign at each floor entrance from the stair to the floor in English and Bengali. Signs shall indicate the name of the stair and the floor level. Signs shall be posted adjacent to the door.	Within 1 month
F-8	Egress lighting	Directional signs are not provided where direction of the path of travel to an exit has changed. Location: 3 storied main production building.	Illuminated directional signs shall be provided where there is a change in the direction for the path of travel and the direction to an exit is not obvious.	Within 1 month
F-9	Egress lighting	Based on the number and location of emergency lights observed, adequate illumination levels are not anticipated along egress routes . Location: 3 storied Main Production Building	Test the emergency lighting system on each floor and provide additional emergency fixtures to provide adequate illumination along the means of egress. Provide a minimum illumination of 10 lux at the floor level within exit stairs and exit discharge paths and minimum 2.5 lux along exit access aisles.	Within 3 months

F-10	Egress lighting	Manual on-off switch is provided for [emergency lighting / exit signage] units. Location: 3 storied Main production building	Remove manual on/off switches from emergency lighting / exit signage units to prevent them from being switched off.	Within 1month

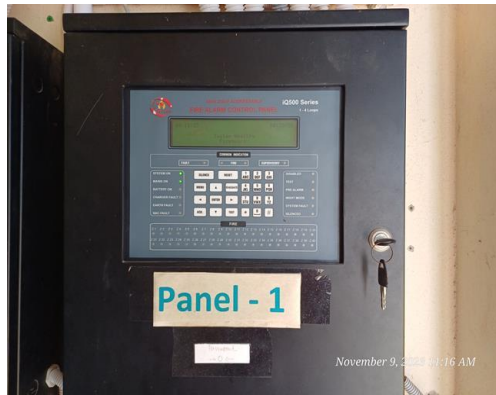
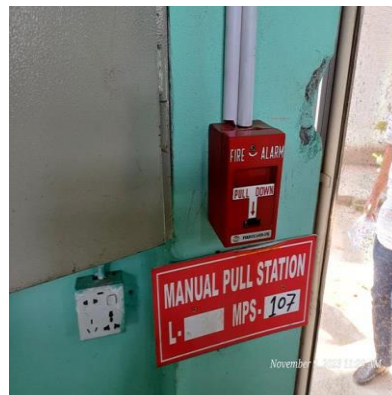
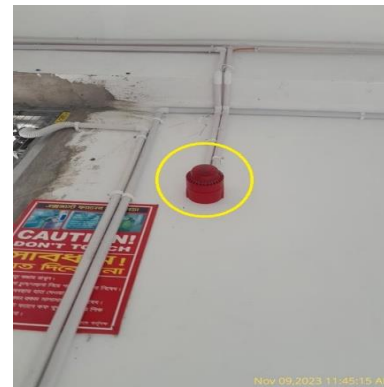
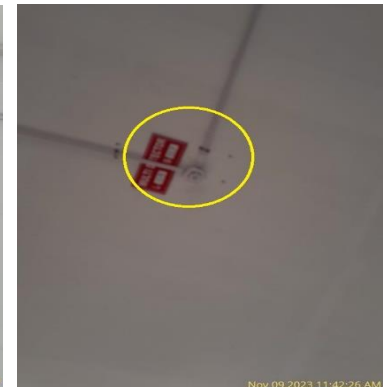
F-11	Fire Alarm & Detection System (FADS)	<p>Addressable fire alarm &amp; detection system installation requires detailed review to confirm compliance with NFPA 72 and RSC standard.</p> <p>Location:</p>	<p>Submit design, documents and calculations to RSC for review prior and based on the review modify the system if there is any.</p> <p>After installation the owner shall contact the RSC for witness of conducting the final acceptance testing of the fire detection &amp; alarm system installation.</p> <p>Also inspect, test and maintain the fire alarm system, and keep written records on-site, in accordance with NFPA 72.</p>	<p>Design Review within 1 month and modification within 3 months (If require).</p>
------	--------------------------------------	--	---	--
