# Best Shirts Ltd

# Building Observations

# Truss supports at roof steel frame

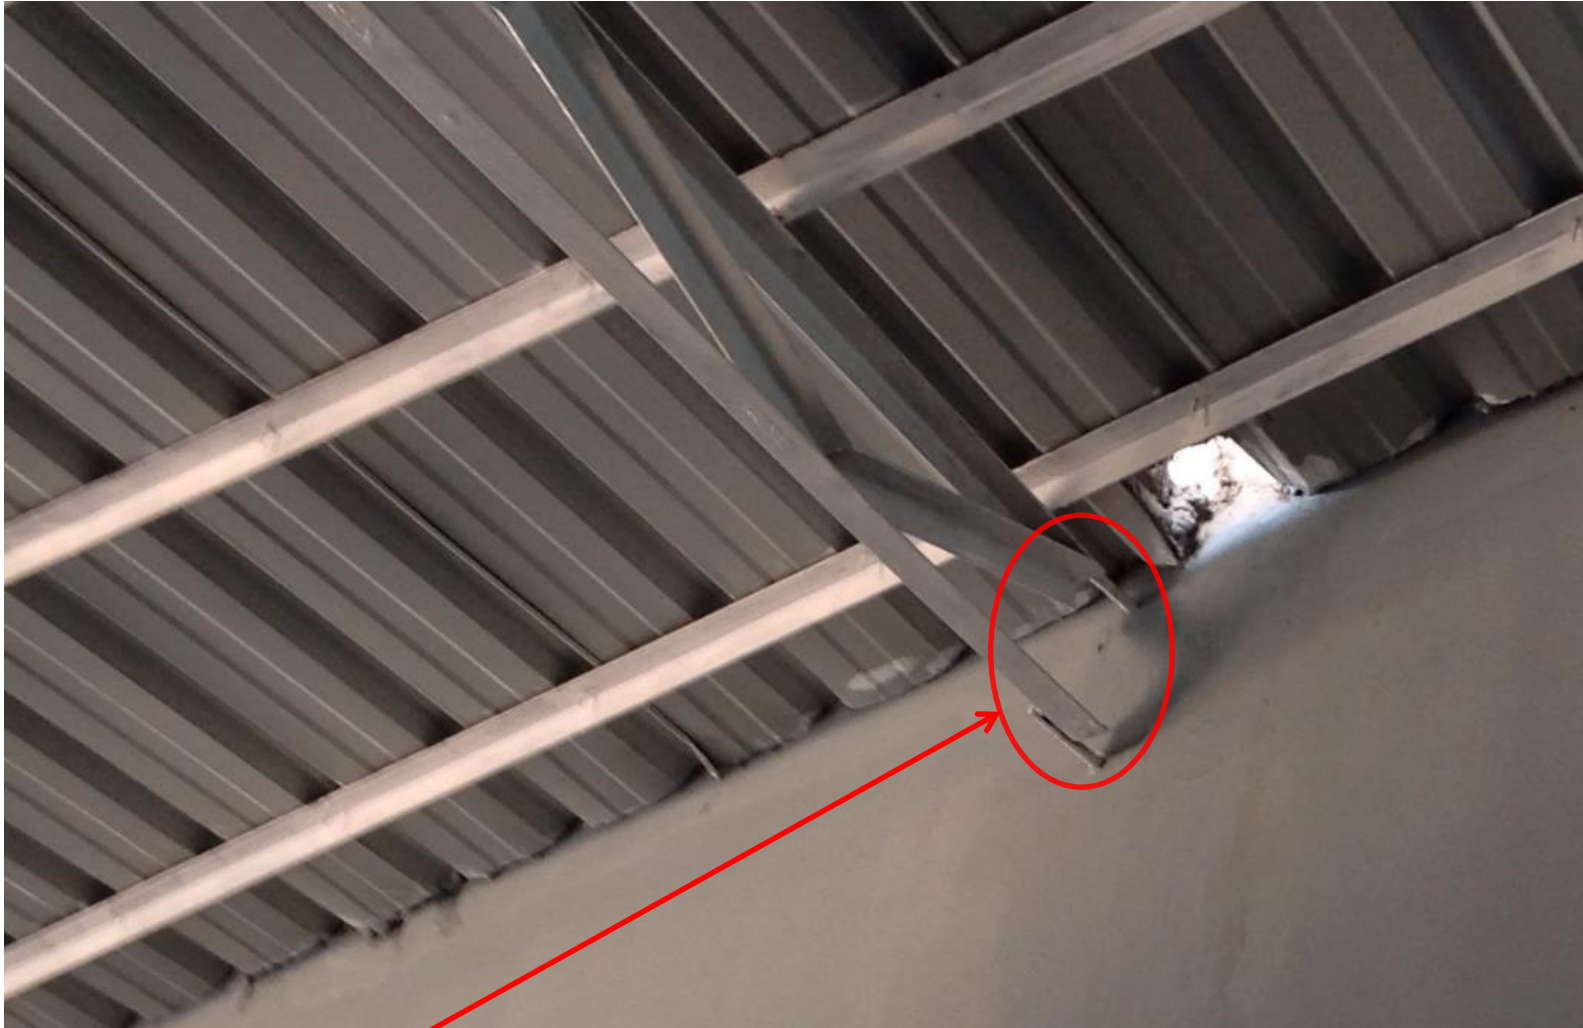
**Non engineered truss supports**

**ITEM 1:** Repair missing steel support and verify lateral stability as well as supports of steel roof

| Item No. | Observation | Recommended Action Plan | Recommended Timeline |
|---|---|---|---|
| 1 | Repair missing steel support and verify lateral stability as well as supports of steel roof | Missing steel support to be replaced | 6-weeks |
| 3 | Repair missing steel support and verify lateral stability as well as supports of steel roof | Engineer to verify the load transfer of the steel roof to the supports and propose repair | 6-months |

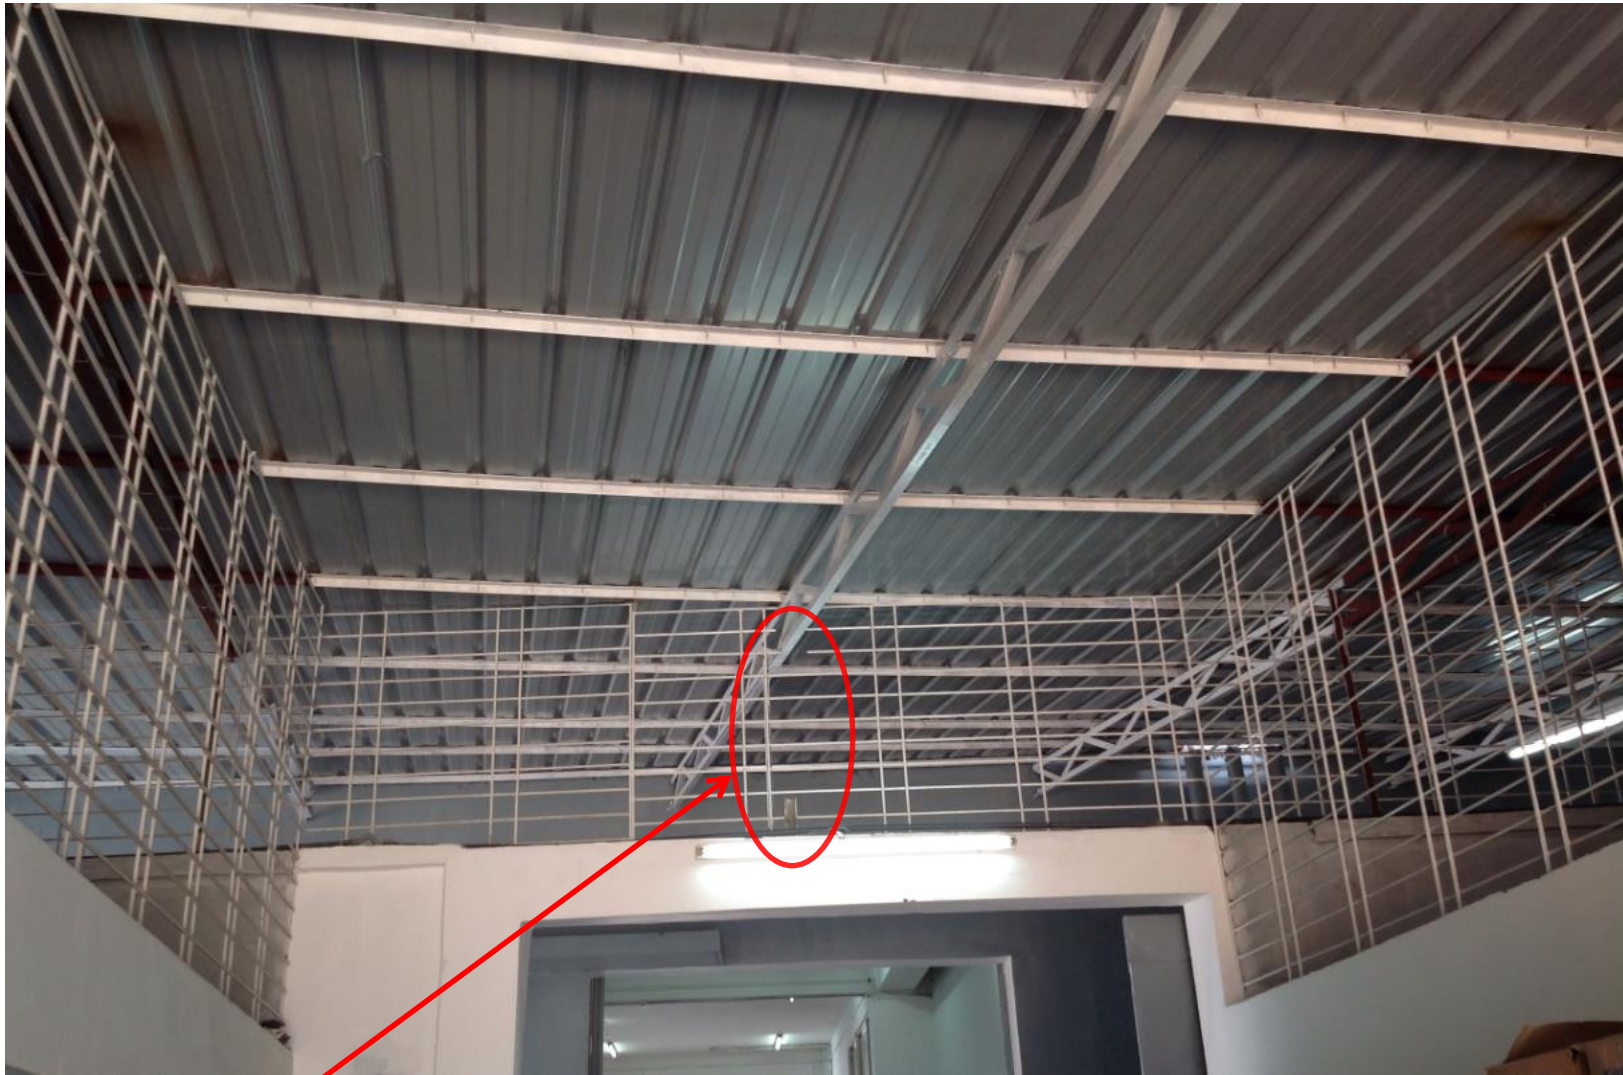
Truss support missing

Lateral Stability of Steel roof to be verified

| Item No. | Observation | Recommended Action Plan | Recommended Timeline |
|---|---|---|---|
| 2 | Repair missing steel support and verify lateral stability as well as supports of steel roof | Engineer to verify the lateral stability of the steel roof | 6-months |
