# INITIAL FIRE SAFETY INSPECTION REPORT

**Factory Name: CORETEX APPARELS LTD.**

**Factory Address: Holding # 160/1, Madhabpur, Kashimpur Metro, Gazipur-1349.**

**Date: 26-November 2023**

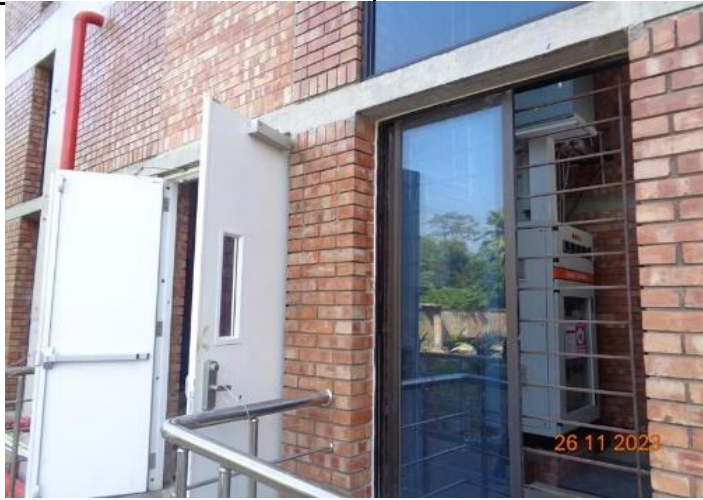
| SI No. | Category | Findings | Required Action | Remediation Time Frame |
|---|---|---|---|---|
| F-1 | Fire Rated Construction | The exit stair enclosures are not separated from work areas and other spaces on each floor by fire-rated construction. | <p>The exit stair enclosure shall be provided with a minimum of 2-hr. fire resistance rating for buildings 4 or more stories. Provide 1.5 hr. fire rated door and seal all penetrations and openings by 2hr. fire rated fire rated barrier construction for building with 4 or more stories</p> <p>Ensure that the fire doors are self-closing and positive latching and that they are provided with fire exit (panic) hardware where serving production floors. If fire doors are required to be held open for functional reasons, provide automatic closing devices tied to the fire alarm system.</p> | Within 3 months |

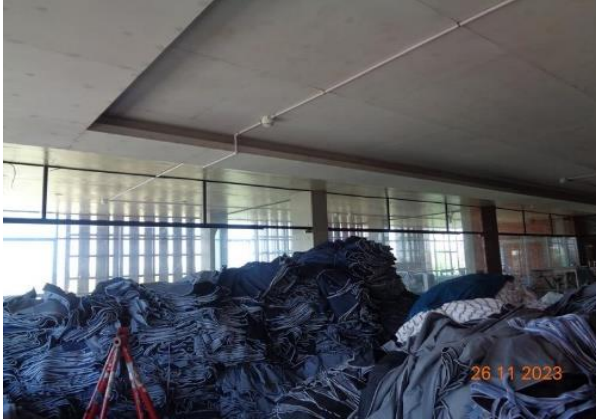
| F-2 | Fire Rated Construction | Areas & rooms used for combustible storage open to the factory are not separated by fire rated construction. | <p>Separate the dedicated storage rooms by minimum 1-hr fire-rated construction. Provide 0.75 hr. fire rated door and seal all penetrations and openings by 1 hr. fire rated barrier construction.</p> <p>Where separate storage rooms are not feasible, provide defined storage areas and limit the storage arrangement as follows:</p> <ul style="list-style-type: none"> <li>- Maximum height of 2.45m (8ft.) , maximum area of 23m<sup>2</sup> (250 ft<sup>2</sup>) and 3m (10ft.) clear distance from adjacent another unenclosed combustible storage.</li> <li>- If the building/floor is sprinkler protected: maximum height of 3.66m (12ft.) and maximum area of 93m<sup>2</sup> (1000 ft<sup>2</sup>).</li> <li>- In-process storage shall not exceed 10 percent of the building area of the story in which they occur.</li> </ul> | Within 3 months |

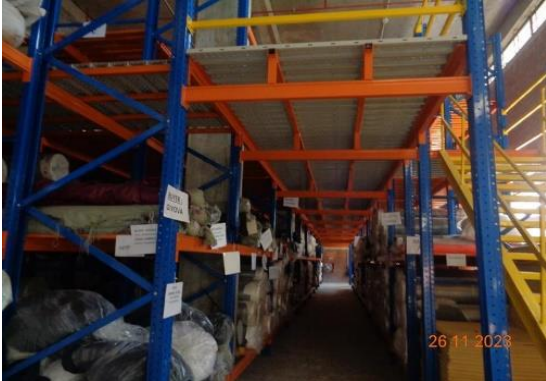
| F-3 | Fire Rated Construction | <p>Catwalk has been constructed on High rack storage and the area of the intermediate deck creates a full floor where the size of the deck is more than 33% of the total floor area and requires fire rated separation.</p> <p>Location: Warehouse Building (Ground Floor.)</p> | <p>Remove the catwalk of the intermediate deck.</p> <p>Or ,</p> <p>Maintain fire separation (3hr for type 1) between floor to floor as per BNBC 2006 Table 3.3.1. Provide required fire rating on the structural elements by following Table- 3.2.4, 3.1.9 &amp; Table 4.4.1 of the RSC Technical Guidelines Standard or Table 3.3.1 of BNBC-2006. Consult a qualified fire protection engineer to design the rated construction barriers in between two floors and in structural members. Factory shall submit all required product datasheet, installation design along with design philosophy to RSC for review prior to installation on site.</p> | Within 6 months |

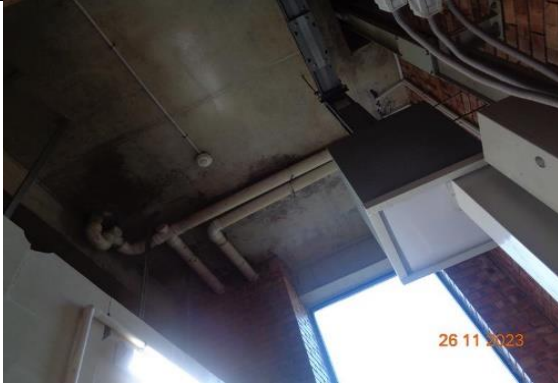
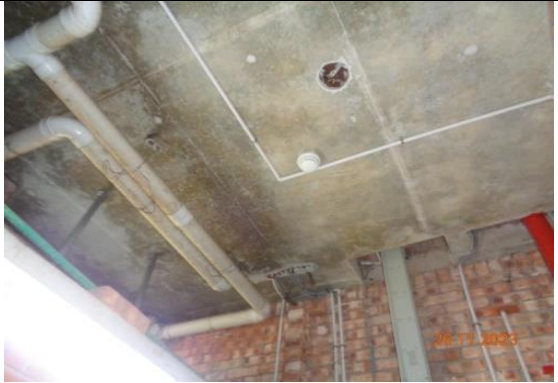
| F-4 | Fire Rated Construction | <p>Unsealed penetrations and openings are located in the fire rated floor/ceiling assemblies.</p> <p>Location: BBT Riser &amp; Sanitary Pipe.</p> | <p>Seal all penetrations and openings in floor/ceiling assemblies to maintain the fire separation at least by 3-hr. The used sealer shall be 3rd party certified and installation shall be as per manufacturer's guideline. (Type-1 Construction).</p> <p>or,</p> <p>Provide a minimum 2-hr fire rated shaft to separate the utility risers from each floor if required. (Type-1 Construction).</p> | Within 3 months |

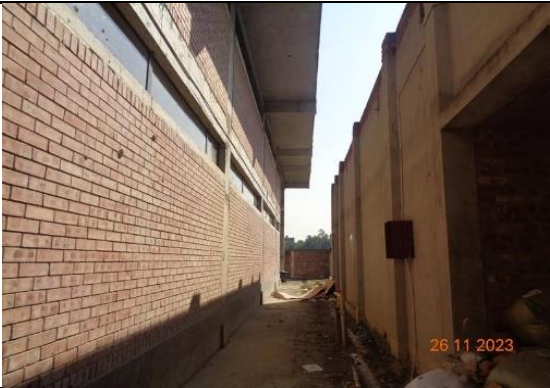
| F-5 | Fire Rated Construction | <p>Room used for combustible storage are not separated by fire rated construction from Boiler Room.</p> | <p>Separate the storage room by a minimum 1- hr fire-rated construction. Seal and/or protected all openings to maintain the required fire separations.</p> | Within 2 months |

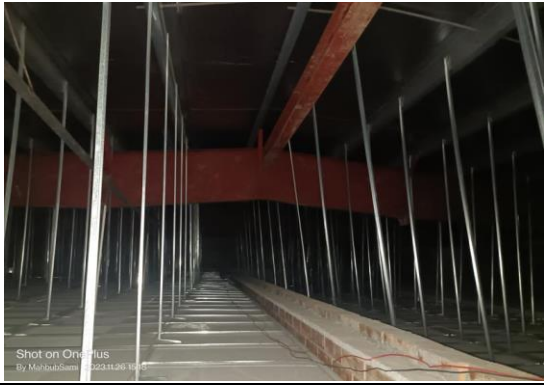
| F-6 | Fire Rated Construction | The structural elements of Main Building 3rd Floor Partial roof is constructed by steel which is non-rated and were found in exposed condition without any fire protection. | The building shall be type-I or II construction. So, provide require rating in the structural elements of the building. Consult with a qualified fire protection engineer. BNBC 2006-Table 3.2.4 | Within 6 months |

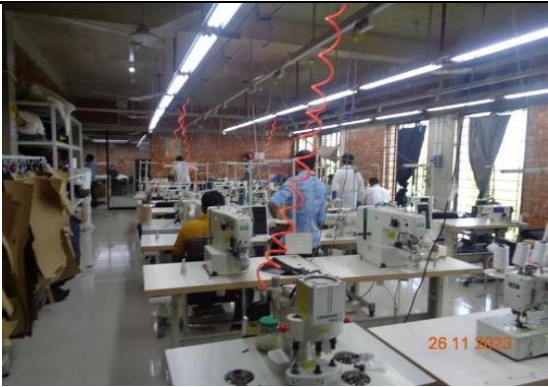
| F-7 | Means of Egress | Adequate aisles found in the Main Production Building. | Provide minimum aisle widths of 36 inch with proper marking & update on evacuation map. | Within 1 month |

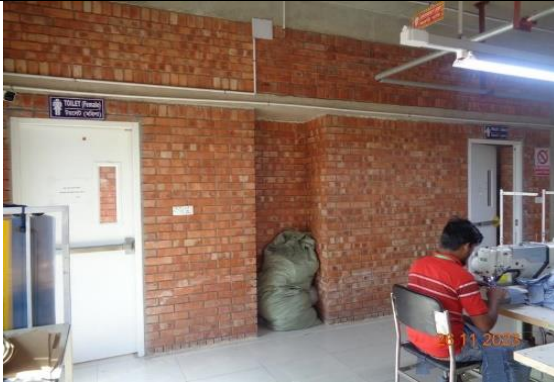
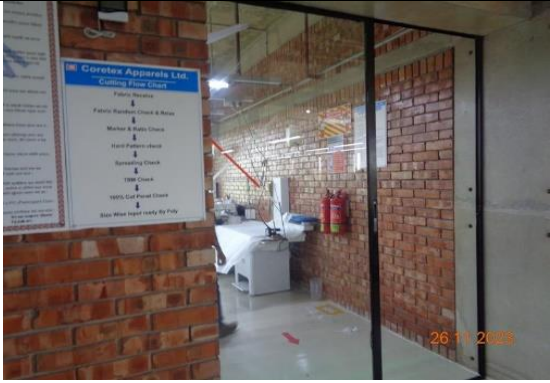
| F-8 | Means of Egress | Sliding & inside swing doors found in several areas throughout the factory. | Replace all gates and doors along the means of egress with side-hinged, swinging egress doors in accordance with RSC Standard. | Within 2 months |

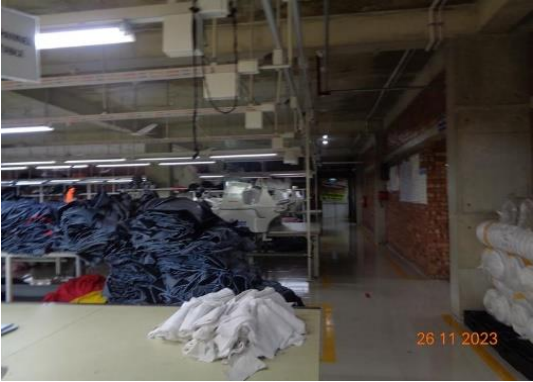
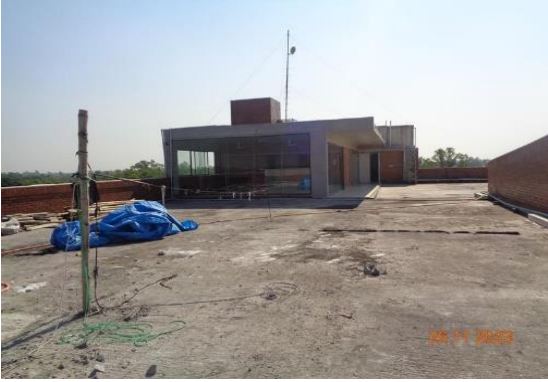
| F-9 | Means of Egress | A single means of egress is provided from (3rd & Occupied Roof) where the occupant load exceeds 49 person. | Provide at least two means of exits leading directly to the street or leading to a corridor or open space having access to exits in two independent and different directions. Dining (E3) is not permitted with moderate hazard occupancies (G2) as per BNBC 2006. | Within 3 months |

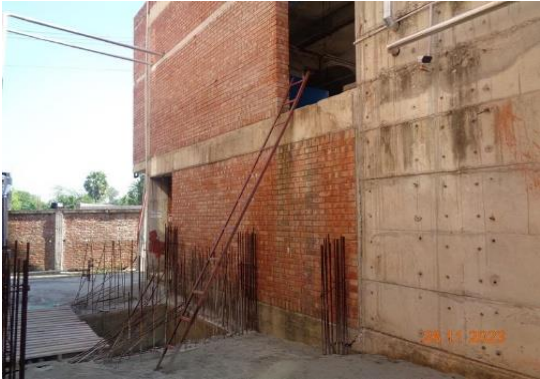
| F-10 | Means of Egress | Compliant Exit Stair not provided at Utility Building 1st Floor. | Provide compliant exits and stairs for this building from top floor to ground floor as per RSC Technical Guidelines (Standard) 6.5.6.2. | Within 1 month |

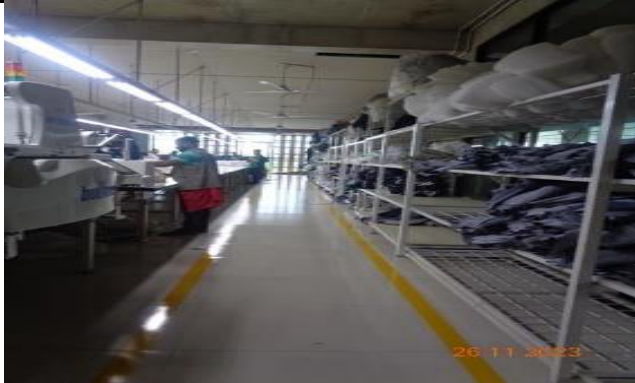
| F-11 | Means of Egress | Inadequate emergency lighting units.<br>(Emergency Light, Exit Sign, Directional Exit Light etc.) | <p>Test the emergency lighting system on each floor and provide additional emergency fixtures to supply adequate illumination along the means of egress. Provide a minimum illumination of 10 lux at the floor level within exit stairs and along exit discharge paths and a minimum 2.5 lux along exit access aisles.</p> <p>Provide exit signs above all building exits to the exterior, all doors to the exit stairs and along all paths of travel where a change of direction is not obvious.</p> | Within 1 month |

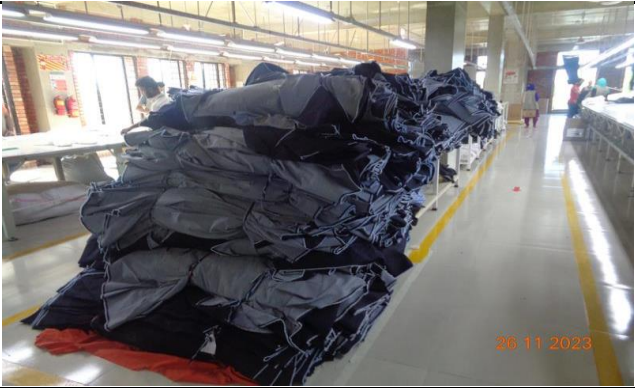
| F-12 | Means of Egress | Common path of travel exceeds the permitted limit (23m/ 75ft) at Ground Floor Finishing Section (Main Building). | Reconfigure the egress arrangement to reduce the maximum common path of travel to not more than 23 meter. | Within 1 month |

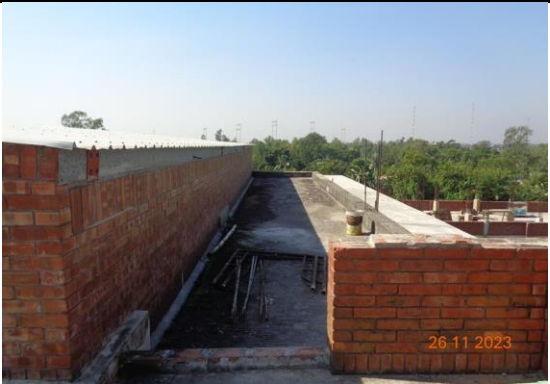
| F-13 | Means of Egress | <p>Parapets or guards are not provided in occupied/occupiable roof.</p> <p>OR</p> <p>Parapets or guards are provided in occupied roof which is less than 1067mm (42 inch.).</p> | Provide parapets or guards with a minimum height of 1067mm (42 inch.). | Within 3 months |

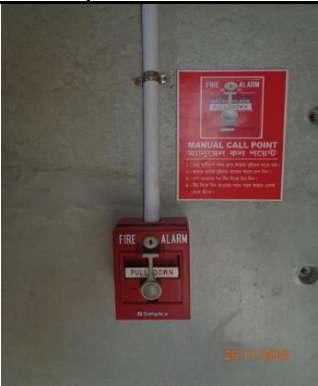
| F-16 | Fire Alarm & Detection System (FADS) | The factory has installed Fire alarm and detection system which requires detailed review to confirm compliance with NFPA 72 and RSC Technical Guidelines (Standard). | Submit the proposed design of Addressable fire alarm system to RSC in accordance with NFPA 72. Installation shall be as per the reviewed design with a listed Addressable Fire Alarm System. | Design within 2 months and installation within 3 months |

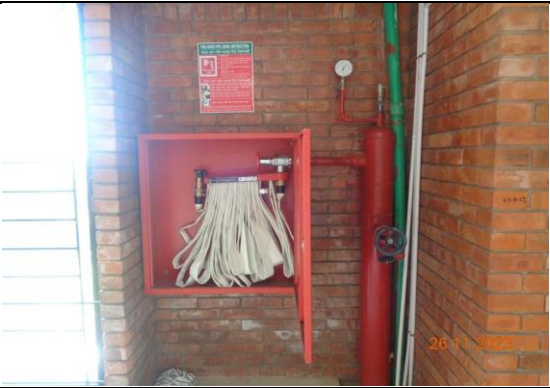
| F-18 | Fire Suppression System (SUPS) | The factory building has an occupied floor greater than 10 meter (33 feet) and installed a standpipe protection system which requires detailed review to confirm compliance with NFPA 14 & 20 and RSC Technical Guidelines (Standard). | Submit the proposed design of Standpipe Protection System to RSC in accordance with NFPA 14 & 20. Installation shall be as per the reviewed design with a listed Standpipe & Fire Pump System. | Design within 2 months, Installation within 3 months |
