# INITIAL FIRE SAFETY INSPECTION REPORT

**Winter Dress Limited (Extension)**

**RSC ID: 24779**

# Fire Safety Inspection Report

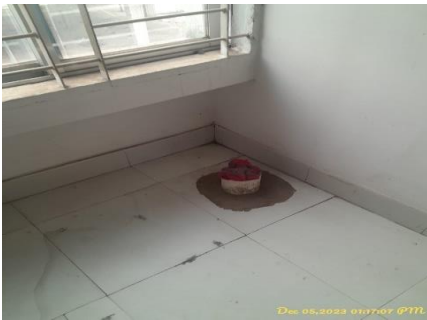
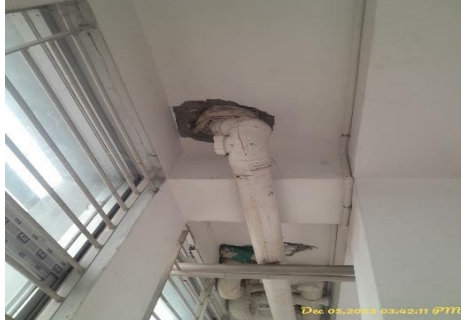
| Sl No. | Category | Findings | Required Action | Remediation Time Frame |
|---|---|---|---|---|
| F-1 | Fire rated Construction | <p>Unsealed penetrations and openings are located in the fire-rated floor/ceiling assemblies.</p> <p><b>Location: Plumbing PVC pipe</b></p> | <p>Seal all penetrations and openings in floor/ceiling assemblies to maintain the fire separation at least by 3-hr. The used sealer shall be 3rd party certified and installation shall be as per manufacturer's datasheet.</p> <p>Or</p> <p>Provide a minimum 2-hr fire rated shaft to separate the utility risers from each floor.</p> | Within 3months |

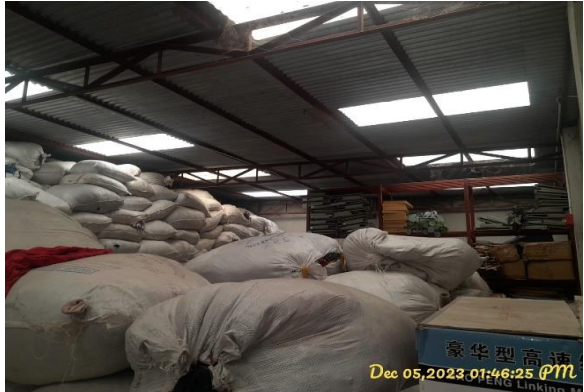
| F-2 | Fire-Rated Construction | <p>The shed-1 &amp; Shed-2 are a single story structure with fire rated wall however the roof is made of steel trusses and tin roof sheet which is non-rated and were found in exposed condition without any fire protection</p> <p><b>Location:</b> Shed-1 &amp; Shed-2</p> | <p>Interim building shall be type-1 or type-2 construction. Provide required fire rating on the structural elements by following Section 4.4 and Table 4.4.1 of the RSC Standard or Table 3.3.1 and Table 4.1.1 from BNBC Part 4.(2006). Consult a qualified fire protection engineer to design the rated construction barriers in between two floors and in structural members.</p> | Within 6 months |

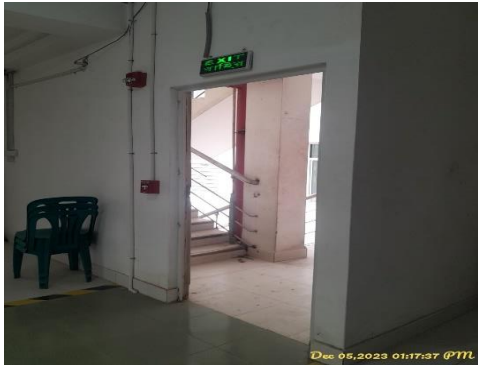
| F-3 | Mean of Egress | <p>The exit stairs are not separated from [work areas, other spaces] on each floor by fire rated construction due to unprotected opening.</p> <p><b>Location: 5-Storeyed building &amp; Three storied fire control building.</b></p> | <p>The exit stair enclosure shall be provided with a minimum 1-hr fire resistance rating for buildings with 3 or fewer stories with 60 minutes opening protection and a minimum of 2- hr. fire resistance rating for buildings 4 or more stories with 90 minutes opening protection.</p> <p>Ensure that the fire doors are self-closing and positive latching and that they are provided with fire exit (panic) hardware where serving production floors. If fire doors are required to be held open for functional reasons, provide automatic closing devices tied to the fire alarm system.</p> | Within 3 months |

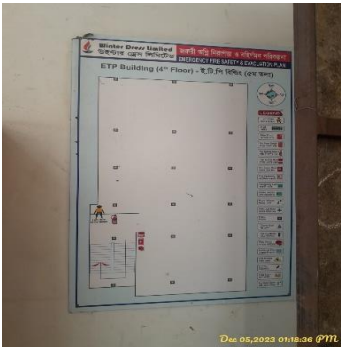
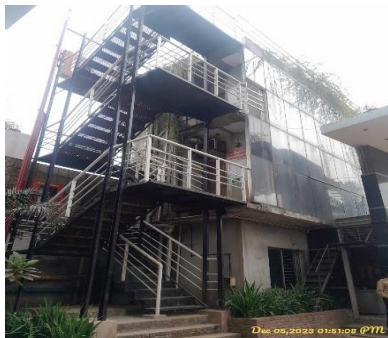
| F-5 | Means of Egress | <p>A single means of egress is provided in the 5-Storeyed ETP building &amp; Three storied fire control building.</p> | <p>Single exit is allowable on ground floor when the occupant load is limited to 50 with maximum travel distance 23 meter.</p> <p>Single exit is allowable on 1st floor when the occupant load is limited to 30 with maximum travel distance 23 meter.</p> <p>All other stories require a minimum of 2 egress exits.</p> <p>So, provide additional means of egress for 5-Storeyed ETP building &amp; Three storied fire control building.</p> | Within 1 month |

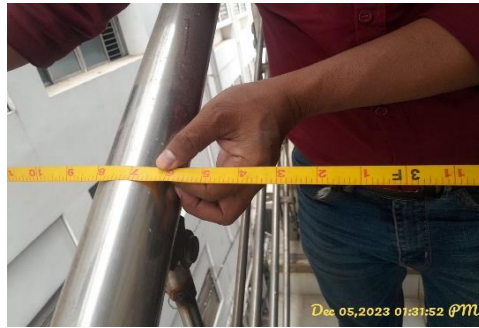
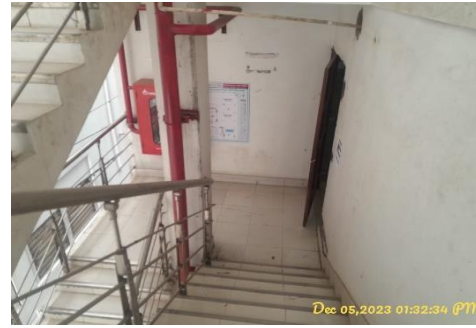
| F-6 | Means of Egress | <p>Width of new exit stair is less than 1.5 m (60 in.).</p> <p><b>Location:</b> 5-storied building &amp; Three storied fire control building.</p> | <p>Provide minimum clear and unobstructed exit stair widths of 1.5 m(60 in.) in accordance with RSC Technical Guideline (Standard) V1- 6.5.6.2.1</p> | Within 3 months |

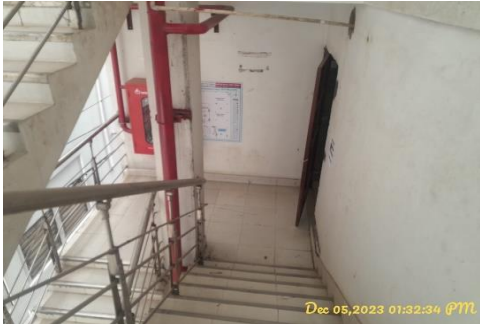
| F-7 | Means of Egress | <p>Handrails are not provided on both sides of both exit stairs.</p> <p>Location: 5-storied building.</p> | <p>Provide handrails on both sides of the exit stair. New handrails shall have a minimum height of 865 mm (34 in.) and a maximum height of 965 mm (38 in.) as measured from the leading edge of the tread. Intermediate handrails shall be provided when the stair width exceeds 2.2 m (87 in.). Rail guards shall be such patterned so that a sphere 200mm (8 in.) in diameter cannot pass through any opening up to a height of 865mm (34in.).</p> | Within 3 month |

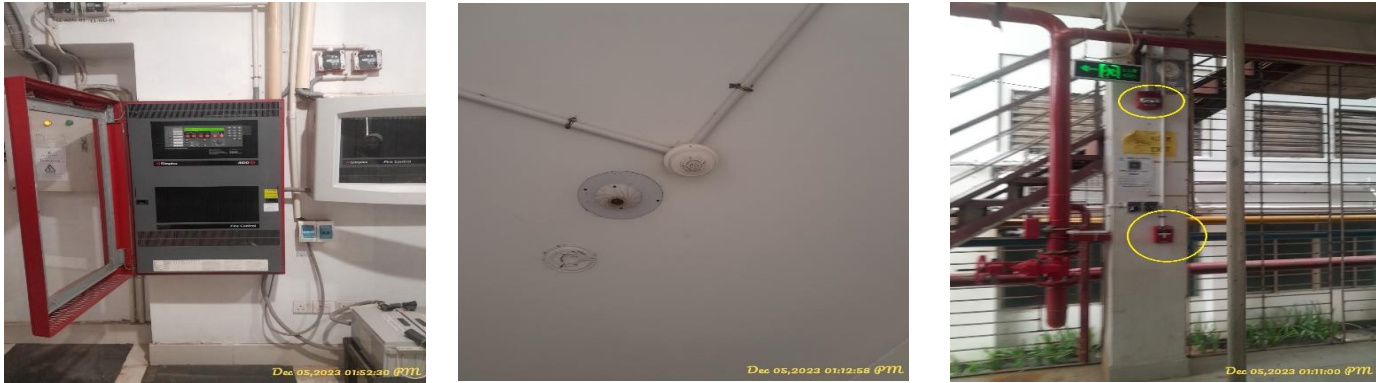
| F-13 | Fire Alarm & Detection System (FADS) | Addressable fire alarm & detection system installation requires detailed review to confirm compliance with NFPA 72 and RSC standard. | <p>Submit design, documents and calculations to RSC for review prior and based on the review modify the system if there is any.</p> <p>After installation the owner shall contact the RSC for witness of conducting the final acceptance testing of the fire detection &amp; alarm system installation.</p> <p>Also inspect, test and maintain the fire alarm system, and keep written records on-site, in accordance with NFPA 72.</p> | Design Review within 1 month and modification within 3 months (If require). |
| <p>The first photograph shows a fire alarm control panel with a red door open, revealing internal components. The second photograph shows a white ceiling-mounted fire alarm detector. The third photograph shows a fire alarm pull station with a red alarm button and a yellow label, mounted on a wall near a staircase.</p> | | | | |

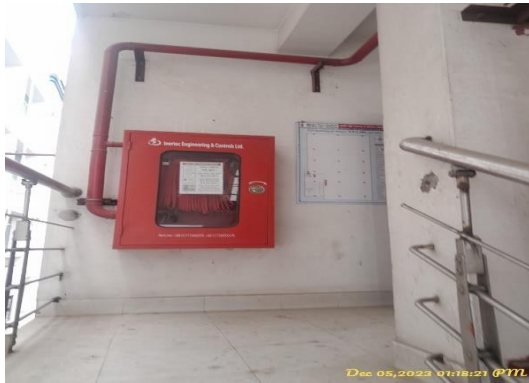
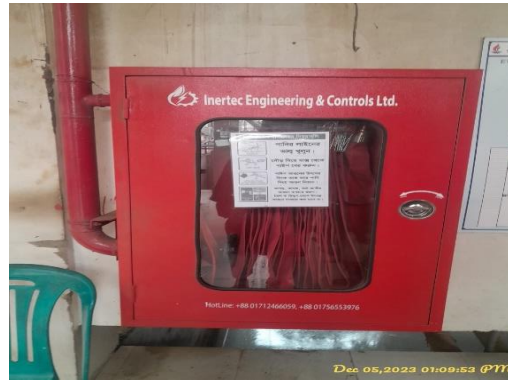
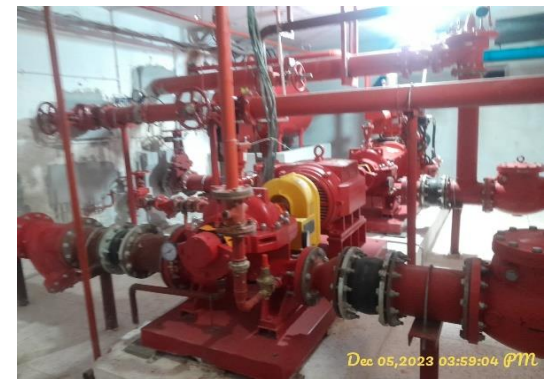
| F-15 | Fire Protection System(Standpipe ) | Standpipe system installation requires detailed review to confirm compliance with NFPA- 14 , 20 ,22 & 24 or as per RSC standard. | <p>Submit the standpipe system drawing to RSC for review.</p> <p>Once the design is reviewed, install and modify the standpipe system throughout the building in accordance with review comment, RSC Standard and NFPA 14,20,22 and 24.</p> <p>After installation the owner shall conduct internal testing and commissioning and then contact the RSC for witness of final acceptance testing.</p> | Design Review within 1 month and modification within 3 months (If require). |
