# INITIAL FIRE SAFETY INSPECTION REPORT

**Euro Arte Apparels Ltd (Extension)**

**RSC ID: 24786**

**Date: 11th December 2023**

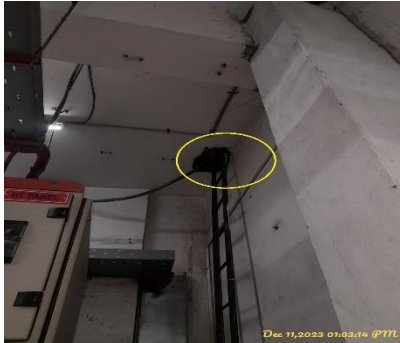
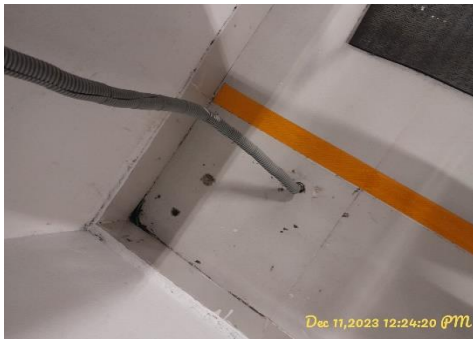
| Sl No. | Category | Findings | Required Action | Remediation Time Frame |
|---|---|---|---|---|
| F-1 | Fire rated Construction | <p>Unsealed penetrations and openings are located in the fire-rated floor/ceiling assemblies.</p> <p><b>Location: Electrical cable</b></p> | <p>Seal all penetrations and openings in floor/ceiling assemblies to maintain the fire separation at least by 3-hr. The used sealer shall be 3rd party certified and installation shall be as per manufacturer's datasheet.</p> <p>Or</p> <p>Provide a minimum 2-hr fire rated shaft to separate the utility risers from each floor if required.</p> | Within 3 months |

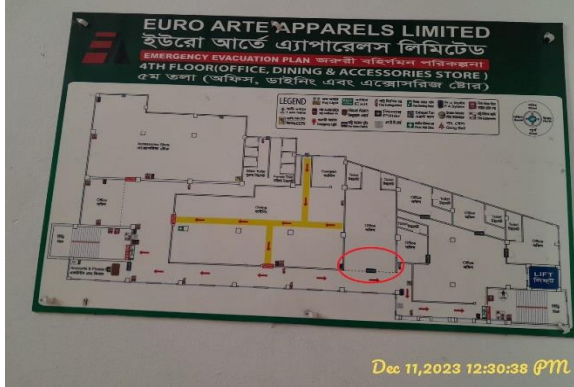
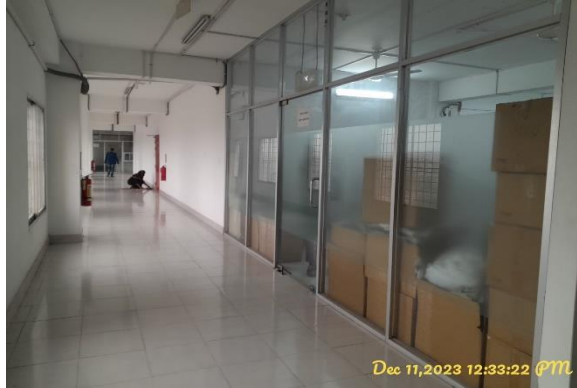
| F-2 | Fire rated construction | <p>The Dining area(E4) is not separated by fire rated construction with the adjacent production occupancies( office area)</p> <p><b>Location: 4th floor of the six storied building.</b></p> | <p>Separate the dining area from production &amp; other occupancies(office area ) by minimum 3-hr fire rated construction. Provide rated exit passageways leading directly to the exit stairs of the same resistance rating.</p> | Within 3 months |

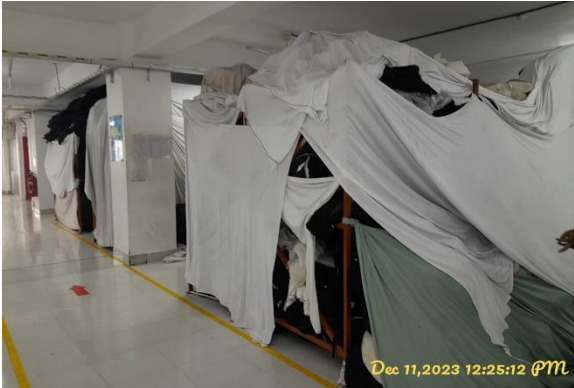
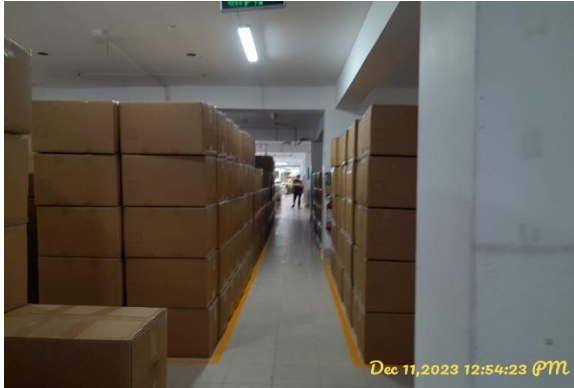
| F-3 | Fire rated construction | <p>Areas used for in-process storage of combustible materials are open to the surrounding occupancy.<br/>Location: 2nd floor &amp; 5th floor</p> | <p>Provide defined storage areas and limit the storage arrangement as follows:<br/>Maximum height of 2.45 m and maximum area of 23 m<sup>2</sup> and is separated by a minimum 3.0 m (10ft) from other storage areas and they do not exceed 10 percent of the building area of the story in which they occur. If sprinkler protected, Maximum height 12 ft (3.66 m) and maximum area of 1000 ft<sup>2</sup> (93 m<sup>2</sup>) and separated by a at least 25 ft (7.62 m) from other storage areas and does not constitute more than 10 percent of the building area or 4000 ft<sup>2</sup> (372 m<sup>2</sup>) of the sprinklered area, whichever is greater.<br/>or,<br/>Enclose the storage area from the surrounding occupancy with a minimum 1 hour fire rated construction.</p> | Within 3 months |

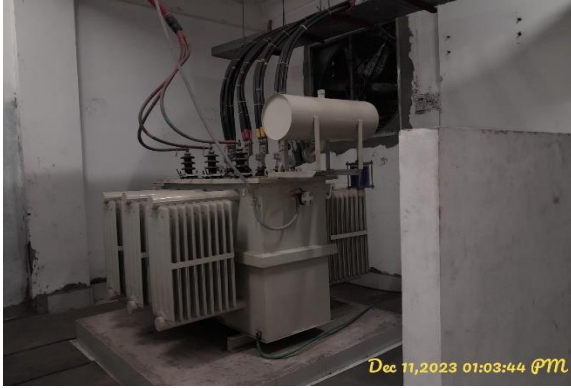
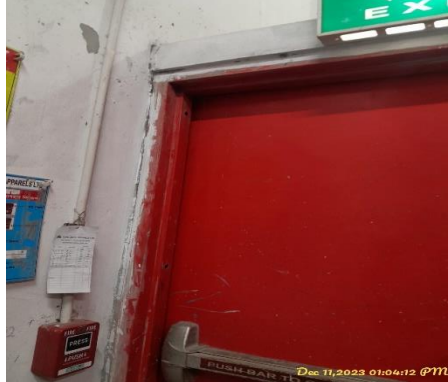
| F-4 | Fire Rated Construction | Transformer room is not properly separated by due to non-functional fire door<br><br>Location: Ground floor of six storied building. | Transformer room shall be separated from other occupancies by a minimum 2-hr fire rated construction (wall, floor, slab etc.). Seal all penetrations and openings (door, window etc. If fire doors are required to be held open for functional reasons, provide automatic closing devices tied to the fire alarm system. | Within 3 months |

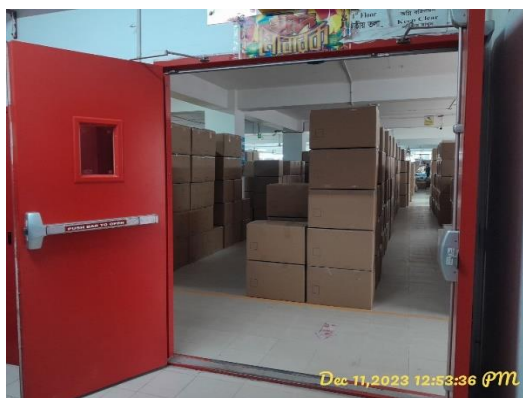
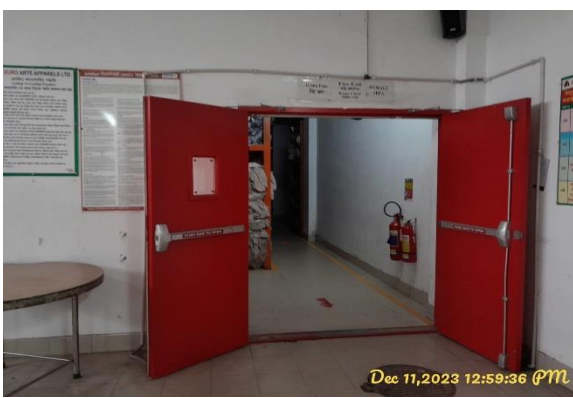
| F-5 | Fire Rated Construction | Store room directly open into exit stair enclosure.<br><br>Location: Ground floor & 1st floor of exit stair-1(south side) | <p>Openings from exit enclosure to storage spaces shall be provided with a vestibule with fire rated construction as per RSC Technical Guideline (Standard) V1-6.14.3 .</p> <p>Provide a 1.5-hr. fire rated door on the exit stair side and a 1-hr. fire rated door on the storage room side. Ensure that the fire rating of the vestibule construction matches that of the exit stair enclosure.</p> | Within 3 months |

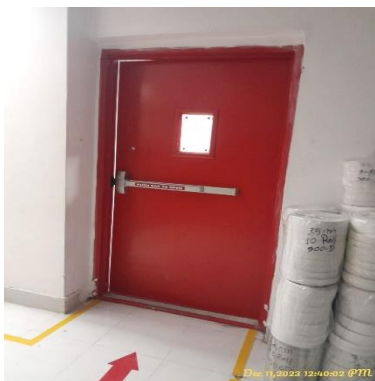
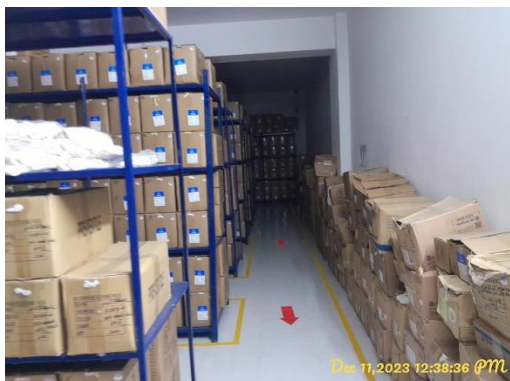
| F-6 | Fire Rated Construction | Store room is not properly separated due to non-functional fire door.<br>Location: ground, 1st & 4th floor. | Separated the store room from medical & prayer room by minimum 1-hr fire rated construction.If fire doors are required to be held open for functional reasons, provide automatic closing devices tied to the fire alarm system. | Within 3 months |

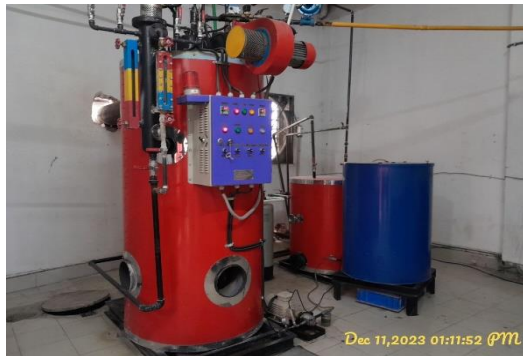
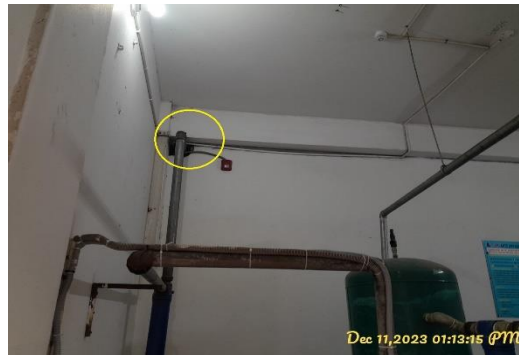
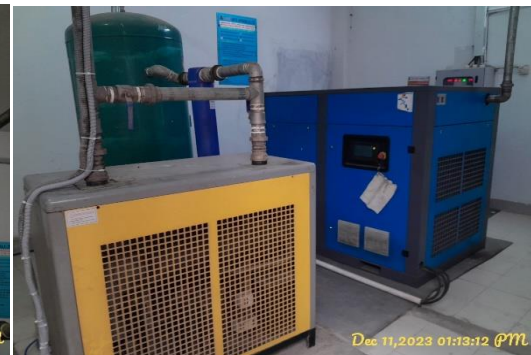
| F-7 | Fire Rated Construction | Compressor & boiler room are not properly separated due to unseal penetration.<br>Location: Ground floor of six storied building. | Seal all penetrations and openings in the wall (full thickness of the wall) assemblies by minimum 2-hr fire-rated materials to maintain the required fire-resistance rating. | Within 3 months |

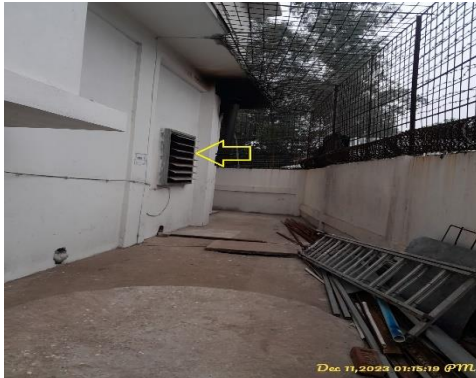
| F-8 | Mean of Egress | <p>The exit discharge path (Egress Court) was less than 10 ft wide and was not separated from the building interior.</p> <p>Location: North side of six storied building.</p> | <p>Seal all penetrations and openings to the interior of the building along the discharge path, up to a height of 10 ft. to provide a minimum 2-hr fire separation.</p> | <p>Within 3 months</p> |

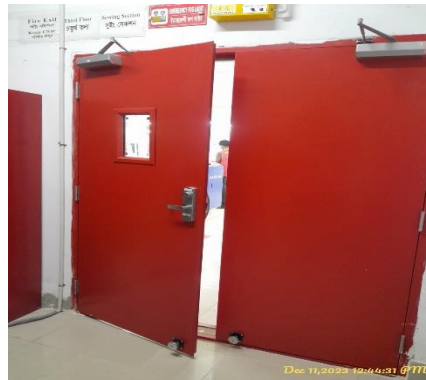
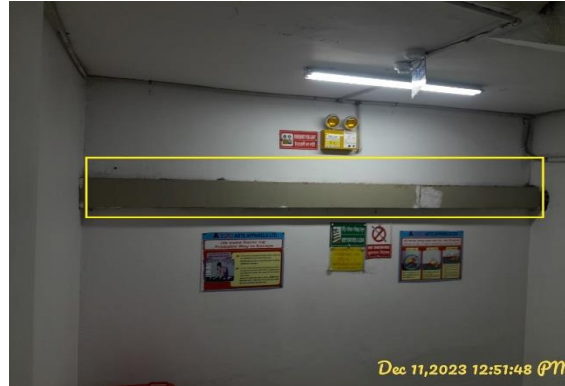
| F-9 | Mean of Egress | <p>The exit stairs are not separated from [work areas, other spaces] on each floor by fire rated construction due to power cable &amp; non-functional fire door.</p> <p><b>Location: Six Storied building.</b></p> | <p>The exit stair enclosure shall be provided with a minimum of 2- hr. fire resistance rating with 90 minutes opening protection.</p> <p>Ensure that the fire doors are self-closing and positive latching and that they are provided with fire exit (panic) hardware where serving production floors. If fire doors are required to be held open for functional reasons, provide automatic closing devices tied to the fire alarm system.</p> <p>Once fire doors are installed, every door in a stair enclosure serving more than 5 stories shall be provided with re-entry unless it meets RSC Technical Guideline (Standard) V1 6.8.3.1.</p> <p><b>No other penetration into and through the exit enclosure except for fire alarm equipment electrical raceway, required exit doors, sprinkler piping, standpipes, and electrical conduit serving the exit enclosure is permitted as per RSC Technical Guideline (Standard) V1-6.14.4 .</b></p> | Within 3 months |

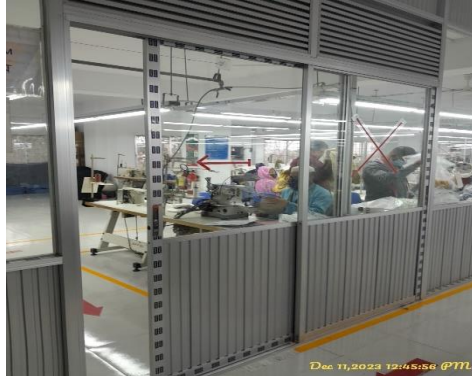
| F-10 | Mean of Egress | Sliding type doors have provided along means of egress at along egress routes.<br>Located: 3rd floor package section. | Replace all sliding type doors & gates by the side-hinged swinging type doors.<br><br>If locks are required for security reasons, utilize special door locking features complying with NFPA 101. | Within 1 month |

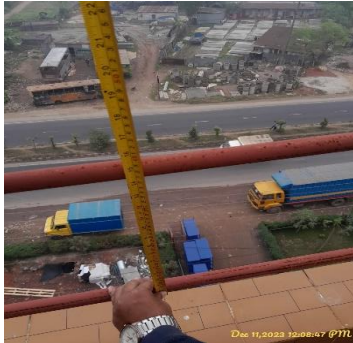
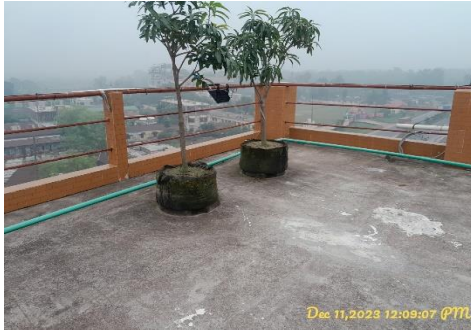
| F-11 | Means of Egress | Parapets or guards are provided in occupied roof which is less than 1067mm (42 inch). | Provide parapets or guards with a minimum height of 1067mm (42 inch.). Open guards shall have intermediate rails or pattern such that a sphere 200 mm (8 in.) in diameter cannot pass through any opening up to a height of 865 mm (34 in.). | Within 3 months |

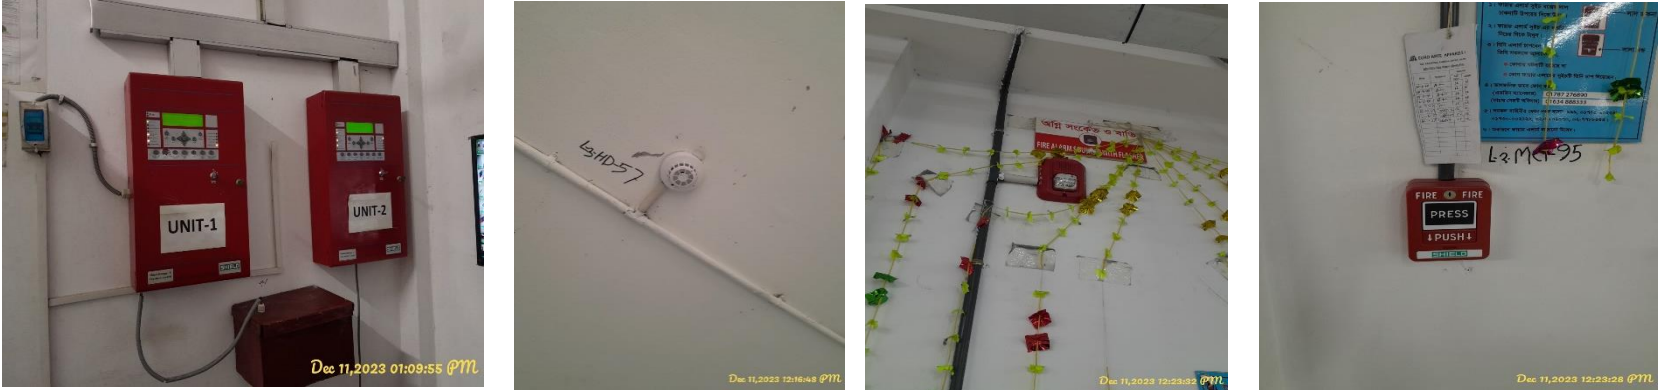
| F-17 | Fire Alarm & Detection System (FADS) | Addressable fire alarm & detection system installation requires detailed review to confirm compliance with NFPA 72 and RSC standard. | <p>Submit design, documents and calculations to RSC for review prior and based on the review modify the system if there is any.</p> <p>After installation the owner shall contact the RSC for witness of conducting the final acceptance testing of the fire detection &amp; alarm system installation.</p> <p>Also inspect, test and maintain the fire alarm system, and keep written records on-site, in accordance with NFPA 72.</p> | Design Review within 1 month and modification within 3 months (If require). |

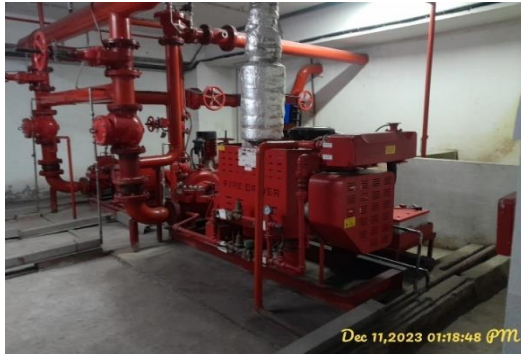
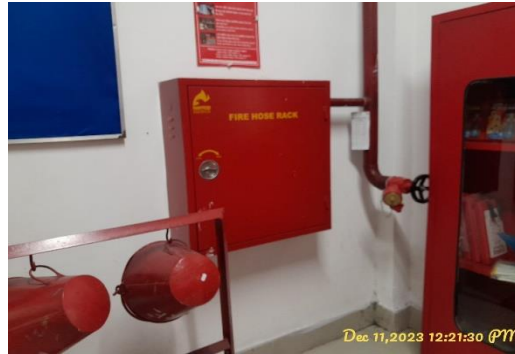
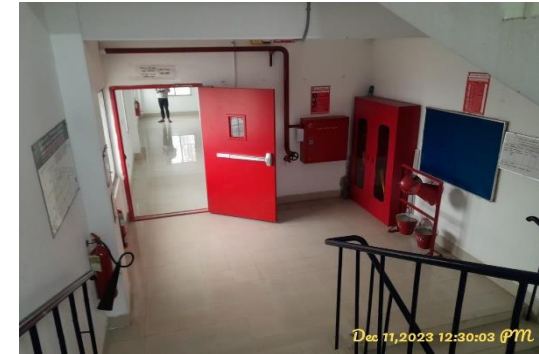
| F-19 | Fire Protection System(Standpipe ) | Standpipe system installation requires detailed review to confirm compliance with NFPA- 14 , 20 ,22 & 24 or as per RSC standard. | <p>Submit the standpipe system drawing to RSC for review. Once the design is reviewed, install and modify the standpipe system throughout the building in accordance with review comment, RSC Standard and NFPA 14,20,22 and 24.</p> <p>After installation the owner shall conduct internal testing and commissioning and then contact the RSC for witness of final acceptance testing.</p> | Design Review within 1 month and modification within 3 months (If require). |
