# **FIRE SAFETY INSPECTION REPORT**

**INTEX LINK GARMENTS LTD.**

**ACCORD ID: 12383**

**PLOT #A 54/55, BSCIC INDUSTRIAL ESTATE,  
CHITTAGONG**

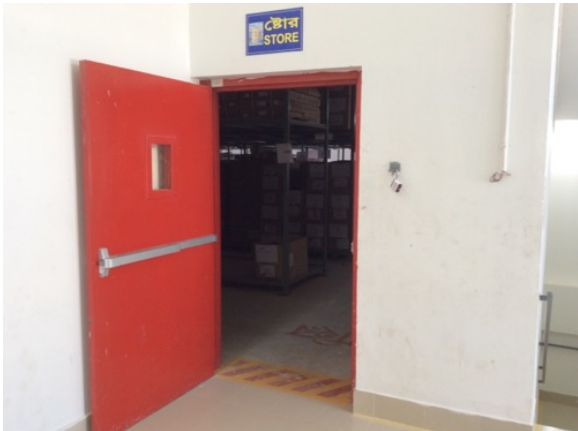
No.	Category	Finding	Recommendation	Remediation Timeframe
F-1	Fire Rated Construction	Proper certification was not available for fire rated doors installed in throughout the factory.	Submit proper certifications for installed fire doors to the ACCORD for approval. If not available, or certification is not approved, install new, properly certified fire rated doors in accordance with ACCORD direction.	Immediately

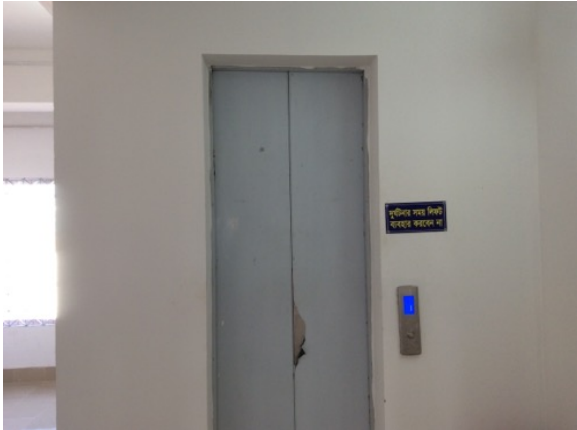
F-2	Fire Rated Construction	The elevator does not have the proper fire rating for the elevator door.	Provide the proper 1.5 hr fire rating for the elevator door.	Within 3 months
