# INITIAL FIRE SAFETY INSPECTION REPORT

**Eslite Garments (Bangladesh) Co., Ltd.**

**RSC ID: 24836**

**Factory Address: Holding # 1125, Jamirdia, Habirbari, Bhaluka, Mymensingh.**

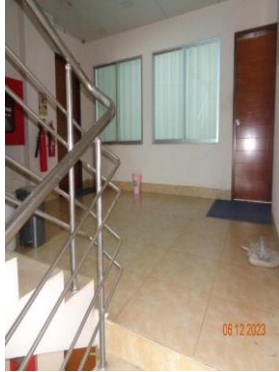
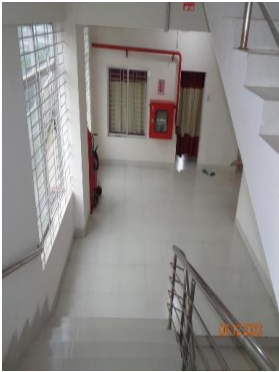
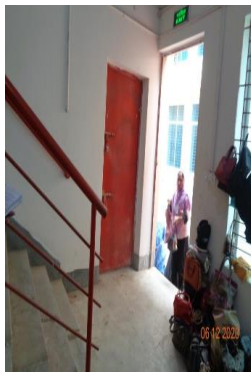
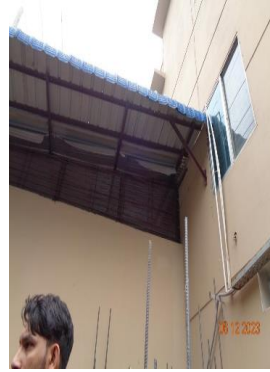
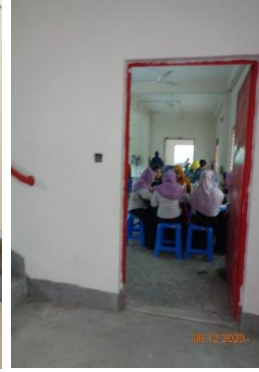
| SI No. | Category | Findings | Required Action | Remediation Time Frame |
|---|---|---|---|---|
| F-1 | Fire Rated Construction | <p>The exit stair enclosures are not separated from work areas, utility area, sleeping areas and other spaces.</p> <p><b>Location:</b> Factory Building, Dormitory Building &amp; Utility Building</p> | <p>Provide minimum 2-hr rated fire wall and 1.5-hr fire rated doors for buildings that are 4 or more stories and minimum 1-hr rated fire wall and 0.75-hr fire rated doors for buildings that are less than 4 stories. Seal all unprotected openings to separate the exit stairs from work areas and other building spaces on all floor levels.</p> <p>Ensure that the fire doors are self-closing and positive latching and that they are provided with fire exit (panic) hardware where serving production floors. If fire doors are required to be held open for functional reasons, provide automatic closing devices tied to the fire alarm system.</p> | Within 3 months |

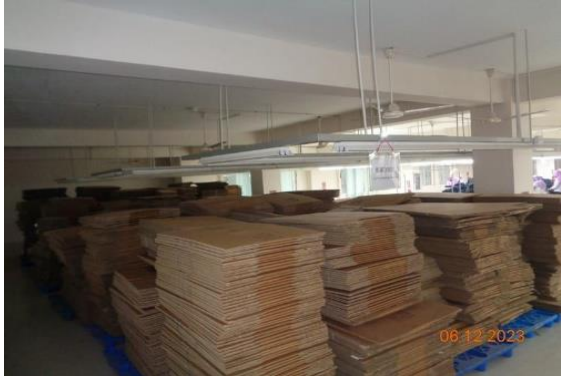
| F-2 | Fire Rated Construction | Areas used for in-process storage of combustible materials are open to the surrounding occupancy. Location: Factory Building. | <p>Provide defined storage areas and limit the storage arrangement as follows:</p> <ul style="list-style-type: none"> <li>- Maximum height of 2.45m (8ft.) , maximum area of 23m2 (250 ft2) and 3m (10ft.) clear distance from adjacent another unenclosed combustible storage.</li> <li>- If the building/floor is sprinkler protected: maximum height of 3.66m (12ft.) and maximum area of 93m2 (1000 ft2).</li> <li>- In-process storage shall not exceed 10 percent of the building area of the story in which they occur. Separate areas of unenclosed combustible storage by a minimum clear distance of 3m.</li> </ul> | Within 3 months |

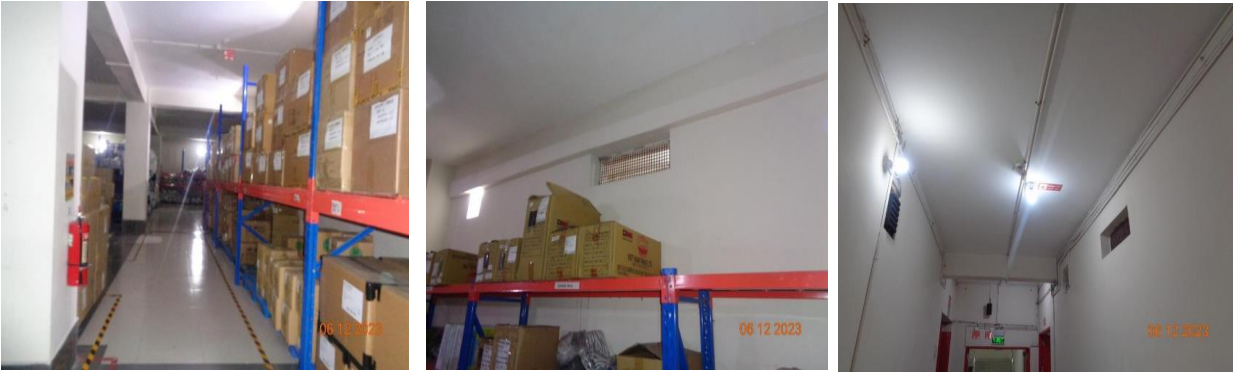
| F-3 | Fire Rated Construction | Room used for combustible storage are not separated by fire rated construction.<br>Location: Ground floor of Factory Building. | <p>Separate the dedicated storage rooms by minimum 1-hr fire-rated construction. Provide 0.75 hr. fire rated door and seal all penetrations and openings by 1 hr. fire rated barrier construction.</p> <p>Where separate storage rooms are not feasible, provide defined storage areas and limit the storage arrangement as follows:</p> <ul style="list-style-type: none"> <li>- Maximum height of 2.45m (8ft.) , maximum area of 23m<sup>2</sup> (250 ft<sup>2</sup>) and 3m (10ft.) clear distance from adjacent another unenclosed combustible storage.</li> <li>- If the building/floor is sprinkler protected: maximum height of 3.66m (12ft.) and maximum area of 93m<sup>2</sup> (1000 ft<sup>2</sup>).</li> <li>- In-process storage shall not exceed 10 percent of the building area of the story in which they occur. Separate areas of unenclosed combustible storage by a minimum clear distance of 3m.</li> </ul> | Within 3 months |

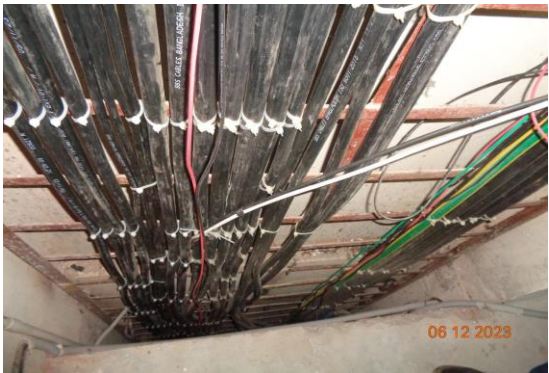
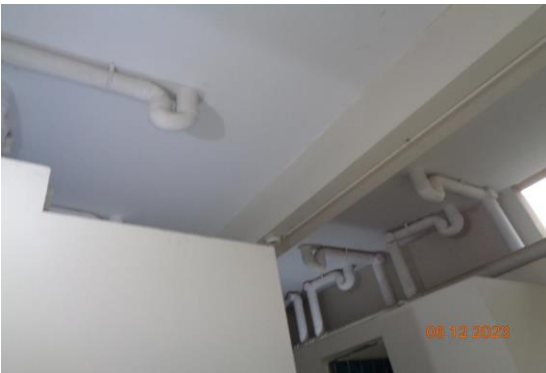
| F-4 | Fire Rated Construction | Unsealed penetrations and openings are located in the fire rated floor/ceiling assemblies due to passing BBT riser and pvc toilet pipe. | <p>Seal all penetrations and openings in floor/ceiling assemblies to maintain the fire separation at least by 3-hr. The used sealer shall be 3rd party certified and installation shall be as per manufacturer's guideline (Type-1 Construction).</p> <p>or,</p> <p>Provide a minimum 2-hr fire rated shaft to separate the utility risers from each floor if required (Type-1 Construction).</p> | Within 3 months |

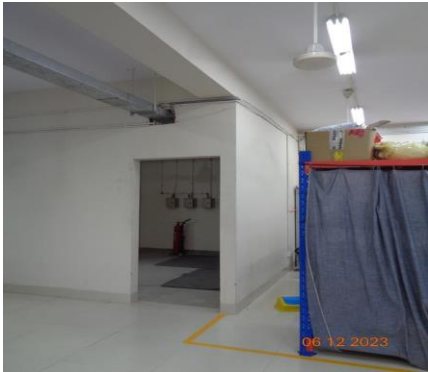
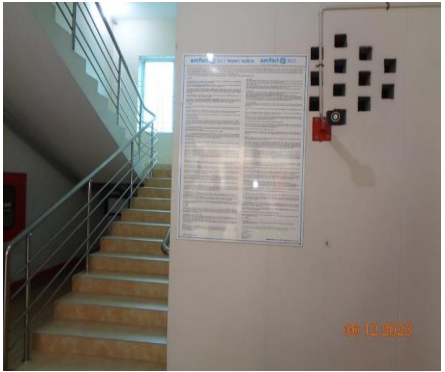
| F-5 | Fire Rated Construction | Unsealed penetrations and openings are located in exit stair enclosures. | Seal all penetrations and openings in exit stair enclosure walls to maintain the fire separation. | Within 6 months |

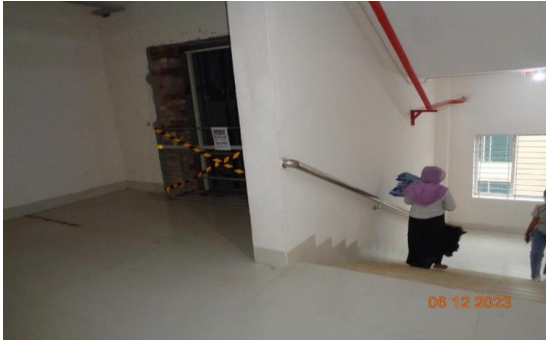
| F-6 | Fire Rated Construction | Elevator shafts are directly open into exit enclosure at Factory Building. | <p>For interim construction, an exit stairway shall not be built around a lift shaft unless both of them are located in a smoke proof enclosure and made of a material with fire resistance rating required for the type of construction of smoke proof enclosure (As per 6.14.3 of RSC Technical Guidelines (Standard) V1.0). So, separate the stair enclosure from elevator shaft throughout the building.</p> <p>Recommended to follow "SUPPLEMENTARY PAPER ON REMEDIATION GUIDANCE ELEVATOR OR LIFT SHAFT OPENING IN EXIT ENCLOSURES" for remediation.</p> | Within 3 months |

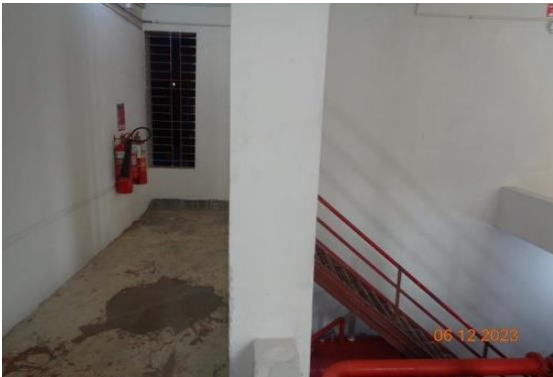
| F-7 | Fire Rated Construction | Fire Pump Room was not separated from Compressor room. | Provide fire pump room with 2 hr rated fire separation when not sprinklered and 1 hr rated fire separation when provided with automatic sprinklers, in accordance with NFPA 20. In the case exterior it shall be 50 ft away from another occupancy. | Within 3 months |

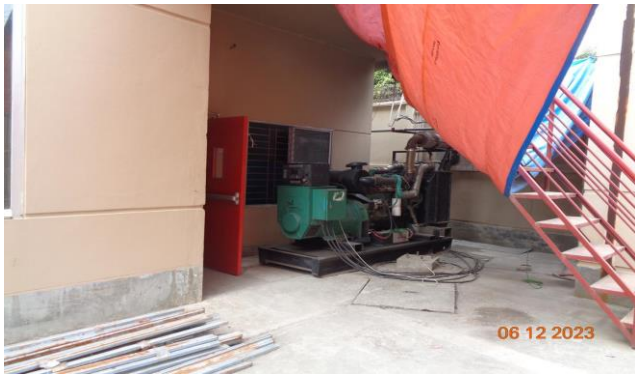
| F-8 | Fire Rated Construction | Generator Room was not separated from egress path. | <p>Separate the generator room by a minimum 2-hr fire-rated construction. Seal and/or protect all openings to maintain the required fire separations. When located to the exterior of a building 3m (10 ft.) spatial distance shall be maintained around the generator. Ensure proper ventilation for the generator room.</p> | Within 3 months |

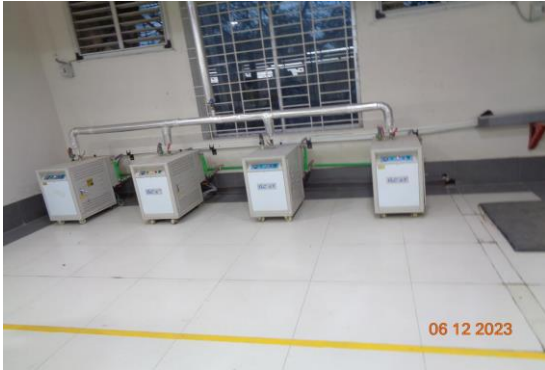
| F-9 | Fire Rated Construction | Boiler was not separated from production floor at 2nd floor, Factory Building. | Separate the boiler by a minimum 1-hr fire-rated construction. Seal and/or protect all openings to maintain the required fire separations. When located to the exterior of a building 3m (10 ft.) spatial distance shall be maintained around the boiler. Ensure proper ventilation for the boiler room. | Within 3 months |

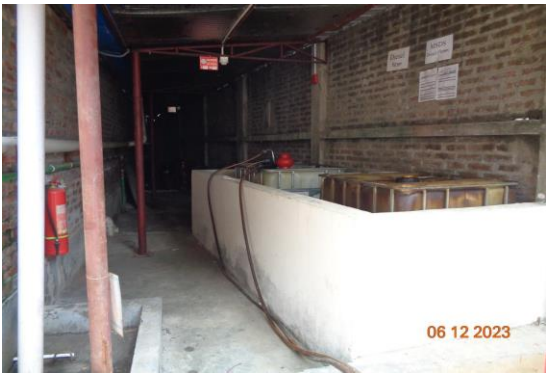
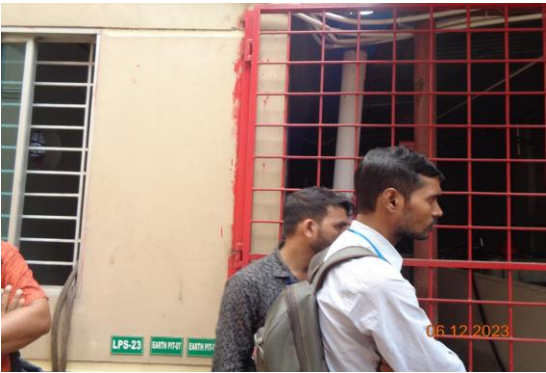
| F-10 | Fire Rated Construction | Hazardous materials / flammable liquid storage area is not separated by fire-rated construction.<br>Location: Diesel store with canteen shed. | Hazardous materials / flammable liquid storage shall be in compliance and separated in accordance with BNBC 2006 Part 3 Section 2.13. Seal and/or protected all openings to maintain the required fire separations. | Within 3 months |

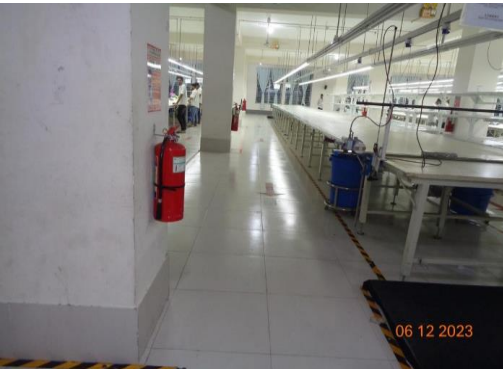
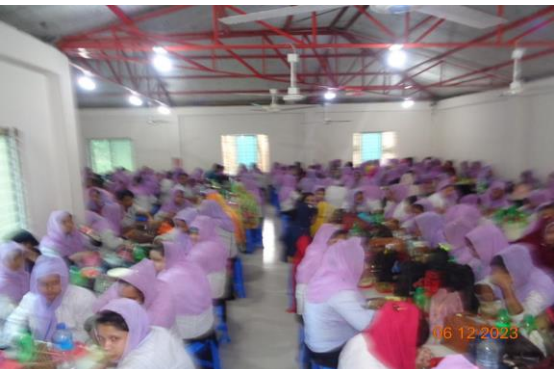
| F-11 | Means of Egress | Adequate aisles not found in the Factory Building & Canteen Shed. | Provide minimum aisle widths of 36 inch with proper marking & update on evacuation map. | Within 1 month |

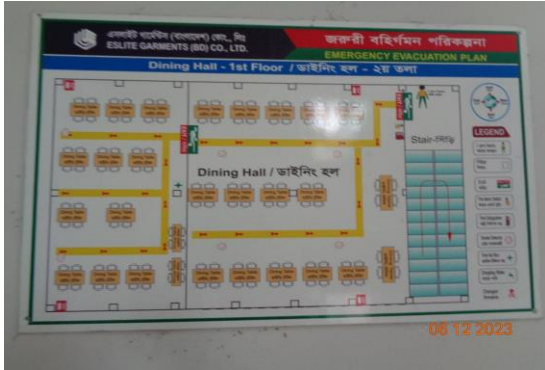
| F-12 | Means of Egress | A single means of egress is provided at Utility Building. | <p>Ground or basement story is allowed a maximum of 50 occupants and 23 m (75ft) travel distance.</p> <p>All other stories which houses utility or assembly occupancy require a minimum of 2 egress exits.</p> <p>Provide additional means of egress.</p> | Within 3 months |

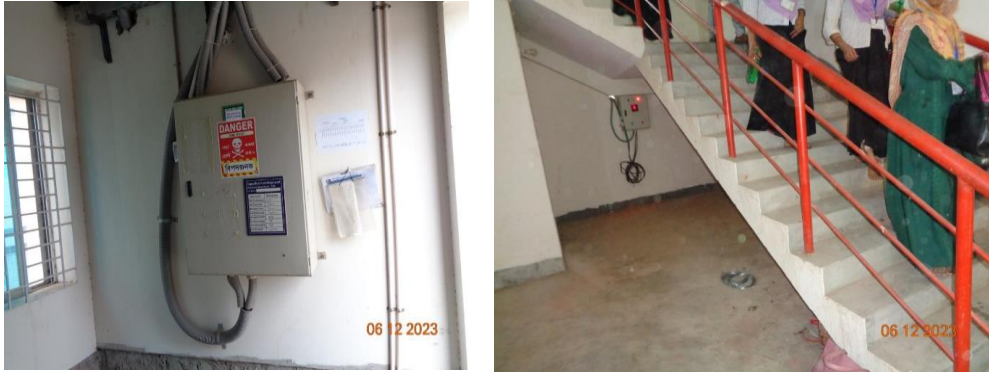
| F-13 | Means of Egress | Electrical Db was found at exit stair enclosure. | Remove all electrical panel or board from exit stair. | Within 1 month |

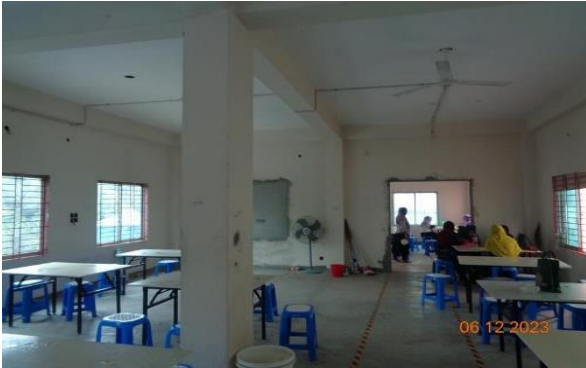
| F-14 | Egress Lighting | Based on the number and location of emergency lights observed, adequate illumination levels are not anticipated along egress routes. | Test the emergency lighting system on each floor and provide additional emergency fixtures to provide adequate illumination along the means of egress. Provide a minimum illumination of 10 lux at the floor level within exit stairs and exit discharge paths and minimum 2.5 lux along exit access aisles. | Within 1 month |

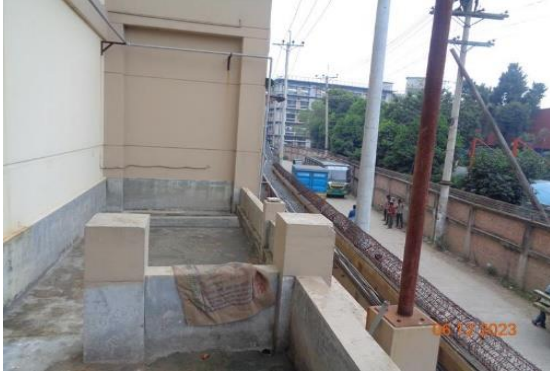
| F-15 | Means of Egress | Parapets or guards are not provided in occupied/occupiable balcony at 1st Floor North side Stair. | Provide parapets or guards with a minimum height of 1067mm (42 inch.). | Within 3 months |

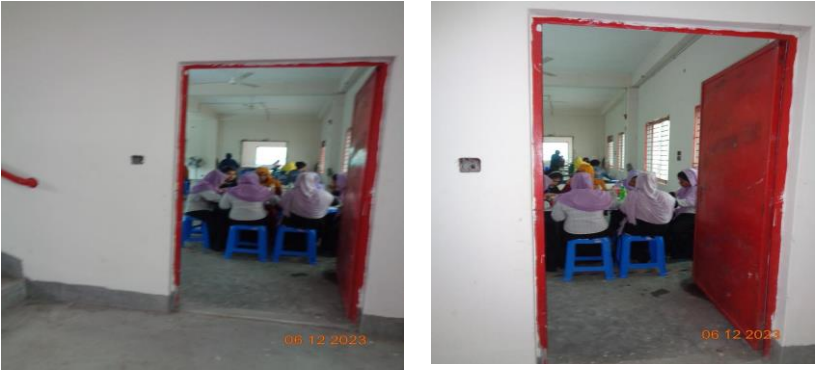
| F-16 | Means of Egress | Exit stair door is not swing in the direction of egress travel at Utility building. | Modify the egress door to swing in the direction of egress travel in a way that it does not swing over stair landing and does not reduce the exit width. | Within 1 month |

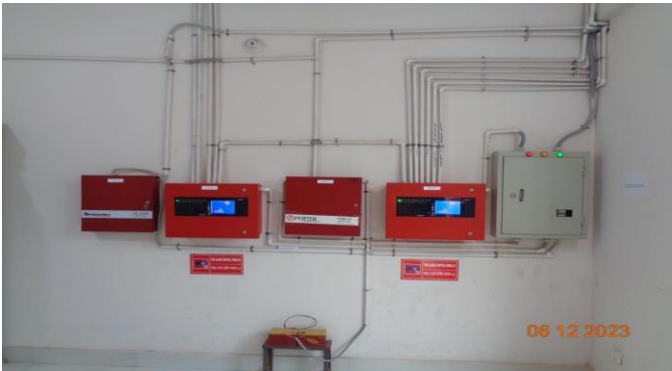
| F-19 | Fire Alarm & Detection System (FADS) | The factory has installed Fire alarm and detection system which requires detailed review to confirm compliance with NFPA 72 and RSC Technical Guidelines (Standard). | <p>Submit the fire alarm system design to RSC for review. Once the design is reviewed, install and modify the fire detection and alarm system throughout the buildings in accordance with review comment, RSC Technical Guidelines (Standard) and NFPA 72.</p> <p>After installation the owner shall conduct internal testing and commissioning and then contact the RSC for witness of final acceptance testing. Also inspect, test and maintain the fire alarm system, and keep written records on-site, in accordance with Table-14.3.1 of NFPA 72.</p> | Design Review within 2 months and installation/modification within 3 months |

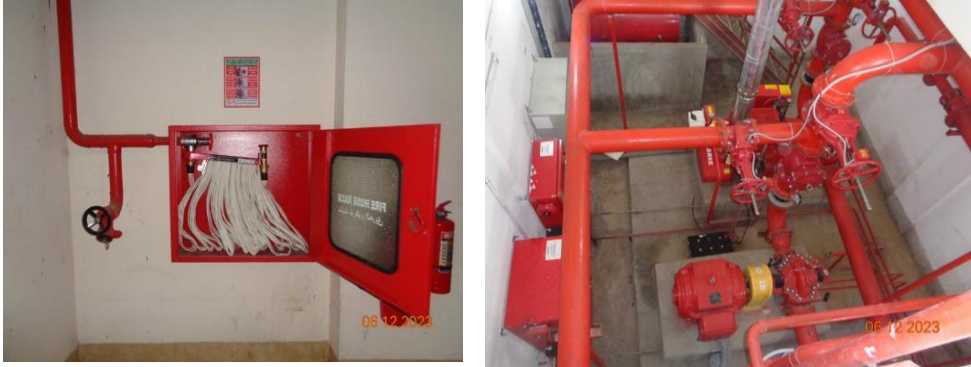
| F-21 | Fire Protection System (Standpipe) | The factory building has an occupied floor greater than 10 meter (33 feet) and installed a standpipe protection system which requires detailed review to confirm compliance with NFPA 14 & 20 and RSC Technical Guidelines (Standard). | Submit the proposed design of standpipe system to RSC in accordance with NFPA 14 & 20. Installation shall be as per the reviewed design with a listed Standpipe & Fire Pump System. | Design Review within 2 months and installation/modification within 3 months |
